700-bar Hydrogen Dispenser Hose Reliability Improvement

Kevin Harrison (Primary Contact), Owen Smith
National Renewable Energy Laboratory
15013 Denver West Parkway
Golden, CO 80401-3305
Phone: (303) 384-7091
Email: Kevin.Harrison@nrel.gov

Fiscal Year (FY) 2018 Objectives

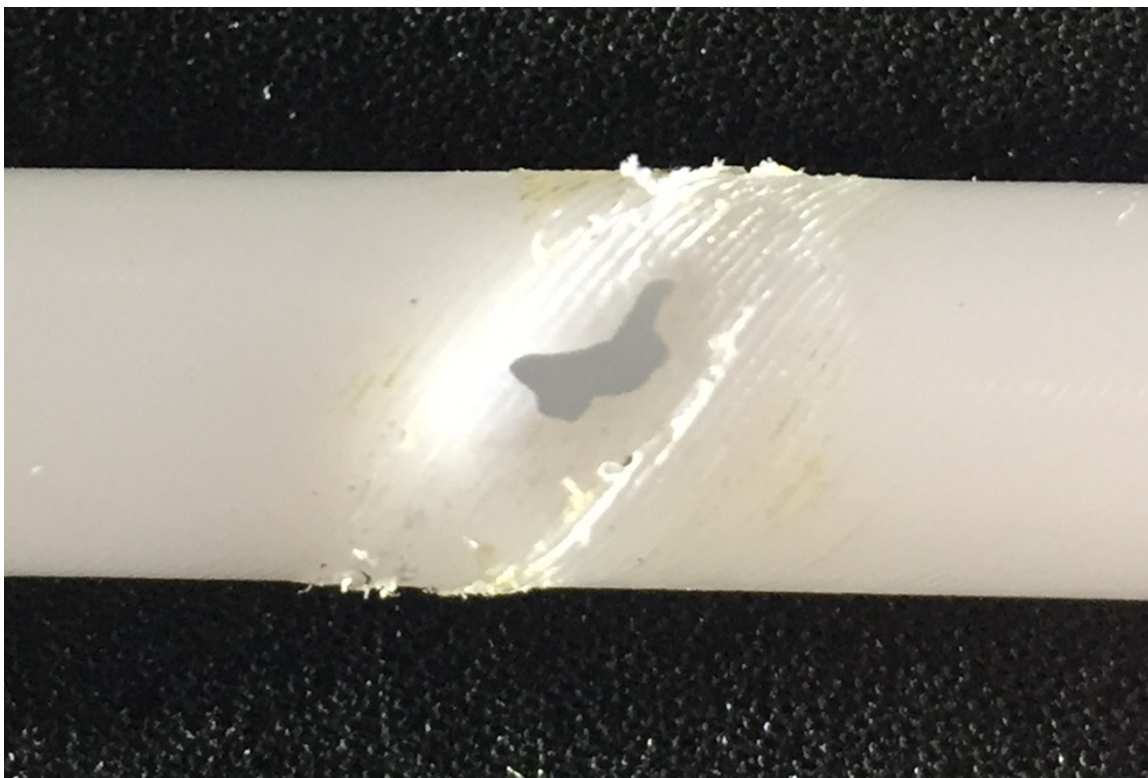
Figure 2. Hose inner-core pinhole leak and general damage

- Examined failure mode of pinhole leak and found evidence of plastic deformation and expanded polymer fibers near one end of pinhole. Other areas of pinhole exhibited sharp edges and loose fibers consistent with shear failure.

During disassembly of hose layers, each layer was inspected. The outer polyamide layer had a 25-mm large blister rupture due to buildup of leaking gas. All the steel overwrap braid layers were intact and undamaged. The polyoxymethylene inner core had significant damage, with an irregular through-wall hole and impressions on the external surface caused by the innermost steel overwrap braiding (Figure 2). There is no protective layer

between the innermost steel overwrap and the polyoxymethylene core. There was some extrusion of polymer material observed between the braids close to the failure location.

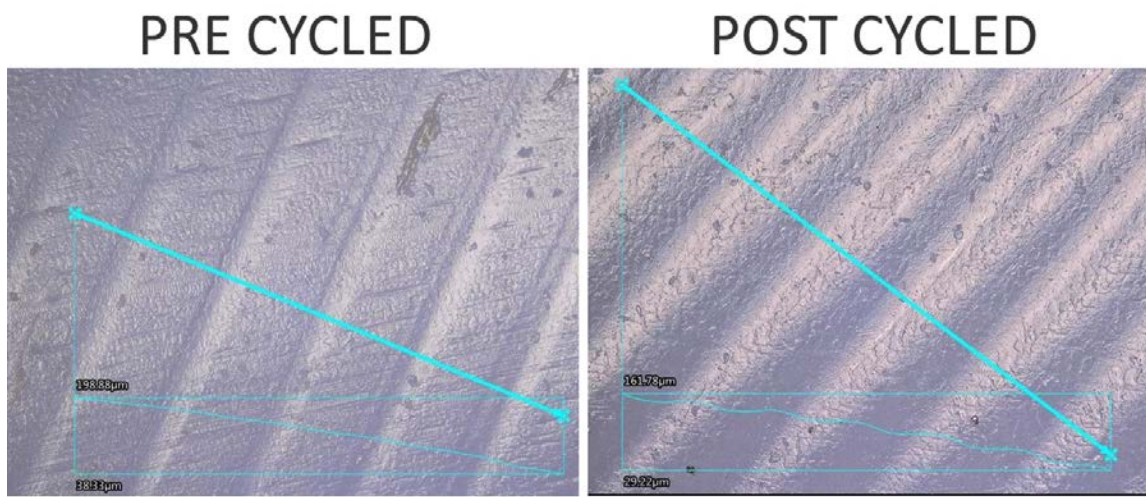
Figure 3. Comparison of wire-overwrap impressions on pre-cycled and post-cycled hose core

- Using optical microscopy and depth composition at 1,000-times magnification, groove impression depths were measured at 18 μm to 21 μm , a factor of 6 to 7 times deeper than a sample of pre-cycled hose with 2.5–3.2 μm impressions.

A Keyence VHX-5000 optical microscope with 1,000X lens and depth composition was used to measure the impression depths from the steel overwrap, compared to a pre-cycled specimen. The post-cycled failed sample was examined on the reverse side from the failure point. The measured impressions were 18–21 μm , and the pre-cycled specimen had impressions measured at 2.5 μm to 3.2 μm deep in the mid-hose (Figure 3). This is a factor of 6 to 7 times greater than pre-cycled, suggesting that continuous flexing of the inner braiding is impacting the core wall thickness and strength.

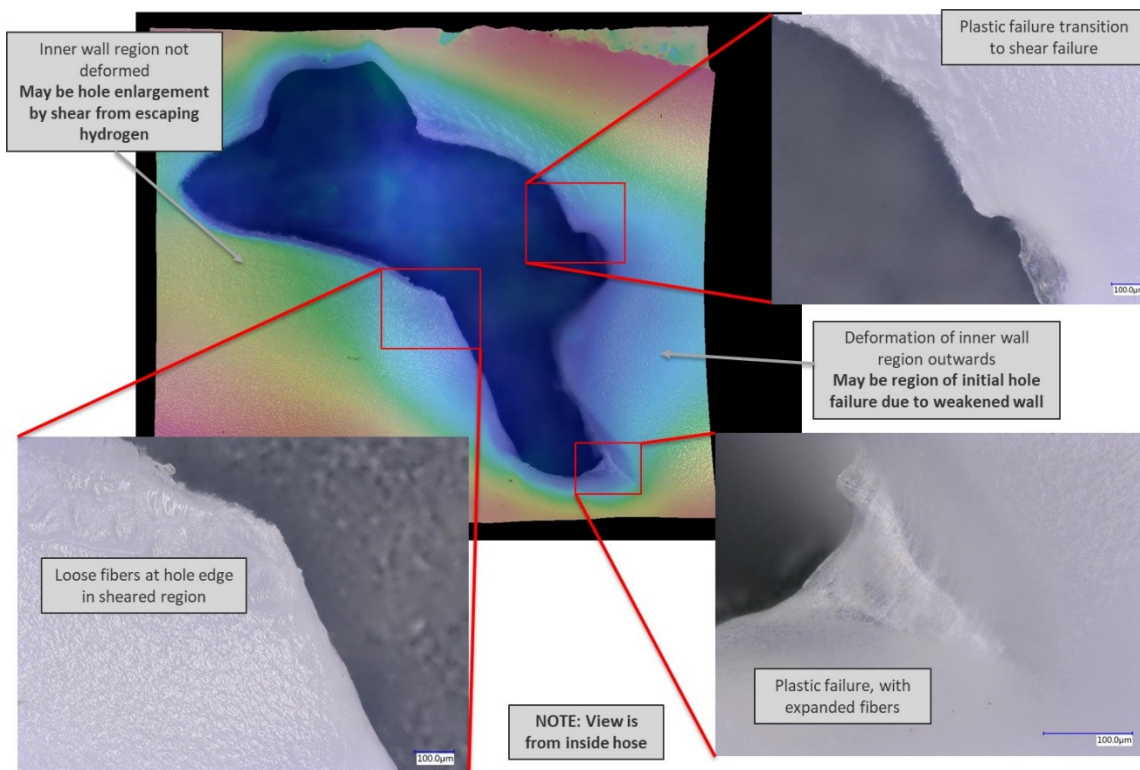
Figure 4. Analysis of pinhole leak failure modes

- Explored for evidence of high-density blistering on polyoxymethylene inner wall caused by hydrogen decompression. High-density blistering results were inconclusive, but large blister was observed 5 mm from failure with an area of 1,375 μm^2 , protruding 17 μm into hose core.

The pinhole leak was examined from the inside by cutting the core open, and evidence of plastic deformation and expanded polymer fibers was found near one end of the pinhole. Other areas of the pinhole inner wall exhibited sharp edges and loose fibers consistent with shear failure, suggesting that the pinhole leak started at soft spots in the wall and proceeded to expand through the core wall due to shear action of escaping hydrogen as shown in Figure 4. Small particulates from 90–300 μm were found on the outside wall, but no major particulates were found in the inner wall. The polyoxymethylene inner wall also was examined for evidence of high-density blistering caused by hydrogen decompression. Results were inconclusive at 1,000X compared to pre-cycled specimens, though some large isolated blisters were observed near the failure location. The largest blister observed was 5 mm from the failure location, with an area of 1,375 μm^2 , protruding 17 μm into the hose core.
