700 Bar Hydrogen Dispenser Hose Reliability Improvement

Kevin Harrison (P.I.)
Owen Smith (Presenter)
National Renewable Energy Laboratory
June 14, 2018

DOE Hydrogen and Fuel Cells Program
2018 Annual Merit Review and Peer Evaluation Meeting

Project ID # PD100

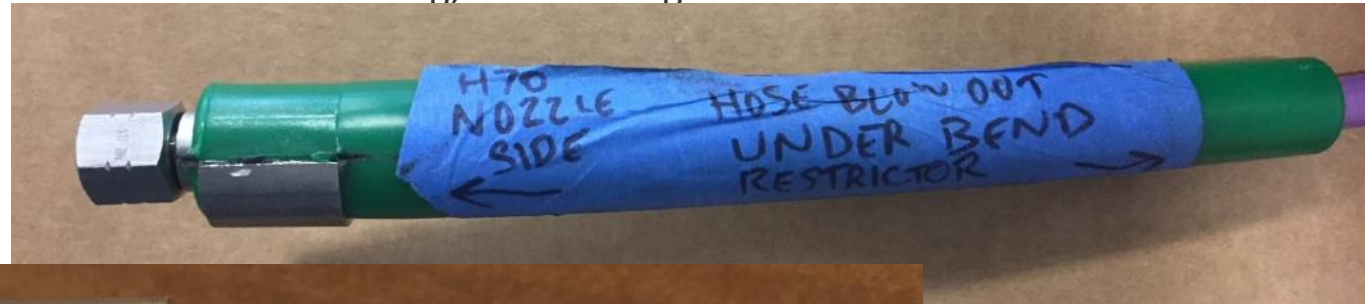
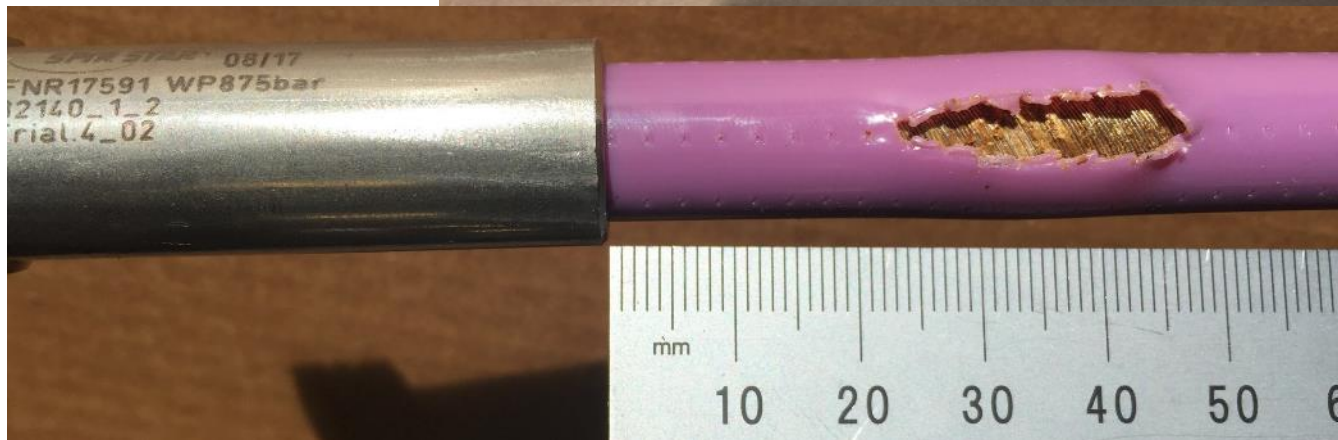
- “Still experiencing through wall failures. Blisters form on the ID which ultimately lead to a hole in the inner liner. The SS braids maintain hose integrity, but not pressure integrity. MTBF is on the order of 1000-2000 cycles.”
- Specific hose from station – had 250mm long, 16mm ID rigid bend restrictor

- 25 mm blister on outer jacket, centered 35 mm from nozzle crimp – similar location of consistent leaks on SpirStar hose #2. No other apparent blistering on outer layer or signs of damage on crimp.
- Wire braiding intact, yellow dirt observed between braiding and outer layer.
- Failed to hold any pressure – leaks from nozzle end. 275kPa leaks to atmosphere within 3 seconds.
- Observed some leaks still coming from permeation pinpricks during bubble check.

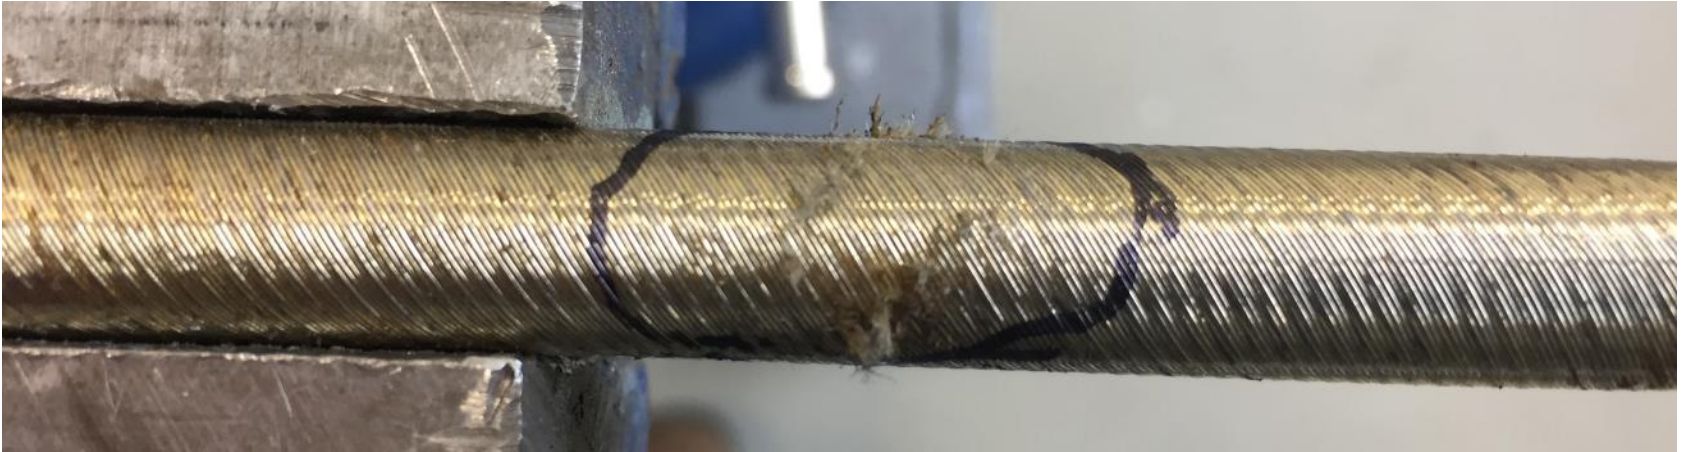
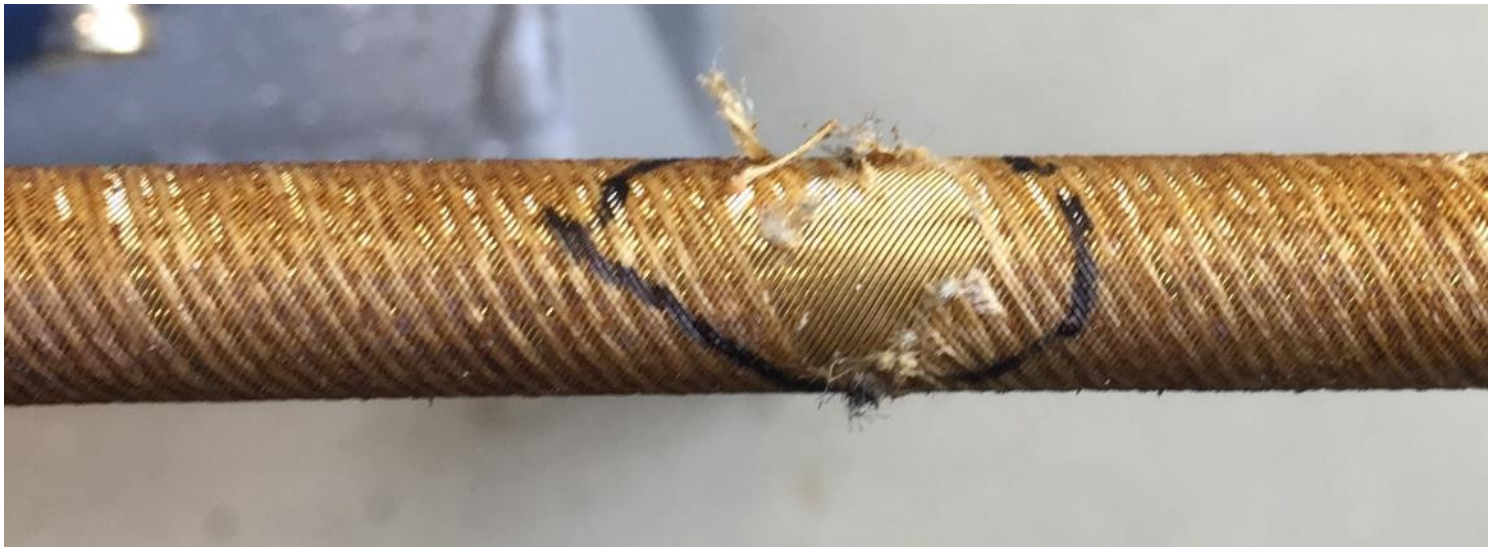
– Outer polyamide layer removed – fiber wrapping seen protruding through steel overwrap

- Fiber wrap layers blown out by escaping gas for each layer. Steel wrap integrity intact. No damage or irregularity seen in any of the steel wraps, including first one directly on polyoxymethylene layer

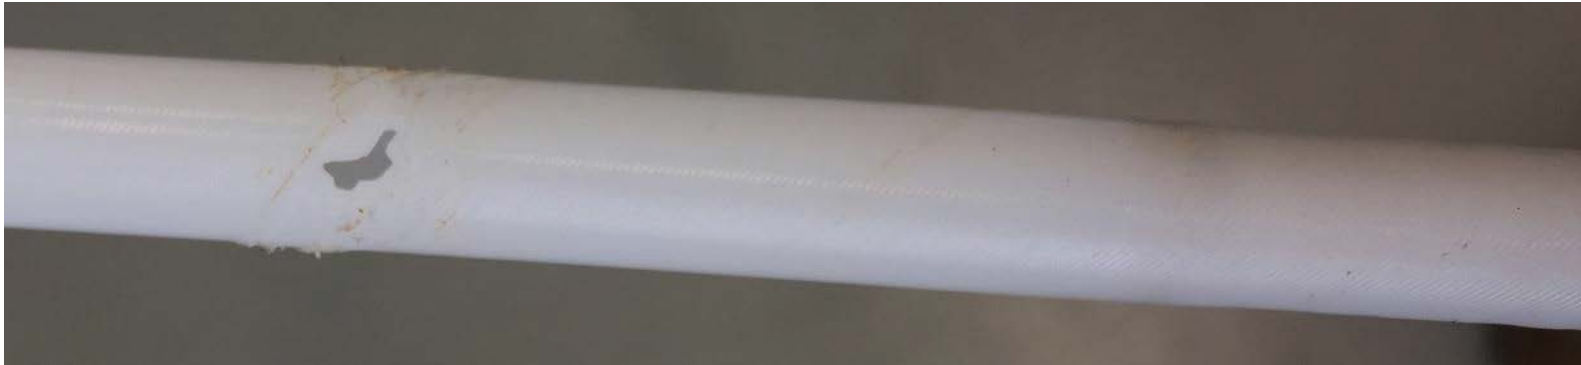
- All steel overwrapping removed. Polyoxymethylene inner layer shows light marking from steel overwrap and slight deformation from crimp fitting.

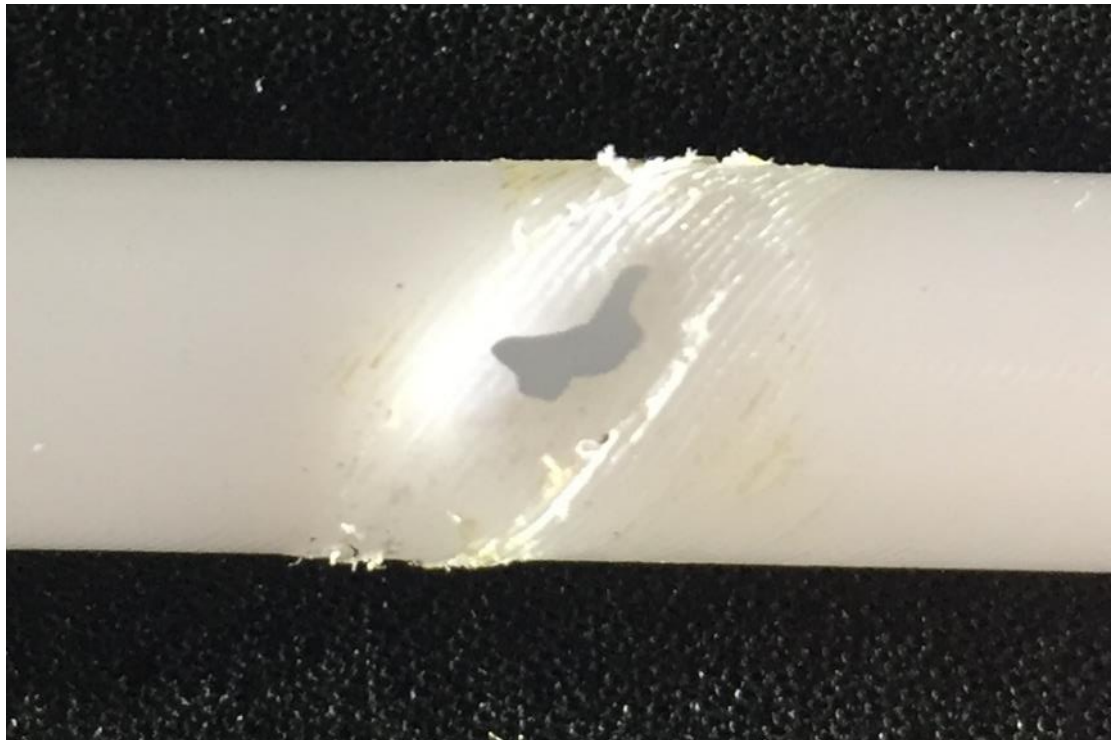
- Large hole in layer source of leak. Significant damage
- Hole irregularly shaped, 3.7mm x 1.3mm.
- Located along inner radius of longitudinal bending curve
- Gouge in inner layer following direction of first steel overwrap braiding, 9.2mm x 3.3 mm
- No protrusion into ID of hose
- Dirt observed in and around gouge

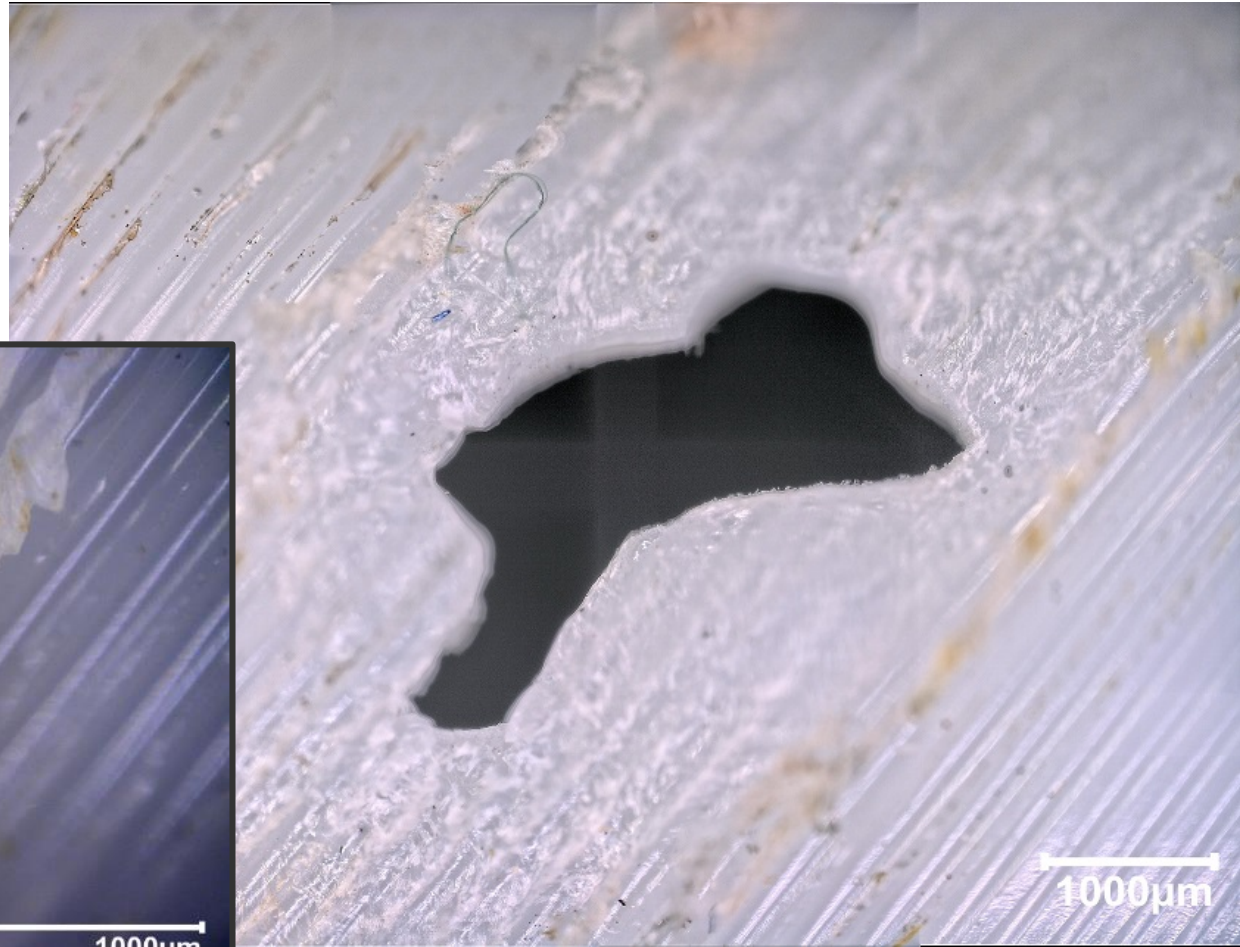
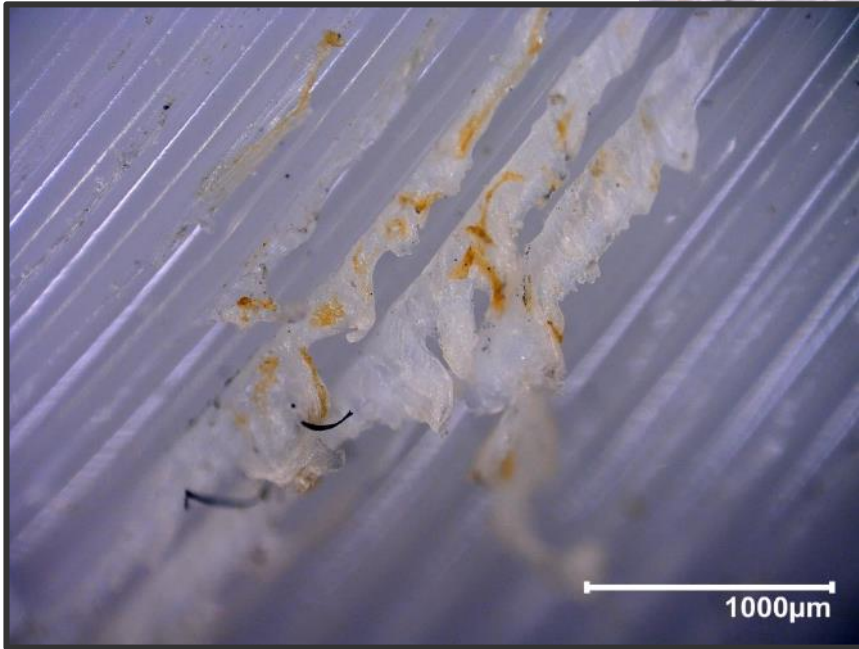
- Metal particles found distributed around hole
- Rust residue seen around polyamide outer layer hole
- 91-297 μm avg particulate size
- Extrusion of polyoxymethylene between wire braiding

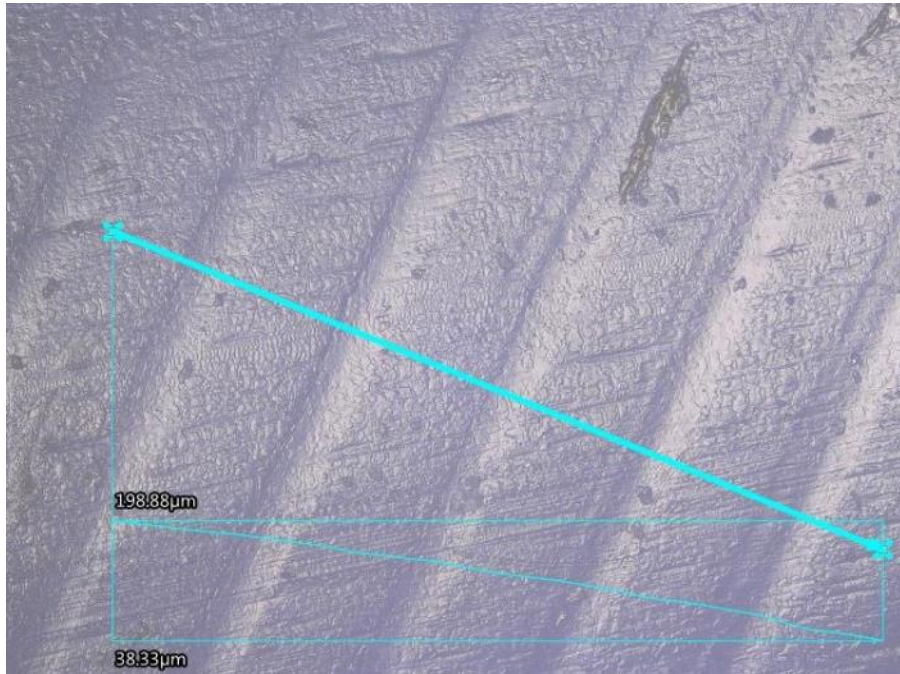
PRE CYCLED

- Visible wire imprints along entire length of hose
- Sample taken from mid-range of hose
- Average depth of imprint: 2.5-3.2 μm

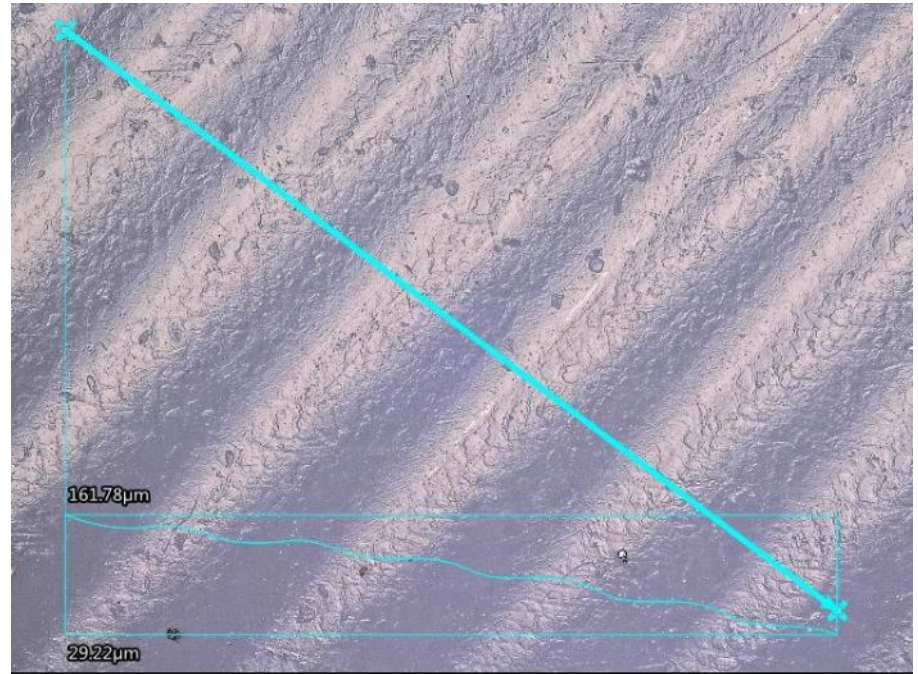
POST CYCLED

- Visible wire imprints along entire length of hose, more pronounced closer to nozzle end crimp fitting
- Sample taken from 7.5cm from end of hose, reverse side of failure area
- Average depth of imprint: 18-21 μm – **6-7x deeper**

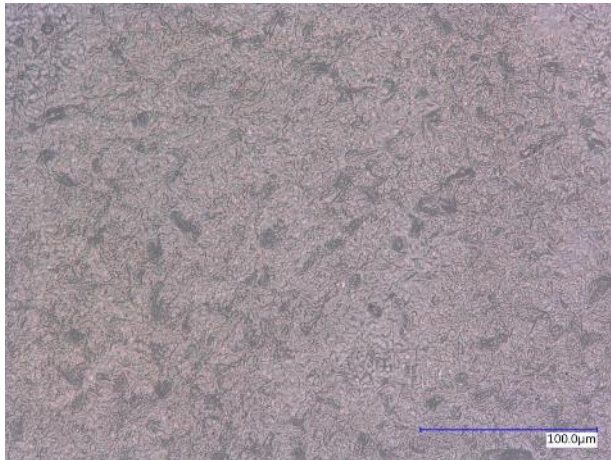
1000X magnification, surface appears glossier

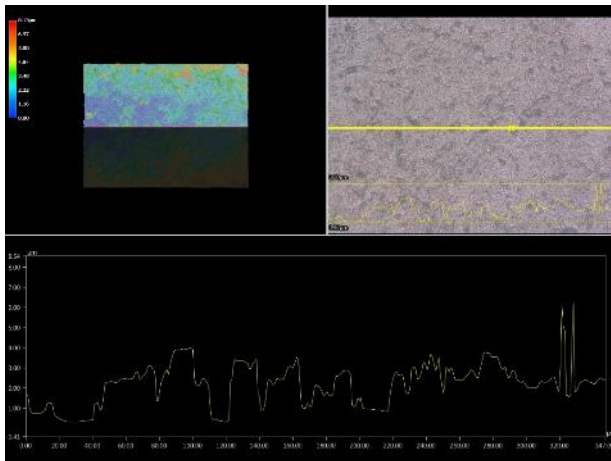
.75-3 μm depth, 15-30 μm width of surface irregularities

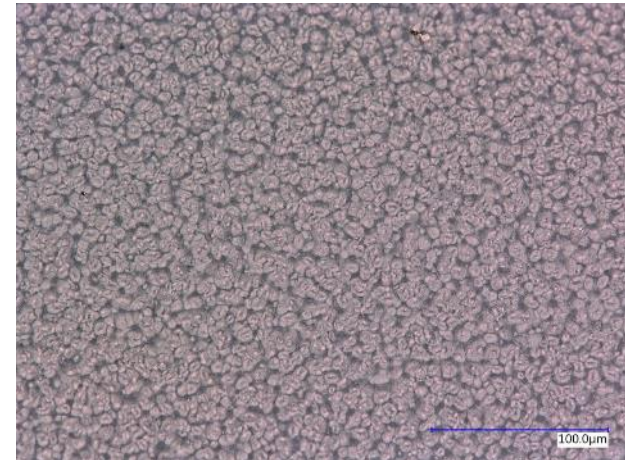
1000x magnification, surface appears more coarse

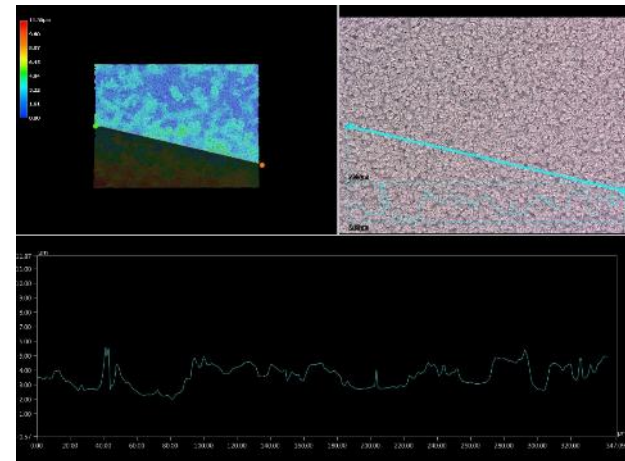
1-3.5 μm depth, 11-34 μm width of surface irregularities

Superficial change in surface, but no significant change in measured surface roughness at 1000X magnification that would indicate high-density blistering in mid-hose sample

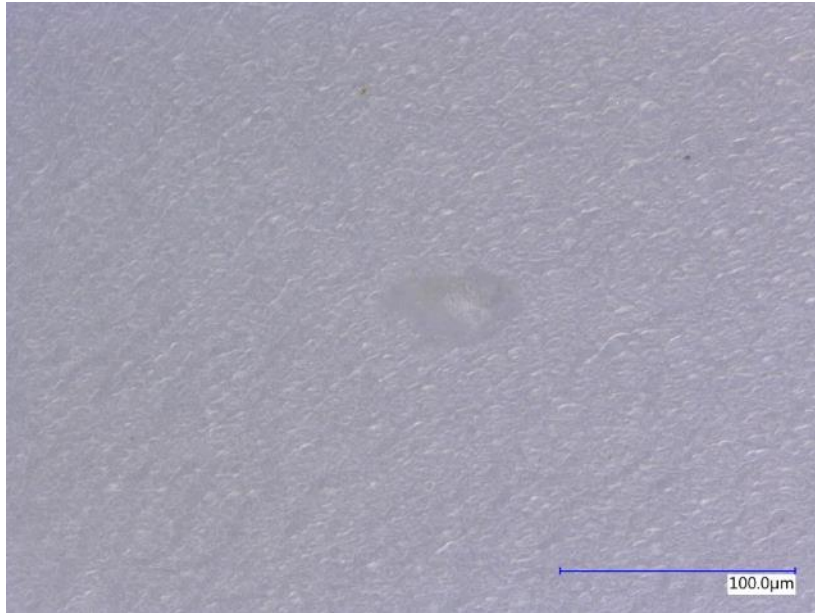
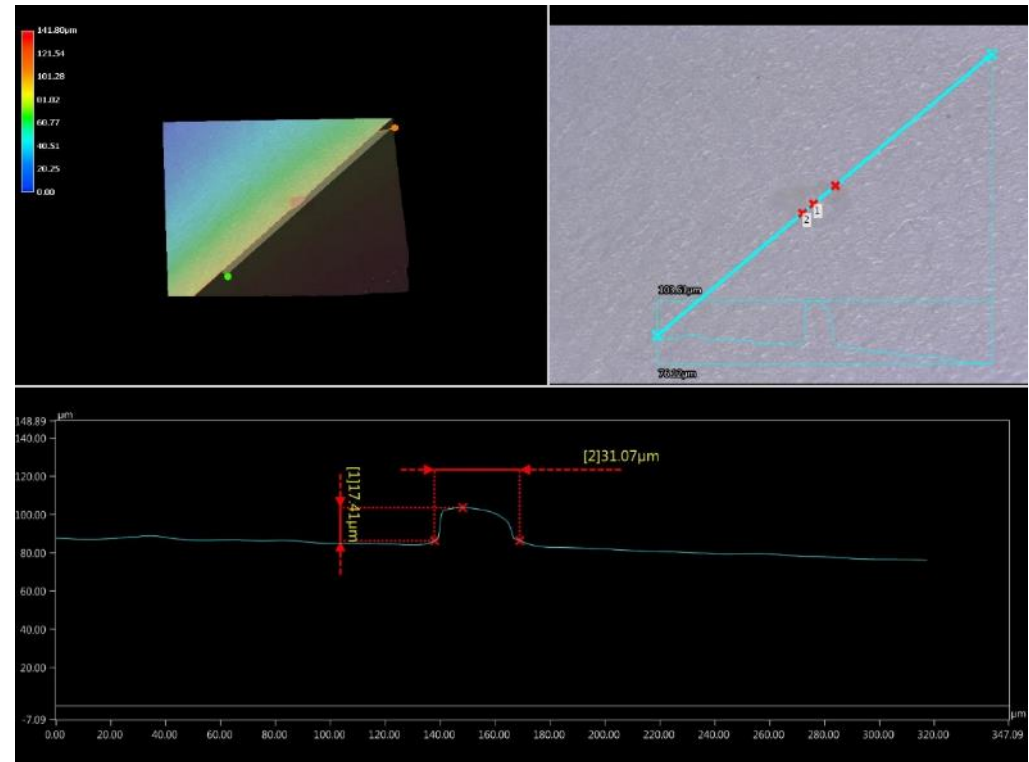
- **Large blister discovered in sample at about 5mm away from failure region**
- Isolated blister, no other similar ones discovered nearby. Not suspected to be contaminant particle
- Blister protrudes into hose inner wall 17 μm, about 1375 μm² area

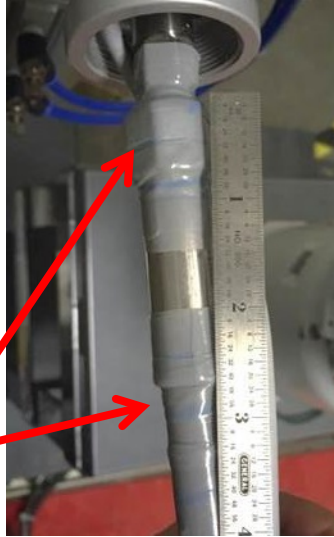
Before

- Tape wrapped around hose near crimp fitting, and on metal fittings with leak detection ports
- No indications were seen after rechecking after 100 cycles without leaks

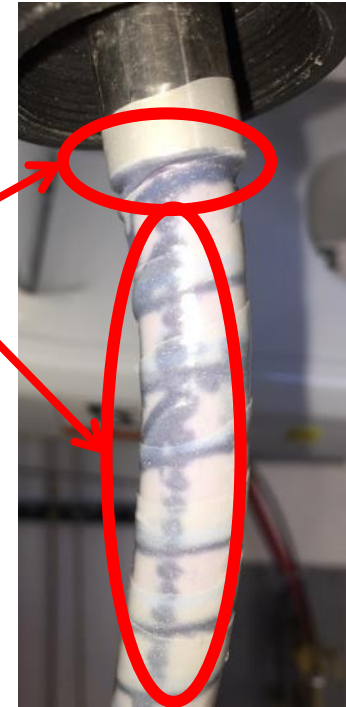
After – 1000 cycles

- Indication** seen on edge of hose crimp. May be due to gap between tape and fitting.
- Clear indications** seen on hose outer layer pinpricks at the nozzle-end crimp, around hose circumference
- No visible physical damage observed on hose surfaces, including at crimp fitting
- No indications on metal fitting leak detection ports

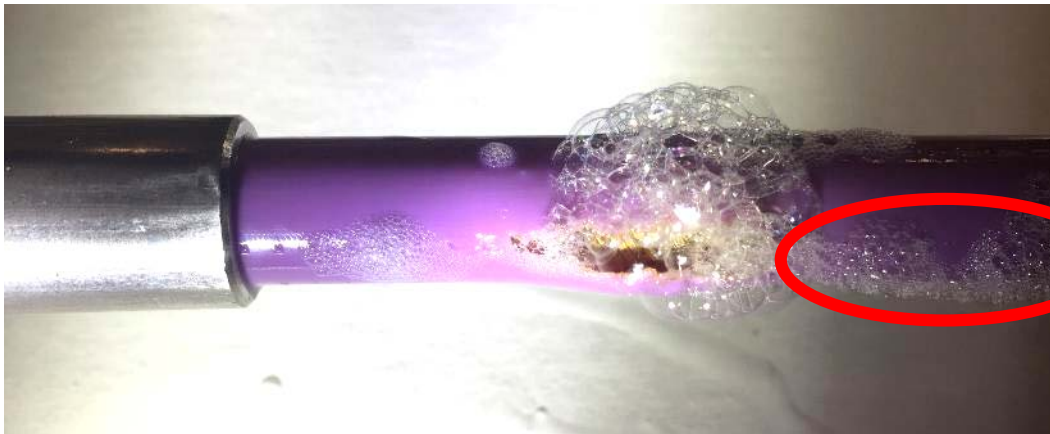
Comparison with Failed Sample:

- Only one large leak source on failed sample
- Bubbles seen coming through nearby pinpricks during nitrogen test of failed sample. Likely transfer of gas through steel wire braiding
