700-bar Hydrogen Dispenser Hose Reliability Improvement

Kevin Harrison (Primary Contact), Owen Smith
National Renewable Energy Laboratory
15013 Denver West Parkway
Golden, CO 80401-3305
Phone: (303) 384-7091
Email: Kevin.Harrison@nrel.gov

Fiscal Year (FY) 2018 Objectives

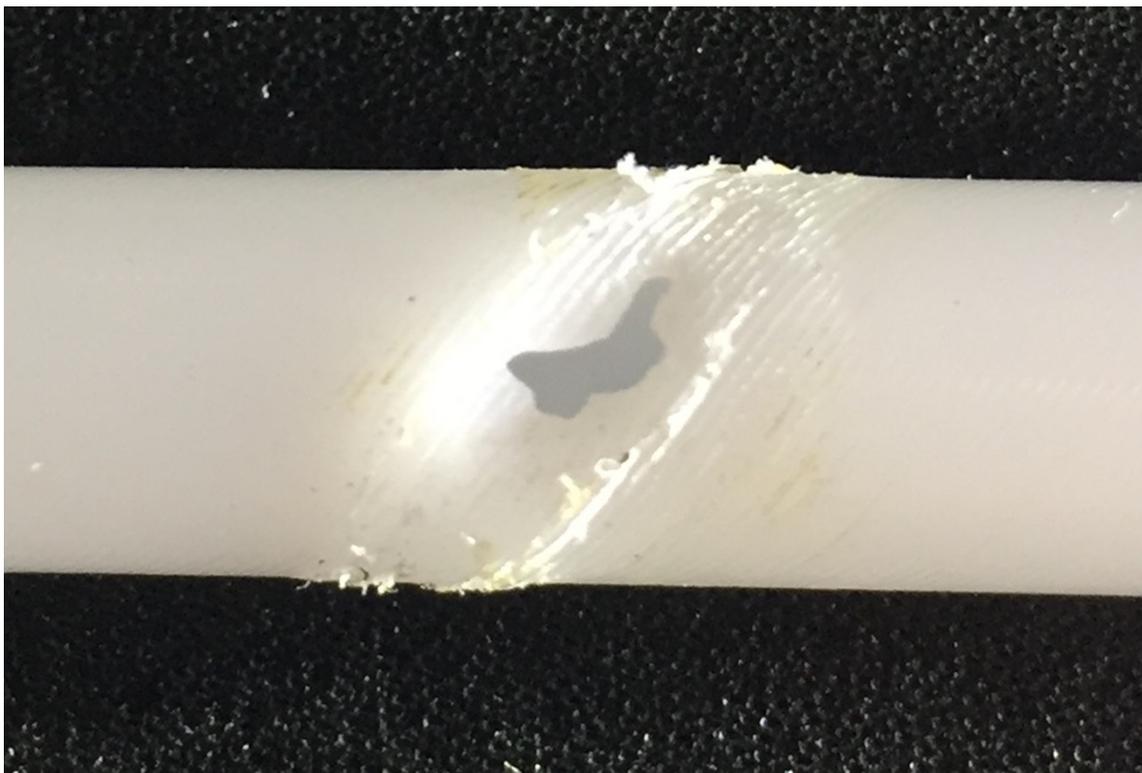
During disassembly of hose layers, each layer was inspected. The outer polyamide layer had a 25-mm large blister rupture due to buildup of leaking gas. All the steel overwrap braid layers were intact and undamaged. The polyoxymethylene inner core had significant damage, with an irregular through-wall hole and impressions on the external surface caused by the innermost steel overwrap braiding (Figure 2). There is no protective layer

between the innermost steel overwrap and the polyoxymethylene core. There was some extrusion of polymer material observed between the braids close to the failure location.

Figure 2. Hose inner-core pinhole leak and general damage

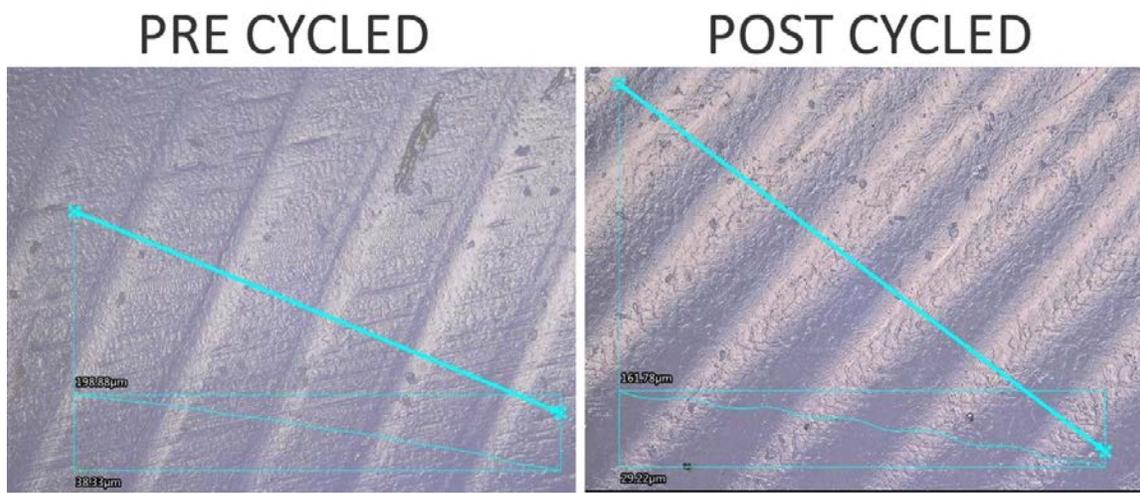
A Keyence VHX-5000 optical microscope with 1,000X lens and depth composition was used to measure the impression depths from the steel overwrap, compared to a pre-cycled specimen. The post-cycled failed sample was examined on the reverse side from the failure point. The measured impressions were 18–21 μm , and the pre-cycled specimen had impressions measured at 2.5 μm to 3.2 μm deep in the mid-hose (Figure 3). This is a factor of 6 to 7 times greater than pre-cycled, suggesting that continuous flexing of the inner braiding is impacting the core wall thickness and strength.

Figure 3. Comparison of wire-overwrap impressions on pre-cycled and post-cycled hose core

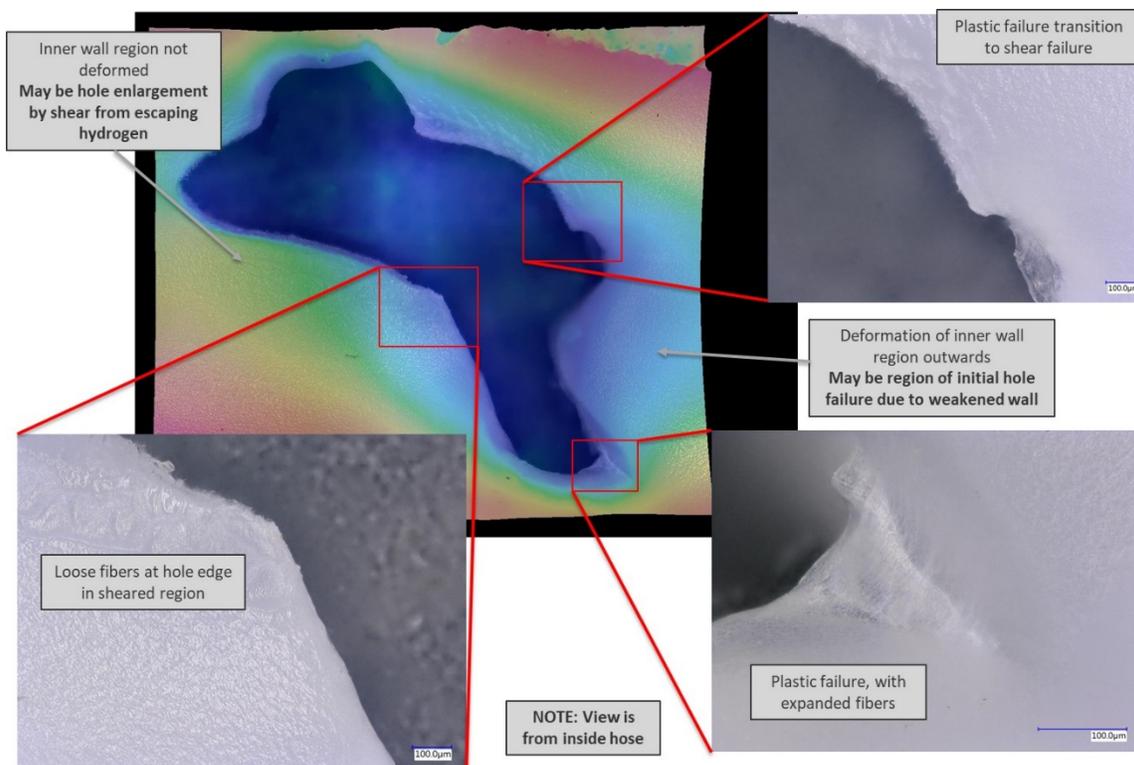
The pinhole leak was examined from the inside by cutting the core open, and evidence of plastic deformation and expanded polymer fibers was found near one end of the pinhole. Other areas of the pinhole inner wall exhibited sharp edges and loose fibers consistent with shear failure, suggesting that the pinhole leak started at soft spots in the wall and proceeded to expand through the core wall due to shear action of escaping hydrogen as shown in Figure 4. Small particulates from 90–300 μm were found on the outside wall, but no major particulates were found in the inner wall. The polyoxymethylene inner wall also was examined for evidence of high-density blistering caused by hydrogen decompression. Results were inconclusive at 1,000X compared to pre-cycled specimens, though some large isolated blisters were observed near the failure location. The largest blister observed was 5 mm from the failure location, with an area of 1,375 μm^2 , protruding 17 μm into the hose core.

Figure 4. Analysis of pinhole leak failure modes
