III.5 Demonstration of Full-Scale Glass Fiber Composite Pressure Vessels for Inexpensive Delivery of Cold Hydrogen

Andrew Weisberg (Primary Contact),
 Salvador Aceves, Tim Ross, Blake Myers
 Lawrence Livermore National Laboratory (LLNL)
 P.O. Box 808, L-260
 Livermore, CA 94551-0808
 Phone: (925) 422-0864
 E-mail: weisberg1@llnl.gov

Subcontractor:
 Spencer Composites Corporation (SCC), Sacramento, CA

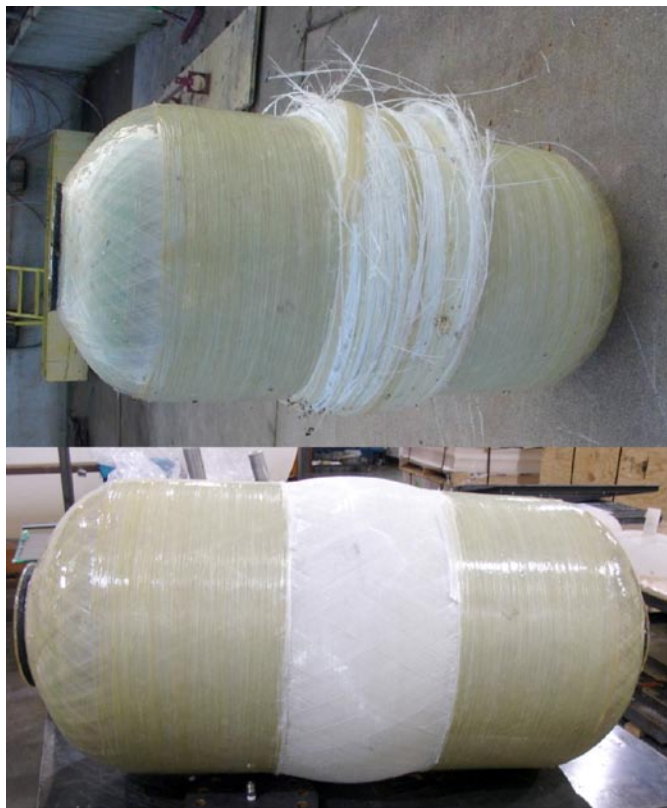
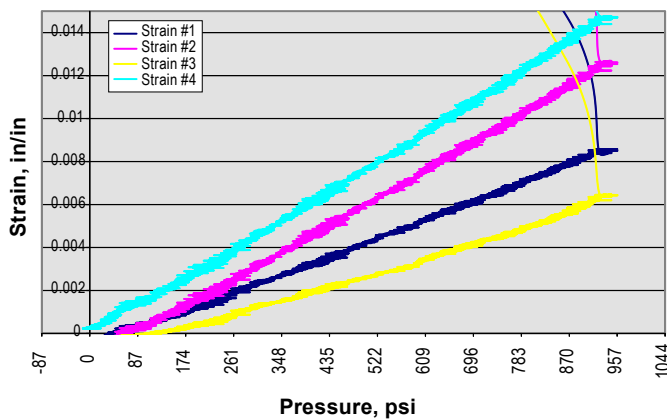
DCPD Liner Burst Test 1/10/11

The first successful burst test of a full-scale (23" diameter, length over 50" that can satisfy ASME Code X certification requirements for all greater lengths) is illustrated in Figure 1. This test was performed with pressurized water to meet permit requirements at SCC's facility in Sacramento, CA. Testing CPVs filled with compressed hydrogen over a period of weeks is planned to prove that full-scale CPVs do not permeate at maximum operating pressure.

FIGURE 1. Successful Burst Test of Trailer-Scale CPV – Figure 1 shows a 23” diameter glass fiber composite pressure vessel that was burst tested with compressed water at ambient temperature. The photograph above shows the CPV after burst was declared, with its composite overwrap layer shredded. The vessel did not actually rupture, but lost most of its pressure and no fluid escaped. This is a very unusual outcome, due to the unprecedented toughness of SCC’s liner material. The middle photograph shows the bulge that formed in the unruptured liner, which accounts for an internal volume increase of roughly 3%, and is enough to explain the depressurization due to the relative incompressibility of water. The bottom figure illustrates four strain gage traces during this test, which prove this CPV’s manufacturing is adequate for designs that ‘burst’ at any pressure within the capabilities of plumbing seals.

into the article shown in Figure 1. That burst test vindicated the improved liner molding process, because it ended in an unprecedented CPV failure mode, which might be called burst without rupture. Just because all the water remained inside after a loud noise and a big pressure drop does not mean this mode is really safer, since gaseous contents would not have dropped in pressure with just a little midriff bulge. But the survival of the liner in that bulge region does prove that the liner remained ductile under rapid straining to over 11% strain. Since design hydrogen delivery pressures only call for 3% liner strain, the liner component that has caused this project so much trouble has been proven to operate beyond its requirements at full scale.

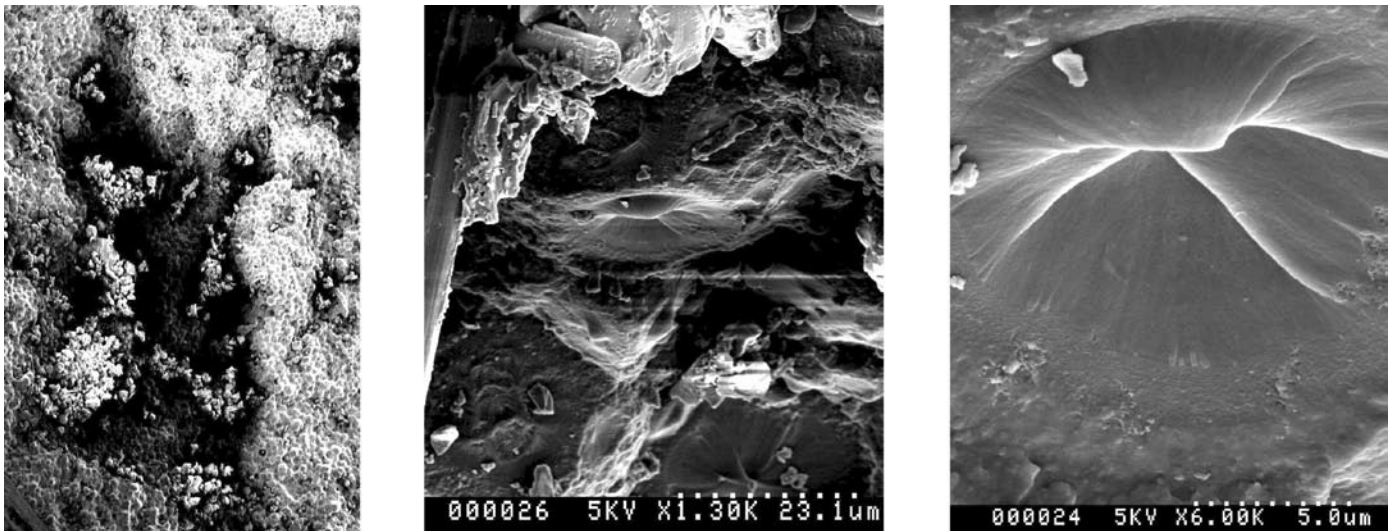
The correct diagnosis was based on SEM imaging of the entire crack surface from the failed 23” liners. The cracks forked, with forks not left on the failure surface being those that didn’t run faster than those that formed the surface. These ‘diving’ forks were later seen on examination with low power optical microscopy, saving considerable time in the SEM. The direction that the ‘tines’ of these forks pointed must be the crack propagation direction, so the crack initiation region was localized between a single pair of forks whose tines pointed away from each other. In that region, shiny surfaces gave way to slight localized frostiness; presumably before the crack propagation ramped up to high speed and could take advantage of orders of magnitude stress concentration at its crack tip. Those frosty regions are represented by the SEM sequence that appears in Figure 3, which focuses in on the “smoking gun” feature found on the complex surface of a diving fork.

That feature is a crater sticking up into a void, but not like craters seen in geology or astronomy. New materials have new failure modes, and this one occurred when the resin was a weak gel. Earlier SEM diagnosis had already determined that the forked cracks in the vicinity of crack initiation were not running in the maximum strain energy release direction (perpendicular to local tension), but went curling around with geometries that might be seen on the surface of puddings that had dried from neglect. The crater feature in question has sharp edges, but these could not have formed when ejecta blew into the void it sticks up in. Gas erupted through the surface of a weak gel into that void, then the gel shrank to form facets on the crater. Although density

measurements have long shown a 6% densification of this resin upon solidification, how that shrinkage was distributed in space did not appear to matter. After LLNL's diagnosis, it was clear that the plastic was cracking itself just where it ran out of more liquid for a wave of catalysis to solidify.

FIGURE 3. SEM Photographs of Liner Crack Surface – Figure 3 shows the “smoking gun” sequence of SEM photographs of a particular portion of the surface whereat a full scale (21” diameter) liner cracked inside of an early-2010 burst CPV. None of these features are visible in an optical microscope, and the sequence of photographs taken at the same point on the failed specimen increase in magnification from left to right. This particular spot was close to the origin of the crack that ruined this liner, causing the test CPV to leak below 800 psi and 0.7% nominal axial strain. The detective work that found the crack origin vicinity is based on forks in the cracked surface, whereat branches of the crack that did not succeed in forming part of the final separation surface dive beneath the surface on view. The origin of the crack must be somewhere between the two forks whose branches point away from that region. Looking into a fork of the crack, in the middle photograph shards of 2.7 micron glass fiber are visible which have been blown into a diving fork branch. On the wall inside that branch the odd “flying saucer” that appears centered in the micrograph at right initially resisted interpretation (since SEM views do not have darkness reflecting tilt angles as optical views do), but many attempts to view it at different angles convinced SEM operators this is a crater with sharp radial ridges.

Knowing what went wrong did not initially make it clear how to fix it. Another wave of dozens of 3" bottles became the front line for variations in the mold tool and resin pour sequence. Control was taken over where catalysis started, and care taken to never let the catalysis wave pass through liquid resin up against a solid wall, either of the mold or of previously solidified plastic. A technique was found to locate defective regions of castings without breaking them and to prepare the shards for SEM imaging, that is shown in Figure 4. But the next question was whether the project could afford to rebuild the 23" tool to incorporate these necessary improvements. The answer appeared to be no, before a real customer for such CPVs showed up in late summer of 2010. The customer could and did pay for a new tool which LLNL's liner mold fit into, but wanted CPVs built faster than SCC had any confidence they might pass ASME certification. This led to an extreme scramble to get LLNL development done on the tool the customer paid for, before the customer got its parts.

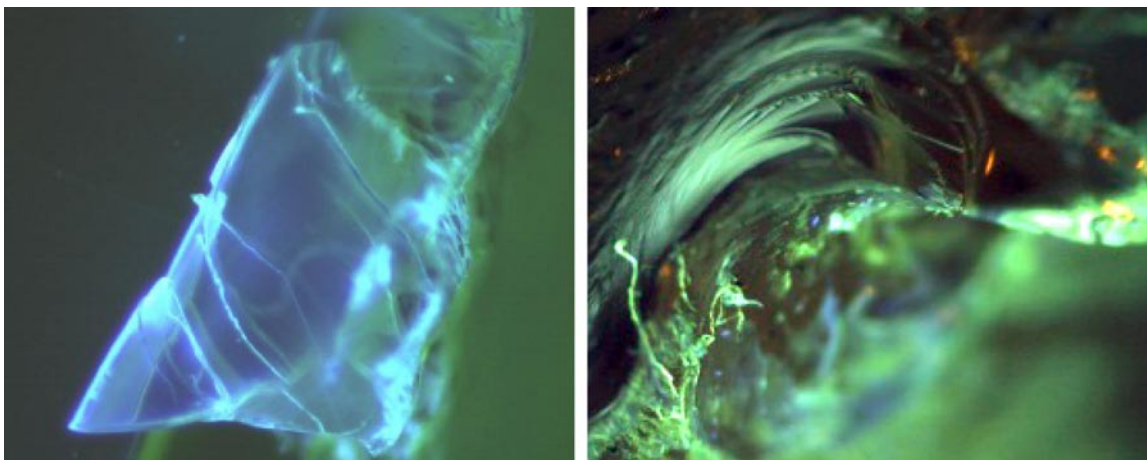
Further surprises were in store when the happily undestroyed vessel in Figure 1 was cut into to see how well its liner's end dome was cast. If the vessel had burst in a more normal way, the region wherein more 'defects' were found might have been lost. Instead Figure 4 shows failure surfaces that have nothing to do with the performance of the CPVs LLNL and SCC are building, and everything to do with the nature of the new material we are developing. Composites built with this material as a matrix have all the right properties, including fiber 'translation' (material tensile strength divided by raw fiber strength) over 90% and no strength loss at 77 K. Castings built with it, however, can have localized frosty regions whereat catalysis ran out

of resin. This generation of 23’ liners just happens to have one of those regions in a ring on its outer mold line (OML, casting terminology for exterior molded surface). The 3” liners that were cracking had several such regions on their inner mold line (IML, interior surface), and that surface goes into tension when the liner inflates, whereas the OML region on the 23” liners goes into compression.

The defective regions were actually visible to the naked eye, with the aid of a flashlight, when looked at through the polished edge of the burst success liner end dome cut out segment. They appear as a tenuous frostiness, which LLNL has come to term ‘nanocracking’, since any frosty region on a cast surface has the kind of frosty surface shown in Figure 3 when examined in the SEM. Once cast into the part, the penetrant dye that visualizes these regions in Figure 4 cannot get in to detect them, but when bar shaped specimens cut with this region in the middle were broken, the dye can be used to decorate the cracks. A forked crack is visible in the left micrograph of Figure 4, which was broken in tension at extreme elongation. A much more complex swirl appears in the right hand micrograph which failed at a few percent strain in torsion.

FIGURE 4. Observed Cracks in Specimens of Successful Liner – Figure 4 shows the splendid images resulting from two crude strength tests performed in a vise. These photographs are taken at low magnification with an optical microscope (commonly called a macroscope), in a combination of ultraviolet and visible illumination. SCC developed a diagnostic technique to make defective liner casting regions visible without a SEM, using a penetrating fluorescent dye. While the SEM cannot image regions likely to initiate cracks buried within cast parts, this technique cannot image defects directly on surfaces. Since the successful liner had not broken during burst testing, it made a fine vehicle to see whether defective regions could be found before they triggered cracks. This ‘experiment’ was conducted in January of 2011 by plunging an industrial vibratory cutter into the dome region of the unruptured yet burst CPV, then taking the wedge cut from the dome through a band saw to cut test specimens. The specimen at left was pulled with a vise grip pliers, and failed at over 100% strain, while the one at right was twisted and failed at several percent strain. They both failed in the millimeter-thick circumferential region where cloudy fuzziness is visible when polished edges of the wedge were illuminated by flashlight, on which the band saw cuts were centered to produce test specimens 3” long by roughly 0.3” square.
