Composite Technology for Hydrogen Pipelines

**Barton Smith, Barbara Frame,
Lawrence Anovitz**
Oak Ridge National Laboratory

**Annual Merit Review
Arlington, Virginia
May 19, 2009**

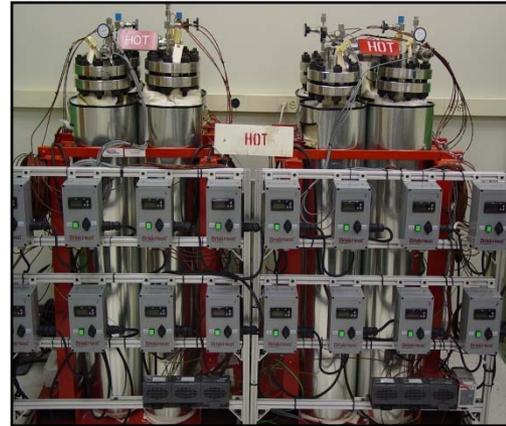
H₂ exposure station at SRNL

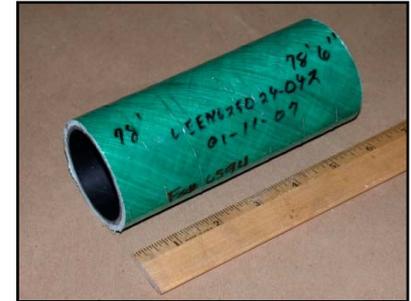
Pipeline test specimens

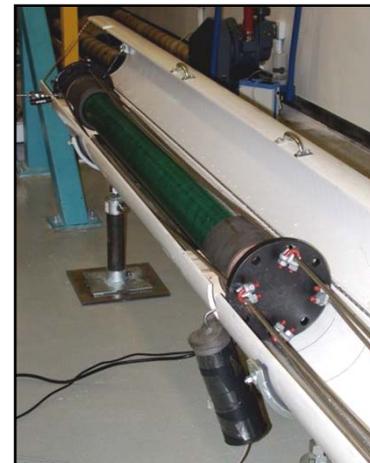
Leakage measurement at ORNL

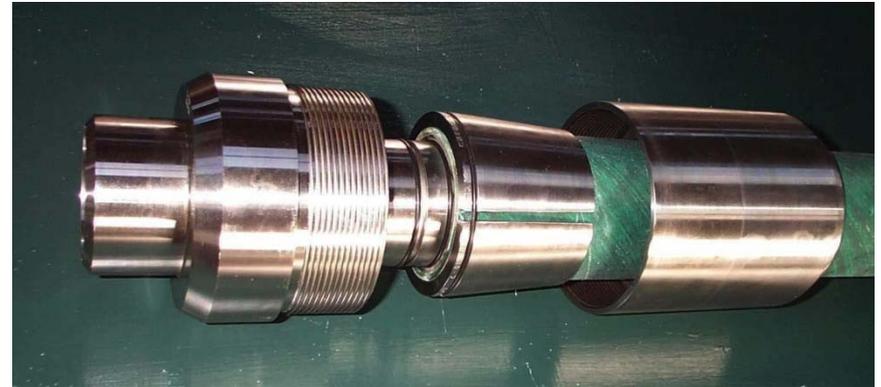
FiberSpar connector with compressive o-ring seals

- **Joining and sensor technologies**
 - Hydrogen leakage through Fiberspar LinePipe™ connectors is very low, $<3 \times 10^{-6}$ mol/s
 - Collaborative effort underway with SRNL to assess joint loading, pipeline flexure, and pressure/temperature cycling on hydrogen leakage for both Fiberspar and PolyFlow connectors

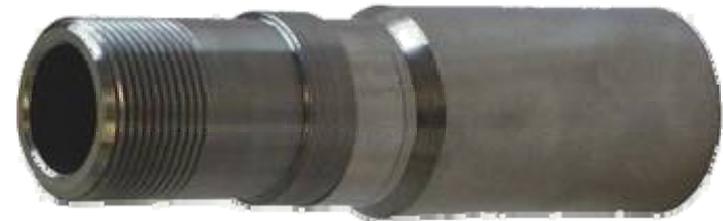
PolyFlow swaged connector

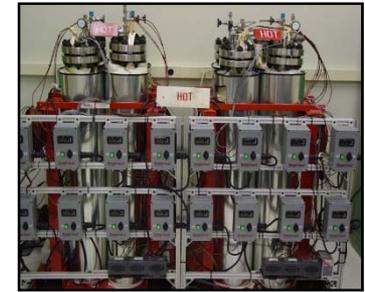
SRNL H₂ exposure station

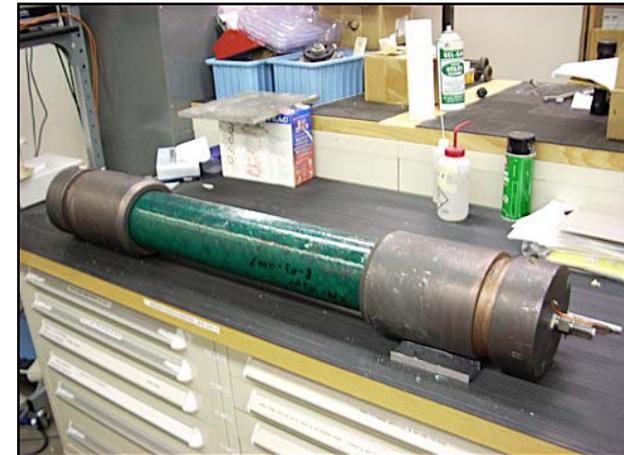
3-ft pipeline specimen being instrumented for blowdown testing

- **Guidance: API 15S - Qualification of Spoolable Reinforced Plastic Line Pipe, Appendix D**
 - **Specimen filled with hydrogen* to pressure rating, specimen heated to temperature rating, these conditions held until pipeline structure is saturated with gas**
 - **Following hold period, specimen depressurize at a rate greater than 1000 psi/min**
 - **Following blowdown, specimen liner was examined and no visual evidences of liner blistering or collapse**

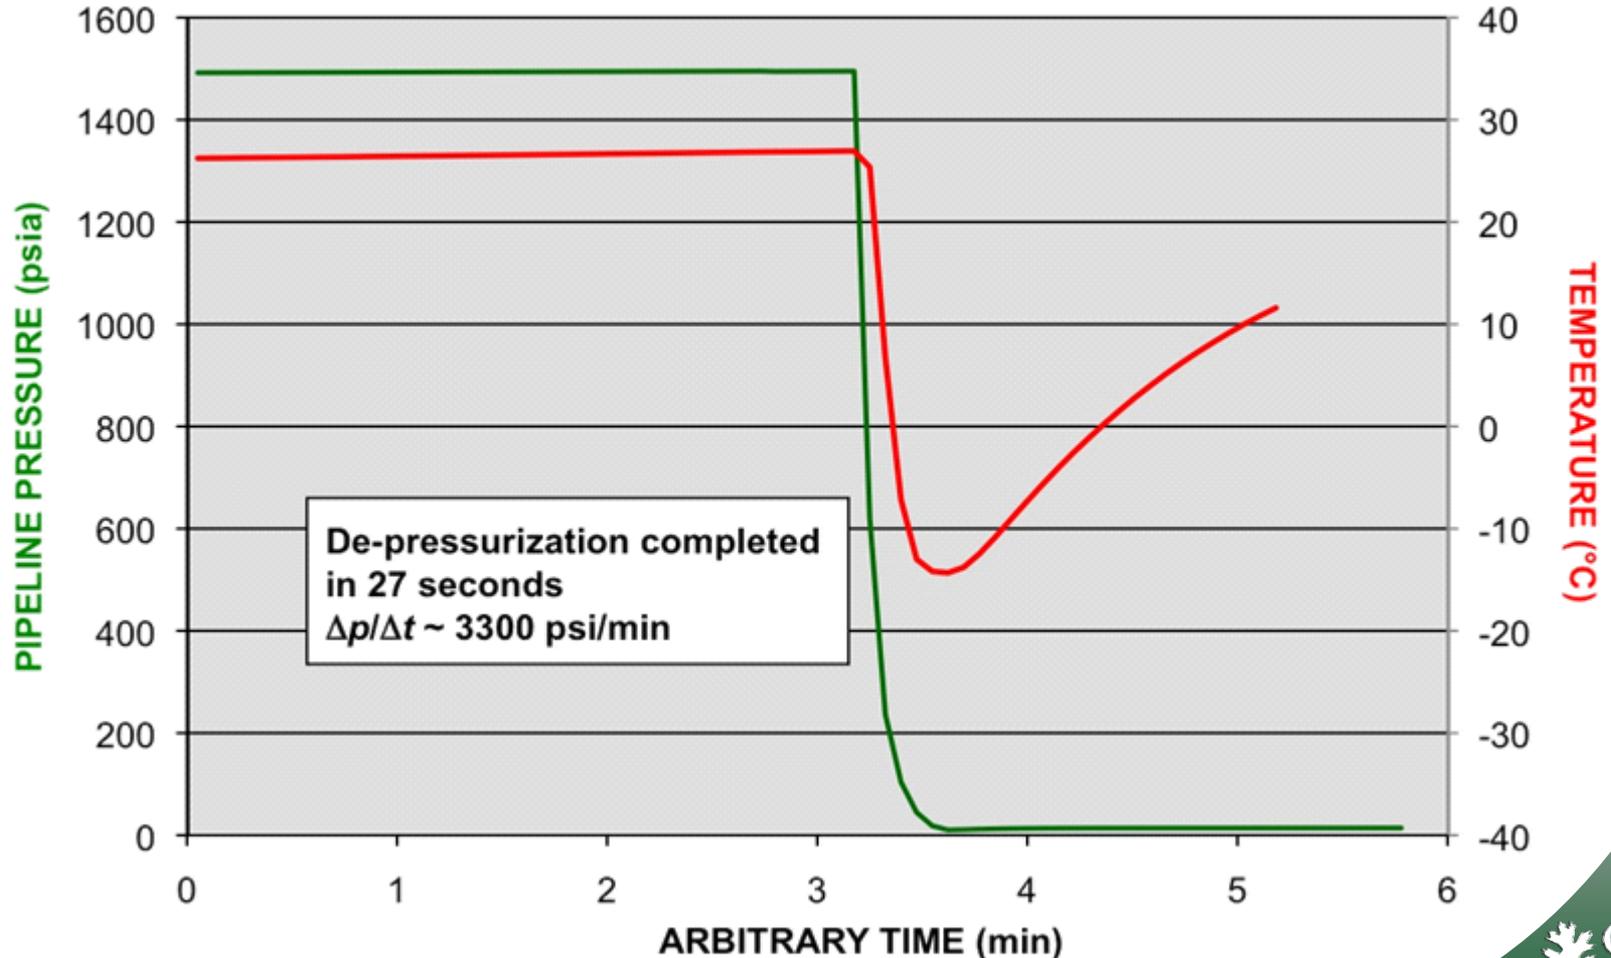
HYDROGEN BLOWDOWN TEST IN FIBERSPAR LP 4-1/2 1,500(E)
3-FT PIPELINE SPECIMEN
DE-PRESSURIZATION PROFILE

Blowdown de-pressurization rate was 3X specified minimum rate

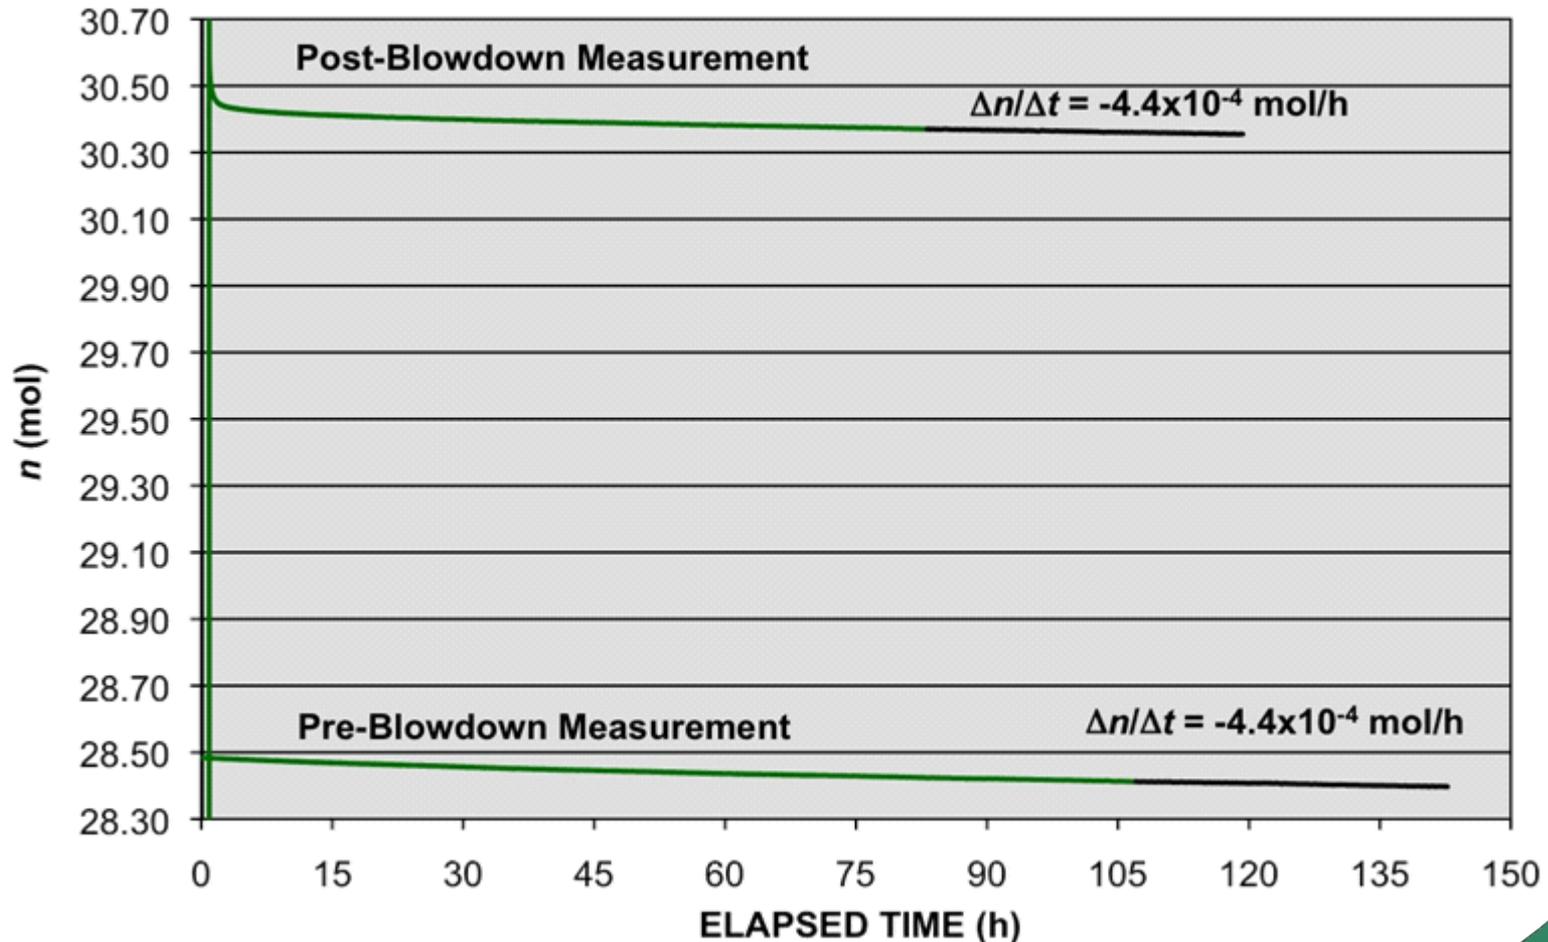
FIBERSPAR PIPELINE LEAKAGE MEASUREMENT
Nominal 1500 psia Pressurization
Moles of Hydrogen Gas in 3-ft Pipeline Specimen

Post-blowdown leakage rate was identical to pre-blowdown rate

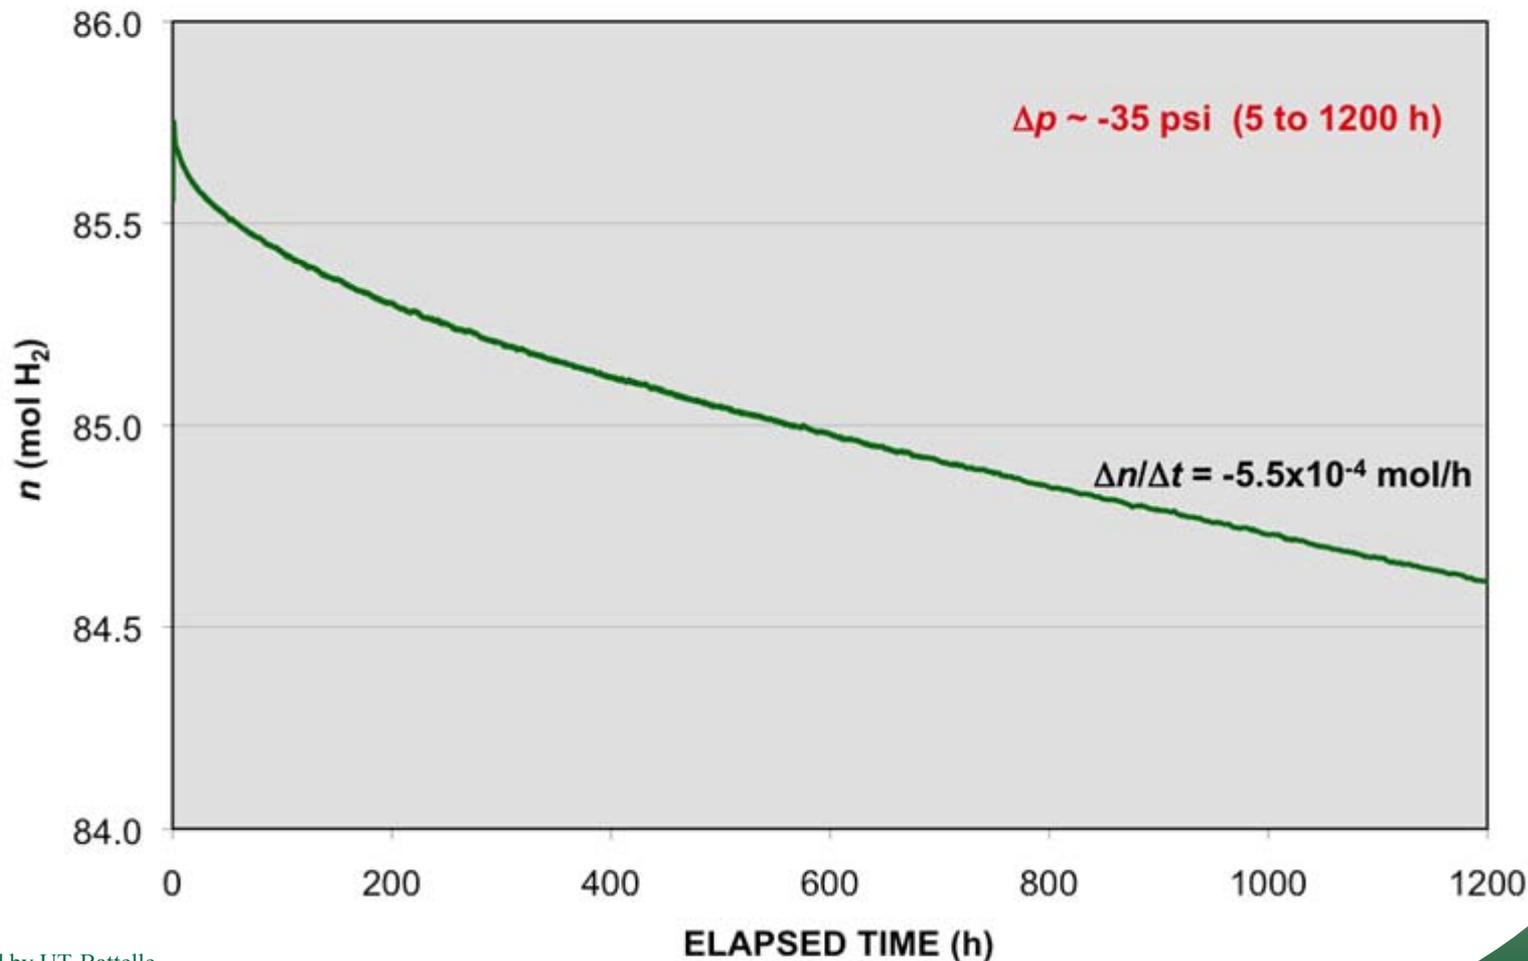
FIBERSPAR PIPELINE LEAKAGE MEASUREMENT
Nominal 1500 psi Pressurization
Moles of Hydrogen Gas in 9-ft Pipeline Specimen

Actual H₂ leakage rate is nearly 50X below predicted rate

In most extensive test to-date, hydrogen lost due to permeation and leakage through end cap seals was less than 0.02% per day. The rate is 45 times below the predicted value for HDPE (PE-3408) liner.

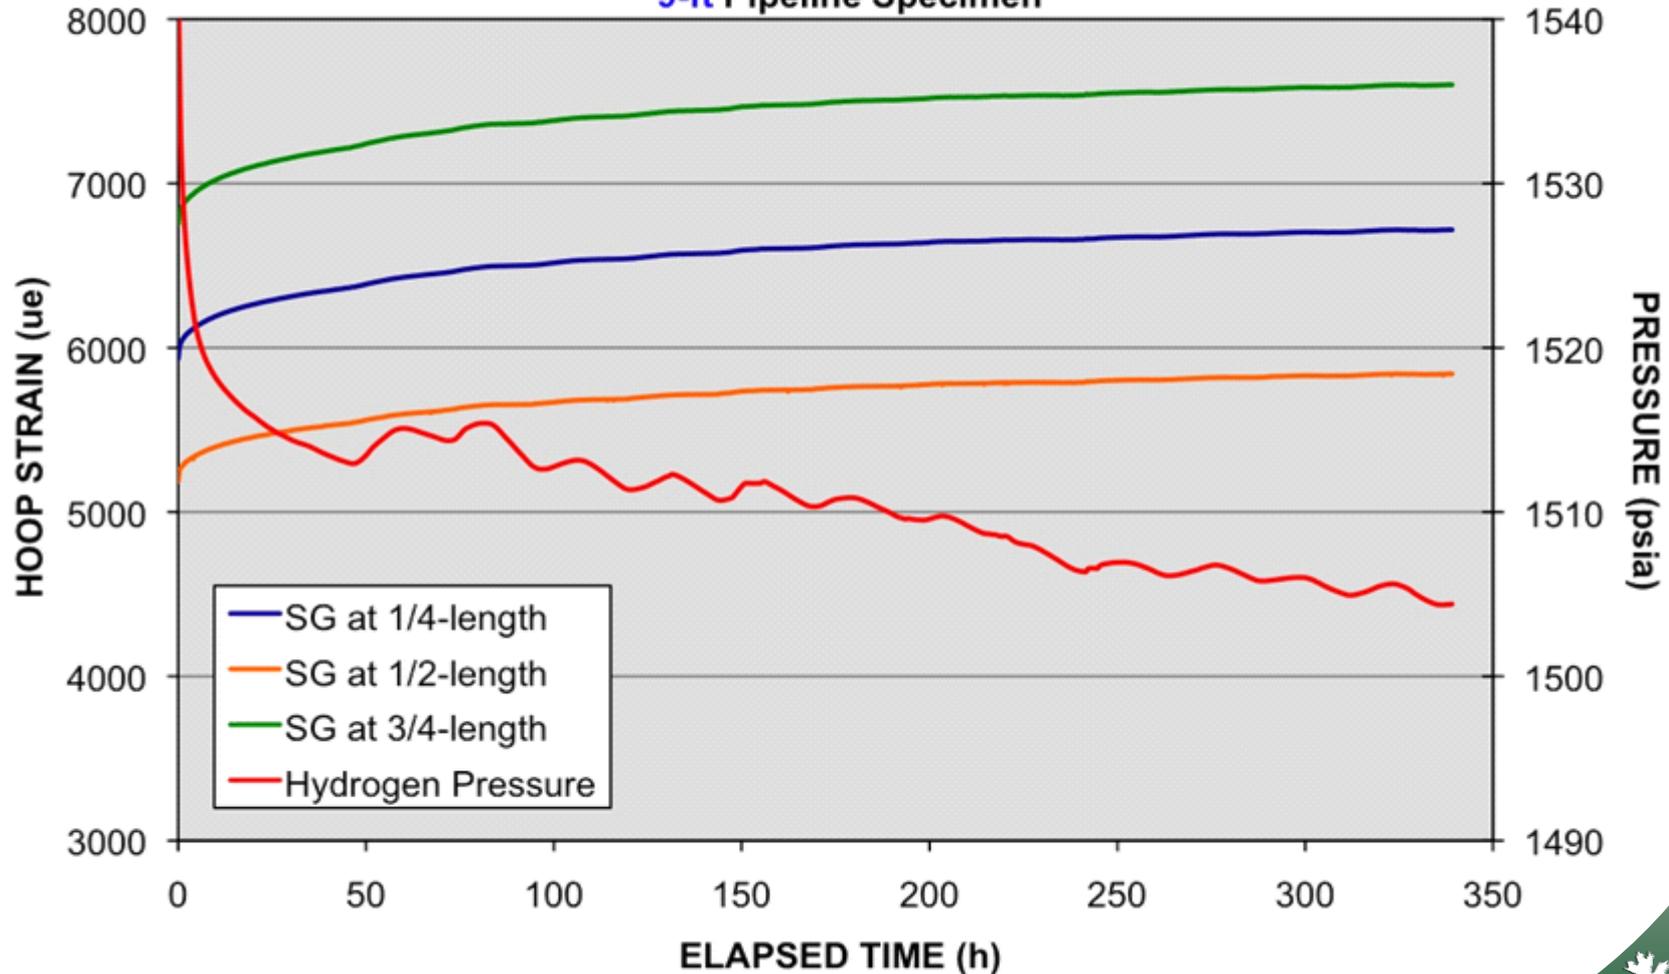
FIBERSPAR PIPELINE LEAKAGE MEASUREMENT
Nominal 1500 psi Pressurization
9-ft Pipeline Specimen

Hoop strain in Fiberspar FRP pipeline during leakage measurements

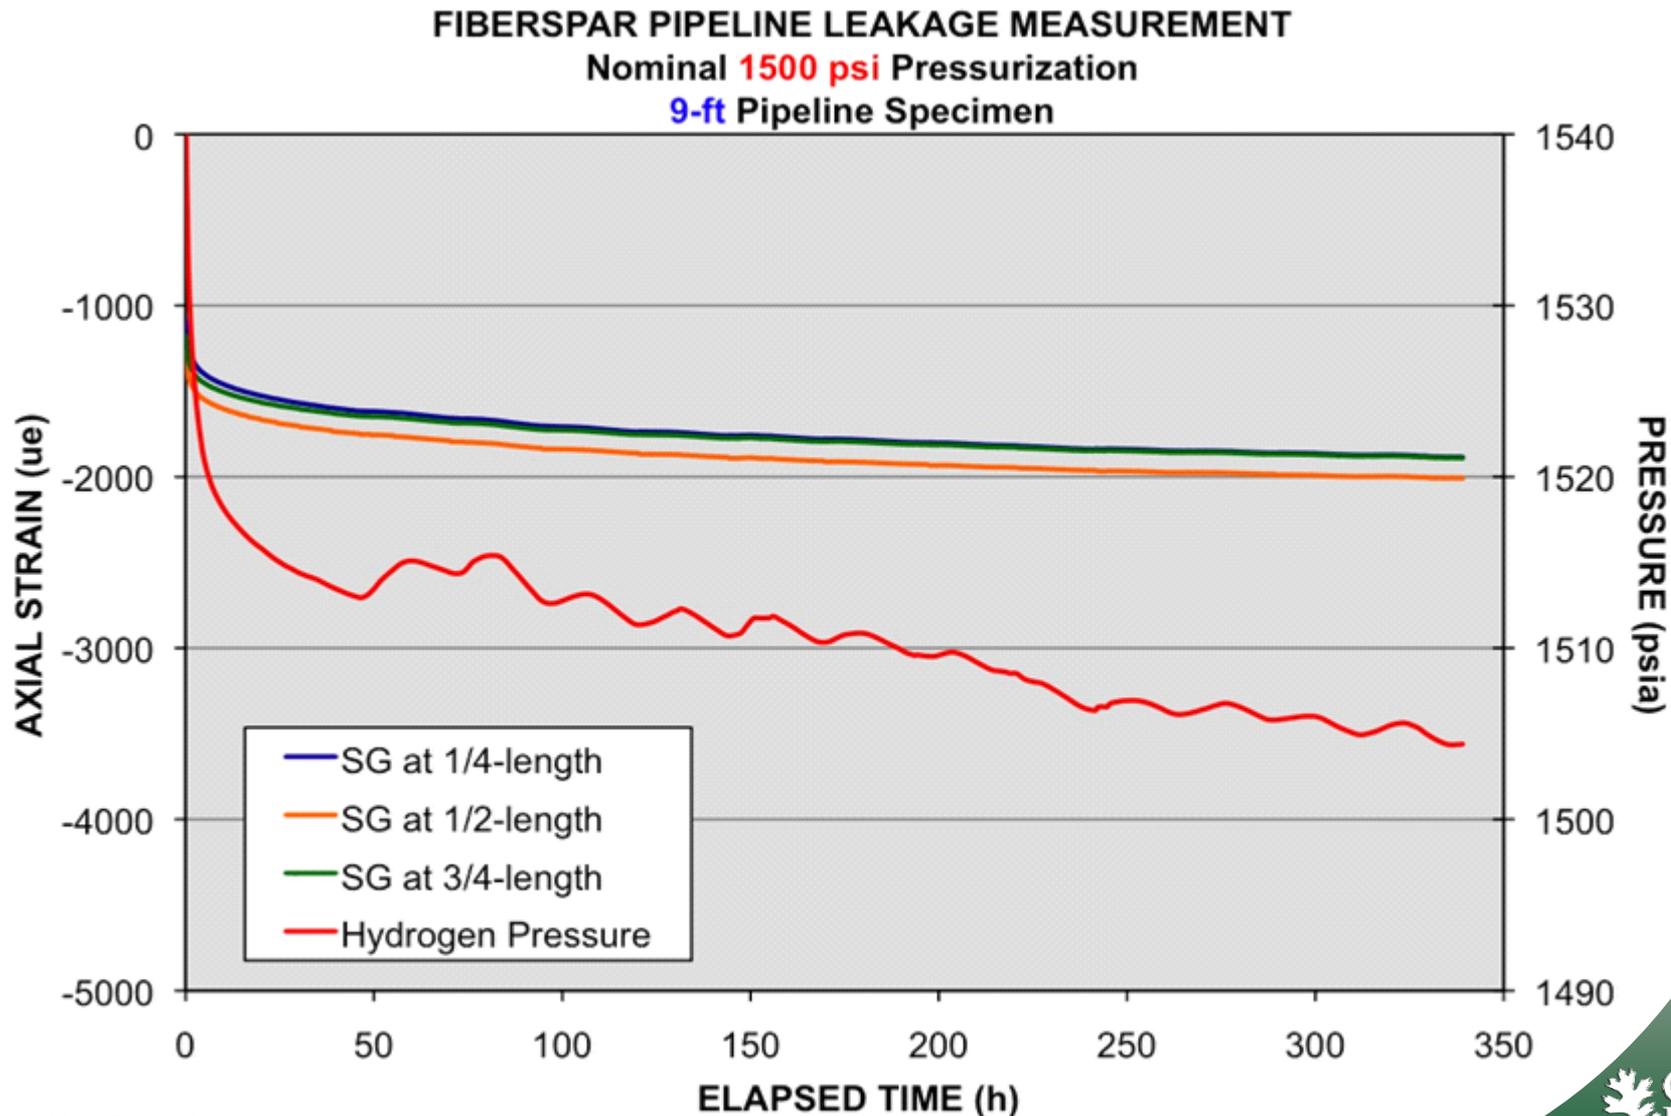
Axial strain in Fiberspar FRP pipeline during leakage measurements

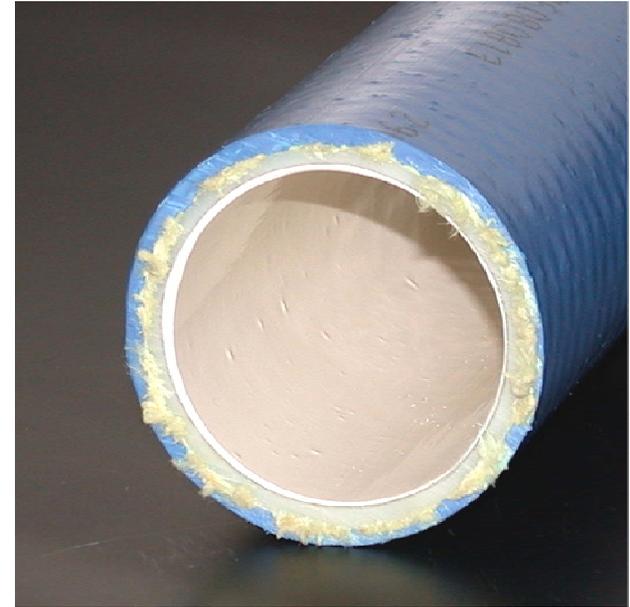
H₂ leakage rate measurements in PolyFlow Thermoflex[®] Reinforced Pipe

- **Liner: Coextruded PPS and PA-6**
- **Reinforcement: aramid fiber rovings braided on liner, laid over four longitudinal rovings**
- **Burst strength determined by braid angle, not by number of plies**
- **PP jacket with damage indicating colorant**
- **Couplings with swaged metal seals**
- **Leakage rate measurements in progress**
