A Combined Materials Science/Mechanics Approach to the Study of Hydrogen Embrittlement of Pipeline Steels

University of Illinois at Urbana-Champaign

2011 DOE Hydrogen and Fuel Cells Program Review

Project ID # PD023

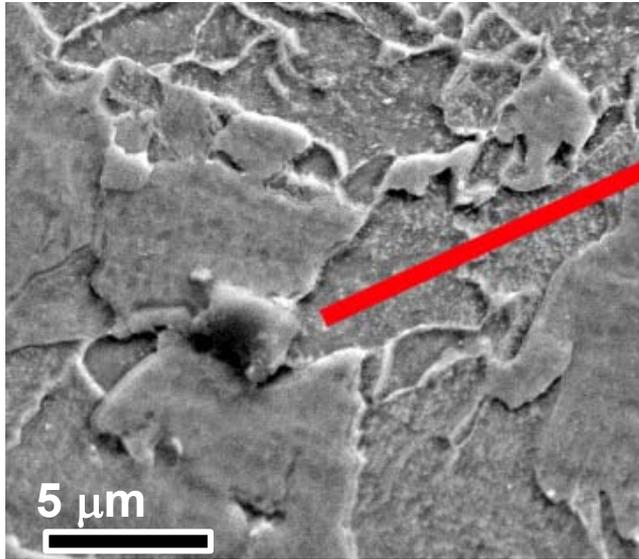
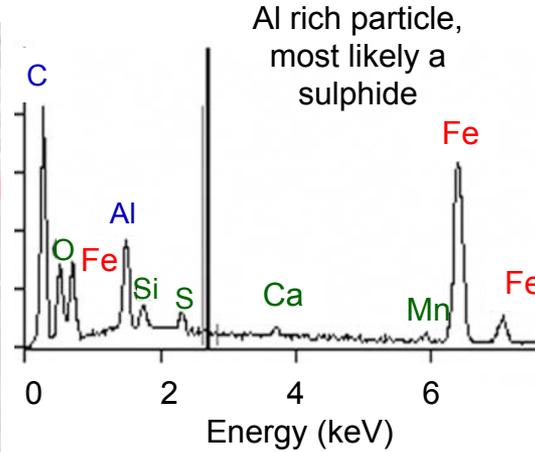
SEM analysis

- Completed microstructural analysis of four “promising” pipeline steels provided by Oregon Steel Mills, and microstructures provided by Air-Liquide and Air Products
- Needed for hydrogen transport analysis

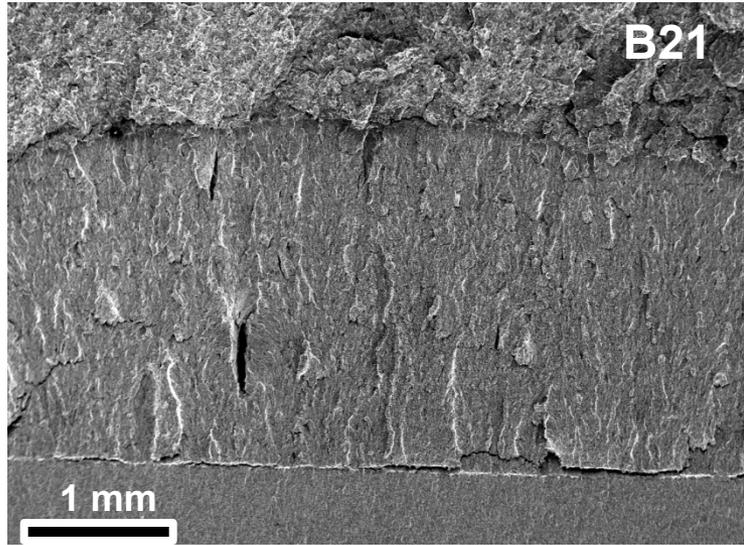
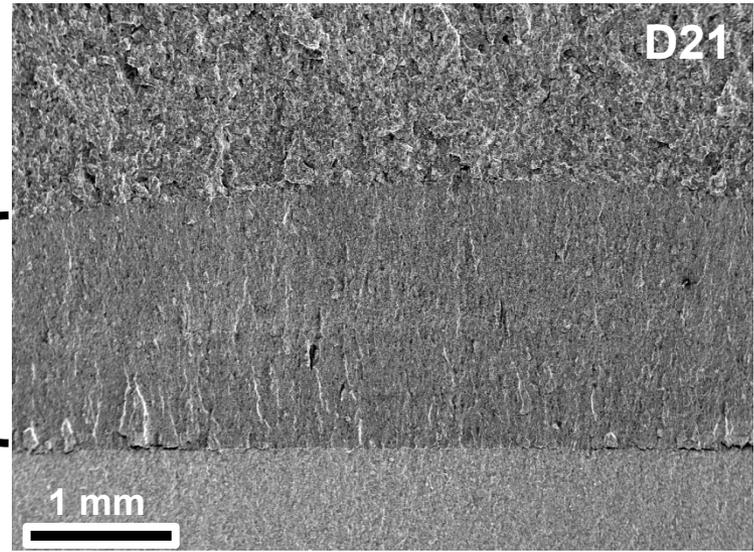
Technical Accomplishment: Wide-view SEM of New Pipeline Steel Microstructures B and D Fractured in 3 ksi H₂ gas

Hydrogen zone

Steel B: low carbon (0.05% by wt.) Mn-Si-single microalloy API/Grade X70/X80 capable of producing a ferrite/acicular microstructure

Steel D: low carbon (0.03% by wt.) Mn-Si-single microalloy API/Grade X60, a predominantly ferrite microstructure with some pearlite

These alloys were found to perform very well in sour natural gas service

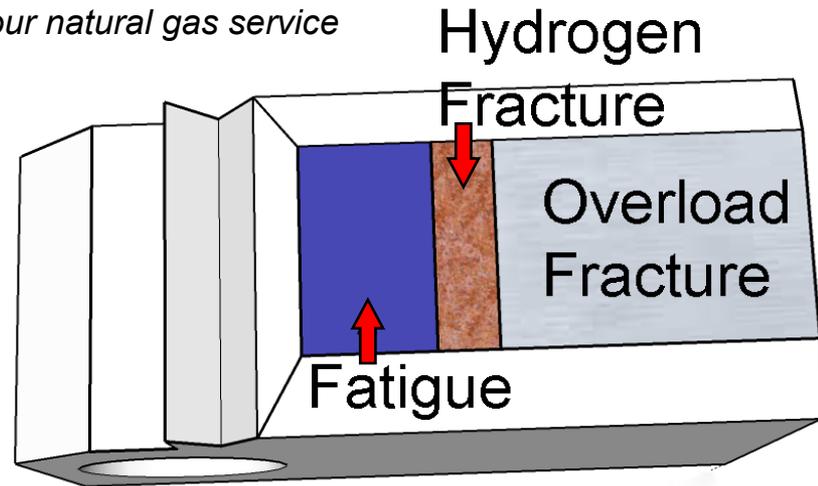
- Compact tension specimens tested in hydrogen environment at Sandia National Labs
- Area of fracture easily identified in SEM
- Identify features of interest

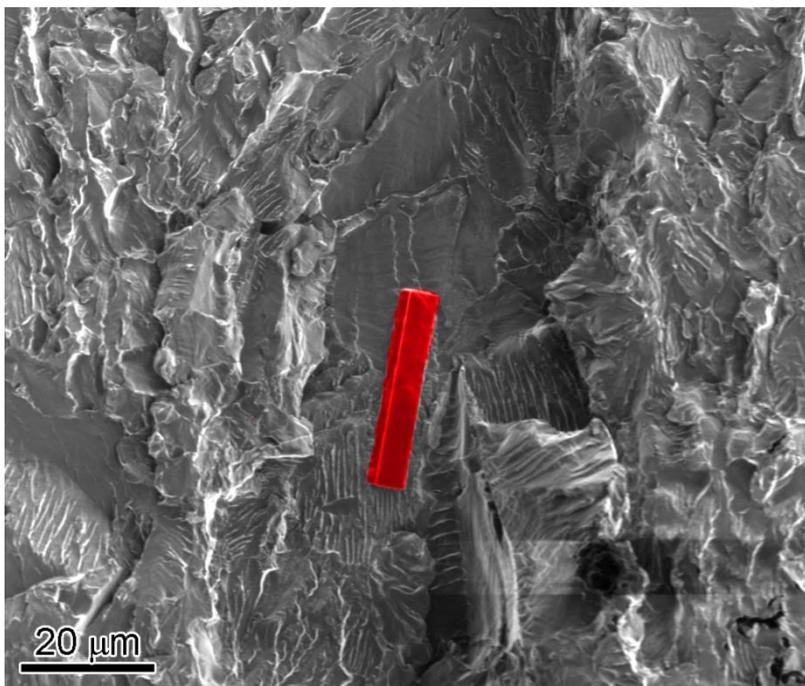
Feathery and featureless flat areas to extract Focused Ion Beam (FIB) samples

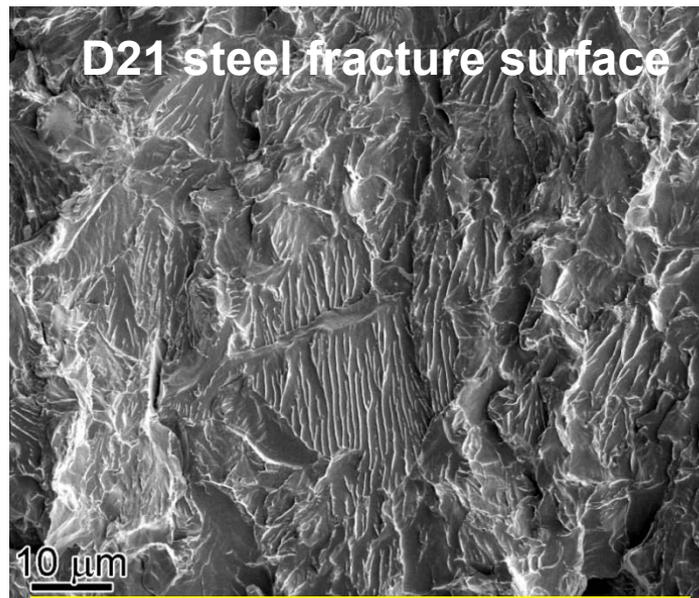
Closer view of two different morphologies

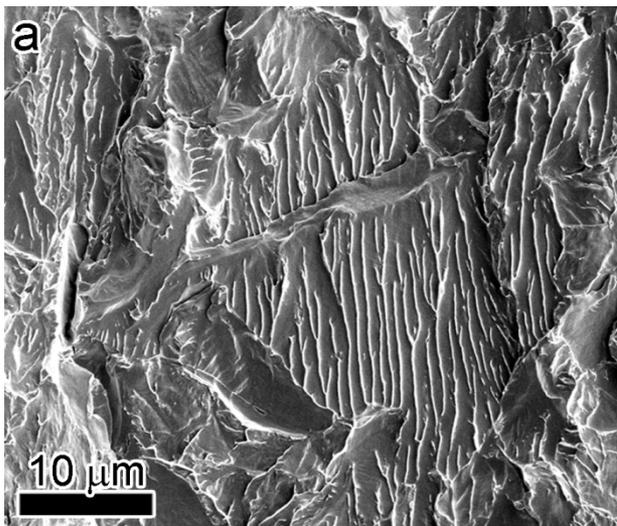
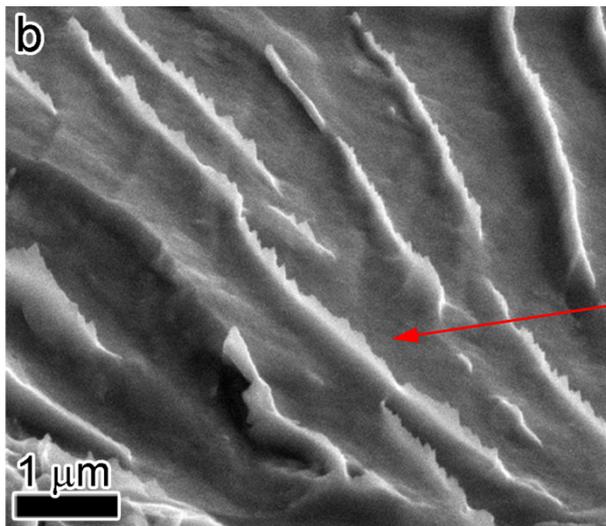
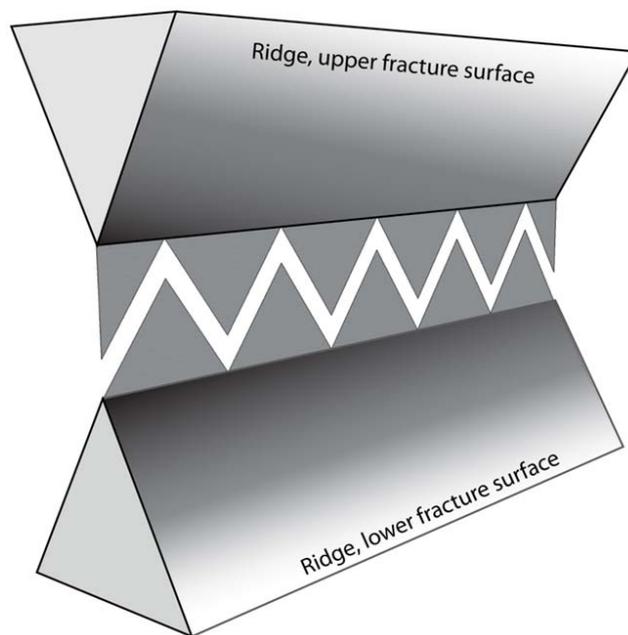
High-resolution SEM image reveals the presence of “saw-teeth” on top of the ridges. These are reminiscent of “saw-teeth” formed on final separation of thin sections in the transmission electron microscope.

Final separation between ridges produces saw-teeth surfaces

The presence of the ridges suggests plastic processes (final separation)

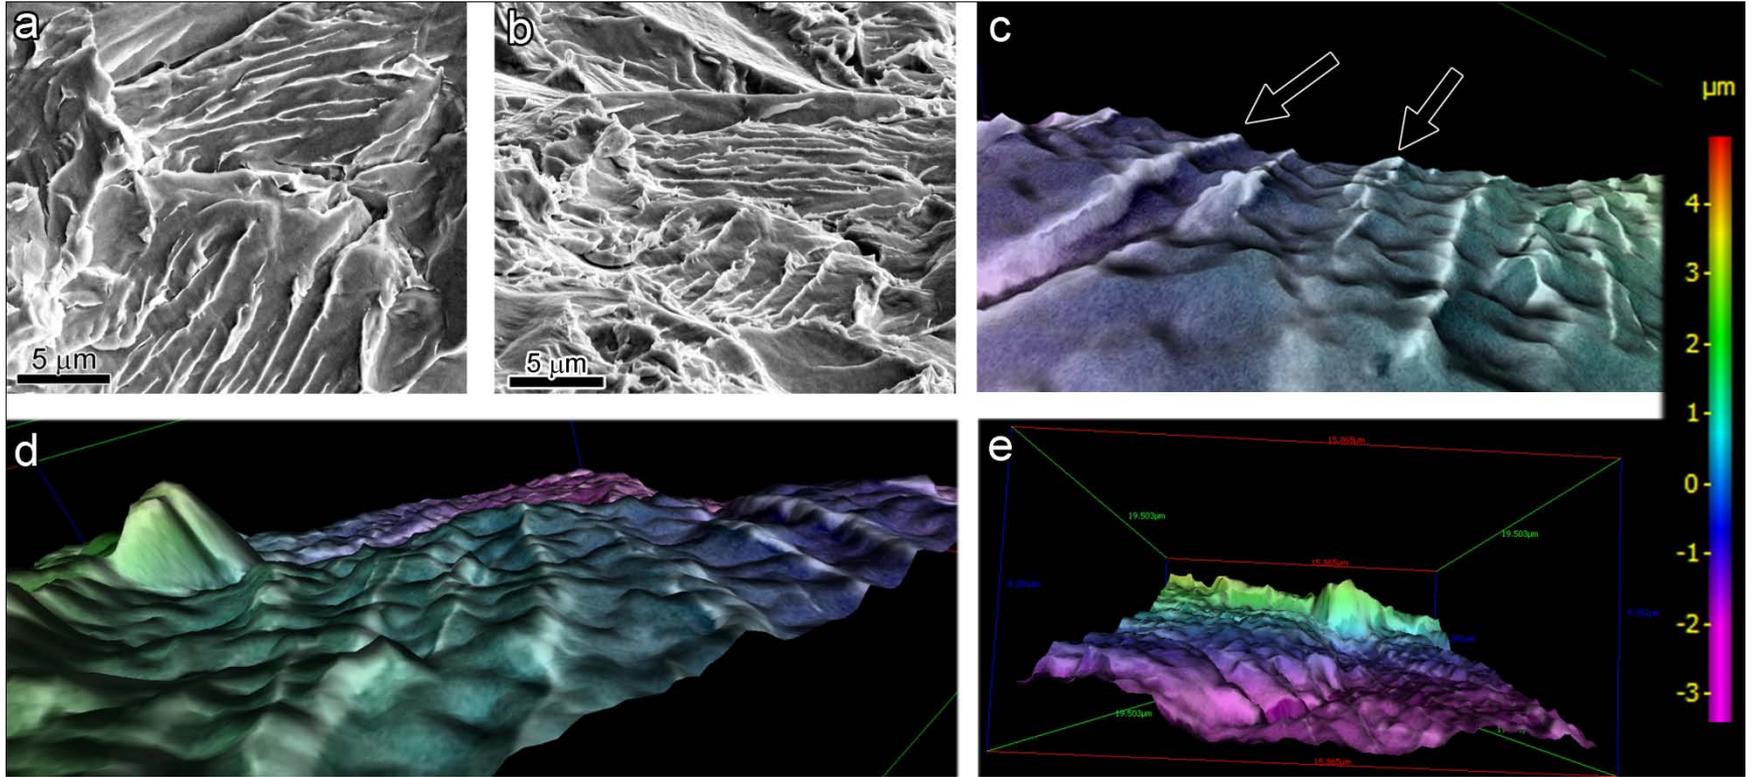
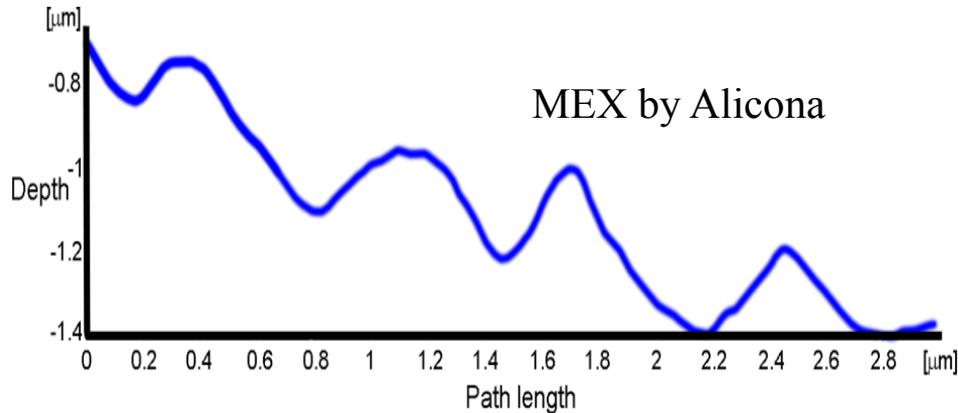
- 3-dimensional view reveals the surface topography confirming the ridge formation.
- Feature height measurement shows ridges are approximately protrusions of 200 nm.

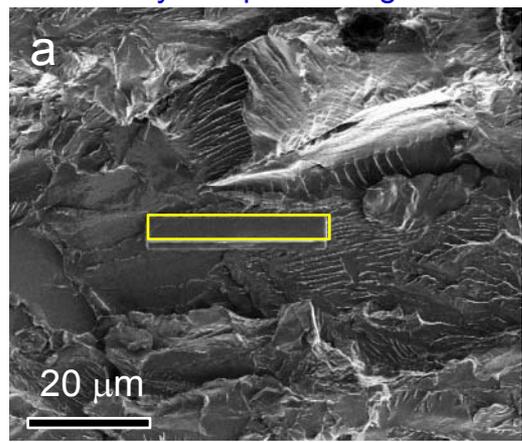
Select site, deposit Pt strip to identify and protect region

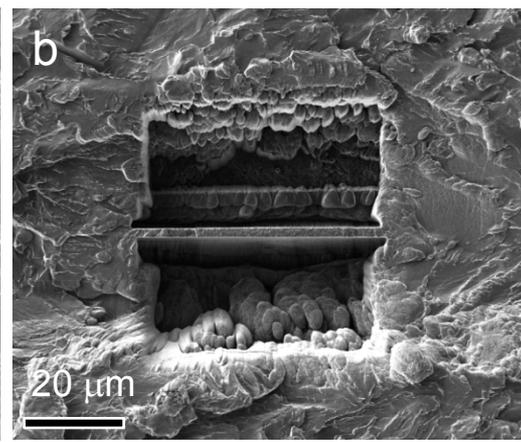
Machine out trenches on either side

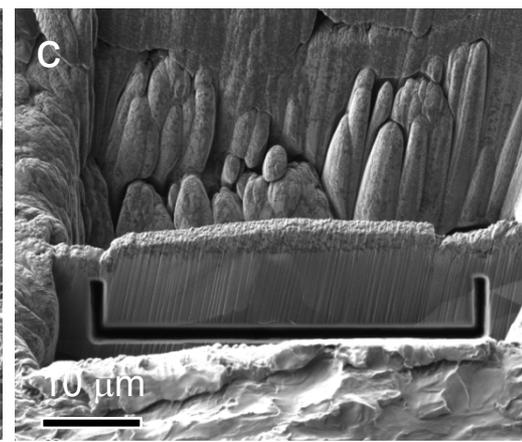
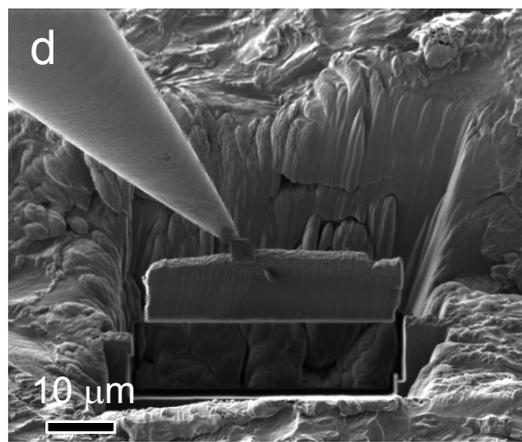
Make U-cut

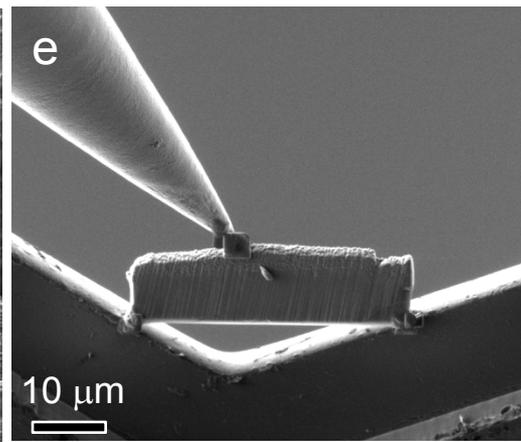
Attach needle to top of sample with Pt. Cut sample free by milling away remaining bridges and lift out

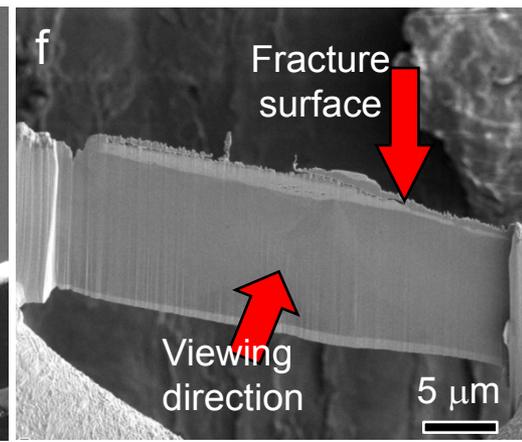
Attach sample to copper grid with Pt.

Cut needle free from sample thin to electron microscopy

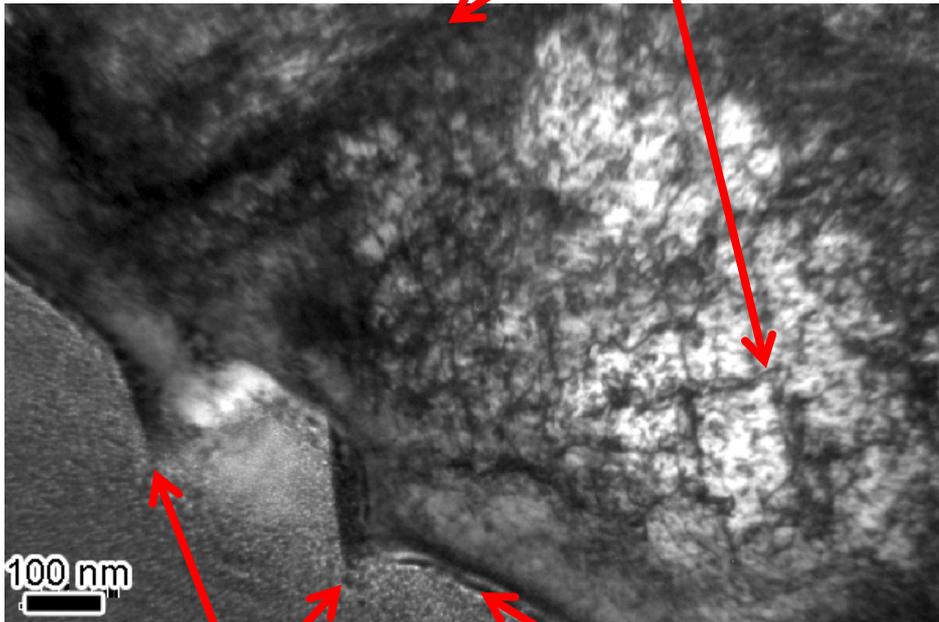
Slip bands

Image shows slip bands parallel to ridge edges, suggesting “*quasi-cleavage*” is not a cleavage like process but is related to dislocation slip. Enhanced and confined slip activity is consistent with hydrogen enhanced local plasticity (HELP) mechanism.

Slip planes densely packed with dislocations

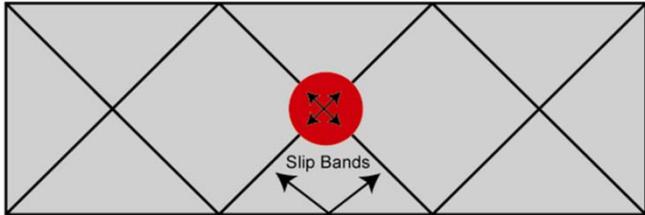
a) Hydrogen-induced void nucleation and growth at slip band intersections

- Open along lines of intersection forming tubes

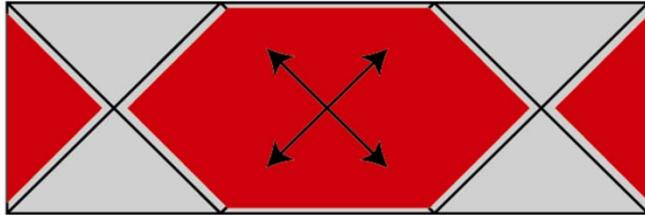
b) Voids expand by dislocation processes until they encounter another void

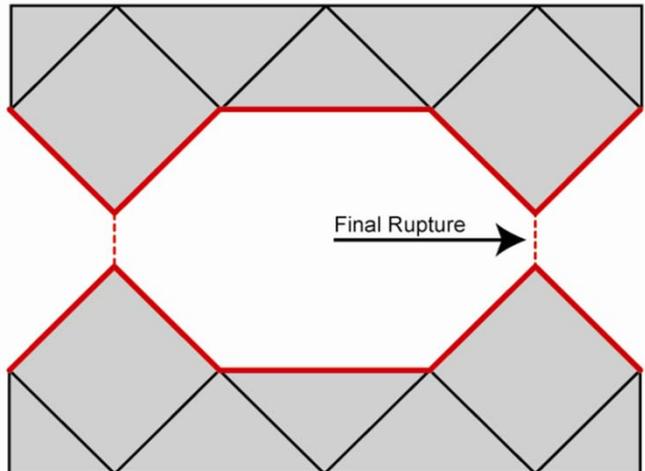
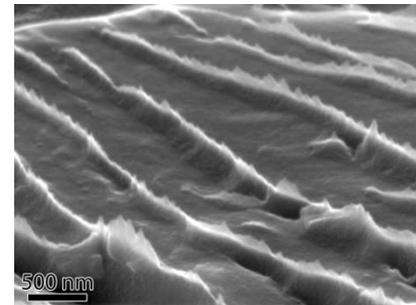
Non-mating, Symmetrical
Fracture Surface

c) Final failure along tops of ridges forming saw-teeth

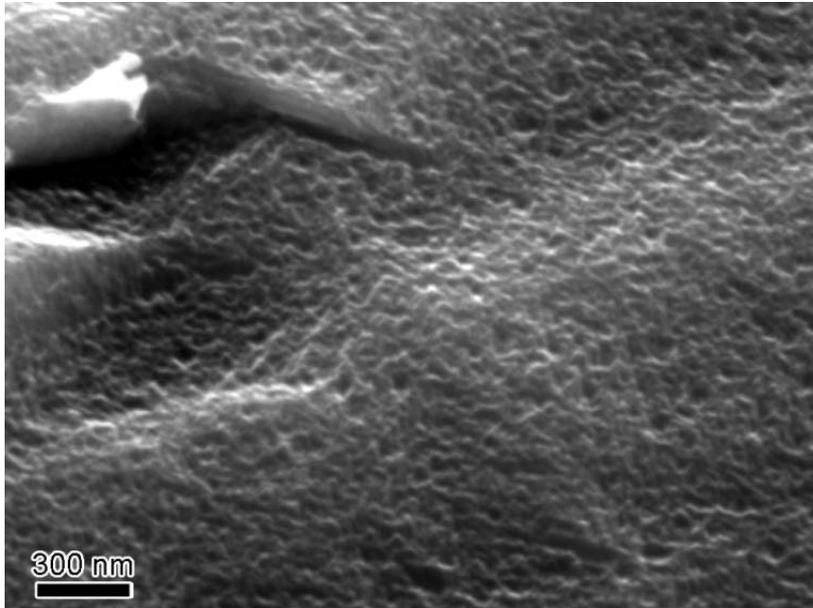
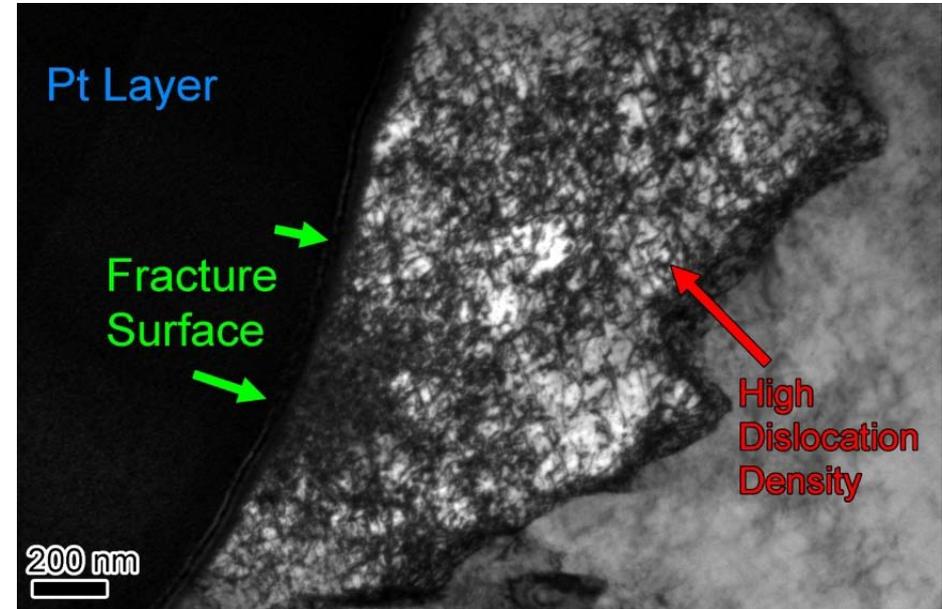
- What we see as **flat surface** in actuality is **heavily dimpled!**
- Fracture process is clearly ductile
- We are resolving these features

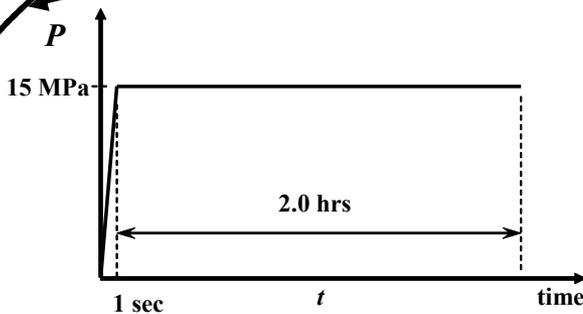
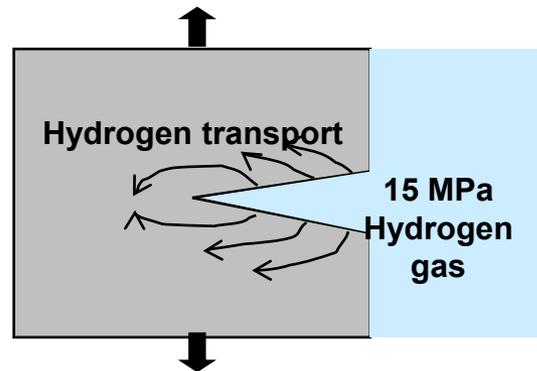
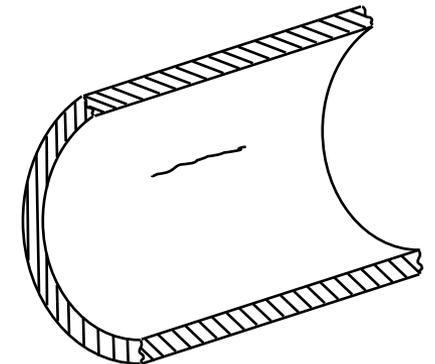
$C_L(t) = 0$ Hydrogen outgassing or impermeable OD surface $J(t) = 0$

outer radius: 8"
 thickness: 0.375"
 uncracked ligament: 0.356"
 initial crack opening: 0.3 μm

$C_L(t) = S \times \sqrt{P}$

Hydrogen gas at pressure P

dimensions are in mm

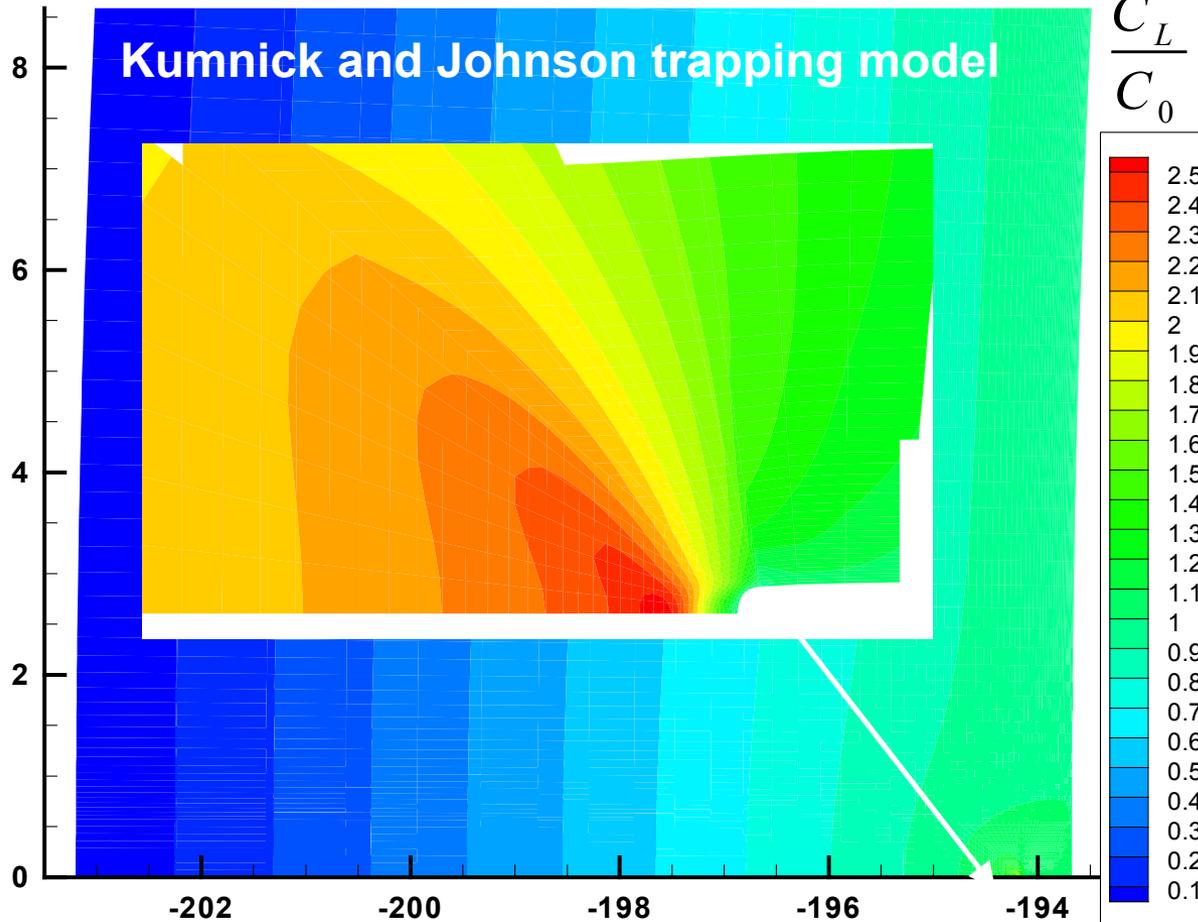
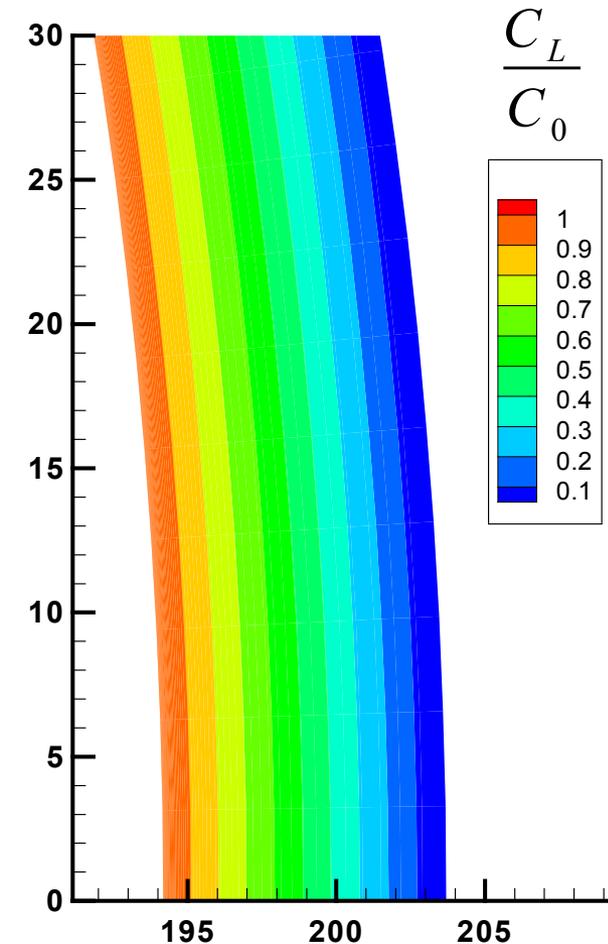
Time to steady-state: 2.0 hr

$$C_0 = 2.65932 \times 10^{22} \text{ H atom} / \text{m}^3$$

$$P = 15 \text{ MPa}$$

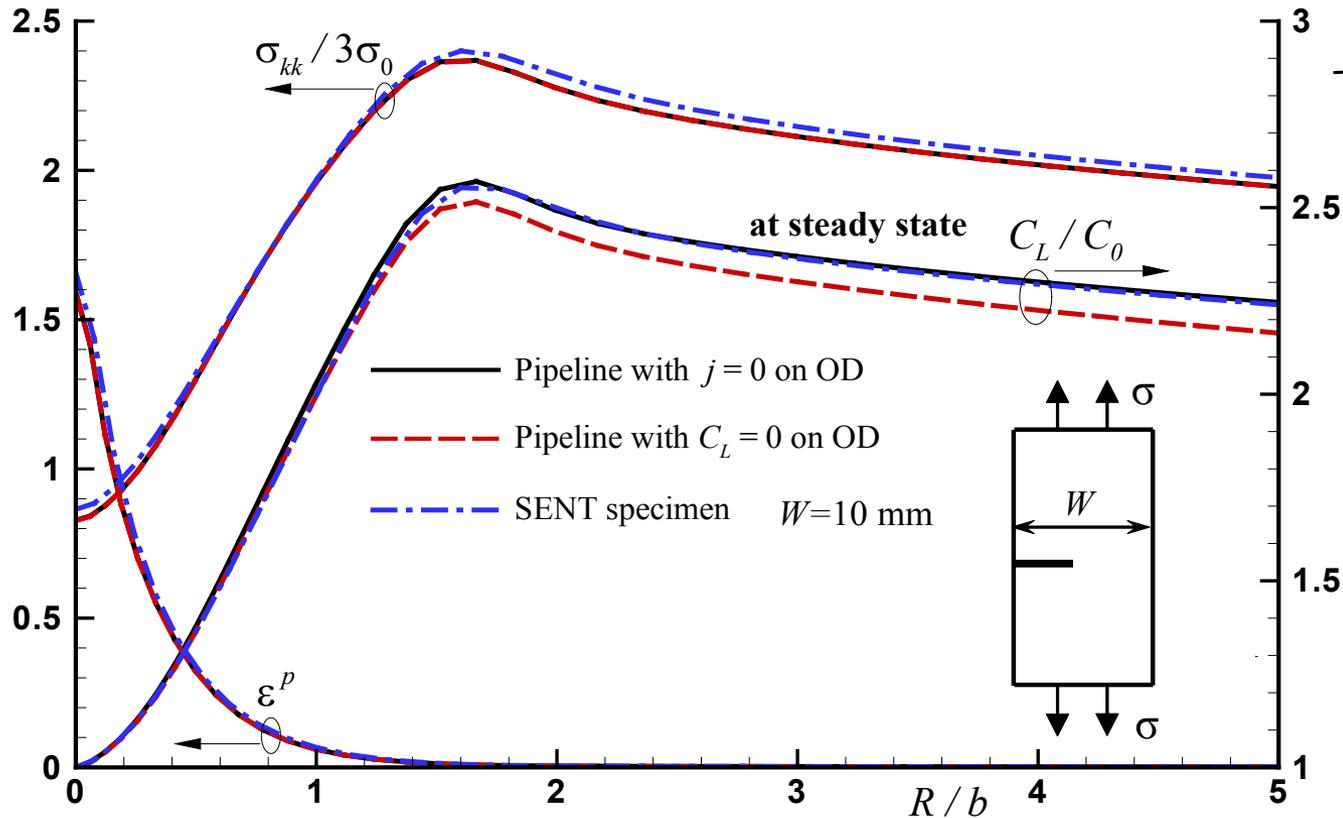
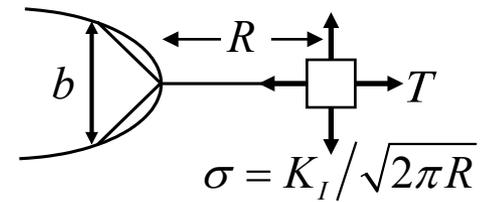
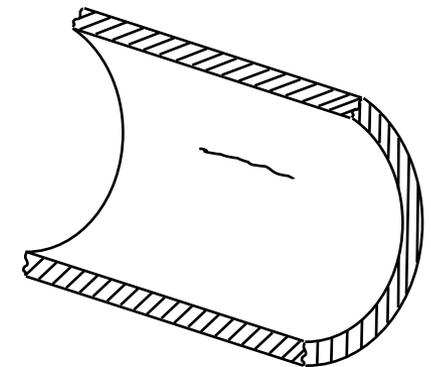
Cracked-Pipeline Fields vs. SENT-Specimen Fields

- Pipeline fields scale with the stress intensity factor and T-stress at the axial crack.
- Single Edge Notch Tension (SENT) specimens can be used to study fracture resistance of a pipeline with an axial crack

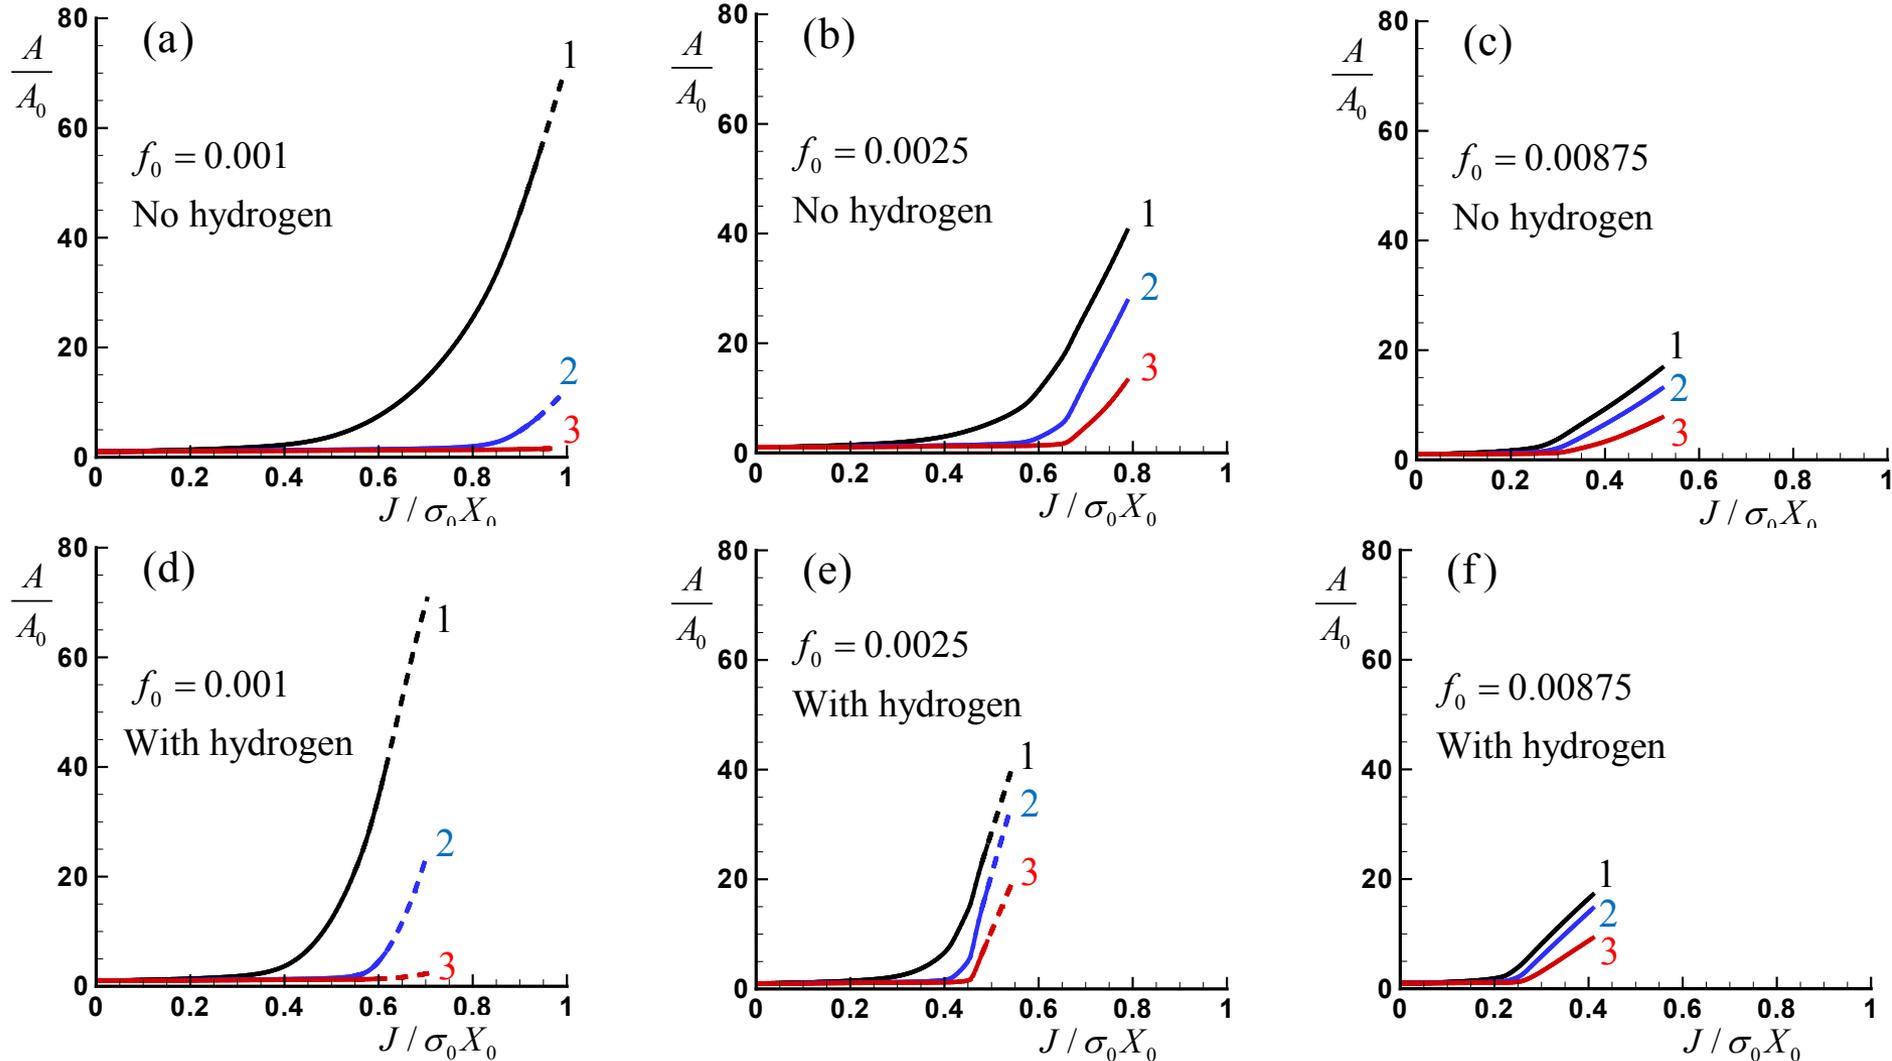
H increases void growth rate and reduces fracture toughness
