## VI.3 Development of Advanced Manufacturing Technologies for Low-Cost Hydrogen Storage Vessels

Mark Leavitt

Quantum Fuel Systems Technologies Worldwide, Inc.  
25242 Arctic Ocean Drive  
Lake Forest, CA 92630  
Phone: (949) 399-4584  
Email: mleavitt@qtww.com

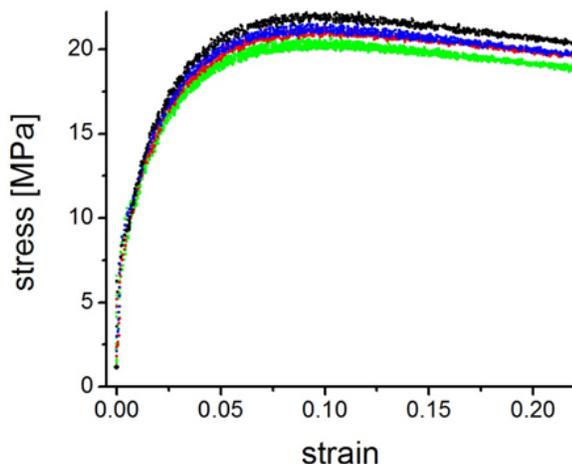
Testing occurred in a high-pressure hydrogen autoclave at pressures of 4,000 psi, 4,500 psi, and 5,000 psi. This represents the upper safe working limit of the autoclave. Multiple tests were carried out at each pressure. Tests exhibiting no inflections (signs of mechanical sticking) in the stress/strain curve are shown in Figure 4. From simple

**FIGURE 4.** Stress/Strain Curves for HDPE Samples Tested in Air (black) and in High-Pressure Hydrogen at 4,000 psi (blue), 4,500 psi (red) and 5,000 psi (green)

examination of these curves, it appears that changes in the modulus are minimal, but there is a clear decrease in the UTS with increasing hydrogen pressure.

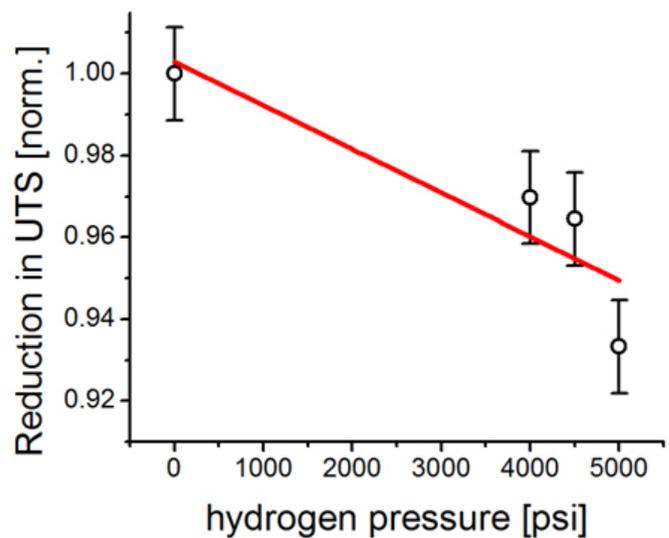
**FIGURE 5.** UTS Data Showing Marked Decrease with Increasing Hydrogen Pressure

The data around the UTS demonstrating a clear decrease in the UTS of up to nearly 10% as compared to in air at 5,000 psi hydrogen. This marked decrease is similar to what was seen in ex situ measurements previously performed by PNNL. Again, these data are only those with no inflections in the elastic region. Figure 5 shows the average UTS as a function of hydrogen pressure. There appears to be a potentially non-linear behavior to the data with the UTS decreasing at more after 4,500 psi, but that cannot be confirmed without further testing at higher pressures not attainable with the current autoclave system.
