## III.7 700 bar Hydrogen Dispenser Hose Reliability and Improvement

Kevin Harrison (Primary Contact), Owen Smith  
National Renewable Energy Laboratory (NREL)  
15013 Denver West Parkway  
Golden, CO 80401-3305  
Phone: (303) 384-7091  
Email: Kevin.Harrison@nrel.gov

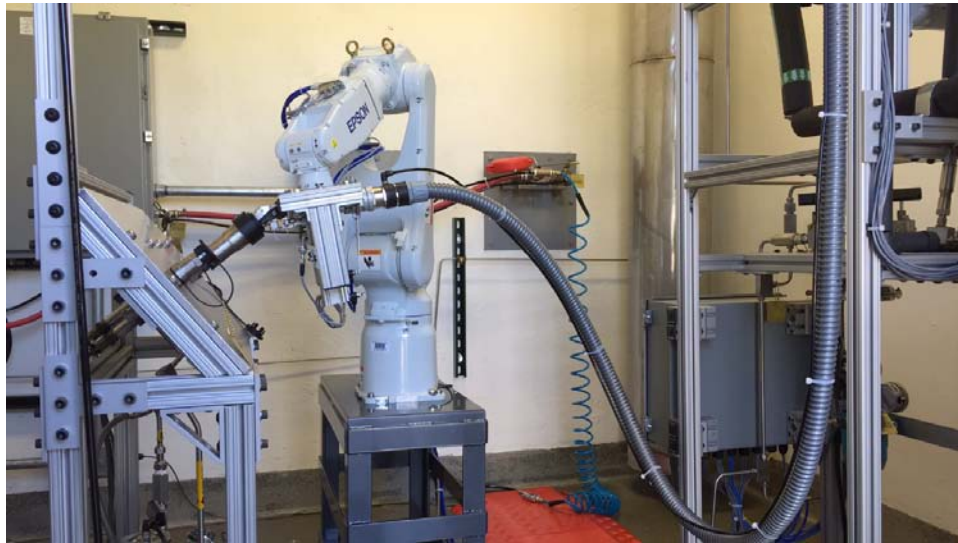
**FIGURE 1.** Hose reliability test stand

A hose reliability test stand, shown in Figure 1, was developed to support full 700-bar fueling simulation capabilities. The test stand uses a six-axis robot using pre-programmed motion paths to capture normal and realistic stresses resulting from friendly human interaction with the hose assembly while maintaining a compact footprint to safely operate in the 9.3 m<sup>2</sup> High Pressure Test Bay, which offers a safe and controlled environment to test components under high pressure to failure while minimizing risk to personnel or equipment. The test stand closely mirrors an actual dispenser in its design and pressure ramping capabilities. A tankless control algorithm was successfully developed using the interaction of an air-loaded pressure regulator on the dispenser side of the test apparatus and flow control valves on the vehicle side.

The leakage rate of the hose is monitored using a vacuum-pump sampling system attached to an outer protective sleeve near each flared crimp fitting to identify hydrogen leaks during the fueling cycles. The sampling flow rate is set to 400 mL/min and was calibrated to measure delayed response times. Chemochromic leak indication tape is also wrapped over the hose end assemblies to further identify exact methods of leakage, and potential inspection methods are verified at regular intervals. Data collected from the hose reliability test stand include pressure, temperature and real-time leakage rates from crimp fitting areas. These data can be used to explore dependency of leak intensity on current pressure and temperature. Permeation of hydrogen

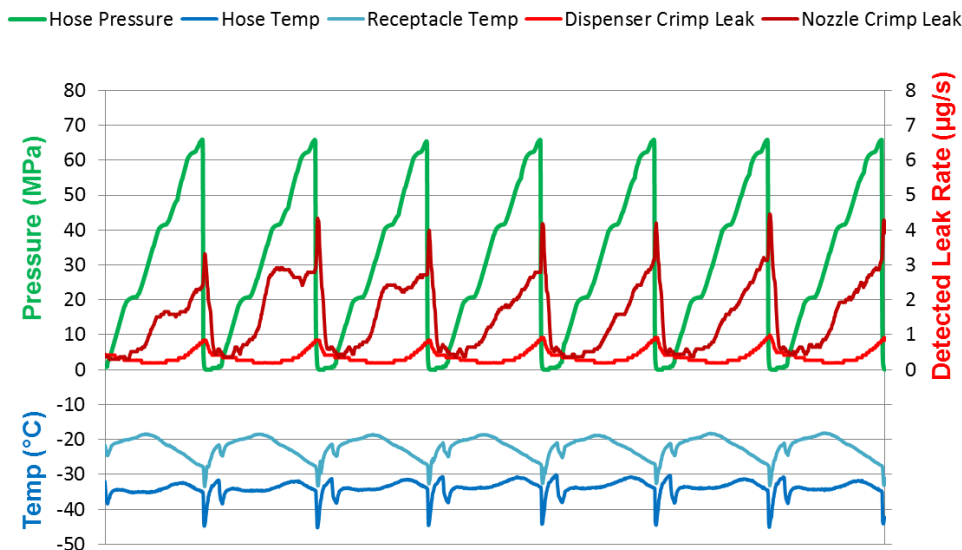
FIGURE 2. Sample of hose cycle pressure profile set, showing leak trends

Typical cycles run with T20, T30, and T40 temperature profiles and longer-term (10 min) pressure holds at 82 MPa were analyzed for permeation effects. The typical cycles were observed to have leak rates that generally increased with pressure and decreased with temperature, with a notable increase in leak activity at temperatures around  $-40^\circ\text{C}$ , close to the glass transition temperature previously measured as  $-50^\circ\text{C}$ . Many pressure holds on the hose assembly, typically those immediately following a cold cycle, exhibit a strong exponential relationship between leak rate and temperature. Other, warmer holds performed during idle periods still leaked, but showed weaker correlations with temperature as shown in Figure 3. Activation energies of 21.9–43.8 kJ/mol were reported for the sample pressure holds shown.

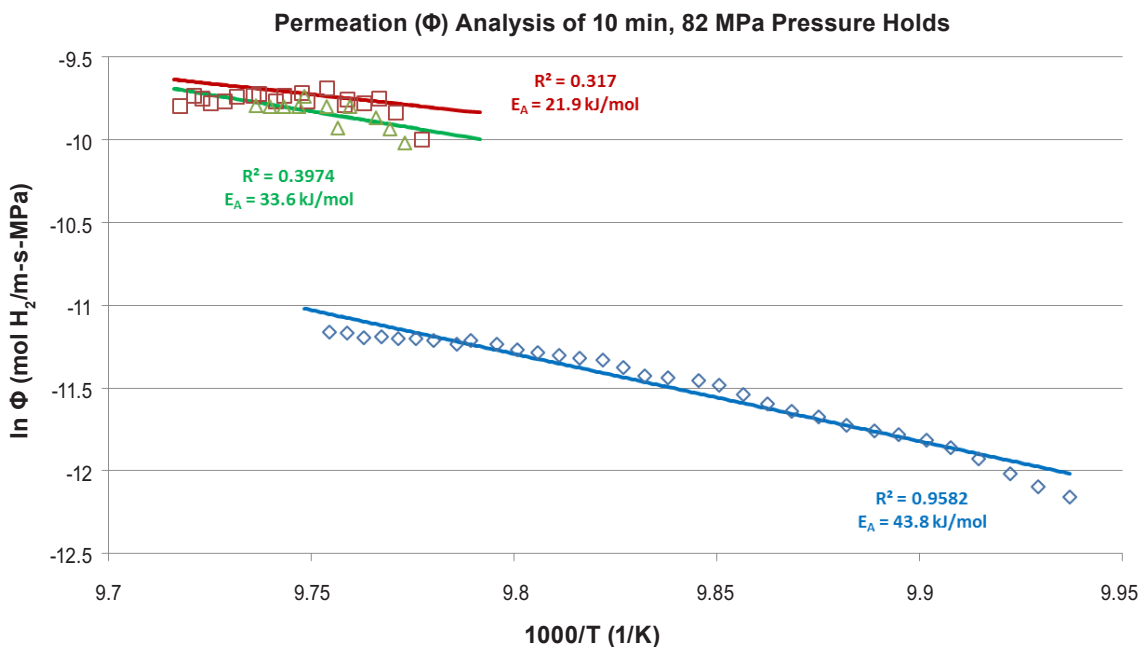
FIGURE 3. Analysis of permeation activity dependency on hose temperature

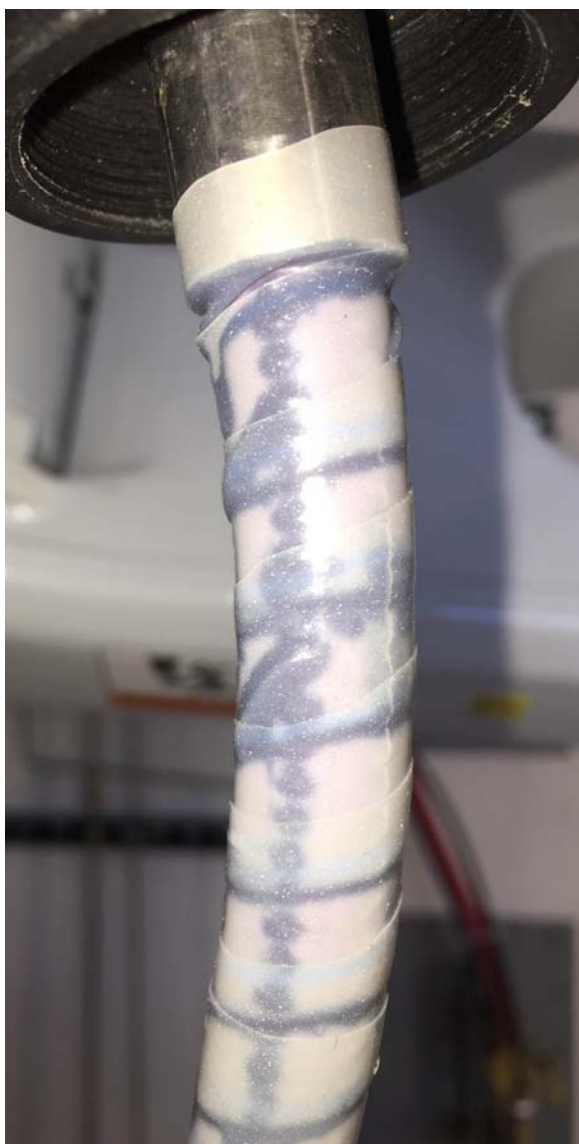
**FIGURE 4.** Chemochromic leak indication tape on nozzle-side hose end

1,000 cycles on the test apparatus, the tape clearly showed heavy leaking from the nozzle side crimp fitting through the pinpricks designed to relieve pressure from permeation of hydrogen, shown in Figure 4. The dispenser side crimp fitting, which had inconsistently leaked smaller amounts, showed fainter but still legible leak marks. In comparison, NREL's dispenser hose, which had filled about 150 times during the same time frame with similar mechanical stressing, had zero leak indications, confirmed with a handheld detector. Chemochromic tape may be very useful to station operators as an inspection method to identify weakened hoses before failure.
