Codes and Standards Analysis

Dr. Michael Swain
University of Miami
May 24, 2004

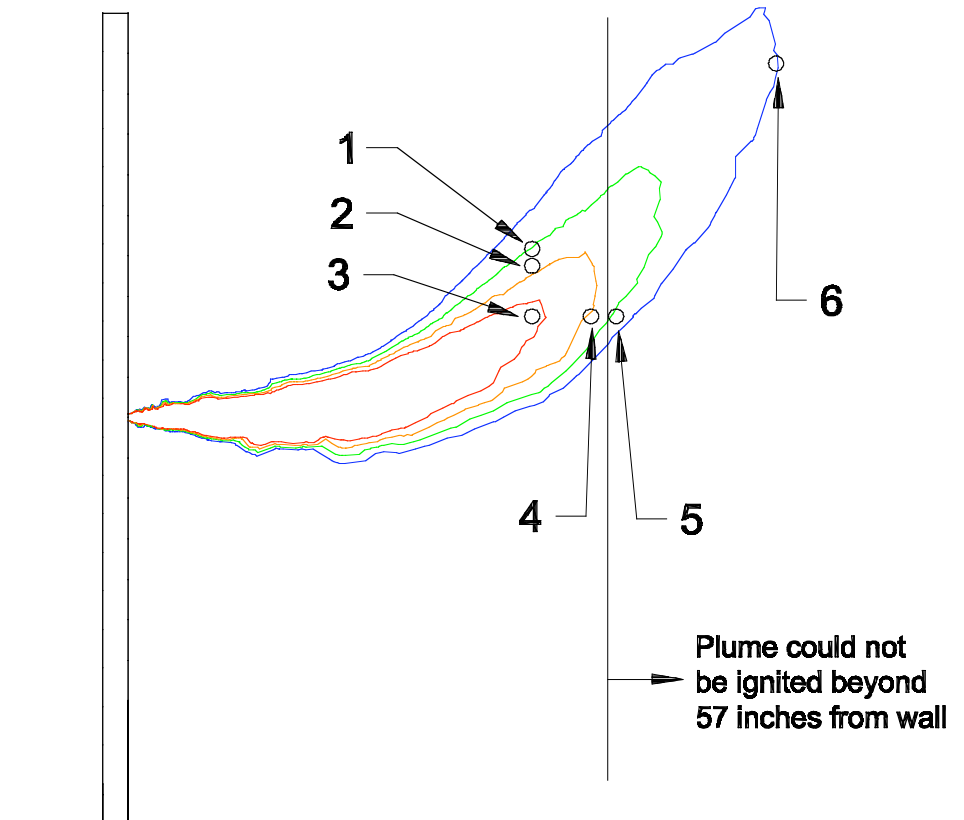
CFD Model @ 45 seconds Hydrogen %	CFD Model @ 60 seconds Hydrogen %	Experimental Data Hydrogen %
Point 1	6.0	5.6	5.0-5.9
Point 2	7.2	6.8	5.6-7.0
Point 3	10.4	10.2	9.4-10.8
Point 4	7.8	7.7	8.1-9.4
Point 5	5.6	5.5	5.6-6.6
Point 6	3.7	4.3	3.5-4.6

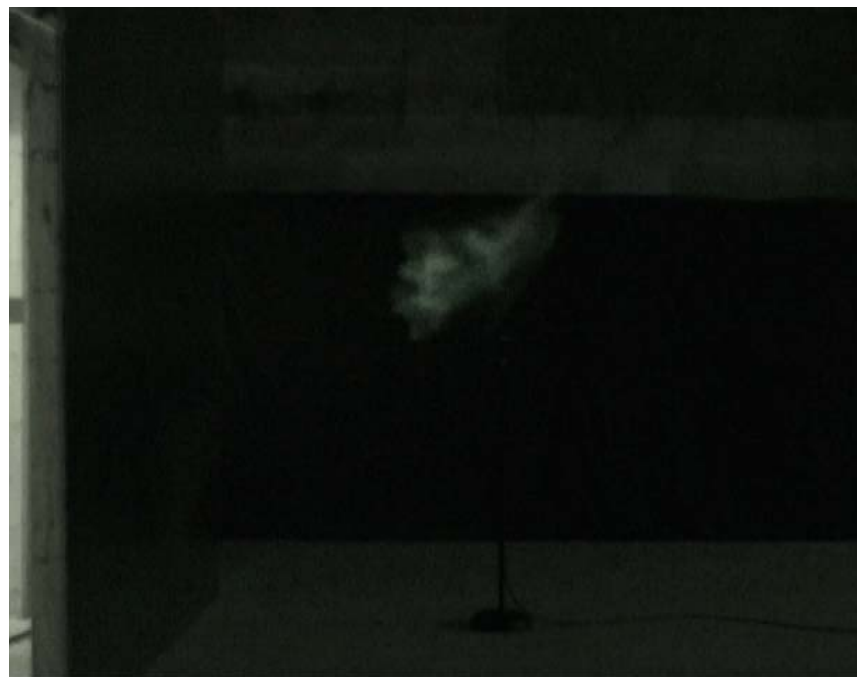
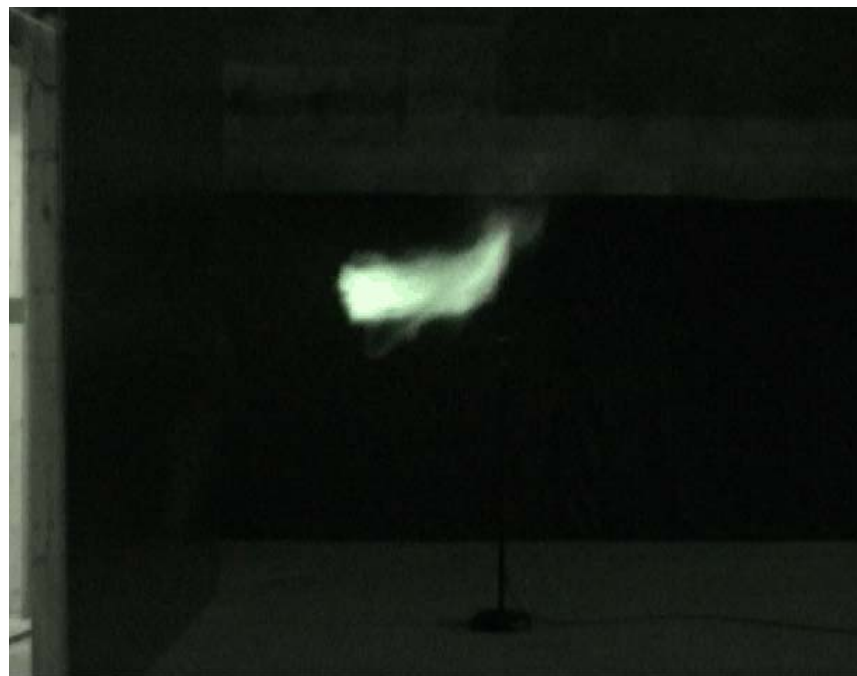
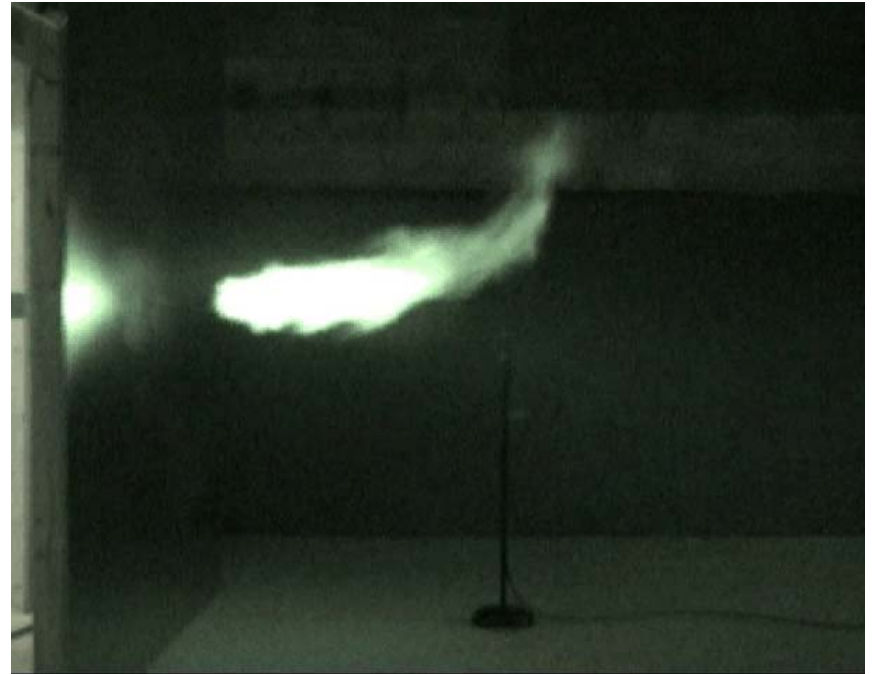
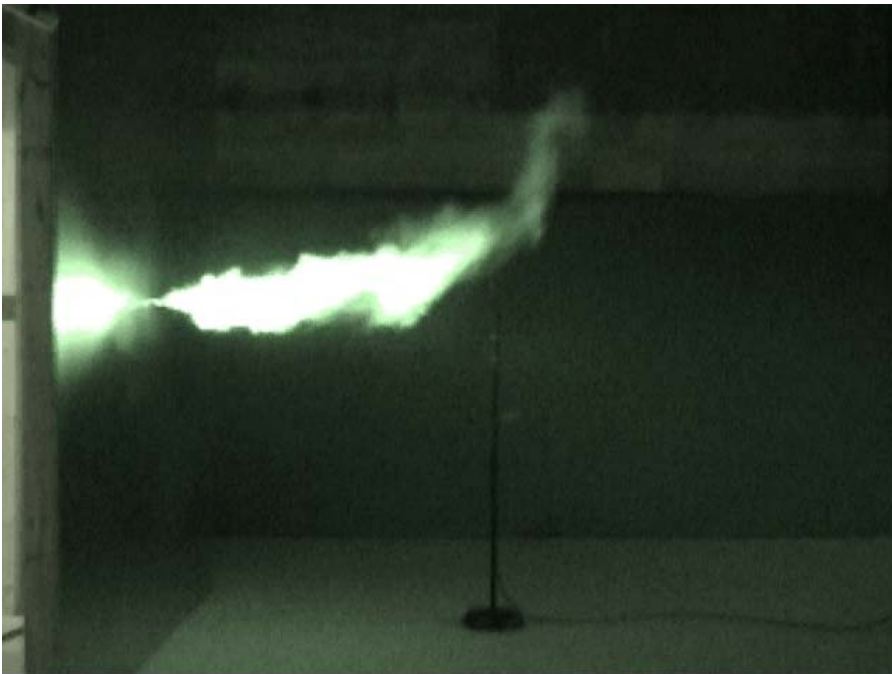
Example of successful ignition attempt
at a location that contained 10%
hydrogen

- Hydrogen flow rate 20 SCFM
- Orifice size 0.263 inches in diameter
- Leak duration 43 seconds

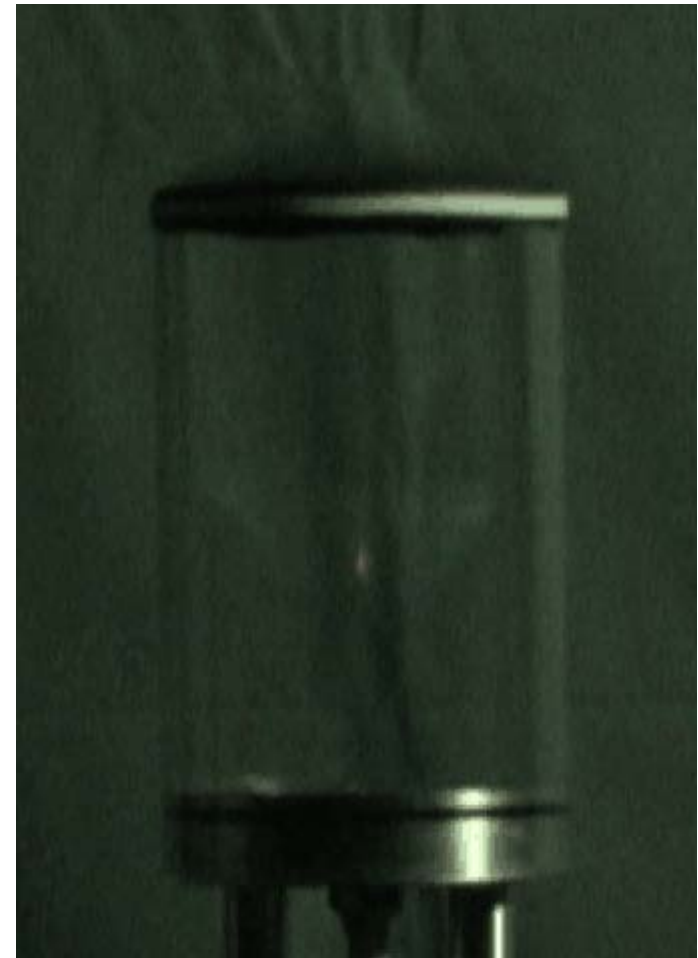
Apparatus for quiescent homogeneous hydrogen-air ignition tests

- Gap of 0.020 inch produced no ignitions of 7% hydrogen but gap of 0.060 inch produced ignitions every time

Ignition of 5% hydrogen after 3rd attempt with gap of 0.126 inches

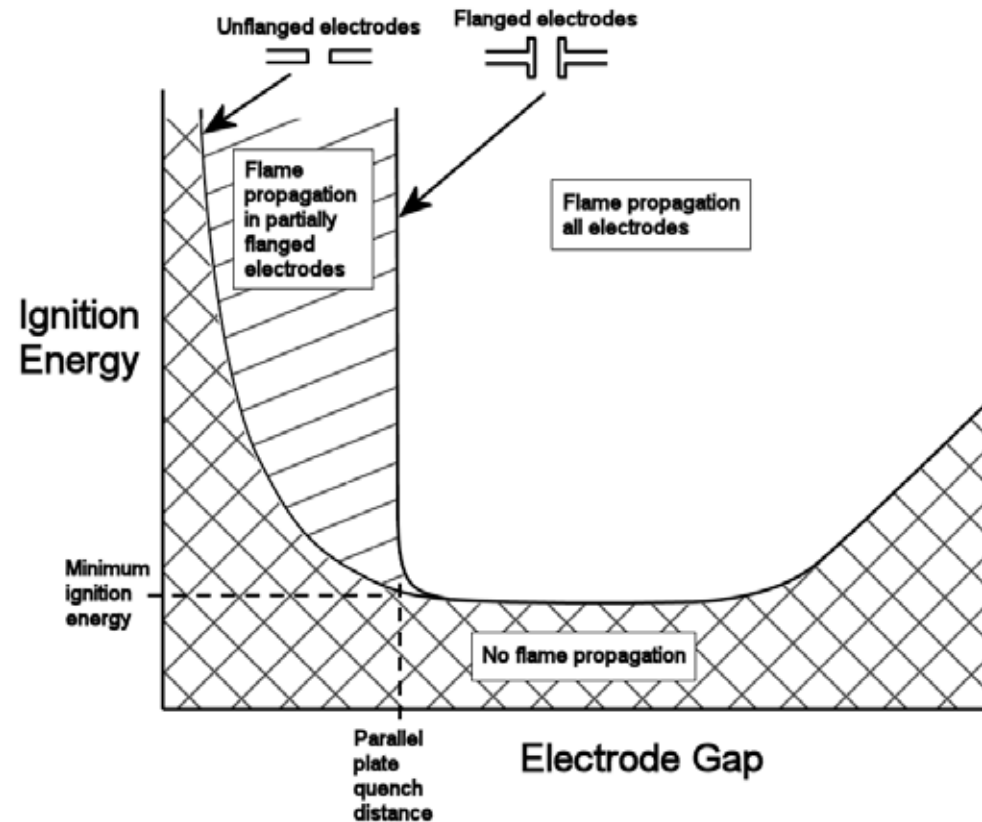
Accepted behavior of flame propagation as a function of ignition energy, electrode gap size and gap geometry

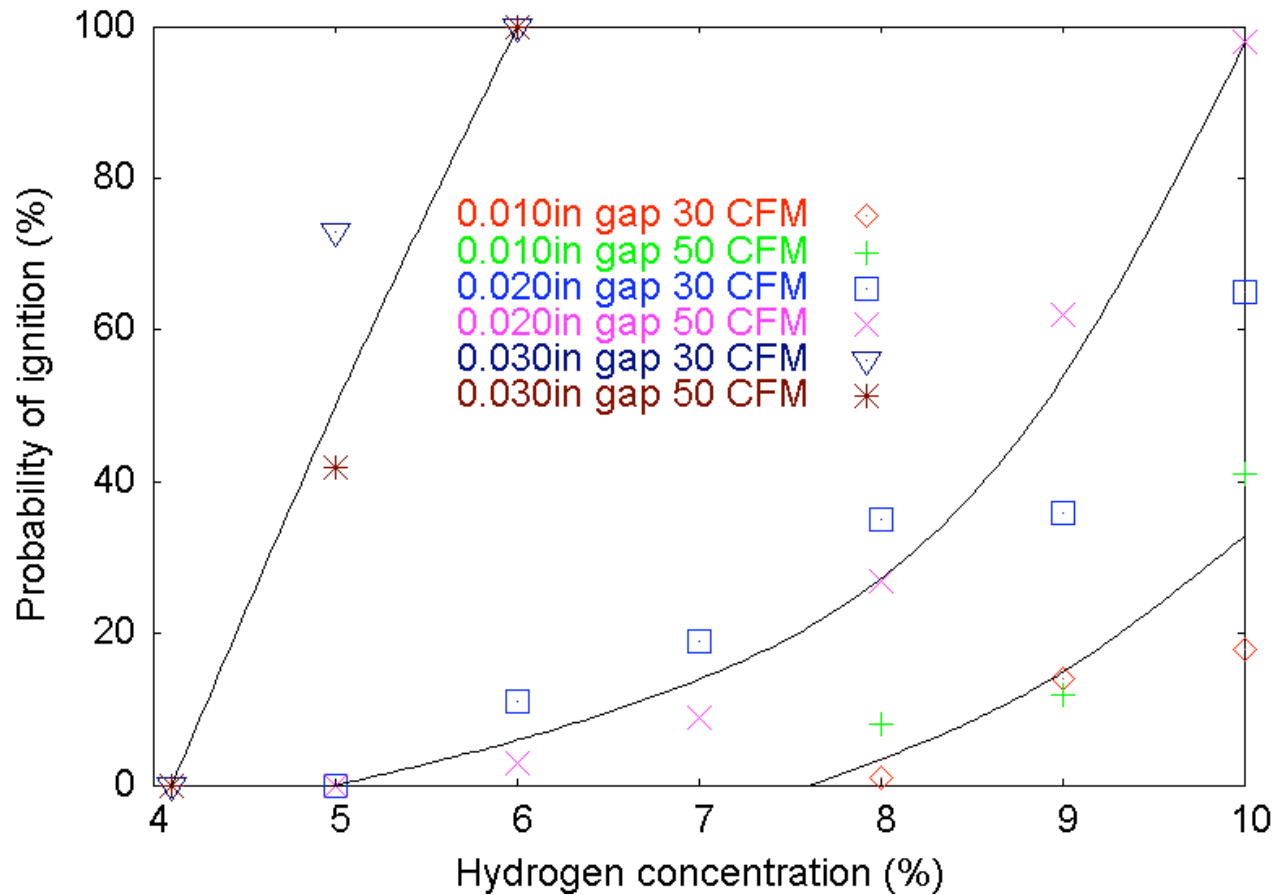
Experimentally determined probability of ignition versus hydrogen concentration for various spark gaps sizes at wall of duct.

- Ignition energy 205 mJ
- Shows weak dependency on Reynolds Number
- Shows strong dependency on spark gap size

- Task B - Demonstrated that lean mixtures of hydrogen and air are not necessarily easily ignited by common ignition sources. This is due to quenching of the flame kernel by the electrodes producing the arc. Ignitability at the wall of the duct was found to be a strong function of spark gap size and a weak function of Reynolds number and ignition energy.

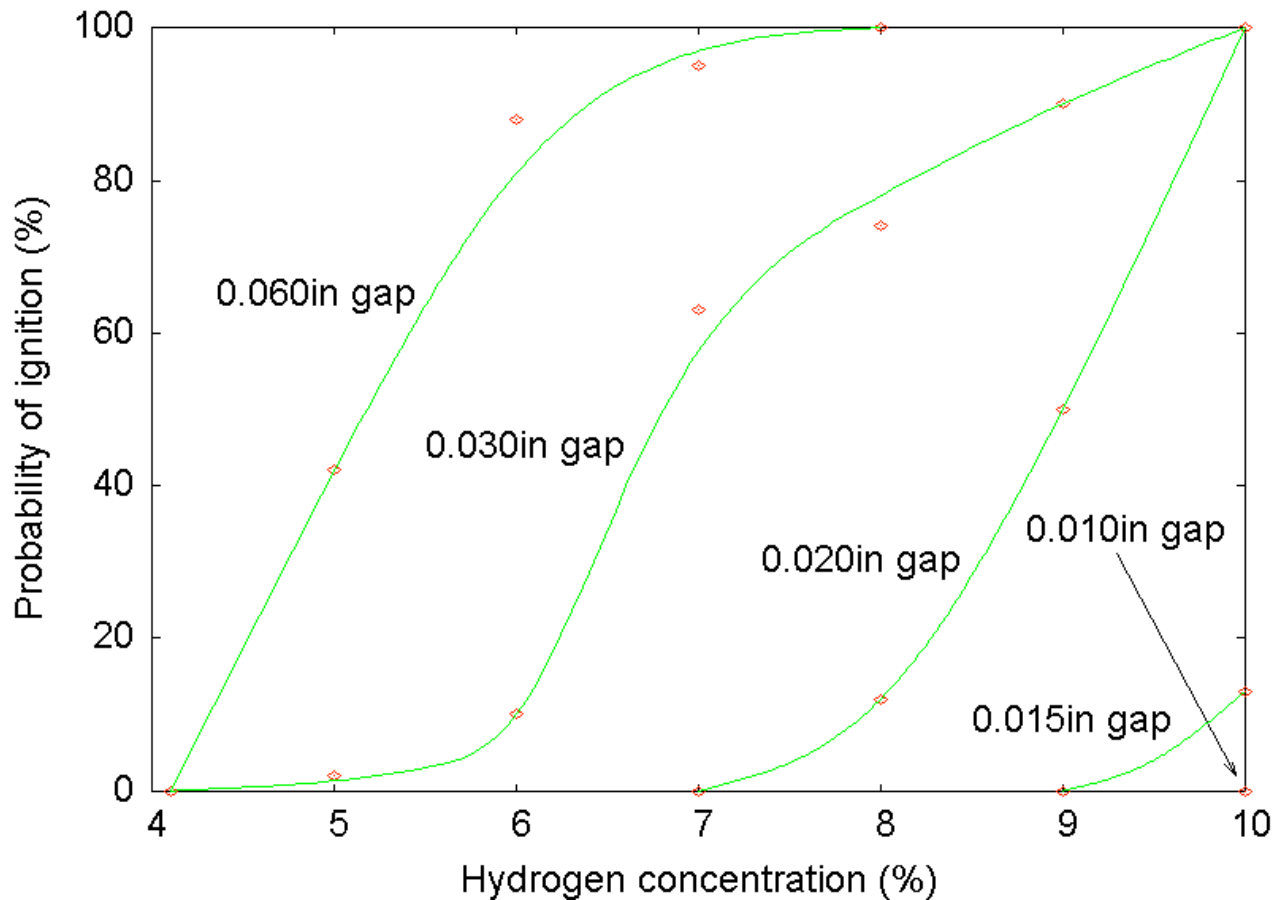
Experimentally determined probability of ignition versus hydrogen concentration for various spark gaps sizes, 0.4 inches from wall of duct.

- Ignition energy varied between 51 mJ and 205 mJ
- Shows weak dependency on ignition energy
- Shows strong dependency on spark gap size

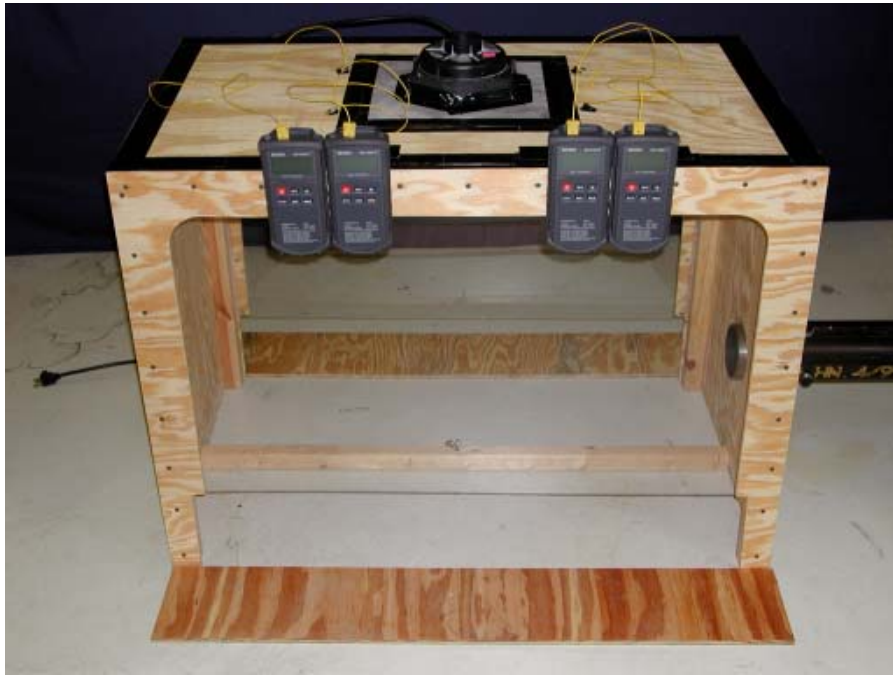
A 10 year old 1.25 HP shop vac motor was initially able to ignite 7% hydrogen. Ignition produced a temperature rise at the thermocouples, the pressure relief panels at the bottom to drop (as shown) and condensation on the Plexiglas. Disassembly of the motor and further scuffing of the brushes allowed ignition of 6% hydrogen.

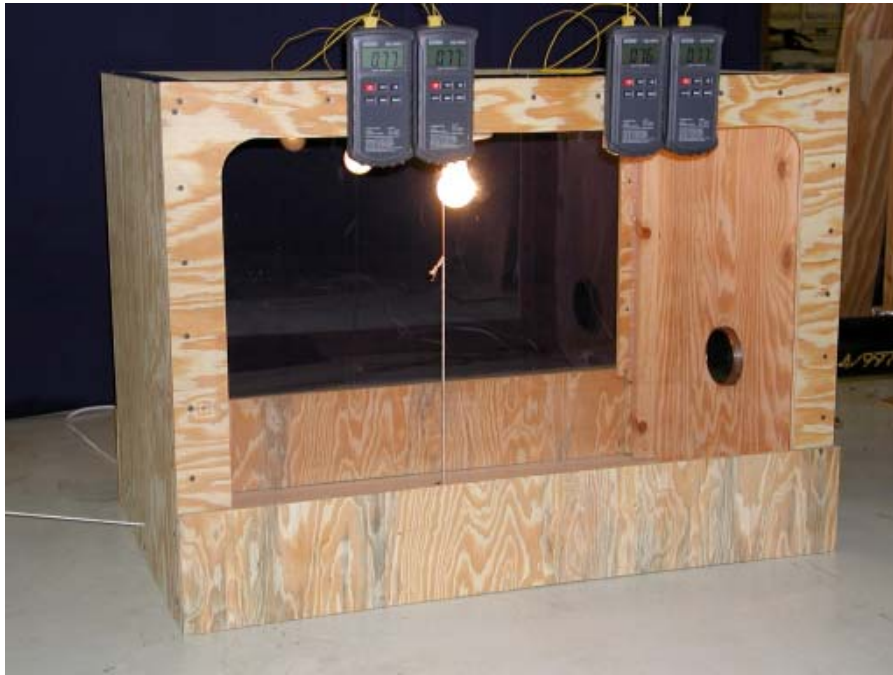
A ceiling light with a pull chain was able to ignite 8% hydrogen. The light switch utilizes a rotating bar to make electrical contact. This inherently produces less quenching than the flat disk type contacts. Ignition occurred on the 7th attempt.

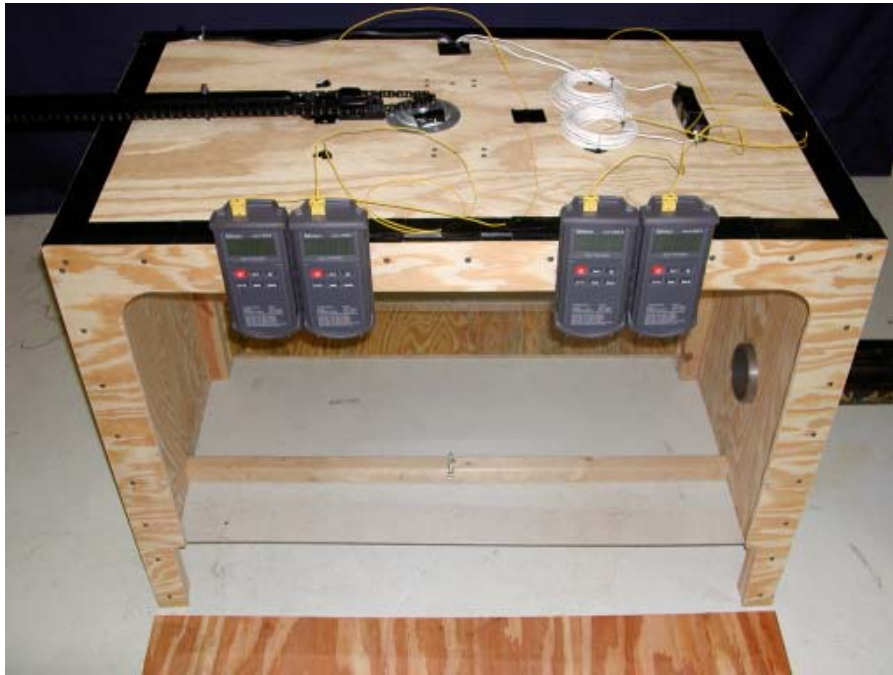
A new residential _ HP garage door opener would not ignite 4%-10% hydrogen concentrations. The motor was operated for one minute at each concentration. Note in the photo on the right that the motor assembly cover was removed to assure access for the hydrogen-air mixture.
