Materials Solutions for Hydrogen Delivery in Pipelines

Dr. Subodh K. Das

Secat, Inc.

Project ID: PDP18

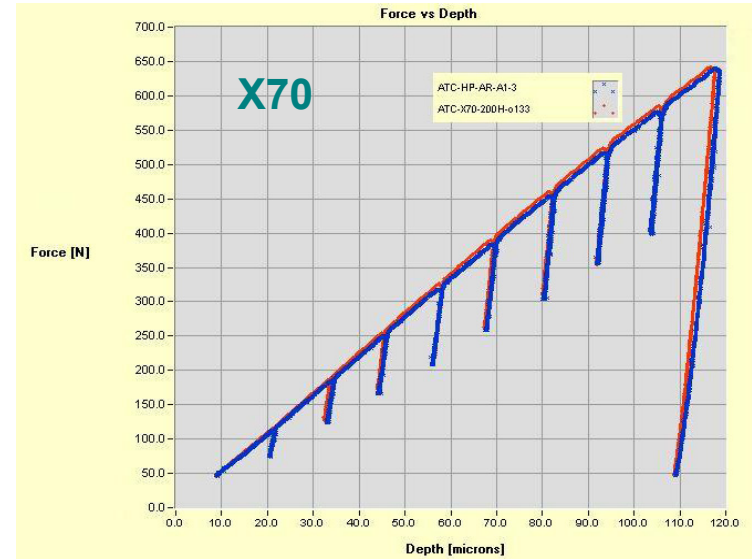
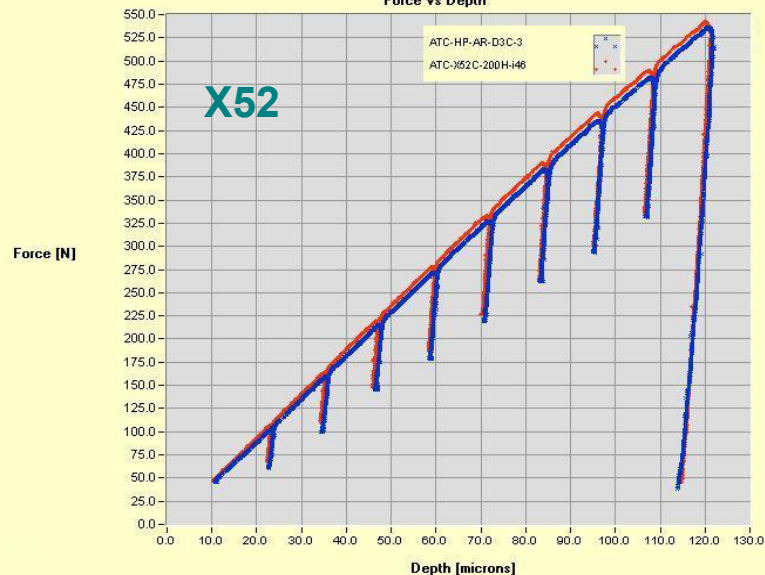
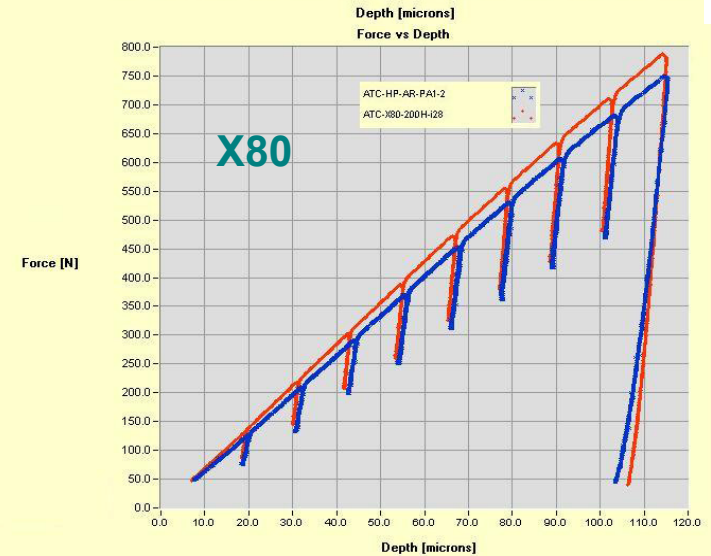
Technical Accomplishments/Progress/Results: In-Situ SSM Testing System -Effects of 200 h exposure to 2,000 psi hydrogen on ABI data of four pipeline steels

- **The ABI-determined fracture toughness of X80 pipeline steel decreased by 12.3%, 25%, 32%, and 30% after 2,000 psi hydrogen exposure times of 5, 25, 100, and 200 hours. It appears that the reduction in fracture toughness saturates at 100 h for the 9.5-mm (0.375-inch) thick sample.**

- **This compared well with the 49% reduction in fracture toughness of 0.5T CT sample tested in an autoclave by Praxair. The complete immersion in hydrogen is more severe than actual hydrogen pipeline transmission application. The ABI hydrogen chamber better simulates the real pipeline steel application. Increase in tensile properties was very small for X80 pipeline steel and no changes were measured for other grades.**

- **No reduction in fracture toughness was observed for ABI disc samples manufactured from Grades B, X52, and X70 exposed to hydrogen pressure with the X80 steel.**

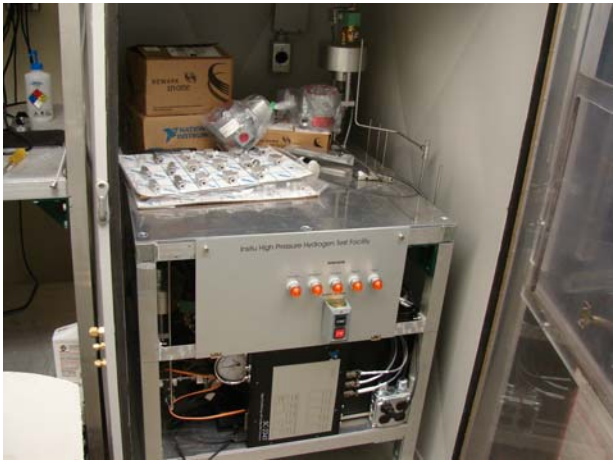
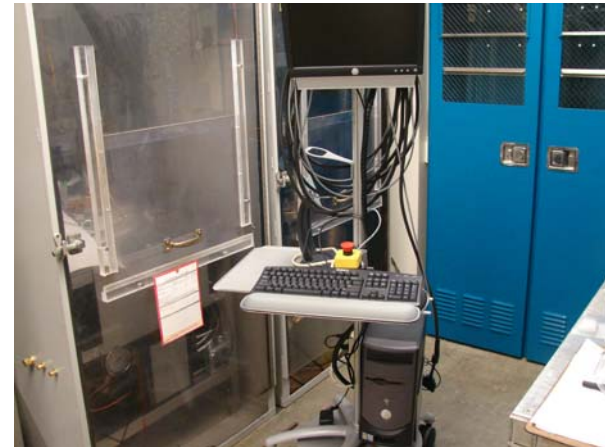
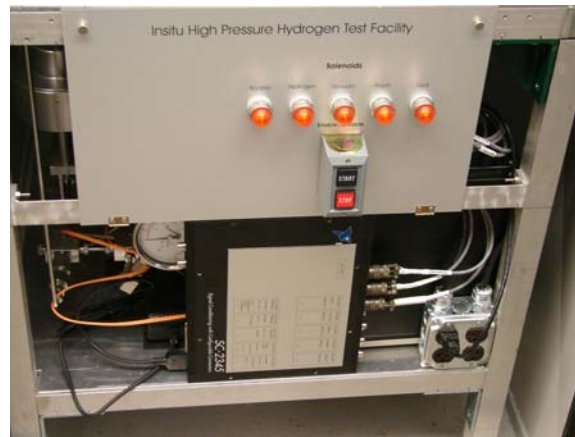
Technical Accomplishments/Progress/Results – Most System Components for High Pressure Testing System are Ready at ORNL

- Complete assembly of equipment for *in-situ* mechanical testing of materials in high hydrogen pressures along with setting up associated safety measures and controls at ORNL.
- Begin measurement of mechanical properties and hydrogen embrittlement characteristics of down-selected steels using traditional mechanical testing.
- Continue thermodynamic, and kinetic modeling of initial down-selected steel compositions.
- Begin permeation testing at University of Illinois of Alloy's A, B, C, and D in uncoated and coated conditions.
- Initiate testing and characterization of samples of commercial grade long seam pipeline welds that have been recently secured.
