# *Materials Issues and Experiments for HTE and SO<sub>3</sub> Electrolysis*

## **Project #PDP30**

# High Temperature Steam Electrolysis Stack Post-test Evaluation and Electrode Development

# Materials Degradation Studies for High Temperature Steam Electrolysis Systems

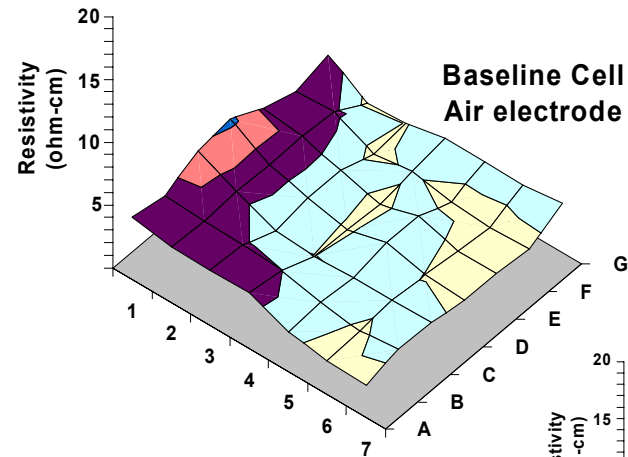
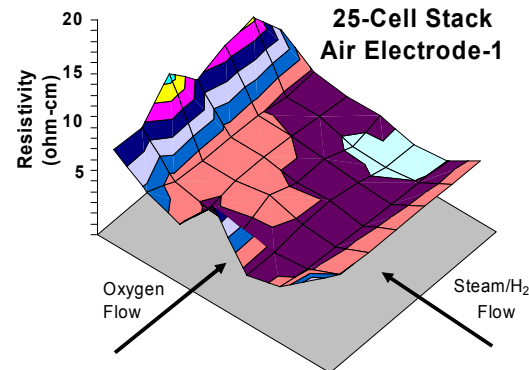
# Resistivity maps for oxygen electrodes show degradation at hydrogen exit of cell

- Baseline Cell (untested) reasonably flat resistivity. 2-6 ohm-cm
- 22-cell stack (200-h) higher resistivity but reasonably flat. 3-7 ohm-cm
- 25-cell stack (1000-h) large growth in resistivity toward hydrogen/steam exit of the cell. 11 – 12 ohm-cm

- 4-point resistivity measurements show
  - Oxygen electrodes degraded along the seal at the hydrogen exit of the stack
  - Steam/H<sub>2</sub> electrodes degraded at the hydrogen exit of the stack
  - The bipolar plate had a highly resistive chromium compound
- Raman micro-spectroscopy identified monoclinic zirconia, Cr-Al<sub>2</sub>O<sub>3</sub> crystals, and Cr-spinel forming in the surface of electrodes
- APS X-ray fluorescence and transmission identified Cr diffusing into the electrode toward the interface and electrode thickness variations
- SEM analysis verified edge degradation via delamination and Sr segregation in the oxygen electrode
- SEM analysis of steam/H<sub>2</sub> electrodes identified Al and Si impurities in areas that showed high resistivity in 4-point measurements

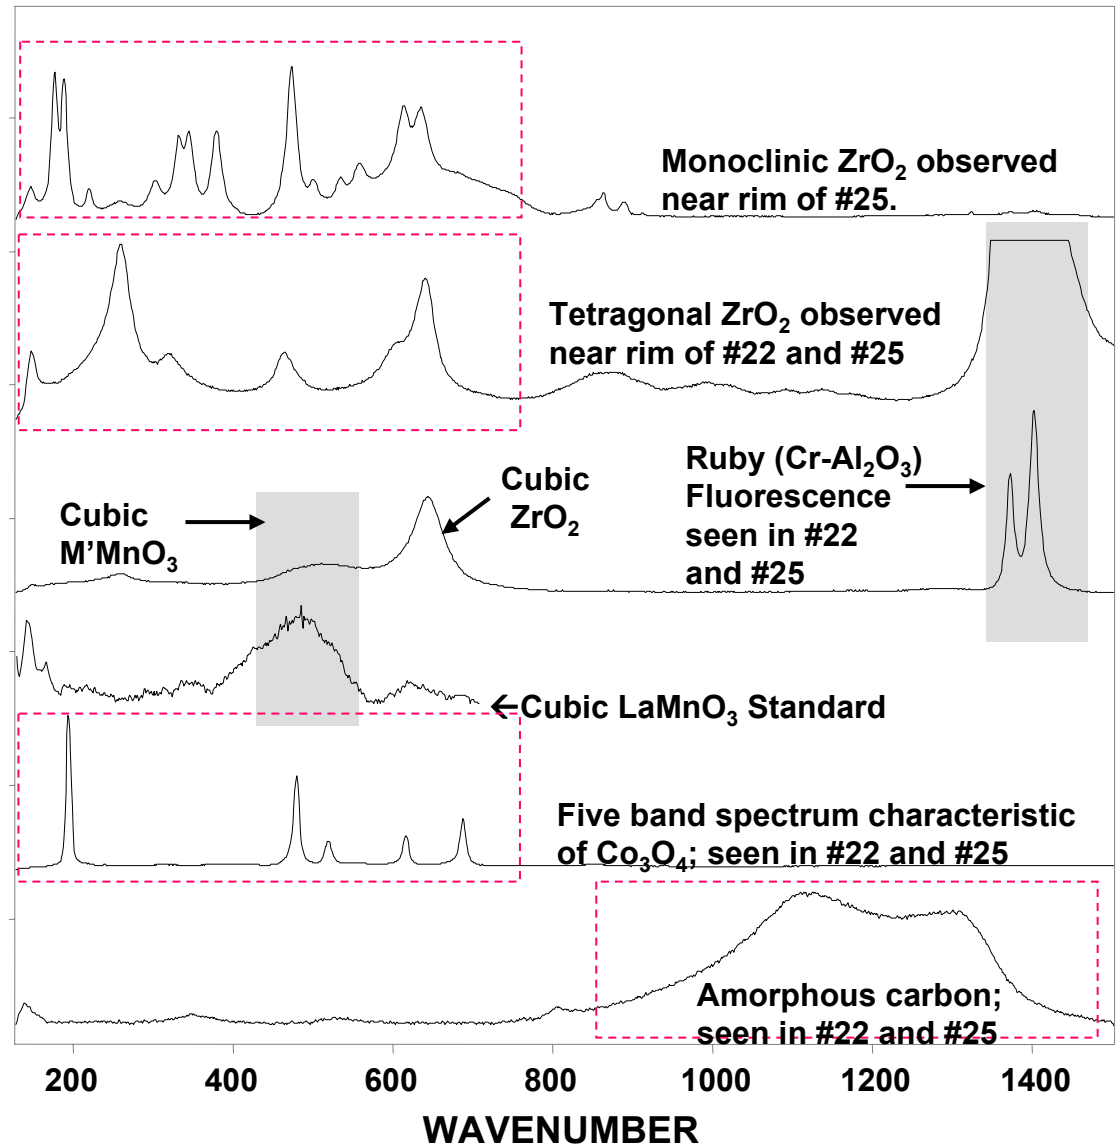
# Raman micro-spectroscopy on oxygen electrodes identifies unexpected phases

- Monoclinic zirconia observed on exposed edges of the ScSZ plate

- Chromium reacted with Al in sealant near edge of electrode

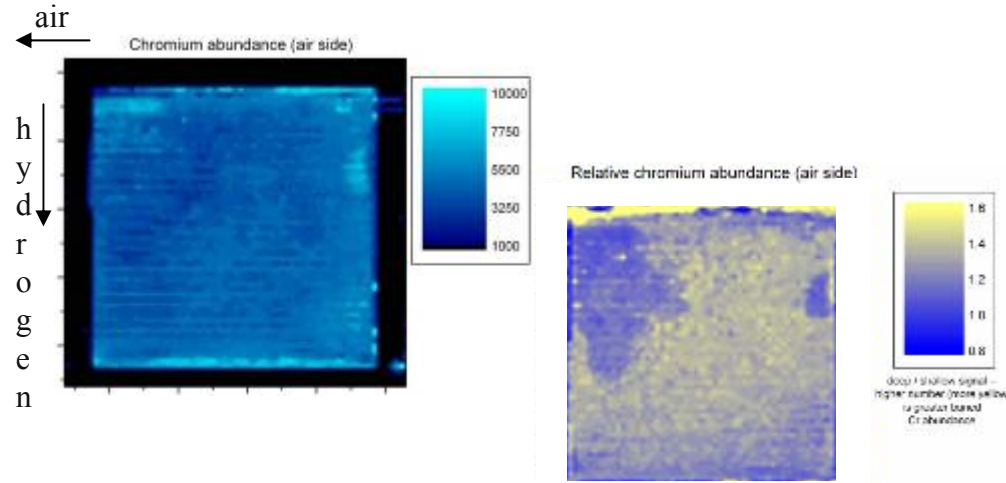
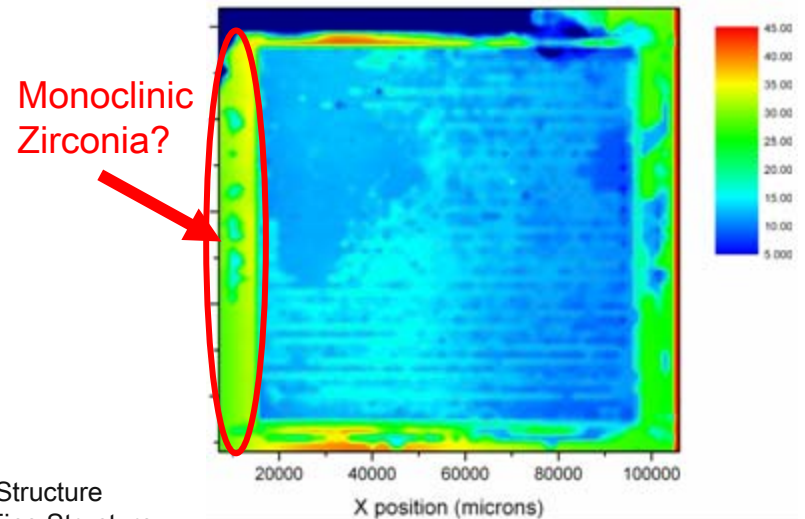
# X-ray fluorescence and transmission show Cr migration and thickness variations in the cell

- Cr deposits along edges of sealant
- Cr deposited only in electrode region and not on zirconia  $\Rightarrow$  solid state diffusion
- Gas flow direction is evident by Cr-deposition pattern
- Cr has migrated into the electrode towards electrolyte interface
- Thickness variation in electrode
- Increased transmission near known degraded edge
- Increased transmission near oxygen seal
- Would like to use XANES & EXAFS determine **chemical state of elements** in areas of interest

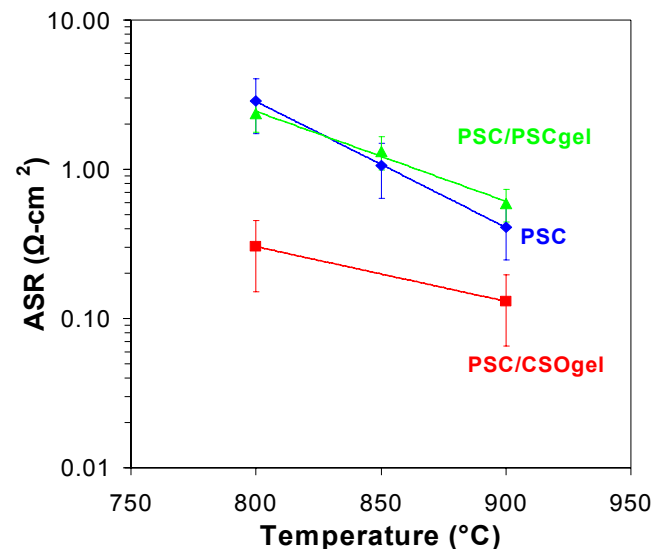
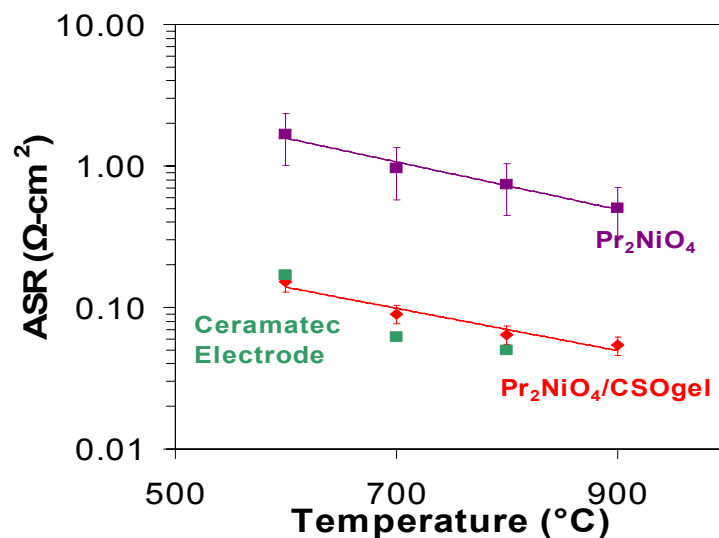
# High temperature electrolysis oxygen electrodes improve with CSO interlayer

- Addition of a CSO interlayer improves performance of PSC electrodes
  - No secondary phases found by XRD
- CSO interlayers improve the performance of  $\text{Pr}_2\text{NiO}_4$
- The roughness on the top of the ceria layer may contribute to the improved performance

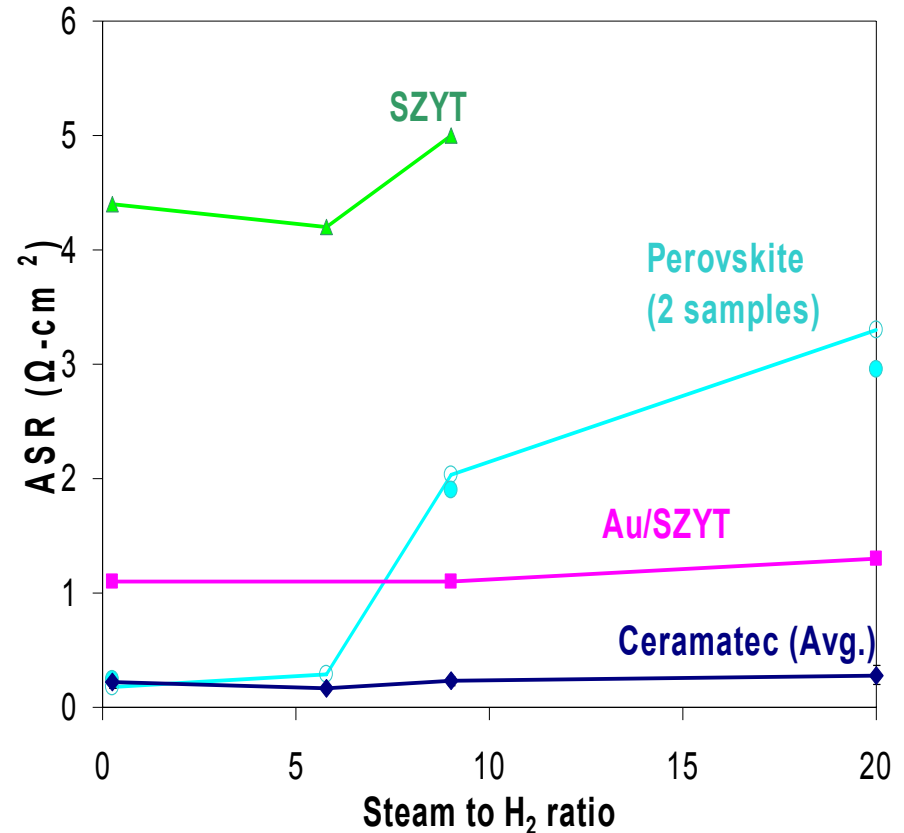
# Increasing steam concentration increases ASR of steam/H<sub>2</sub> electrodes

- ASR results for ZYT, LSCM, and Nb<sub>2</sub>TiO<sub>7</sub> follow the same trend

Temperature = 830°C

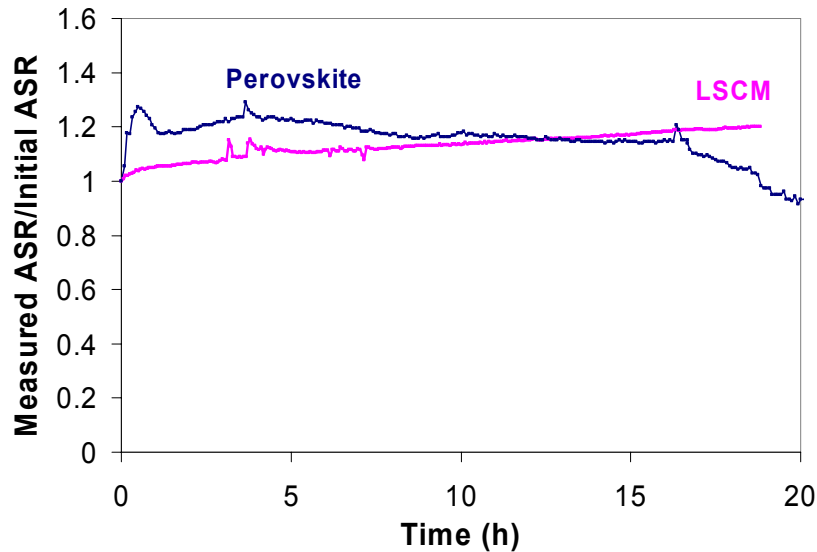
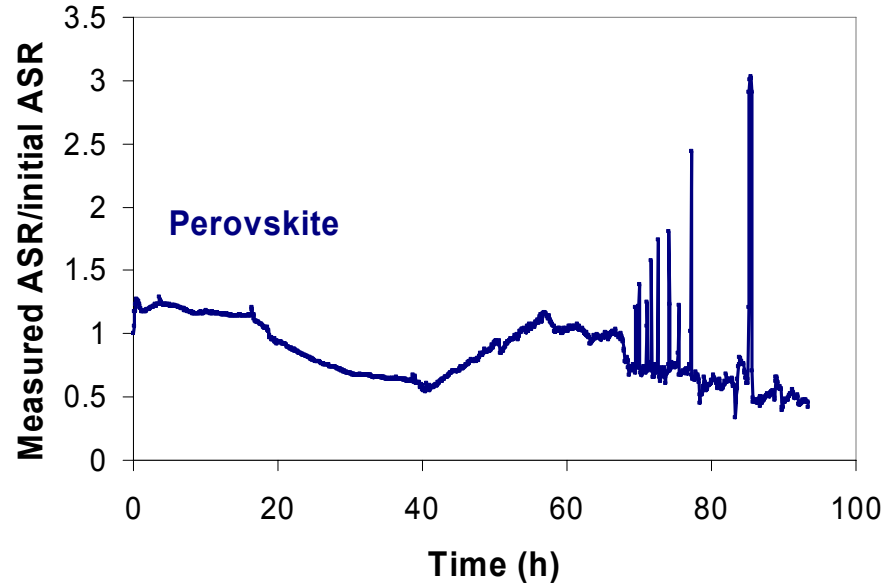
# Steady state performance of steam/hydrogen electrodes shows that oxides may replace Ni-YSZ

- Temp = 830°C
- Current density = 200 mA/cm<sup>2</sup>
- Feed gas = H<sub>2</sub>
- Steam to H<sub>2</sub> ratio = 6

- Degradation of the perovskite sample is due in part to exfoliation of the counter electrode, which was made out of the same material
  - Exfoliation also occurred with Pt and Ni-CeO<sub>2</sub> counter electrodes

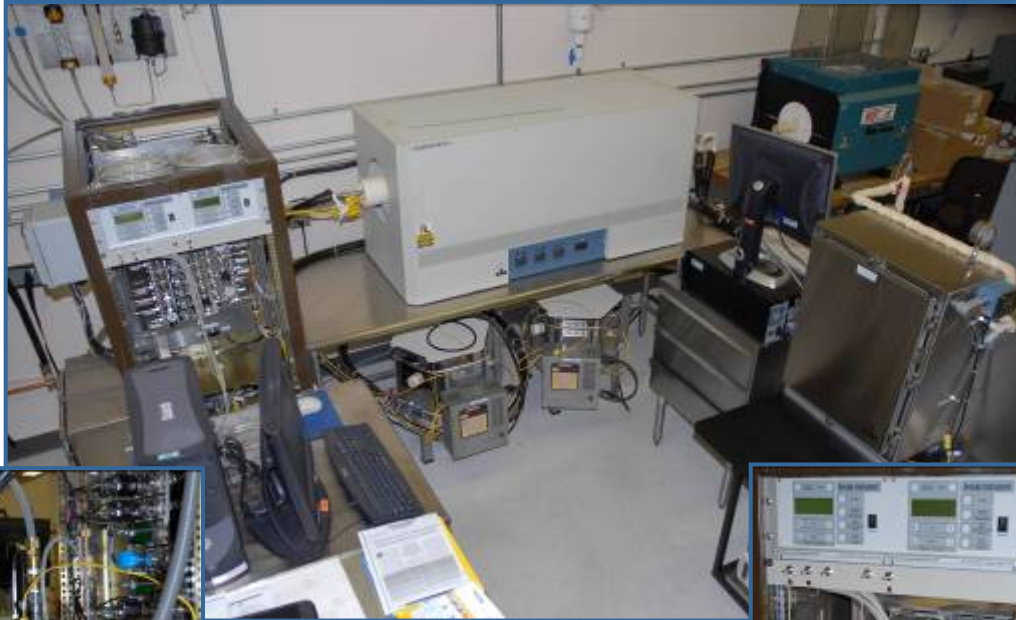
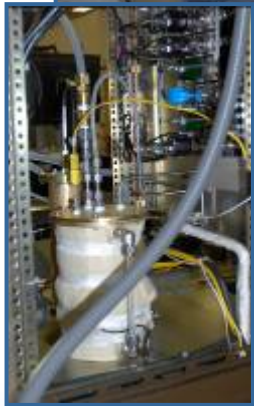
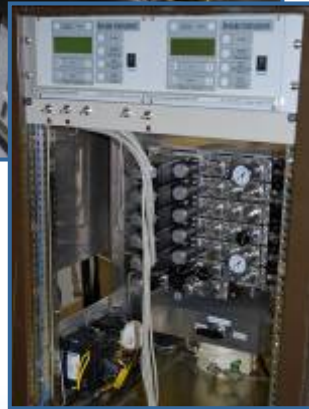
**High temperature  
steam electrolysis  
corrosion test stand**

- **Three independent furnaces**
- **Three sets of parallel gas supply lines**
  1.  $\text{H}_2\text{O}/\text{H}_2/\text{N}_2$  (steam provided by heated water bath)
  2.  $\text{Air}/\text{O}_2$
- **Gas mixtures set with mass flow controllers**
- **Automatic data logging**
- **$\text{H}_2$  and  $\text{O}_2$  gas safety systems:**
  - Trace He injection to detect  $\text{H}_2$ - $\text{O}_2$  gas cross-mixing
  - Interlocked  $\text{H}_2$  and  $\text{O}_2$  monitors in laboratory

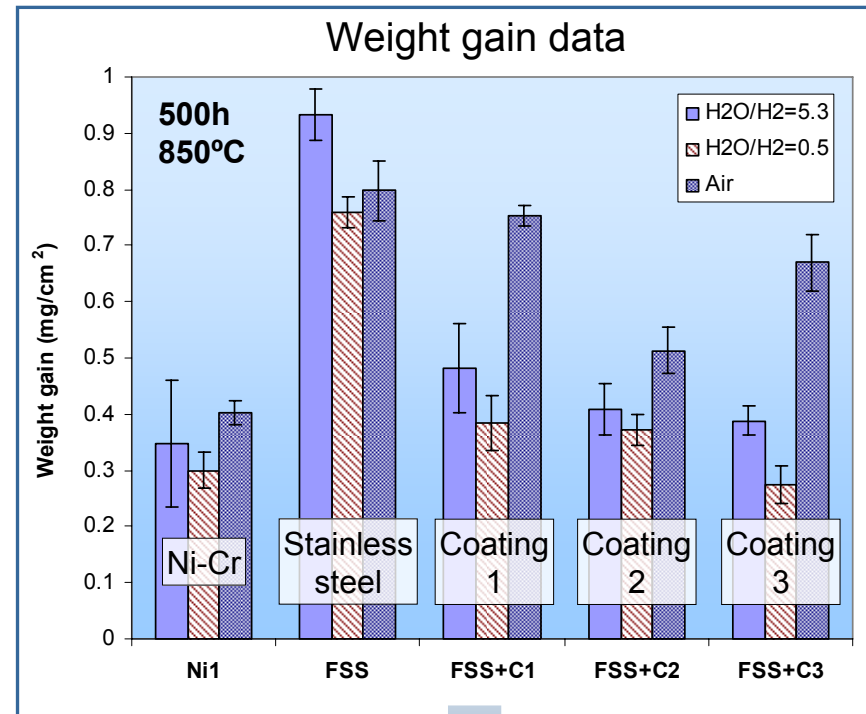
- 500 h tests completed at 850°C with the following gas mixtures:
  - $H_2O/H_2 = 5.3, 0.5$
  - Dry air
- *Sample characterization is ongoing:*
  - *Scale microstructures and thickness*
  - *Scale chemistry*
  - *Scale resistivity as a function of temperature:*

- Ni-Cr alloy base metal more corrosion resistant in both  $H_2O/H_2$  and air than ferritic stainless steel
- Proprietary Ceramatec coatings effective in reducing corrosion in  $H_2O/H_2$ ; less effective in air

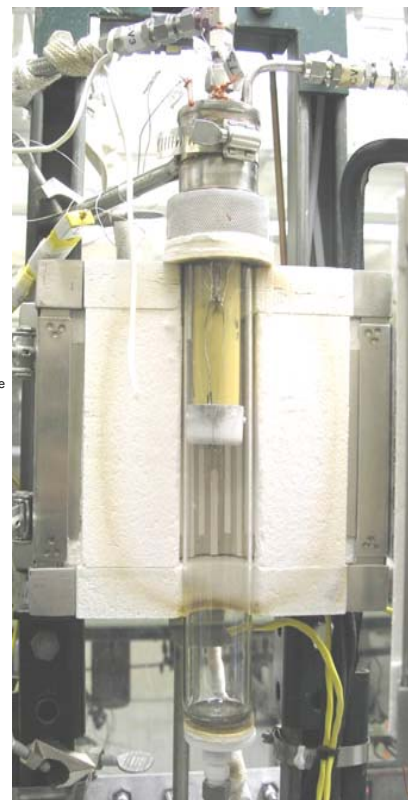
# $SO_3$ electrode test fixture

- $H_2SO_4/H_2O$  mixture is sprayed into sample tube above the cell
- $O_2$  and  $SO_2$  monitored by mass spectrometry

- Electrochemical cell was shown by cyclic voltammetry to reduce some  $SO_3$  to  $SO_2$

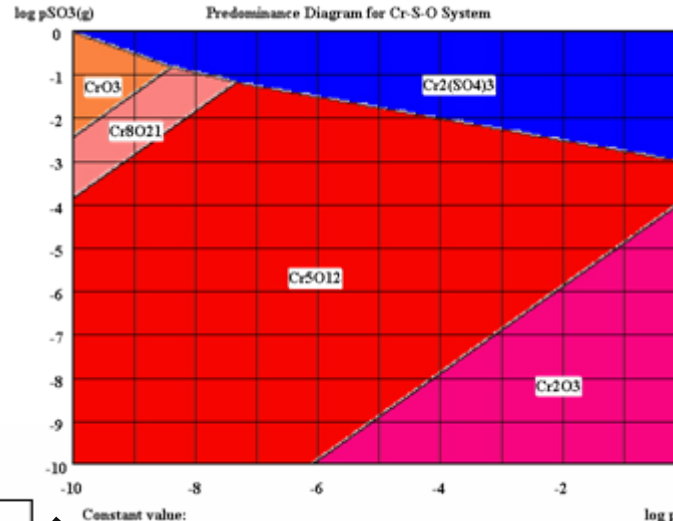
- Calculated predominance diagrams illustrate stable phases in  $\text{SO}_2$ - $\text{SO}_3$ 
  - Blue = Sulfate *undesirable*
  - Red = Oxide
  - Yellow = Metal

**Example:**  
Chromium  
Predominance  
Diagram

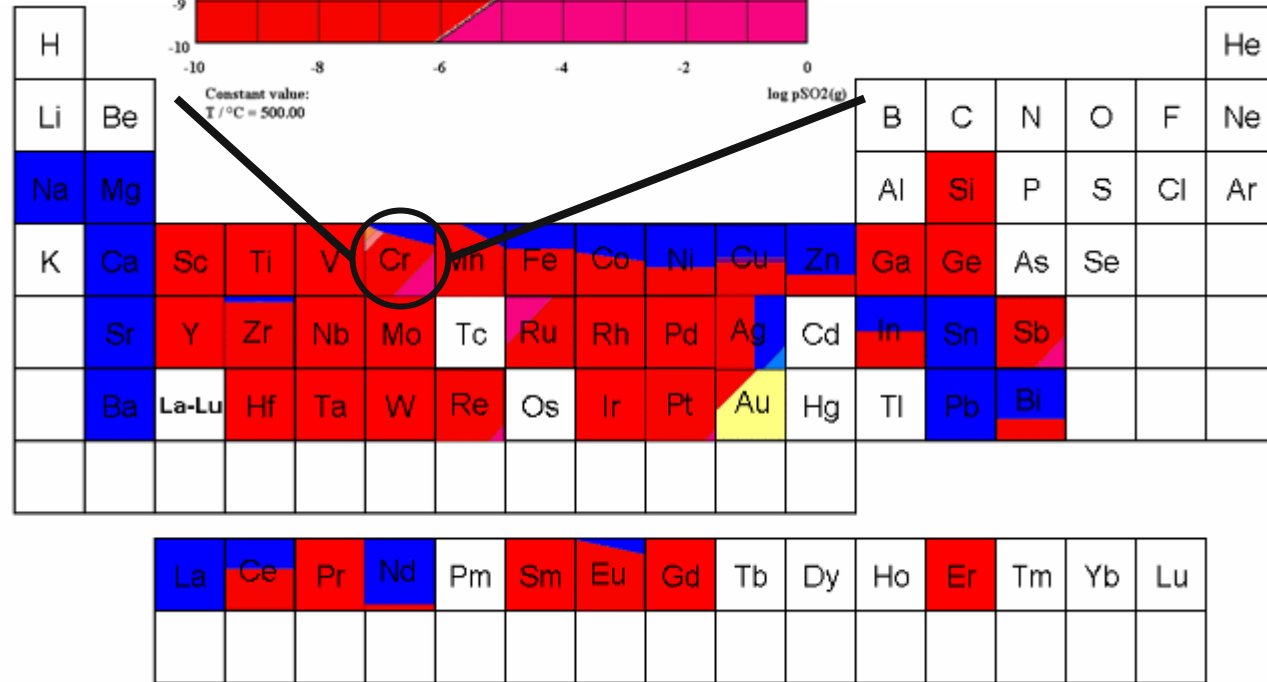
- Gold is only stable metal
- Traditional SOFC electrodes are not stable in  $\text{SO}_2/\text{SO}_3$
- Candidate oxide has been identified, fabricated and tested as electrodes, others being fabricated
