Corrosion and Crack Growth Studies of Heat Exchanger Construction Materials for HI Decomposition in the Sulfur-Iodine Hydrogen Cycle

Bunsen Wong
General Atomics
May 15, 2007

Construction materials are needed for four different chemical environments in Section III of the S-I Cycle

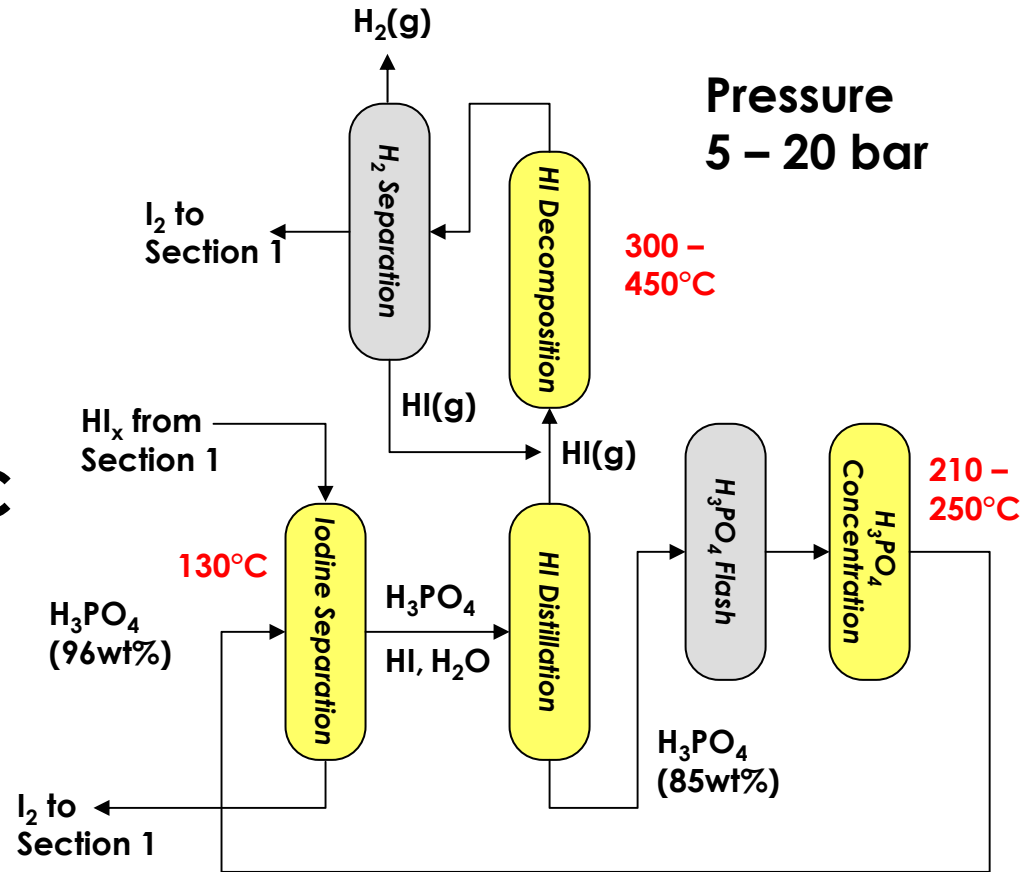
- **Iodine Separation**
 $\text{HI}_x\text{-H}_3\text{PO}_4 - 140^\circ\text{C}$
- **H_3PO_4 Concentration**
 $85\text{-}96\text{wt}\% \text{H}_3\text{PO}_4 - 250^\circ\text{C}$
- **HI Distillation**
 $\text{H}_3\text{PO}_4\text{-H}_2\text{O-I}_2\text{-HI} - 190^\circ\text{C}$
- **HI Decomposition**
 $\text{H}_2\text{-I}_2\text{-HI (g)} - 450^\circ\text{C}$

Upper Corrosion Limits
Tubing/Valves – 2.95 mpy
Vessel – 19.7 mpy

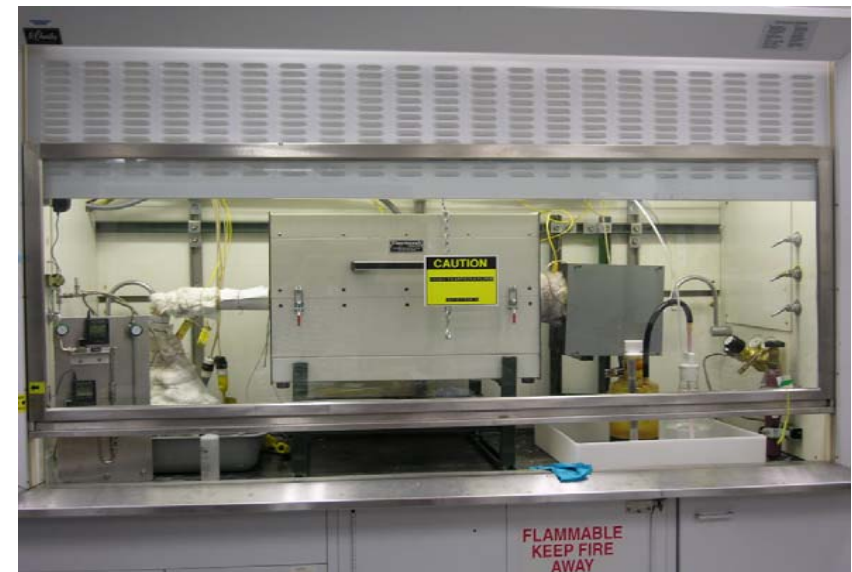
The HI decomposition materials test system replicates the HI gaseous decomposition environment

- Eliminates the need to procure expensive HI gas
- Test materials for both HI decomposition and iodine condensation

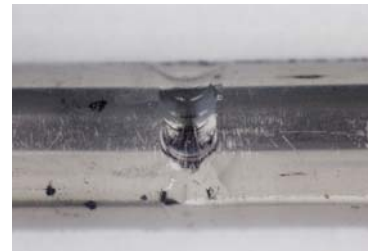
0 hr

178 hr

A Ta-10W tube section with a Ta weld

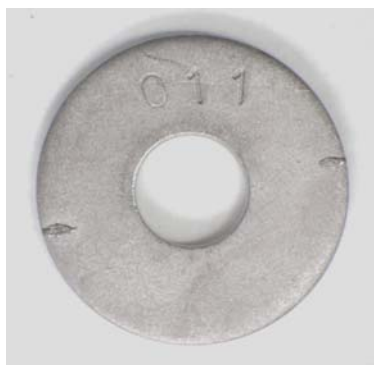
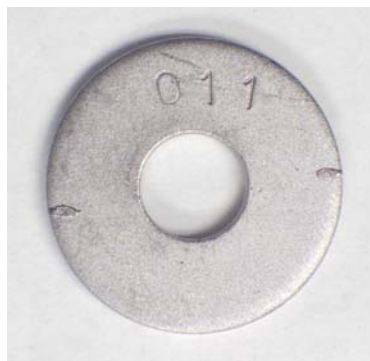
0 hr

294 hr

- Ta plated washer showed no sign of corrosion after immersion in $\text{HI}_x + \text{H}_3\text{PO}_4$

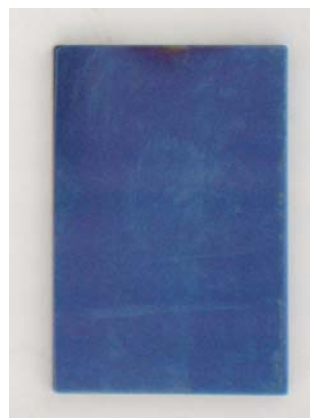
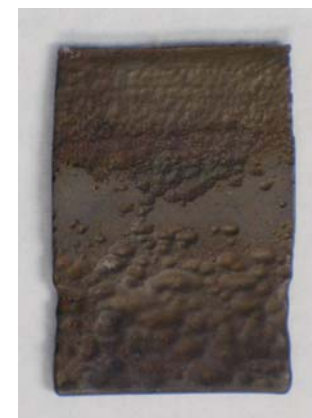
- Cr-Mo steel coupon coated with sputtered Ta and then anodized. Severe corrosion took place after immersion in $\text{HI}_x + \text{H}_3\text{PO}_4$

0 hr

399 hr

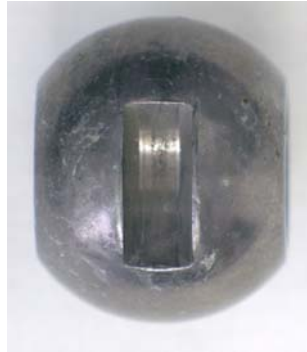
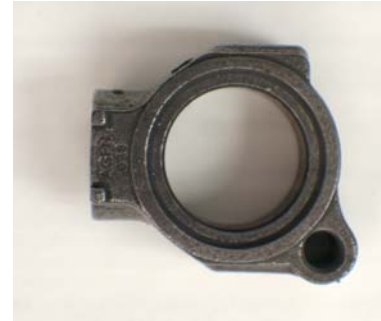
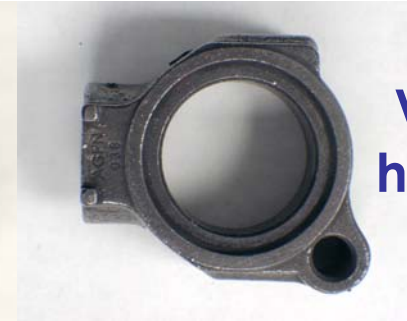
Valve ball

Performance of Ta coated components such as fittings and valves have also been evaluated

- Most valves parts did not show any sign of corrosion

0 hr

1160 cycles (88 hr)

1160 cycles

Valve housing

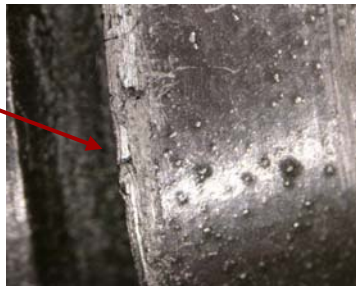
- Testing did reveal incorrect assembly can lead to damage in the Ta coating

Damaged fitting during installation

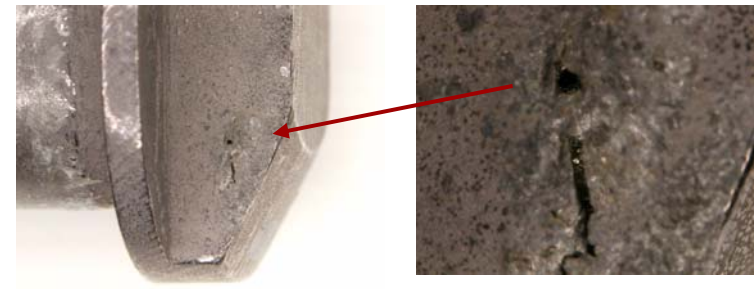
Incorrectly installed valve drive bolt
