Composite Technology for Hydrogen Pipelines

**Barton Smith, Barbara Frame,
Lawrence Anovitz, Timothy Armstrong**
Oak Ridge National Laboratory

**Annual Merit Review
Arlington, Virginia
June 11, 2008**

Project ID #: PD19

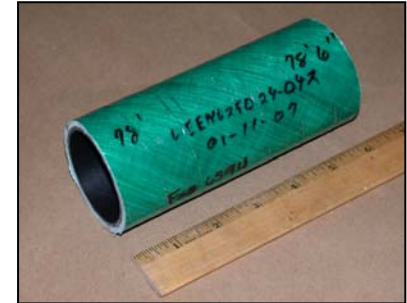
Pipeline test specimens

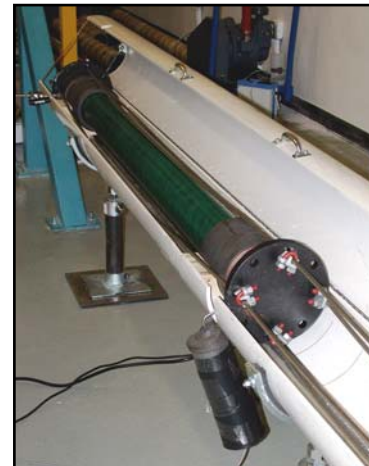
Leakage measurement at ORNL

- **Task 1: Pipeline materials compatibility testing**
 - One-month hydrogen exposure completed with no materials degradation; longer-term exposure underway
 - Initial pipeline leakage measurements completed: smaller than expected leak rate (0.03% per day); additional measurements underway
 - Blowdown testing of FRP pipeline specimen in progress

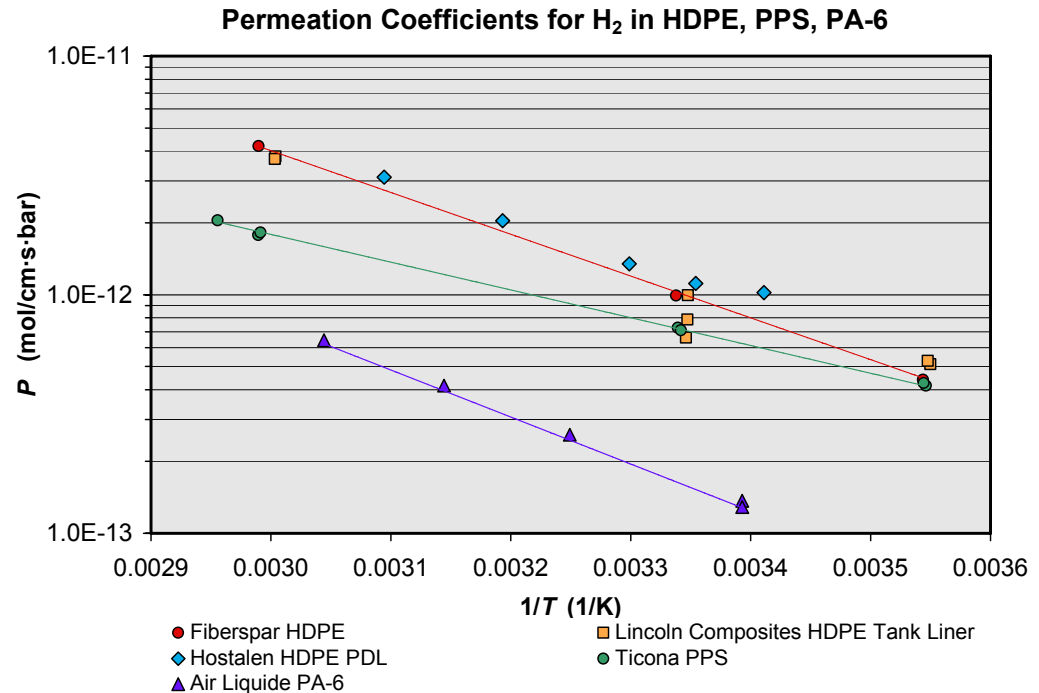
- **Task 2: New contributions to polymer permeation literature**
 - Permeation coefficients for H_2 in HDPE exhibit pressure dependence
 - Coefficients for H_2 in PA and PPS are smaller than those for HDPE
 - Evaluation of surface fluorination treatment in progress

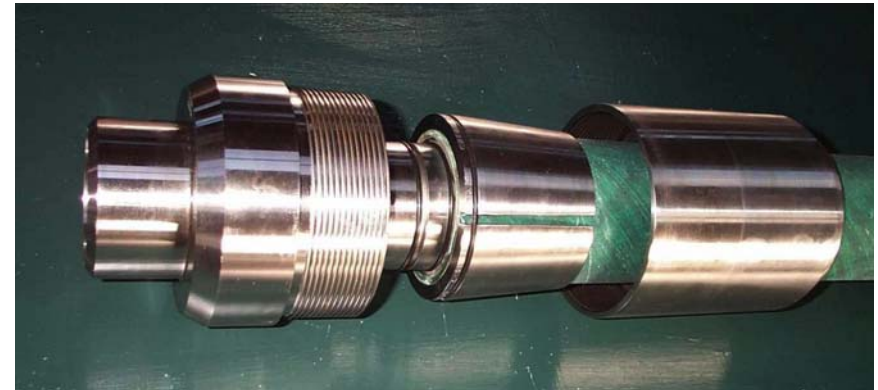
FiberSpar connector with compressive o-ring seals

- **Task 3: Joining and sensor technologies**
 - Indirect evaluation of hydrogen leakage through Fiberspar LinePipe™ connectors showed very low leakage rate ($<3 \times 10^{-6}$ mol/s)
 - Collaborative effort with SRNL to assess joint loading, pipeline flexure, and pressure/temperature cycling on hydrogen leakage for both Fiberspar and PolyFlow connectors

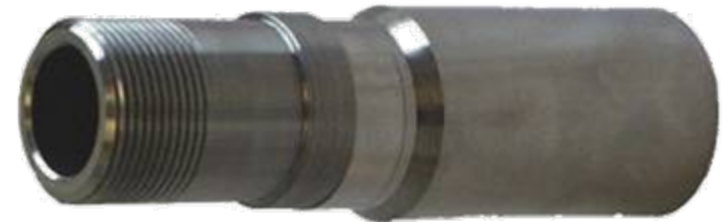
PolyFlow swaged connector

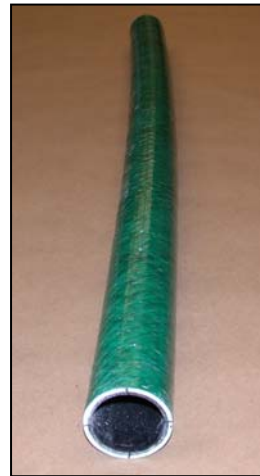
4-pt bending test specimen

- Accelerated aging procedure used to screen for long-term effects of hydrogen exposure on composite pipeline under normal-usage conditions
- Specimens of Fiberspar pipelines and constituent materials
 - Immersion in 1000 psi H₂
 - Accelerated aging at 140°F (60°C)
 - 1 month & 8 month exposures

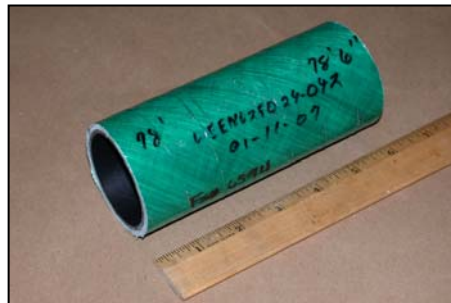
Compression test specimen

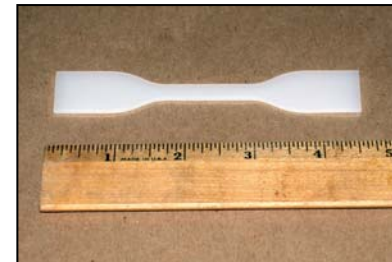
Tensile-test specimen of liner material

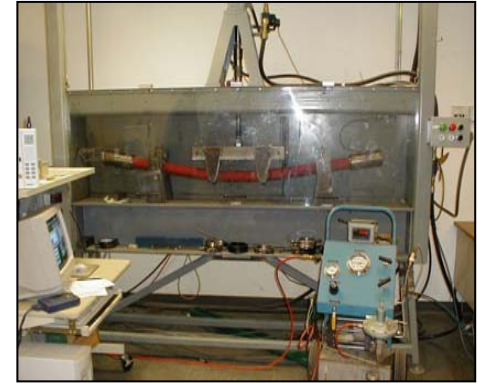
4-pt bending test at Fiberspar

- **Post-exposure testing of pipeline specimens and materials**
 - 4-point bending test to assess laminate cracking
 - Short-term pressure burst test (ASTM D1599)
 - Parallel plate compression test (ASTM D2412)
 - Tensile tests and DMA of liner, matrix resin, glass filaments
- **No statistically significant differences between as-received, air-exposed and hydrogen-exposed pipeline specimens and materials**

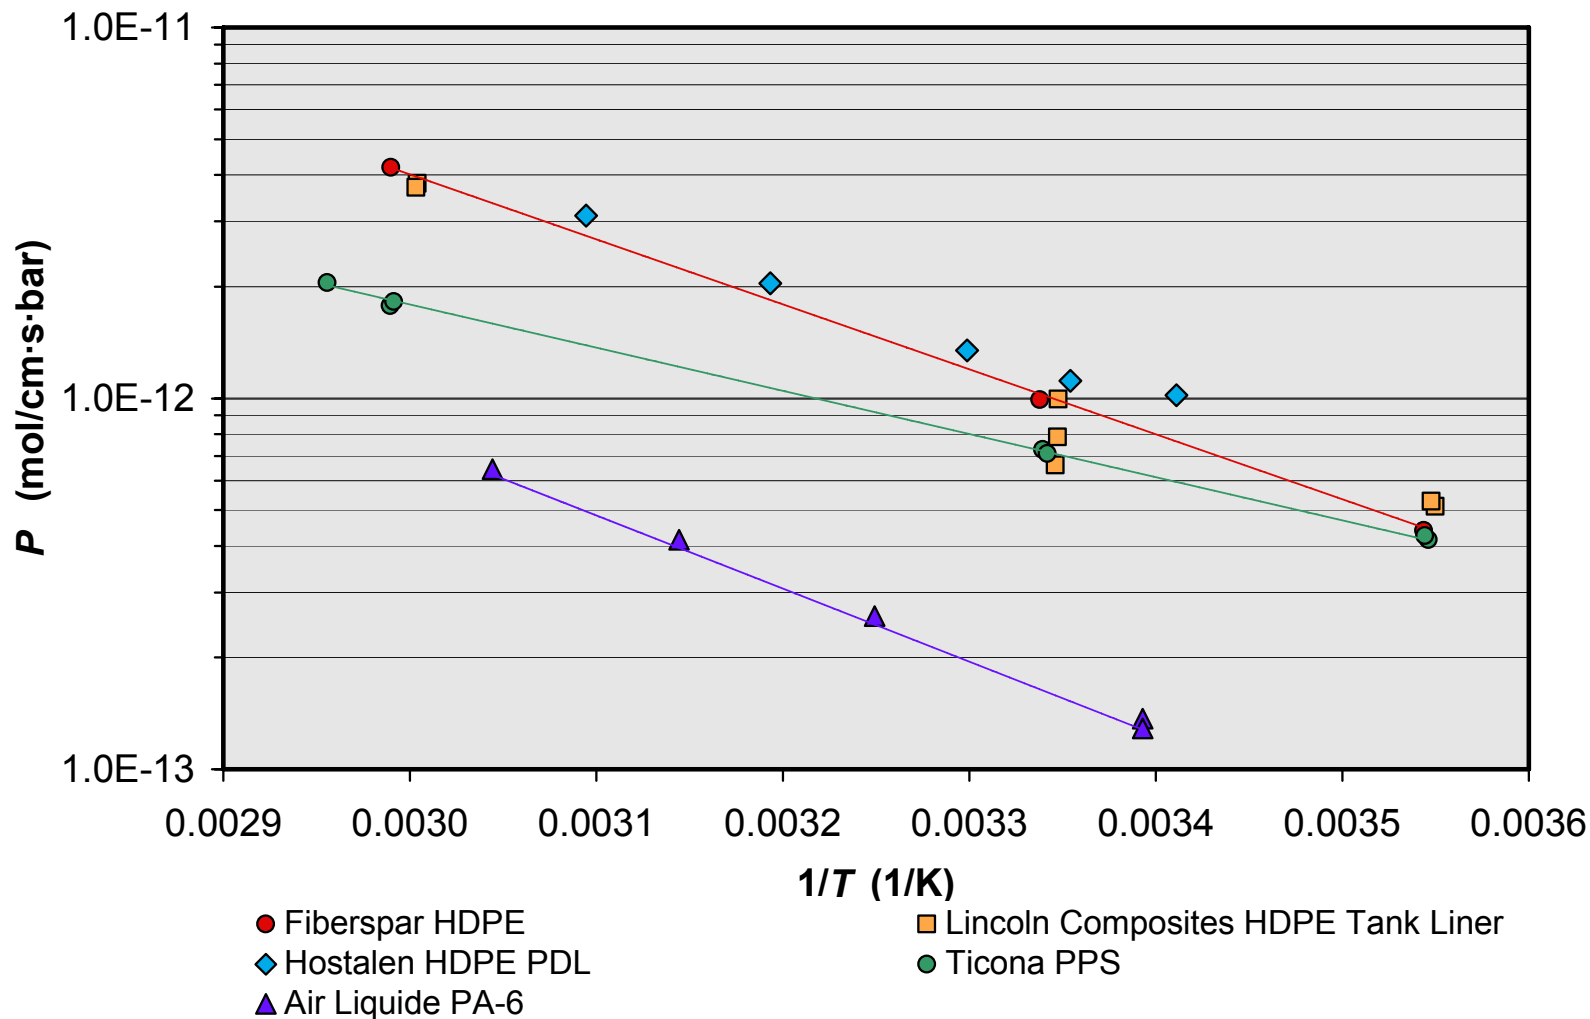
Permeation Coefficients for H₂ in HDPE, PPS, PA-6

New permeation coefficient measurements for H₂ in HDPE, PPS

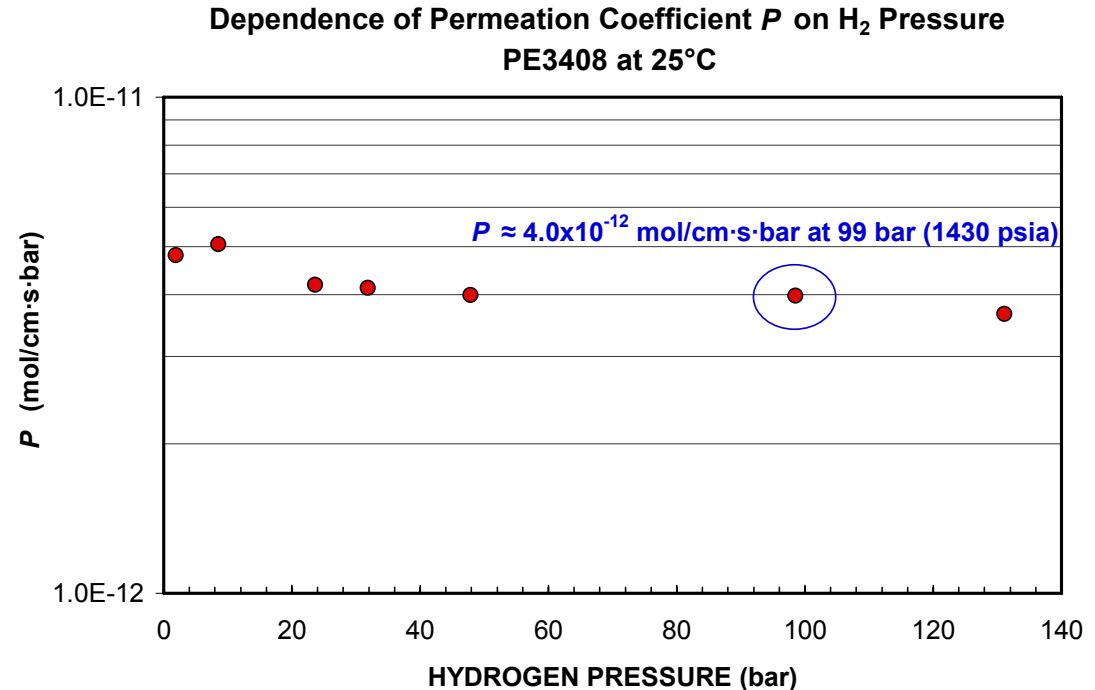
- Predicted hydrogen leak rate in 1.83-m pipeline

- $dn/dt = 1.7 \times 10^{-2}$ mol/h
- This leak rate would be equivalent to a loss of 3.4×10^{-5} kg/h

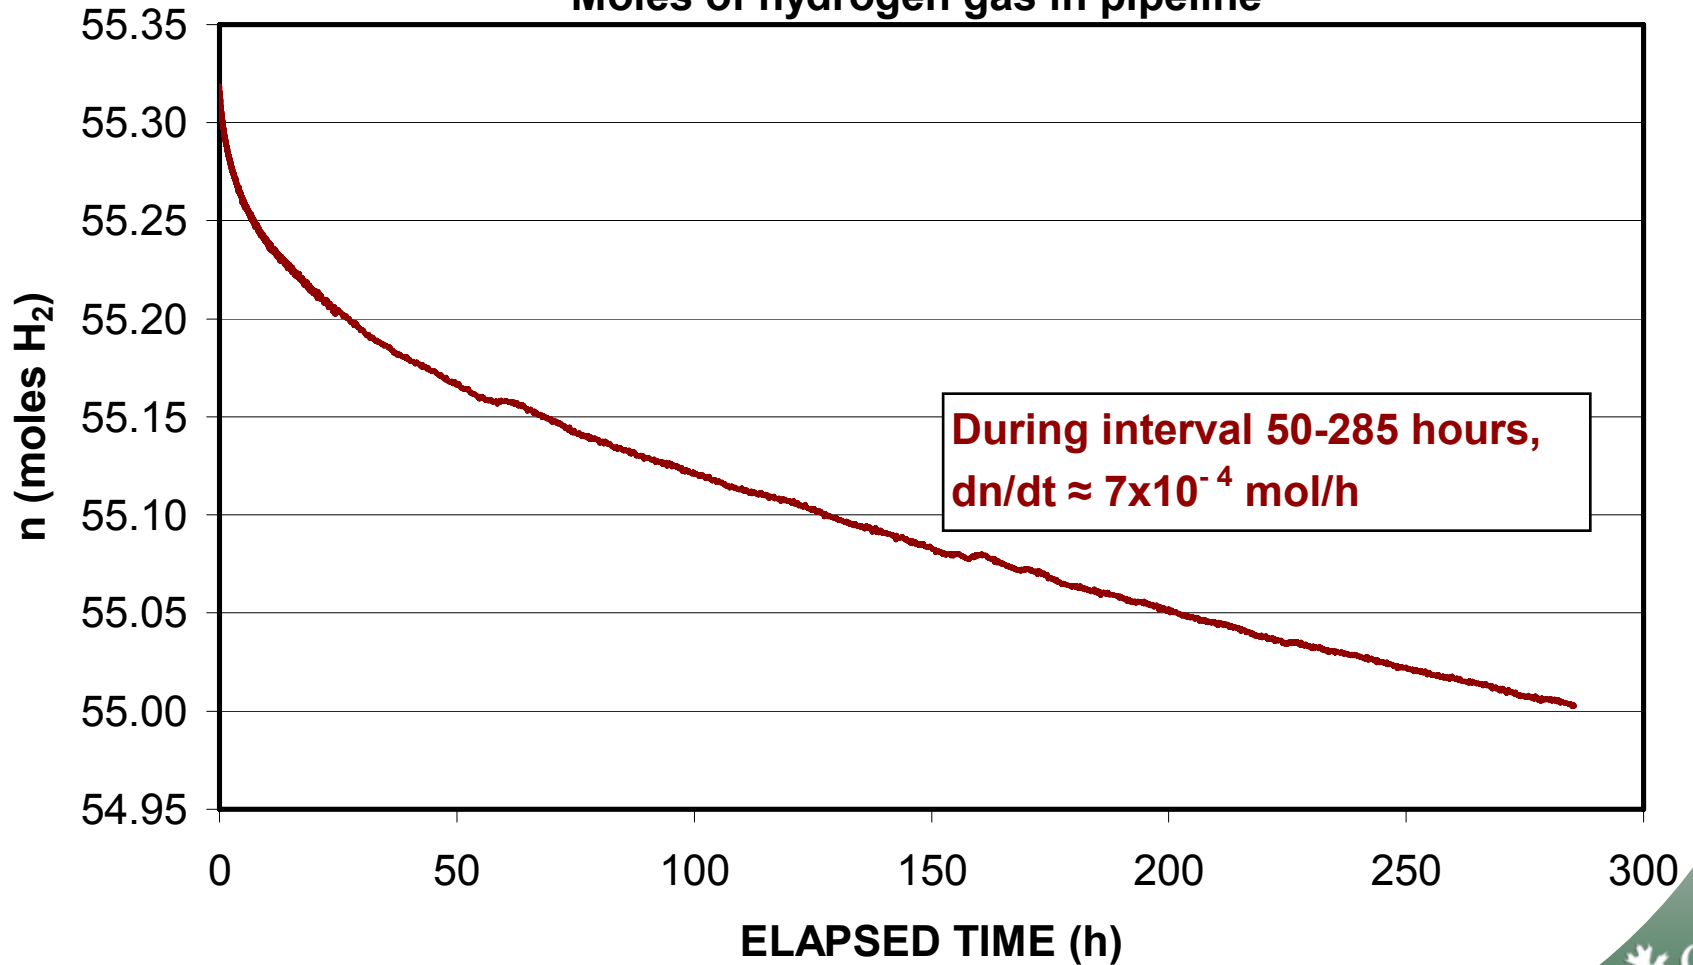
Pipeline Leakage Measurement
1500 psia (103 bar) Pressurization
Moles of hydrogen gas in pipeline

H₂ leak rate in pipeline with HDPE barrier tube is better than expected

- Leakage from end cap seals is not a significant contribution to total leak rate
- Product loss due to permeation
 - $dn/dt = 7 \times 10^{-4} \text{ mol/h} \rightarrow 2 \times 10^{-2} \text{ mol/d}$
 - Pipeline under test contained approx. 55 mol H₂
 - Loss due to barrier tube permeation and end cap seal leakage was 0.03% per day, about 20 times less than that predicted using permeation coefficient for PE-3408 liner

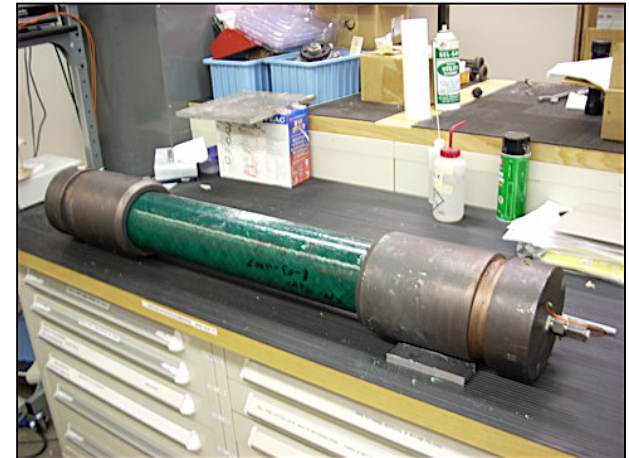
- **Guidance: API 15S - Qualification of Spoolable Reinforced Plastic Line Pipe***
 - **Fill specimen with hydrogen to pressure rating, heat specimen to temperature rating, and hold these conditions until pipeline structure is saturated with gas**
 - **Following hold period, de-pressurize specimen at a rate not less than 1000 psi/min**
 - **Examine specimen liner for evidence of blistering or collapse**

1-meter pipeline specimen instrumented for blowdown testing
