Improved Accelerated Stress Tests Based on FCV Data

Timothy Patterson (P.I. and Presenter), Robert Darling, Vivek S. Murthi

UTC POWER

Project ID: FC015

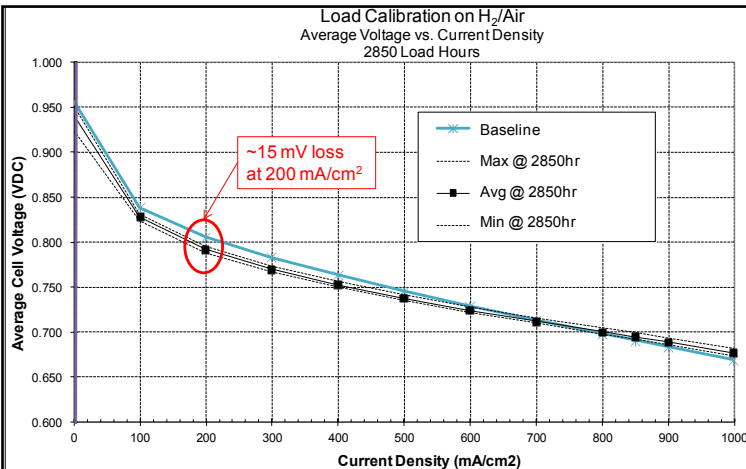
UTC 2008 fleet leader at BOL and EOL

~ 15 mV loss @ 0.2 A/cm²

~50% Platinum area loss

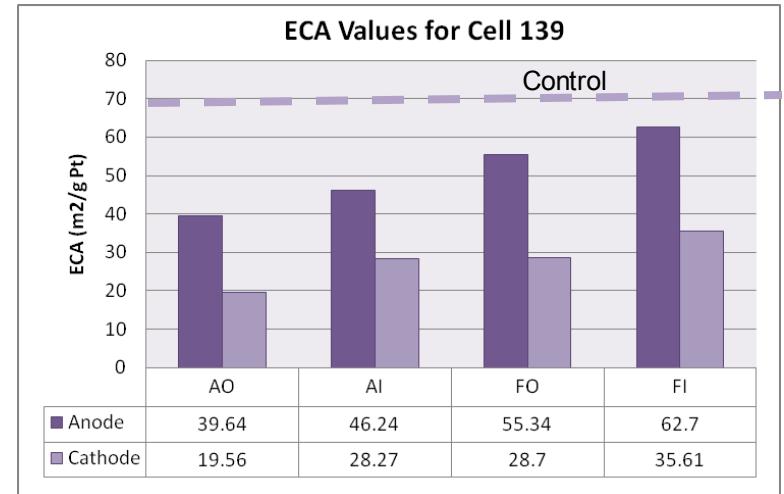
ECA measurements performed on subscale sections at indicated locations (calculated particle size shown in red)

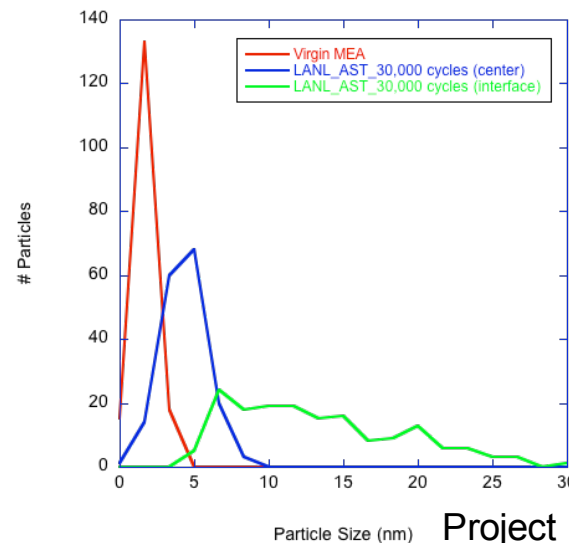
TEM

- ❑ After AST, formation of large Pt single crystals at cathode - membrane interface observed with little Pt precipitation observed within membrane
- ❑ This can be explained by difference in gas compositions; Platinum will precipitate in membrane under H₂/Air and just outside of membrane under H₂/N₂

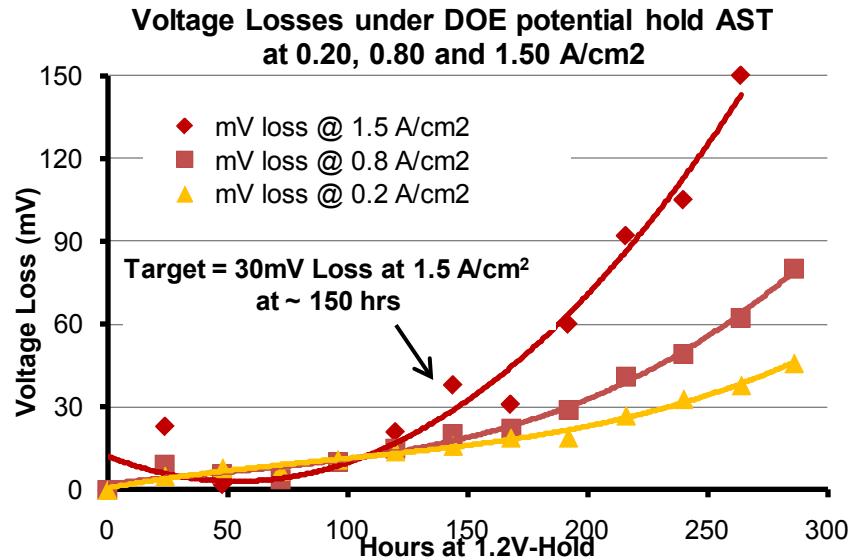
Observed @ 285 hr	DOE Target @ 400 hr
~40% mass activity	≤60% mass activity
>150mV @ 1.5 A/cm ²	≤30mV @ 1.5 A/cm ²
~50% ECA loss	≤40% ECA loss

Severe carbon corrosion under Lab AST

Damaging potentials avoided in 2008 fleet leader

2006 and 2007 fleet leaders suffered from carbon corrosion

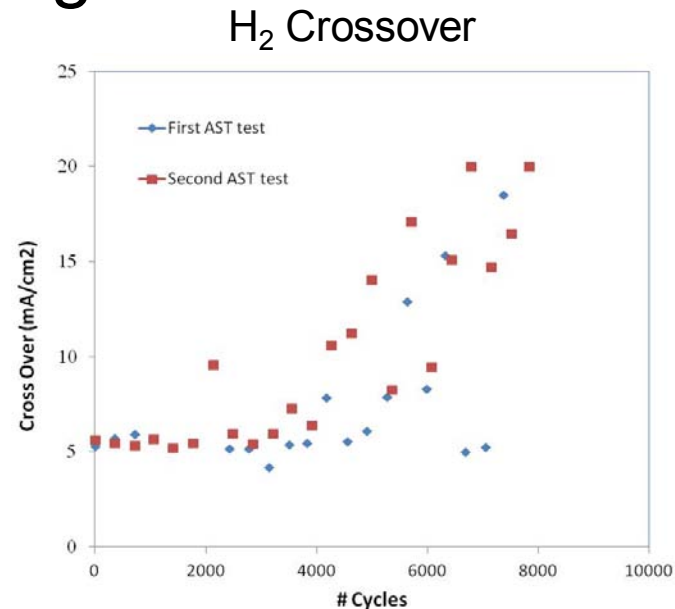
DOE AST Target @ 20000 cycles	Observed @ 7000 cycles
Crossover	<2 mA/cm ²	20 mA/cm ²
Shorting Resistance	> 1000 ohm cm ²	~1400 ohm cm ²

- ❑ Membrane mechanical AST resulted in acceleration factor of ~6X vs. fleet operation with same failure mode

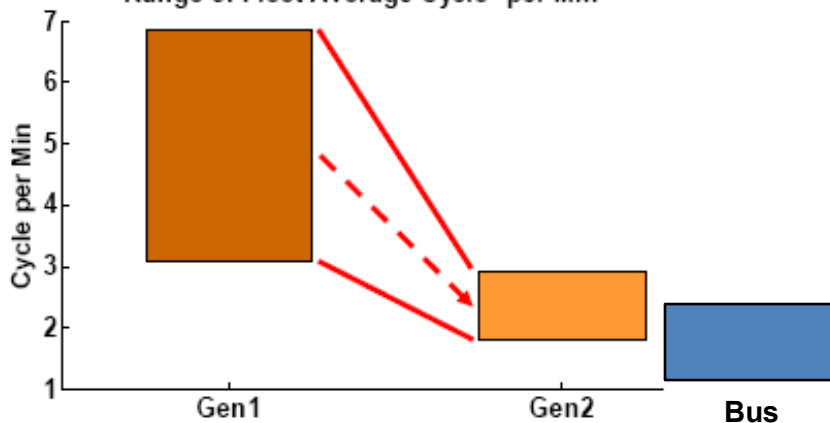
Range of Fleet Average Cycle¹ per Min

from "Controlled Hydrogen Fleet and Infrastructure Analysis" TV001, K. Wipke of NREL, 2010 AMR

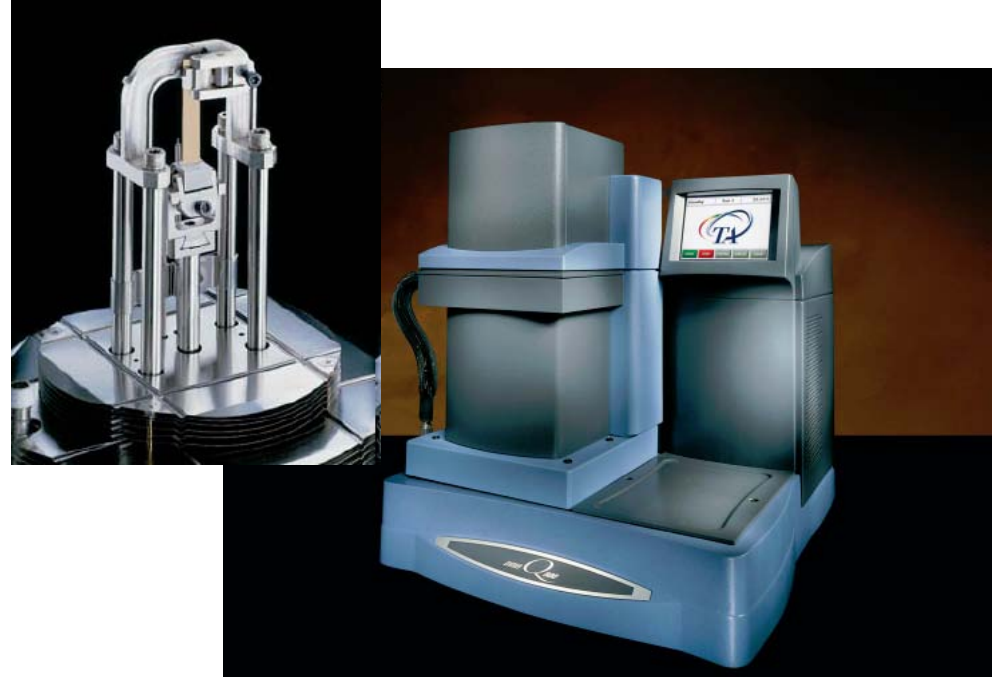
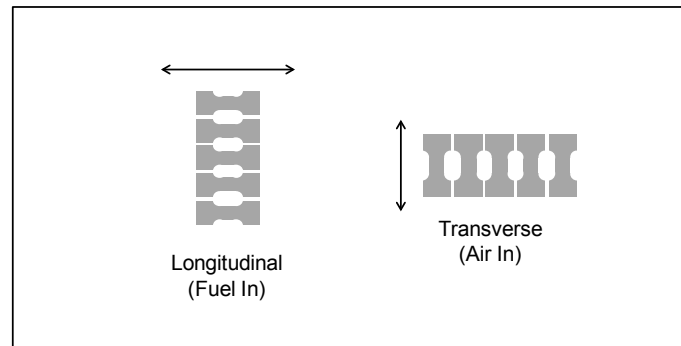
Experimental – dynamic mechanical analysis (DMA)

Sample: MEA

Conditions:

Sampling configuration:

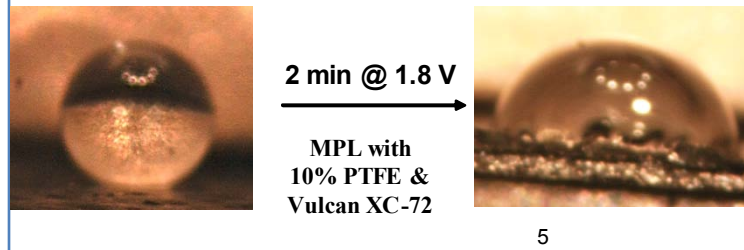
GDL Corrosion

- Occurs at all normal cathode potentials
- Can be partially oxidized to form surface oxide groups
$$C + H_2O \rightarrow C-OH + H^+ + e^-$$
 - Results in change in surface hydrophobicity
- Can be fully oxidized to form gas
$$C + 2H_2O \rightarrow CO_2 + 4H^+ + 4e^-$$
 - Results in change in structure
- Cycling vs holding at fixed potentials leads to different results
