# Materials Solutions for Hydrogen Delivery in Pipelines

Secat, Inc.

2011 U.S. DOE Hydrogen Program Annual  
Merit Review and Peer Evaluation Meeting  
Arlington, VA

Project ID – PD047

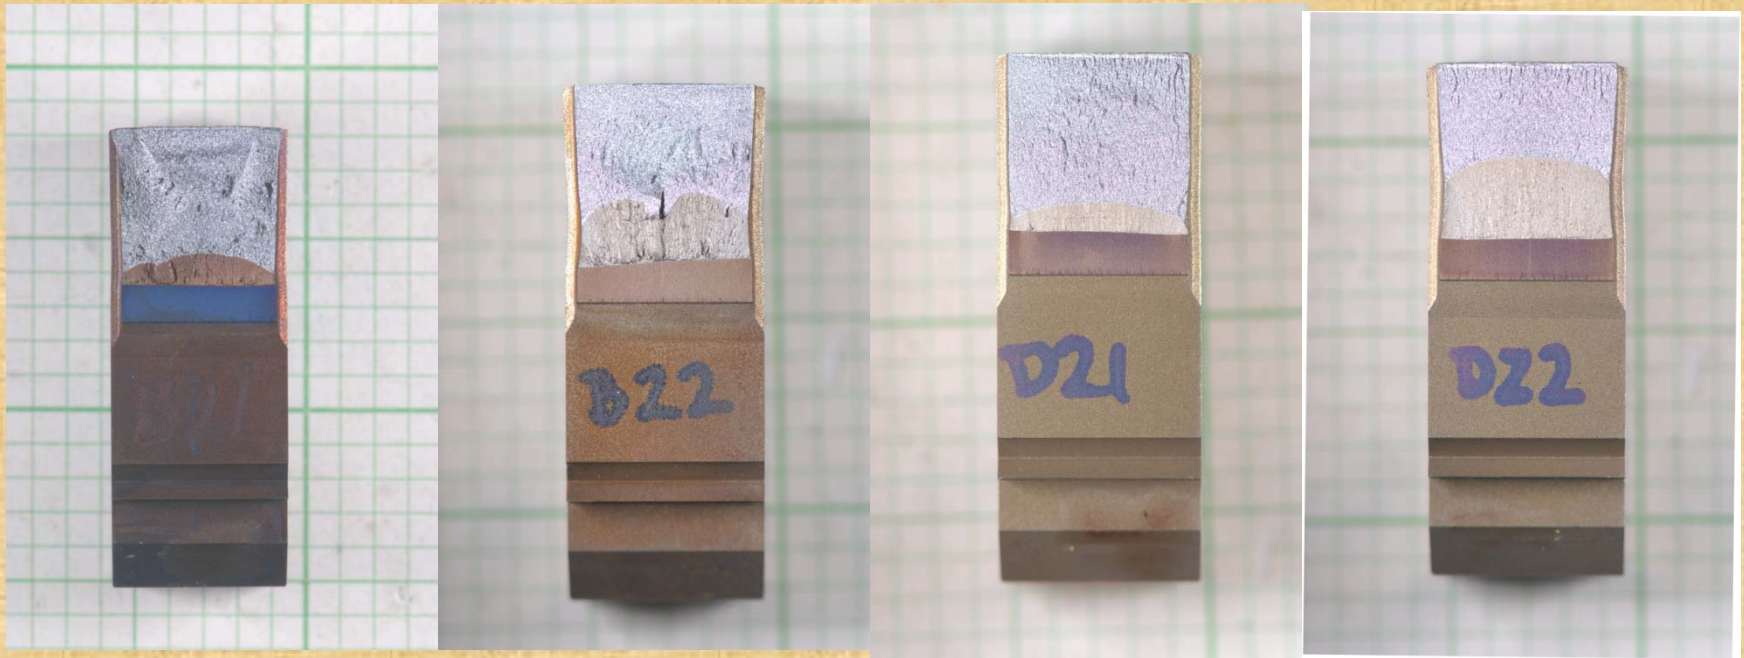
# Technical Accomplishments - Fracture Toughness Test Results – Alloy B and D, 3000 psi

•Note separation in Alloy B22 fracture.  
Maybe related to microstructural banding  
of chemically segregated centerline.

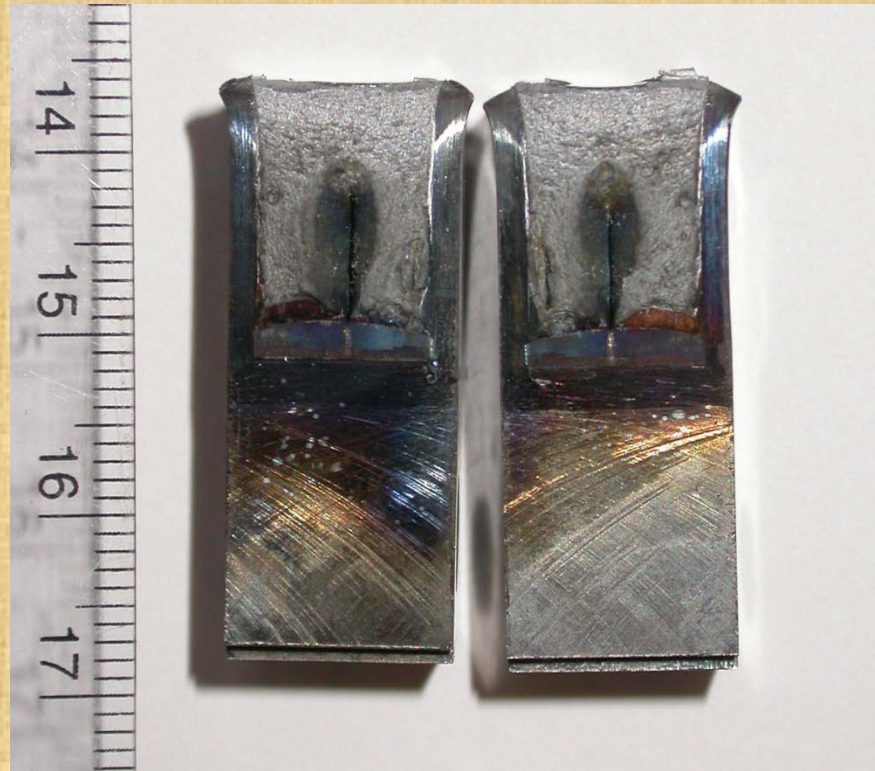
# Technical Accomplishments - Fracture Toughness Test Results – Pipeline Alloy A (Private Funded), 3000 psi

•Note large separation/delamination in Alloy A fracture. Maybe related to microstructural banding of chemically segregated centerline. This needs to be understood better as to cause and it's effect on test results. Alloy A fracture toughness results are not yet complete on this sample.

- Increasing pressure appears to decrease resistance to hydrogen effect. There maybe a potential threshold pressure for a given microstructure.
- Separations/delaminations that occur in some of the testing may bias the results. Detailed examination is required to understand the presence of these vs. microstructural characteristics. ***This is an important point to follow up on in future hydrogen work beyond the scope of this project.***

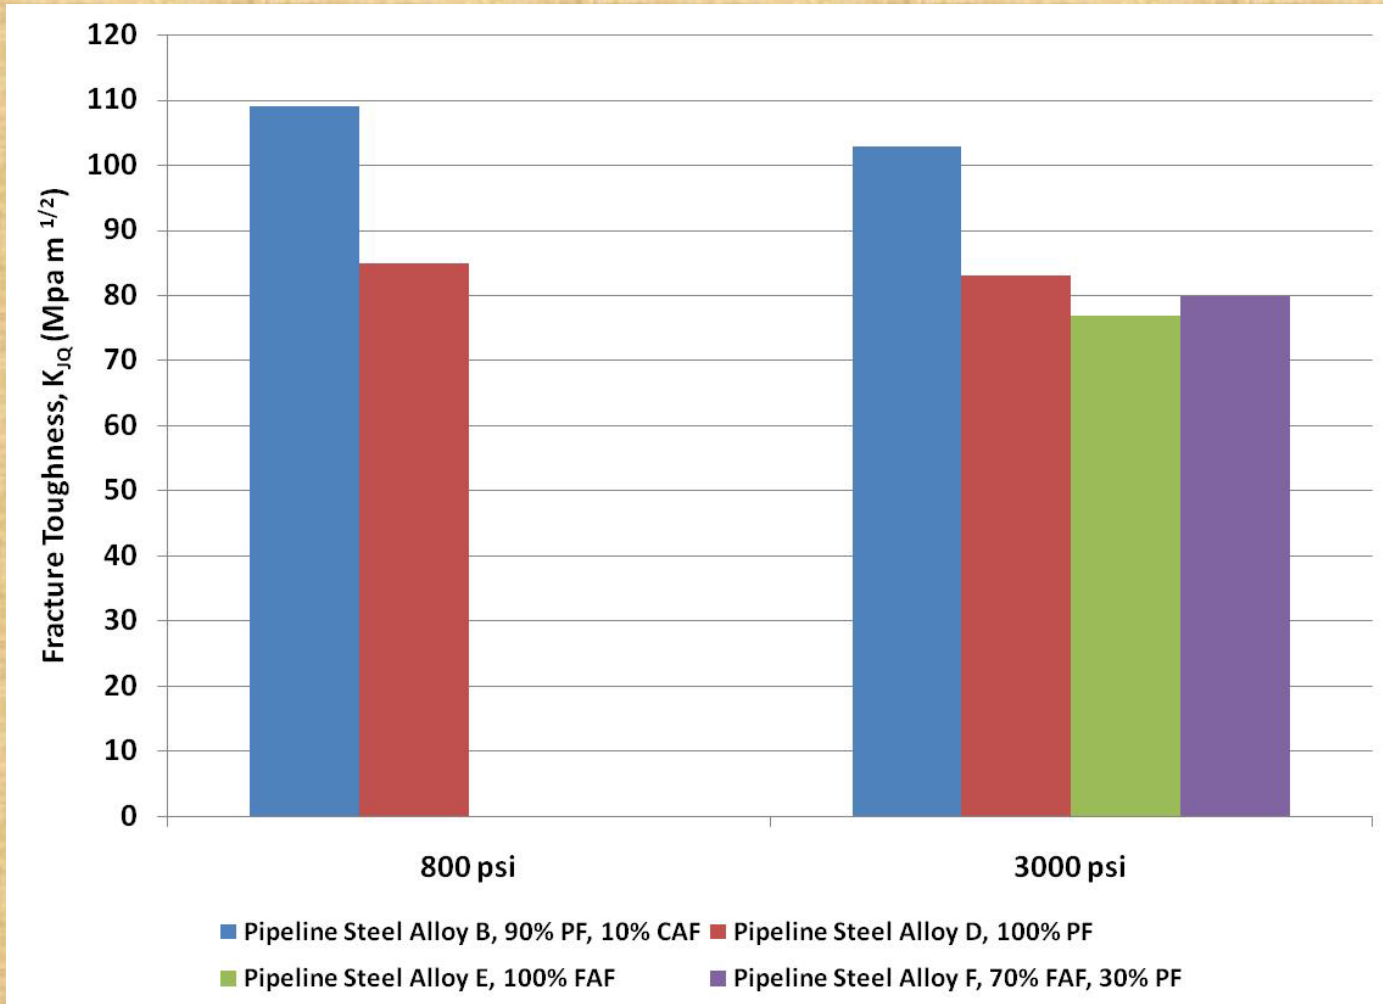
# Technical Accomplishments - Fracture Toughness Test Results – Pipeline Steel Alloy’s B, D, E (Private Funded), and F (Private Funded) $K_{JIC}$ vs. Pressure, Average Values

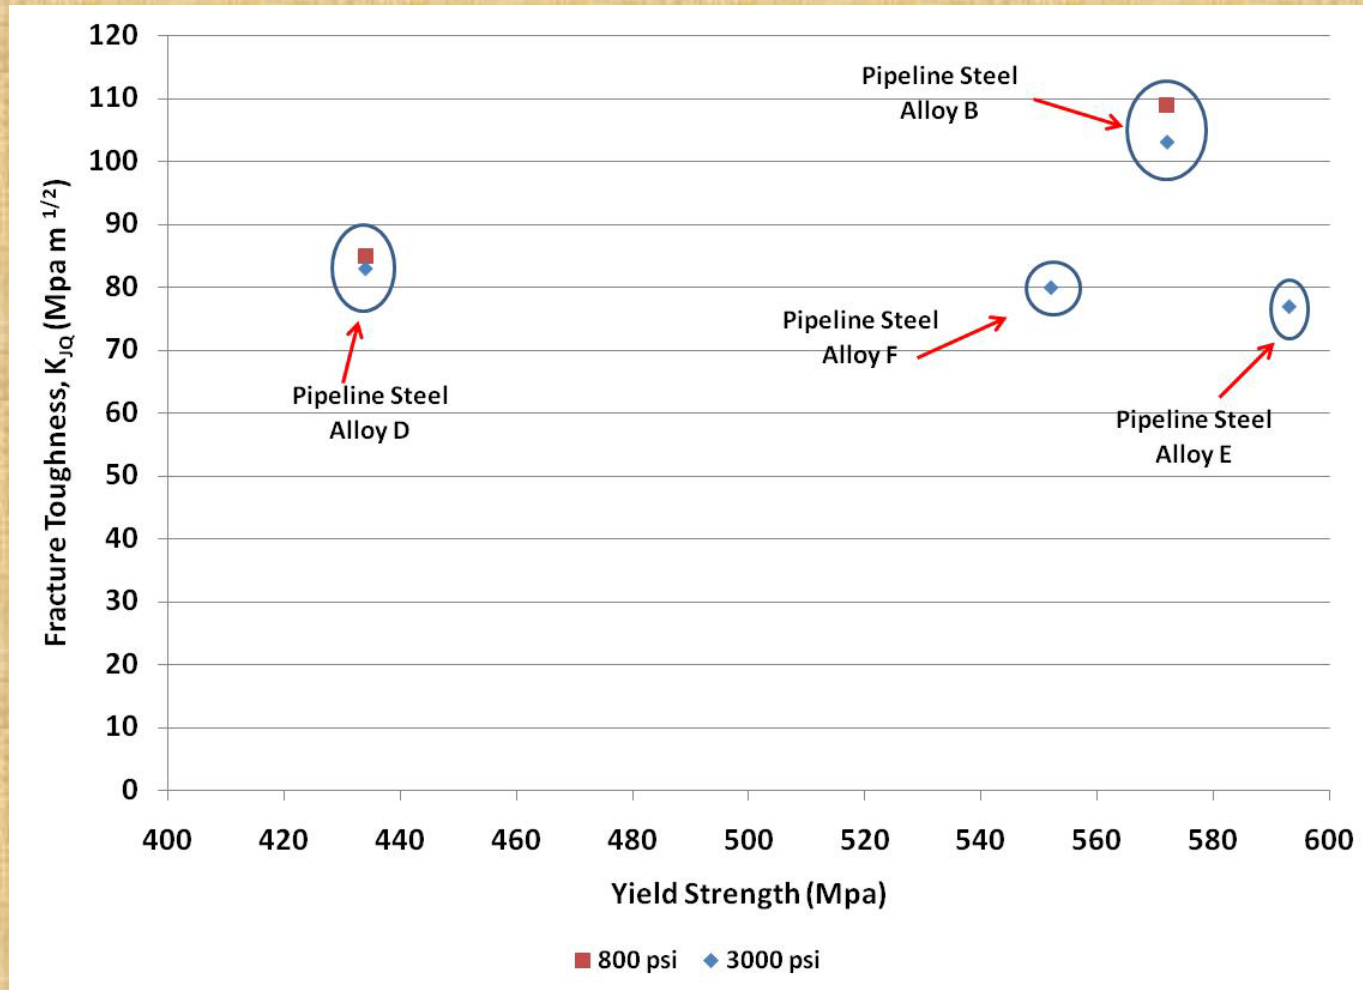
# Technical Accomplishments - Fracture Toughness Test Results – Pipeline Steel Alloy's B, D, E (Private Funded), and F (Private Funded), $K_{JIC}$ vs. Actual Yield Strength, Average Values

- Increasing yield strength **does not** appear to necessarily result in decreased fracture toughness due to the effect of hydrogen in the 800-3000 psi pressure range tested. Microstructure dependent. This may be different than what others have reported at higher pressures.

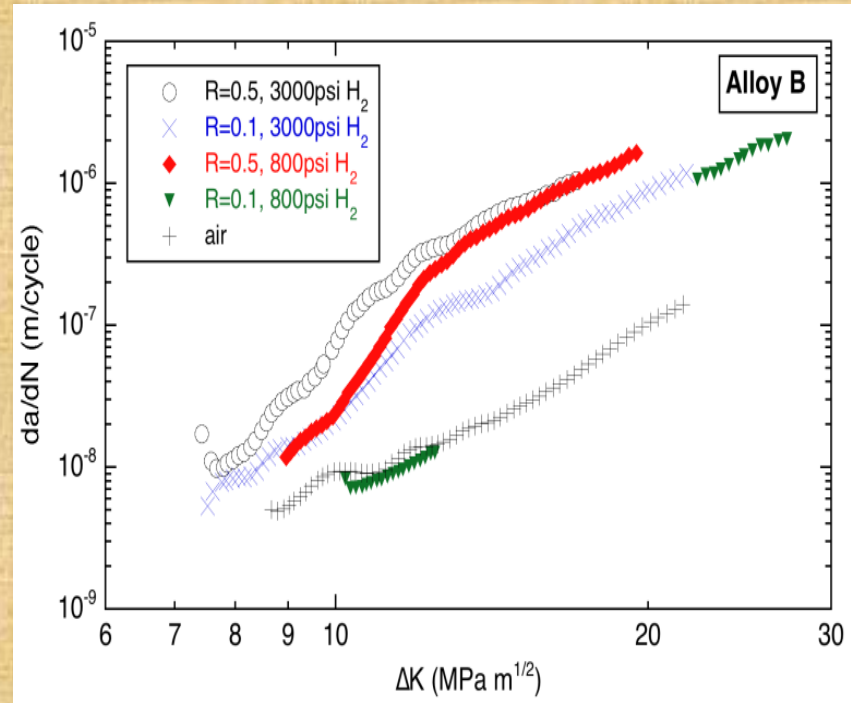
**MEASURED FATIGUE CRACK GROWTH RATES FOR ALLOY B**

- R-ratio values of 0.1 and 0.5 performed similarly in the fatigue testing for the two pipeline steel microstructures tested.
- At relatively high  $\Delta K$  ( $>12$  MPa m<sup>1/2</sup>) the FCGR is about 20 times greater than air, however at lower  $\Delta K$  the FCGR starts to converge for both air and H<sub>2</sub>.

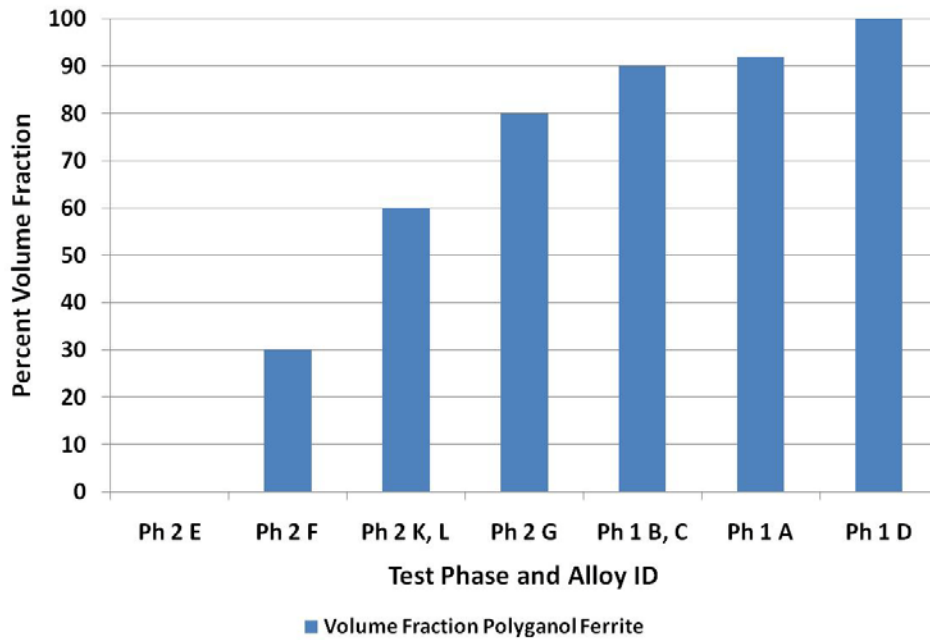
Volume Fraction Polyganol Ferrite

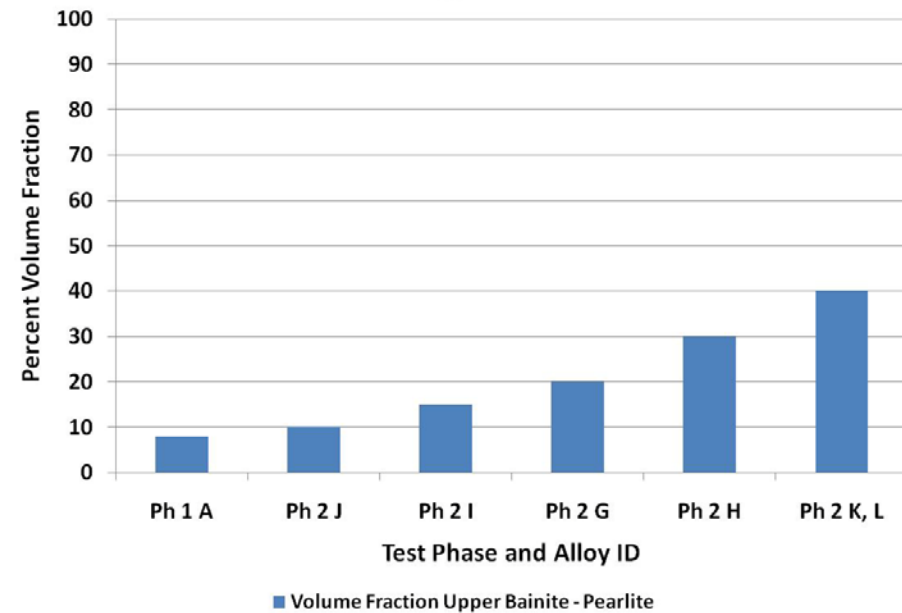
Volume Fraction Upper Bainite - Pearlite
