# Fiber Reinforced Composite Pipelines

George Rawls (PI) and Thad Adams  
Savannah River National Laboratory

May 15, 2013

**Project ID #: PD022**

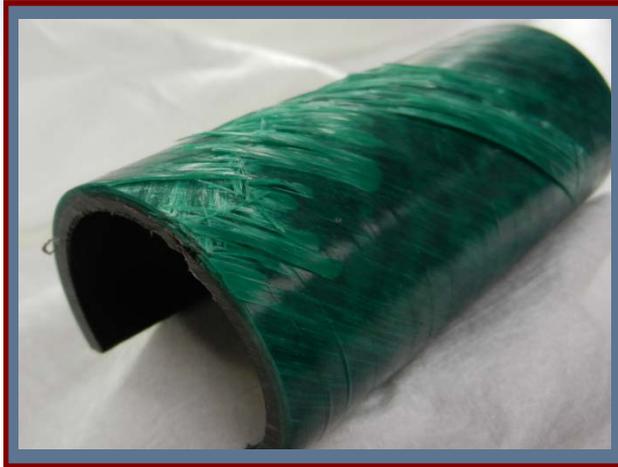
Section Cut From Fatigue Sample

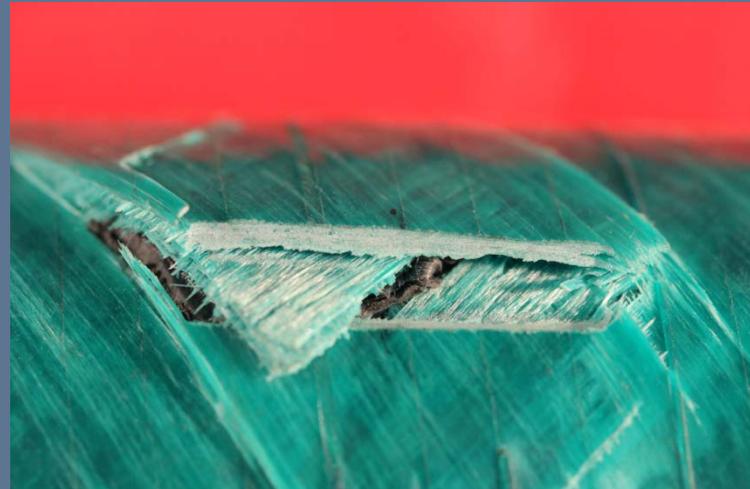
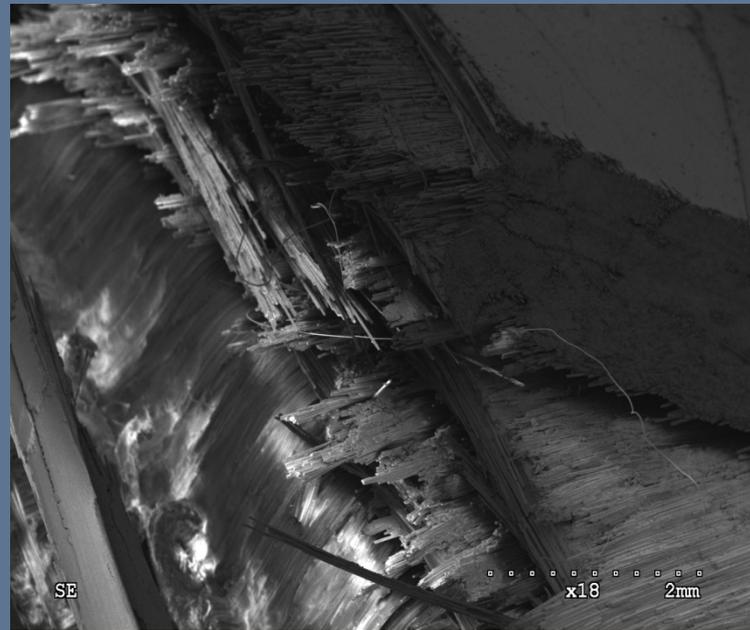
- Fatigue Tests have been performed on 2 flawed FRP samples (These test were completed in FY 12)
- The baseline flaw (1" x 0.125") a 40 % depth was tested.
- The 2 flawed samples failed after 2830 and 4862 full design pressure cycles
- The failure mode showed that the delamination of the FRP started to occurred at the bottom of the flaw and continued through thickness until failure occurred
- This data will be used to provide design and inspection information for ASME Codification

- Fatigue testing of both flaw been conducted. These tests have shown that a flaw will effect the fatigue life of FRP. These flawed fatigue test provide valuable information for installation and inspection requirements

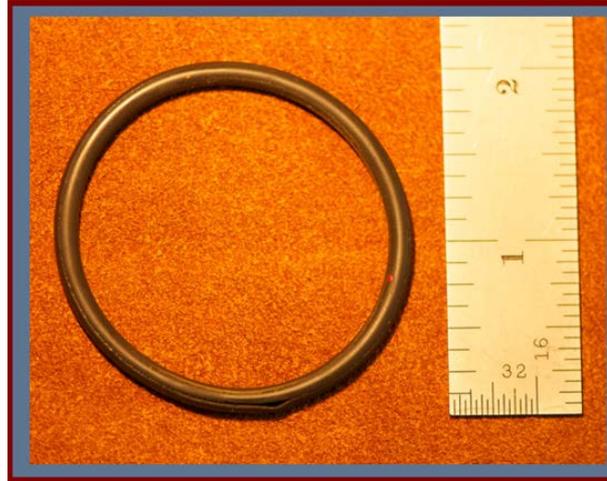
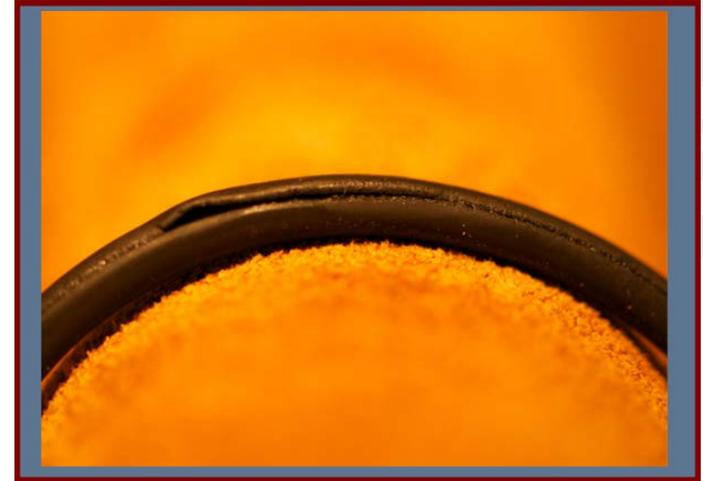
- O-ring failures occurred during the fatigue testing of the structural layer at all pressure levels
- The O-ring failures show classic indication of extrusion from their retaining groove
- The failure is a progressive distortion of the O-ring from the fatigue loading. The O-rings did not leak while testing with hydrogen or during burst testing

O-ring Damage 750 psig Fatigue Test

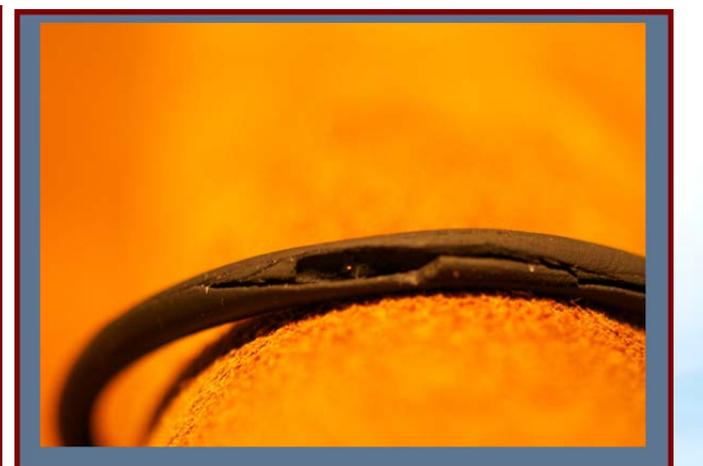
O-Ring Damage 3000 psig Fatigue Test

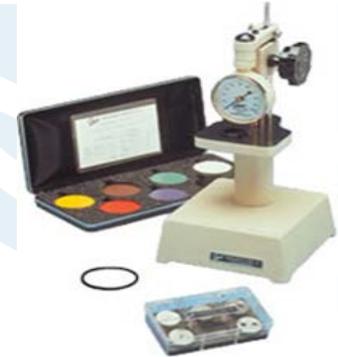
- The failure is a progressive distortion of the O-ring from the fatigue loading
- Testing of the O-ring material showed that the material hardness (durometer level) was lower than the specified design value. Tested values showed that the rubber hardness was in approximately 60 Durometer M. Where values of 70 to 90 would be required based on literature data

Micro-O-Ring Hardness

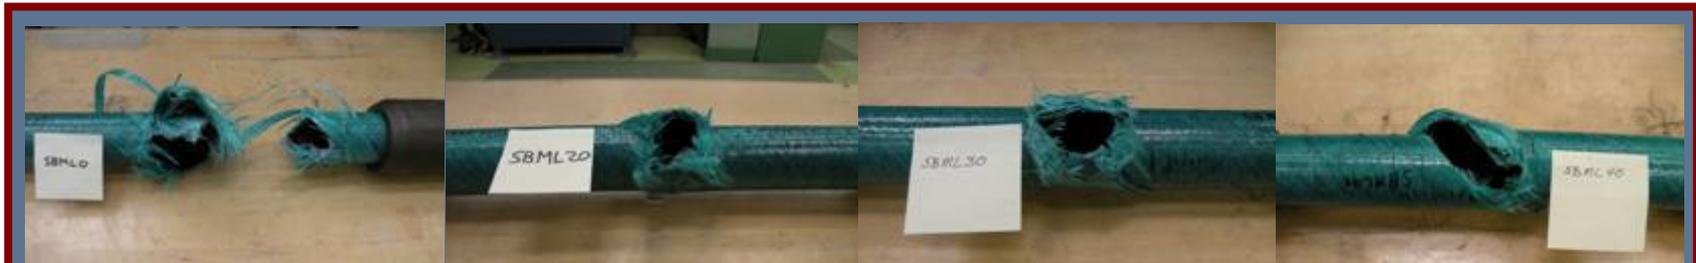
Baseline Flaw  
Width 1"x 0.125"  
40% Depth

- Reduction in Burst Pressure from unflawed condition to 40% through wall flaw of 28 % for short term burst and multiple layer reinforcement
- With the 40 % through wall flaw there is still a margin of approximately 3 above the rated pressure

Failure mode changes from global to local and then move back towards global as flaw depth increases

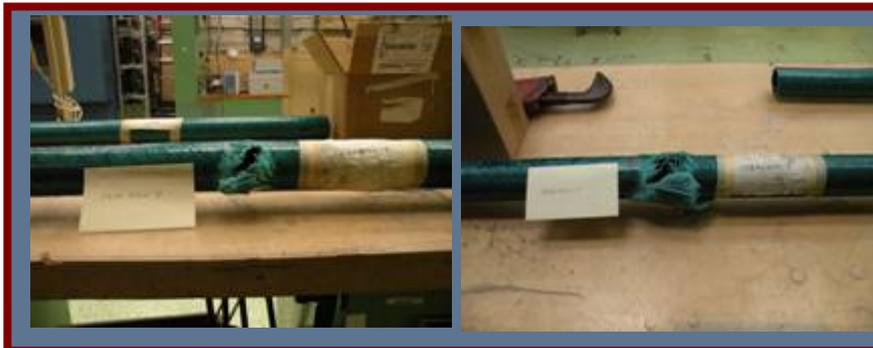
2 X Width 1"x 0.25"  
40% Depth

2 X Length 2"x 0.125"  
40% Depth

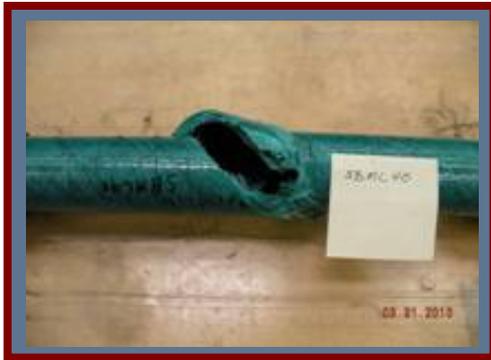
Baseline Flaw  
1"x 0.125"  
40% Depth

No Evidence of Bulging Under Sustained Pressure

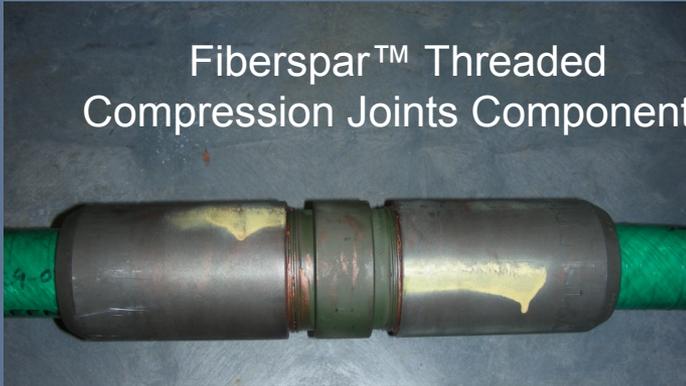
Fiberspar™ Threaded Compression Joints Components

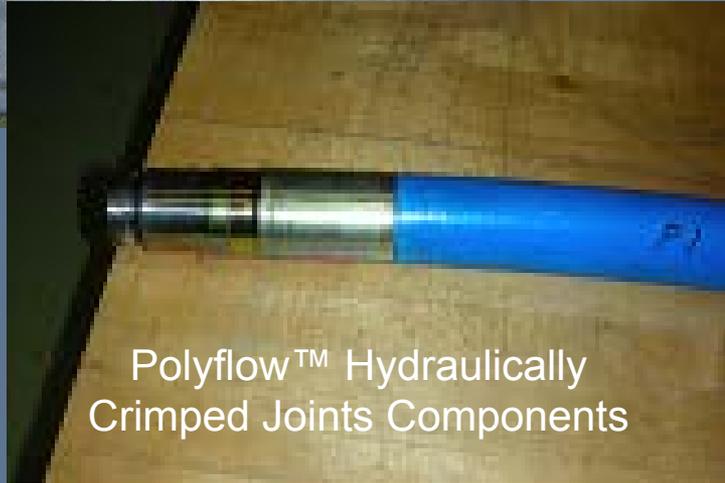
Polyflow™ Hydraulically Crimped Joints Components

Sample	Leak Rate STD CC H <sub>2</sub> /Sec
Fiber 1	9.8x10 <sup>-5</sup>
Poly 1	9.5x10 <sup>-3</sup>
Poly 1+	5.0x10 <sup>-2</sup>
