Hydrogen Component R&D

**2016 DOE Annual Merit Review
Hydrogen Safety Codes and Standards**

National Renewable Energy Laboratory

Project ID # SCS002

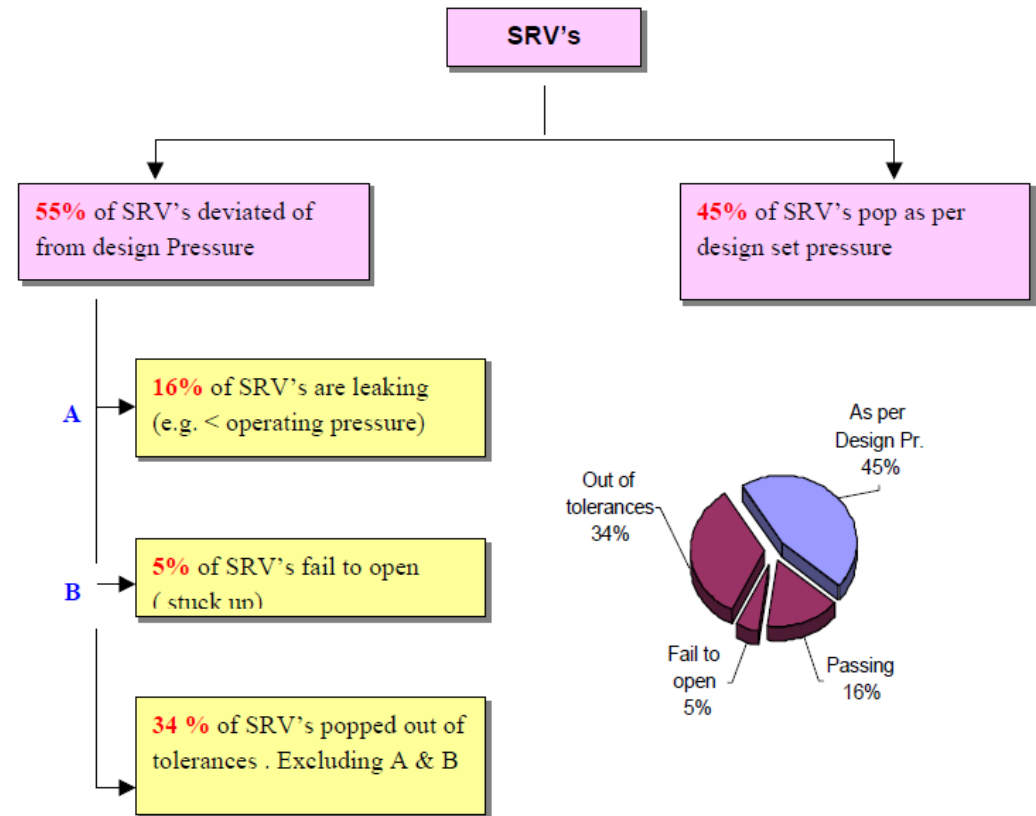
THE HIDDEN FACTS OF PROCESS SAFETY VALVE RELIABILITY

- Industry study shown at right depicts results of plant wide study
- 100% of in-service relief valves were pulled from operation and inspected
- 55% of the relief valves were out of specification, either failed to open within $\pm 3\%$ of the setpoint or leaked above specification

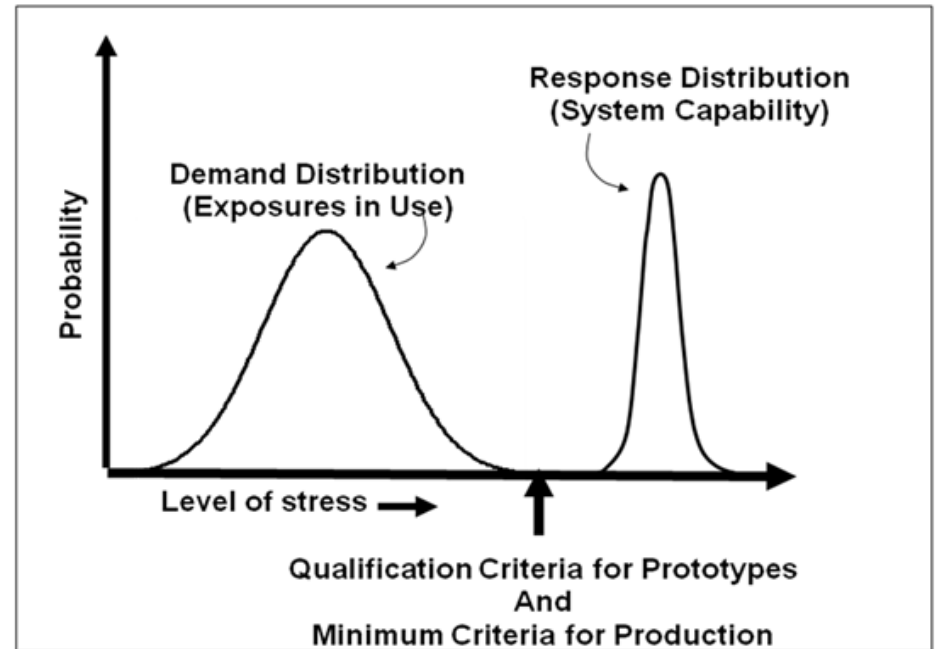
FIGURE 3 - RELATIONSHIP OF DEMAND AND CAPABILITY DISTRIBUTIONS

- SAE J2579 diagram shows the relationship between operating demand and system capability (failure)
- Desire for failure data to show low sigma (predictable end of life)
- NREL is testing two valves that have known field failure. Pressure relief device 440C nozzle field failure occurred after three months operation.
- Response distribution for performance based testing methodology should be able to reproduce failure with repeatable results and low sigma distribution

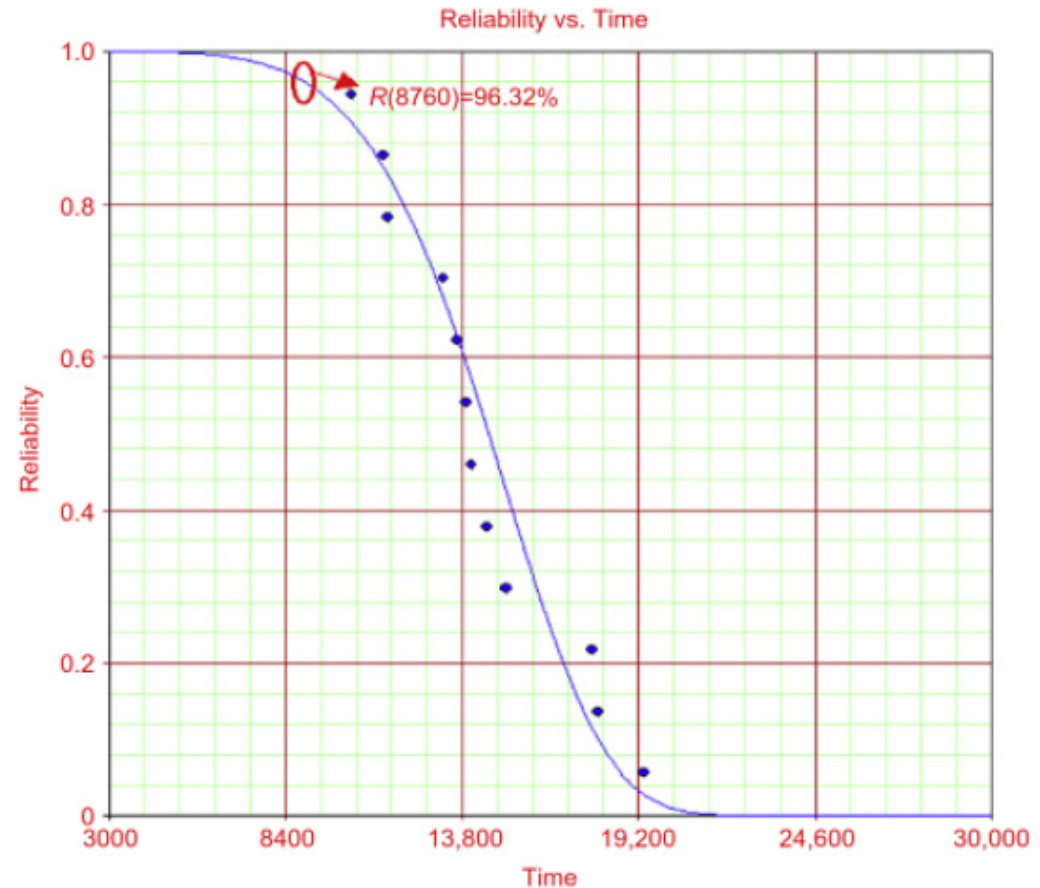
FIGURE 2-7 Logic element reliability curve under operational conditions.

Typical reliability curves for well behaved data will result in failures occurring within a well defined time (normal distribution)

- Reliability data with a normal distribution typically has a well understood failure mechanism (material degradation, fatigue, aging etc.)
- PRD reliability data has not been shown to exhibit a normal distribution

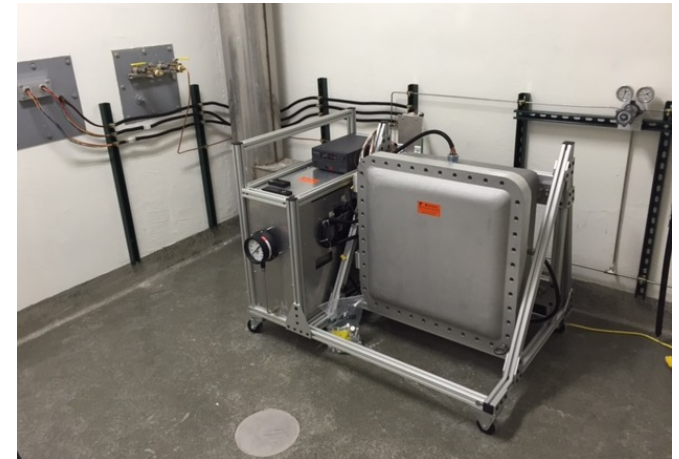
Relief valve apparatus
installed in ESIF high pressure test bay

- Qualitative ALT (Accelerated Life Testing) testing to duplicate known field failure under controlled laboratory conditions
- Accelerated stresses of temperature and pressure in hydrogen environment
- Leak detection to identify point of failure

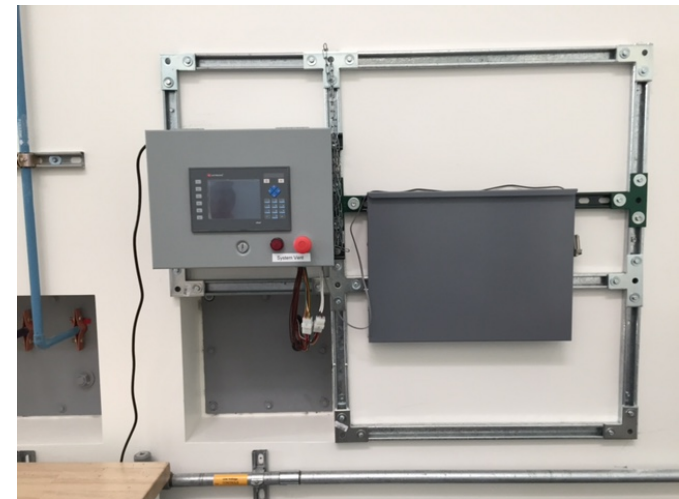
Relief valve programmable logic controller
(PLC) control box

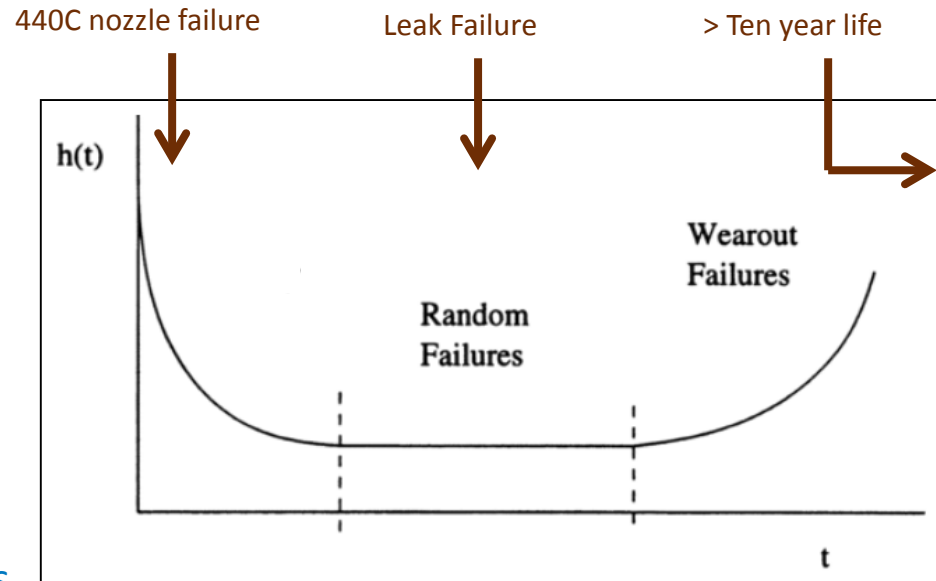
- Two valves tested under this test project were subject to ten years equivalent operational life with no terminating failures, i.e. crack size and growth rates were below failure threshold (categorized as wearout failure - determined to be greater than ten years life based on two test samples)

These test results show that PRD failure modes in hydrogen service don't originate from a single root cause. Understanding of fracture mechanics methods for failure prediction is important for component design in hydrogen service. Use of performance based component level tests may not reveal all insufficiencies for design qualification purposes.

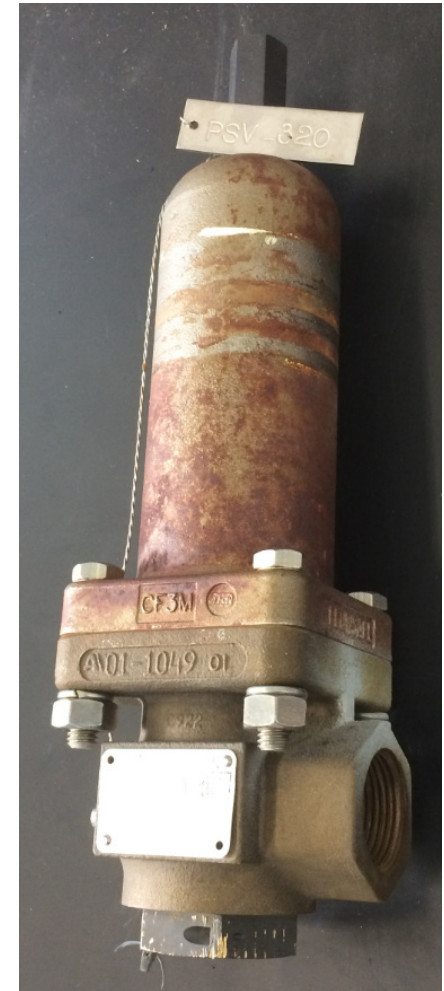
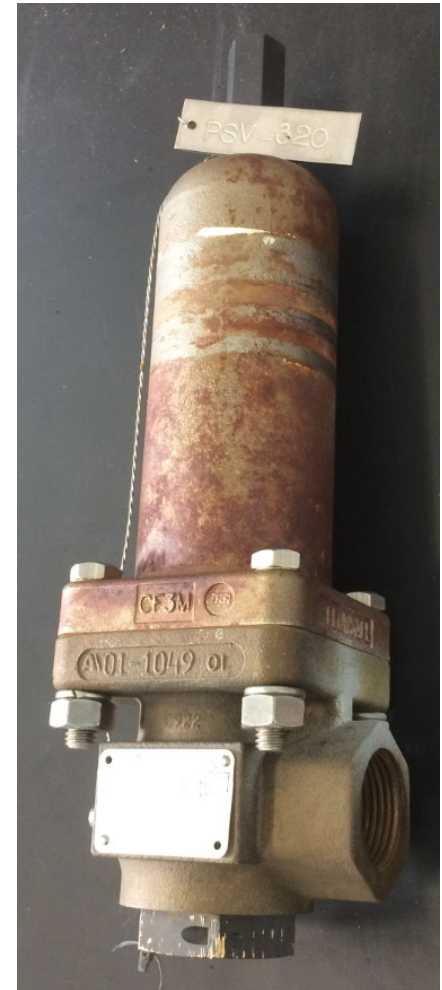
- At NREL's Wind to Hydrogen demonstration site, a PRD failed open, venting hydrogen, with no facility damage or injury
- The relief valve was located on a medium pressure 3000 psig stationary storage. The relief valve was set at a 4000 psig set point

- During venting, the relief valve reseated at a pressure of just a few hundred psi, venting down the majority of the hydrogen in the storage system with no incident.

- After removal from the system, the valve was sent to the manufacturer for root cause failure analysis
- The manufacturer first tested the valve and found that it relieved at $\pm 3\%$ of its set point (per ASME specification). The manufacturer was not able to reproduce the spurious opening that occurred during operation.

- After disassembly and inspection the manufacturer analysis was not able to determine a root cause of the failure. (these random failures are known to be an issue with relief valves and in general are not a serious safety concern, releasing hydrogen up a vent stack that is designed for this purpose)

- *Heating of a few hundred degrees can cause thermal expansion of the bonnet and relaxing of the spring. This heat could have been caused by a hydrogen leak at the base of the valve that found a spark and ignited. The hydrogen flame is difficult to see but could produce high localized temperatures.*

- *Vibration/shock load on the valve could cause the valve to pop open. Once the valve is open, the gas flow is designed to keep the valve open, reseating at some point 10% to 20% below the set pressure. The loading could be caused a process/piping shock, water hammer, wind generated pipe harmonic or some other upset. There could also be some other external shock caused by impact from an unknown source. (note: failure to reseat could be caused by ice buildup as a result of thermodynamic cooling in the venting gas)*

- *Particulate contamination could work into the seating area, causing the valve to crack open. Once the valve is open the gas flow could keep the valve open. Any evidence of particulate contamination could be flushed out by the flowing gas.*

Relief Device Root Cause Failure analysis will often be inconclusive, in this case the relief valve when vented down and pulled from service was able to relieve pressure within $\pm 3\%$ of the original set point

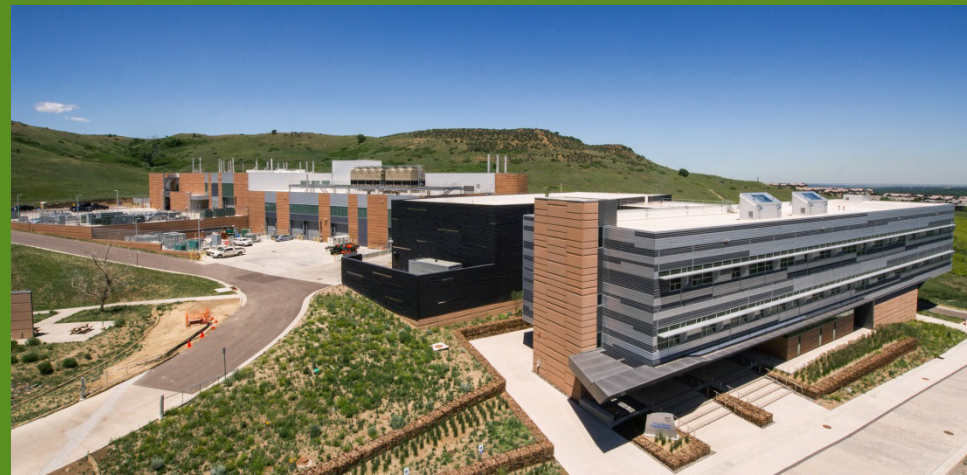
ESIF – Energy Systems Integration Facility
NREL laboratory facility provides laboratory space R&D testing of high pressure hydrogen component and system.
