700 Bar Hydrogen Dispenser Hose Reliability Improvement

National Renewable Energy Laboratory

DOE 2017 Annual Merit Review

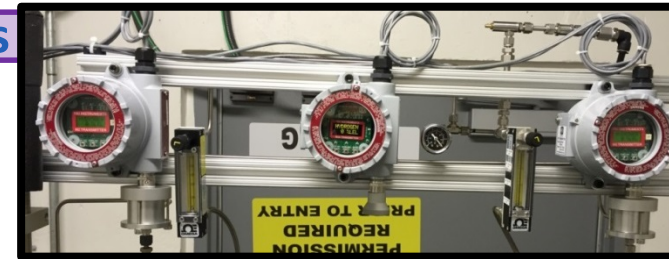
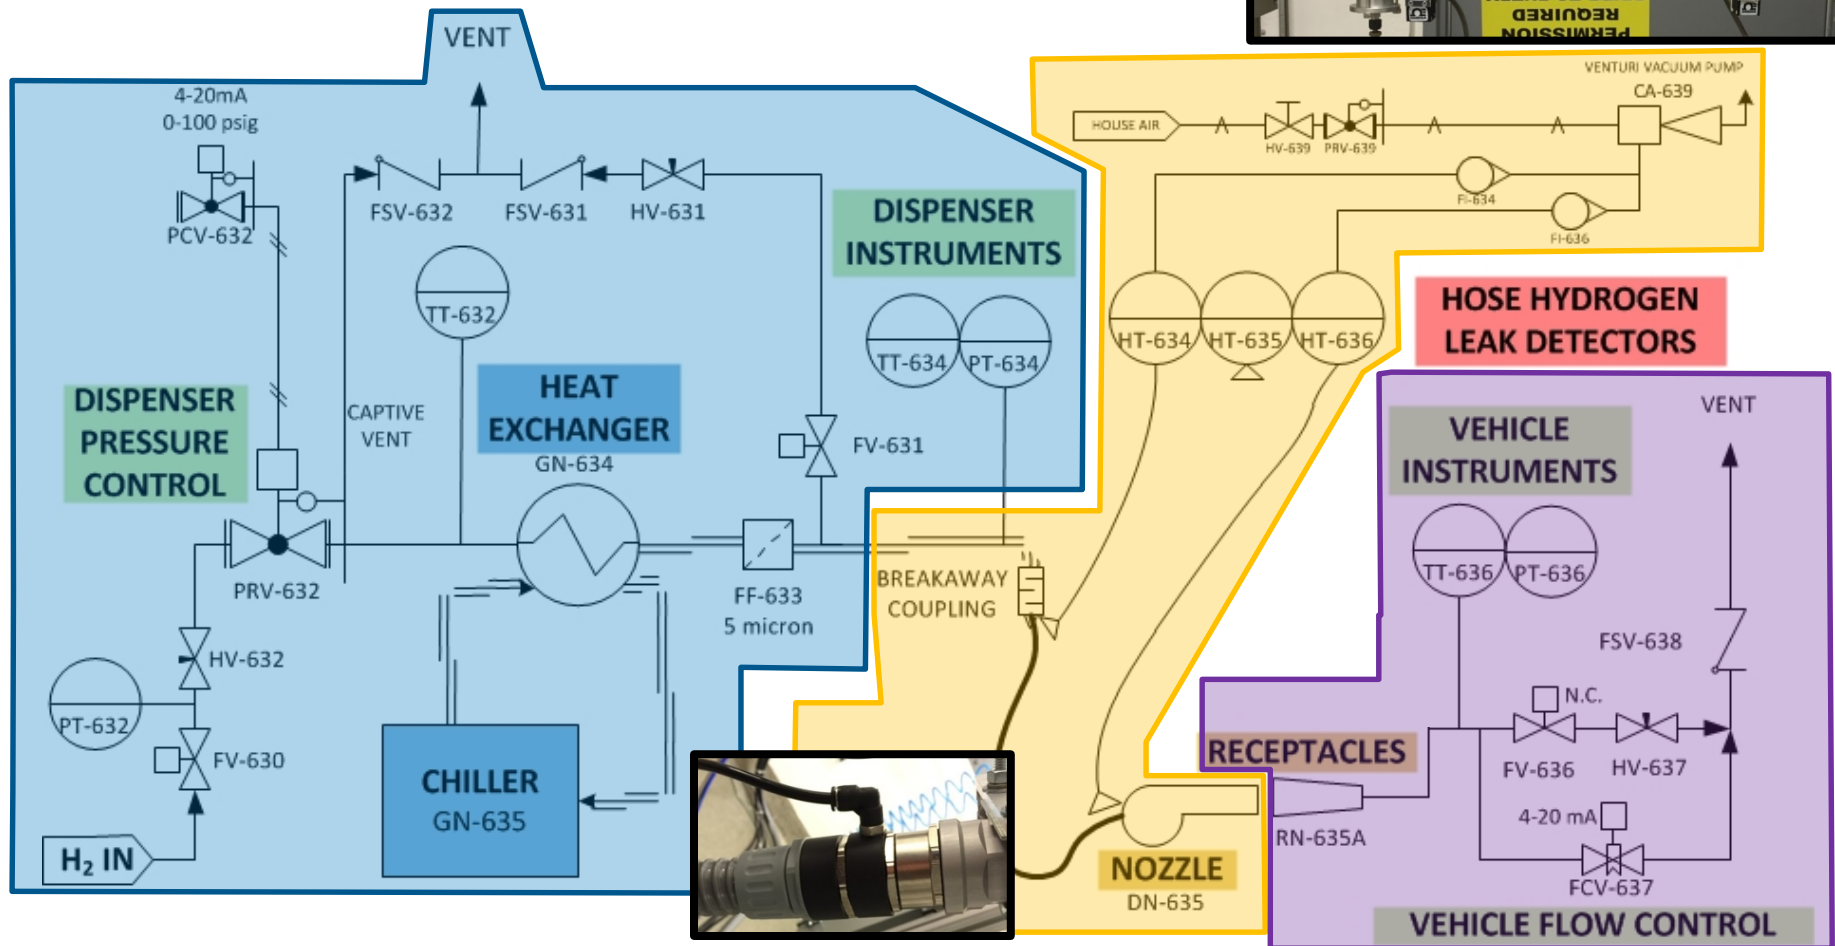
Approach – Hose Test Stand System Design

- ‘Dispenser’ subsystem based on commercial dispensers
- Tankless flow control for low-mass, pre-cooled cycles
- Active leak sampling at hose interconnections

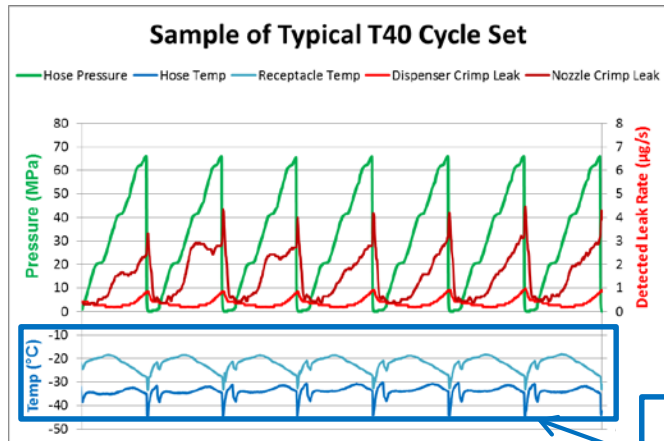
- Dispenser-side hose crimp fitting had small leaks at Cycle 1856
- Nozzle-side hose crimp fitting consistently leaked at Cycle 3033
 - Leaks occur during cycles, pressure holds, and venting

Starting mass: 57.880 grams
Ending mass: 57.776 grams
Mass loss: ~ 160 micrograms/sec

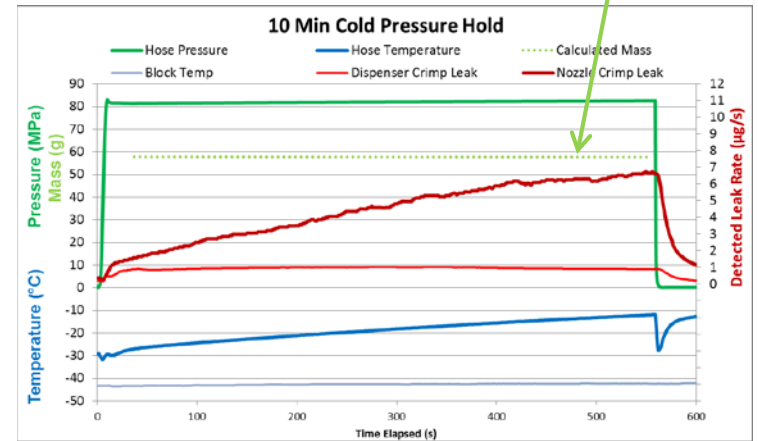
Receptacle temperature remains close to hose temperature – consistently cold hose with ~200 grams per cycle

- >1500 cycles successfully achieved with consistent leaks present
- Pressure holds on the complete dispenser (including heat exchanger and valves) indicate a leak rate of approximately 100-500 micrograms per second – or a mass loss of **0.1% to 0.4%** over 10 minute holds
- Hose passes every 5-sec NFPA leak check common in commercial fueling
- **Hose passes the only pass/fail criteria in codes – 10 ccN/hr (3235 µg/s)**

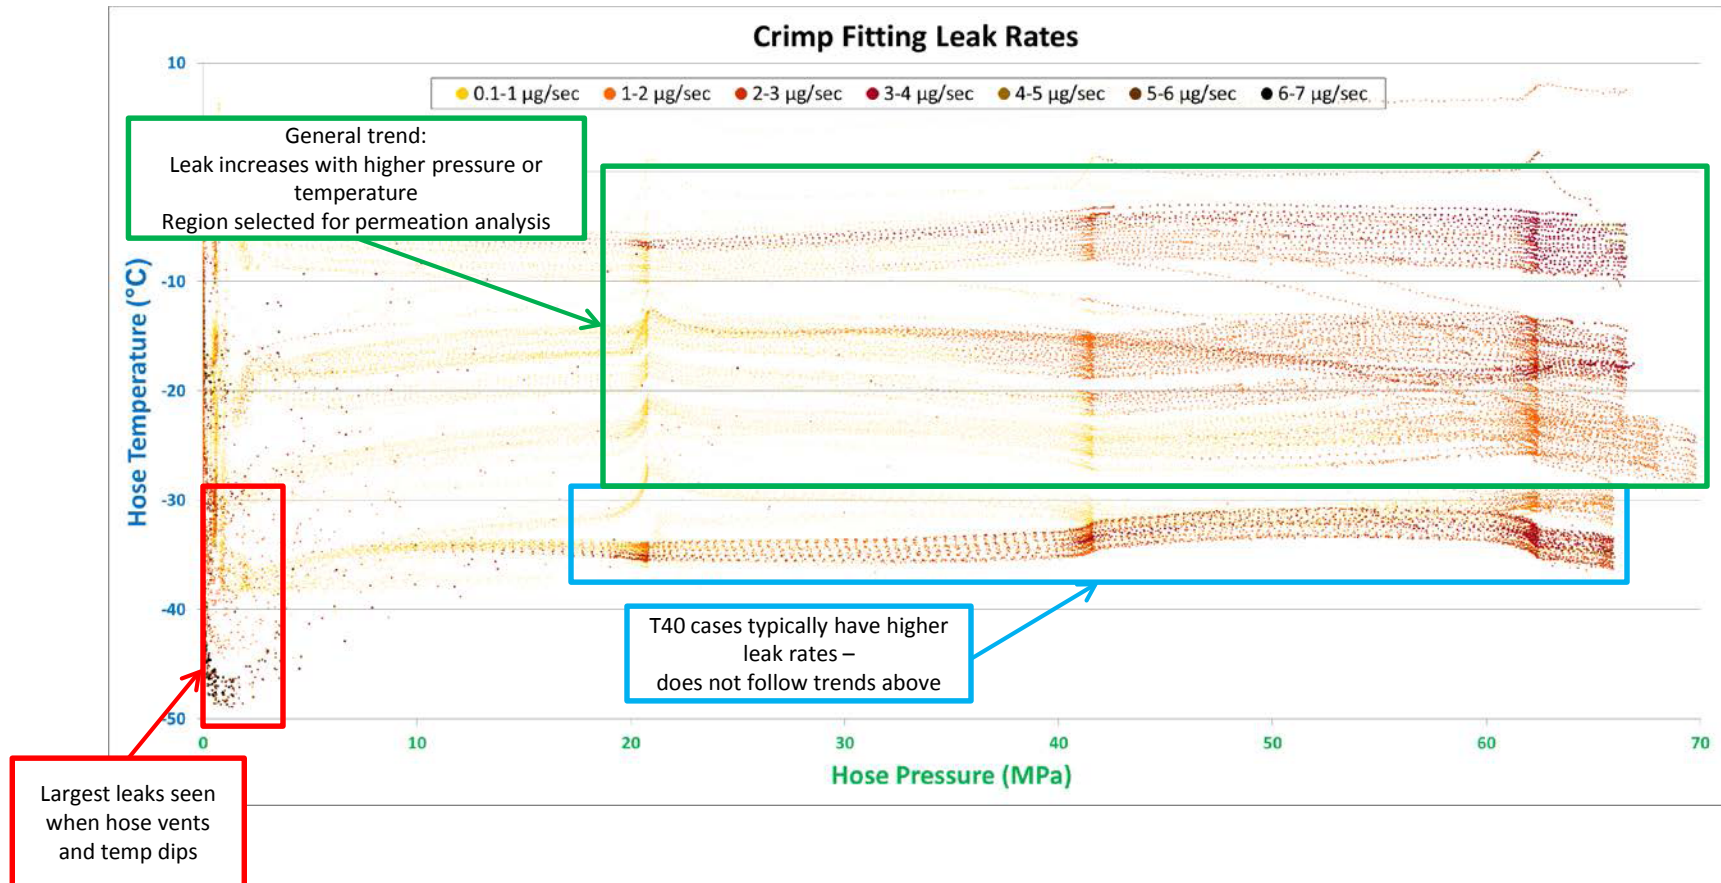
Progress – Leak Variation by Temperature

- Profiles run at different temperatures to explore leak relationship
 - T40 (typical), T30, T20 and -10C (not in J2601) cases at similar pressures
 - 157 total cycles in analysis, alternated to reduce cumulative effects

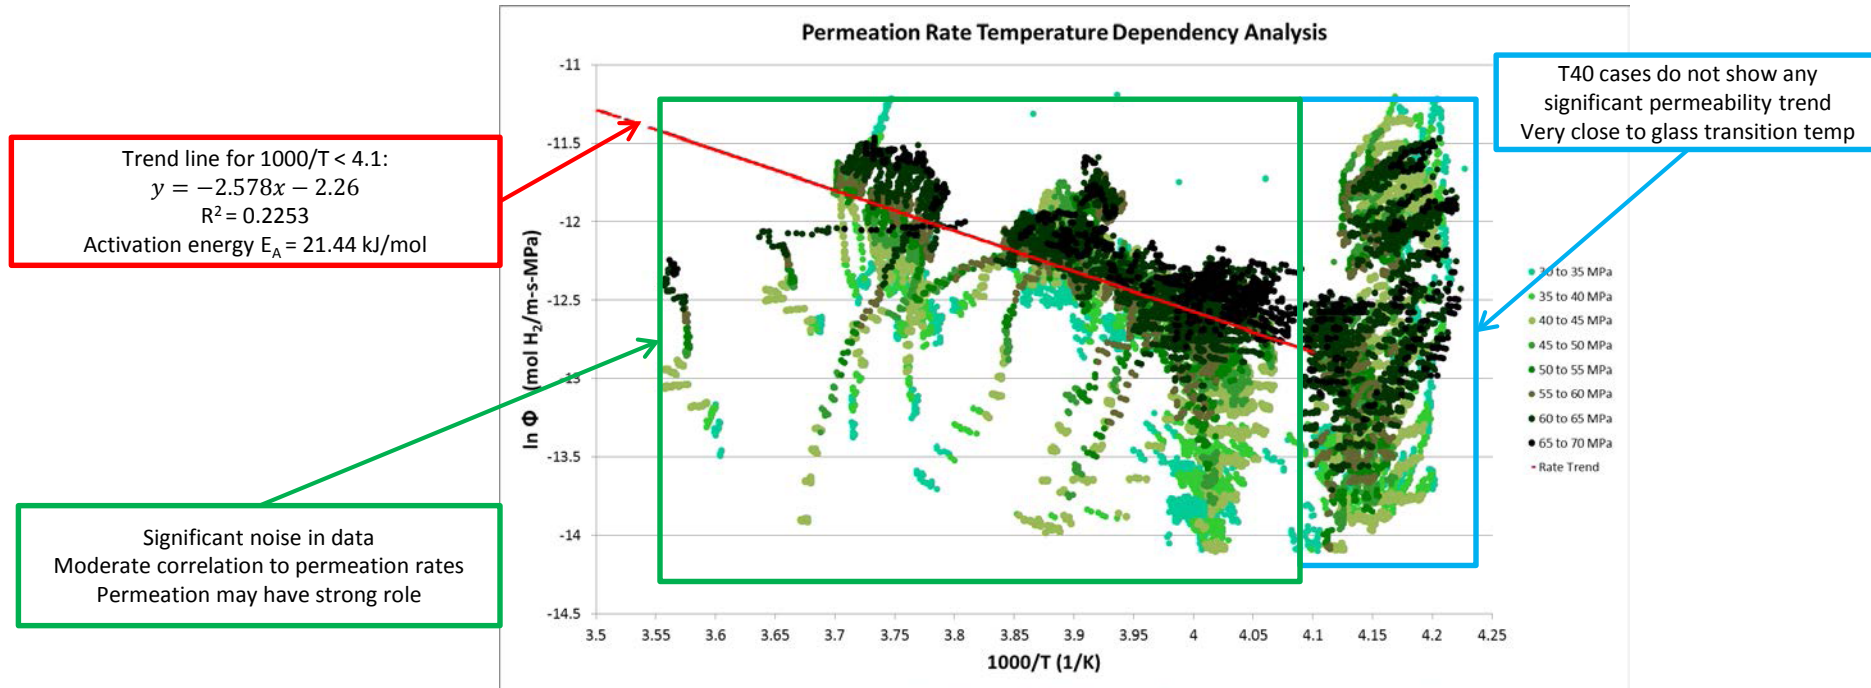
- **Permeation analysis performed on temperature variation cycle set**
 - Drawbacks: Pressure changes – not steady-state, time lag in effect
 - Permeability constant may be offset due to interference from leak sources (pinhole, crimp)
 - Can still look at the overall trends for temperature dependency indicating some effect from permeation or similar process
 - Only pressures > 30 MPa studied to reduce noise and leak carryover from previous cycle

- **Data shows moderate possible permeation effects except for T40 cases**
- **Glass transition (-50C @ 0 MPa) may be affecting results in T40 cases**

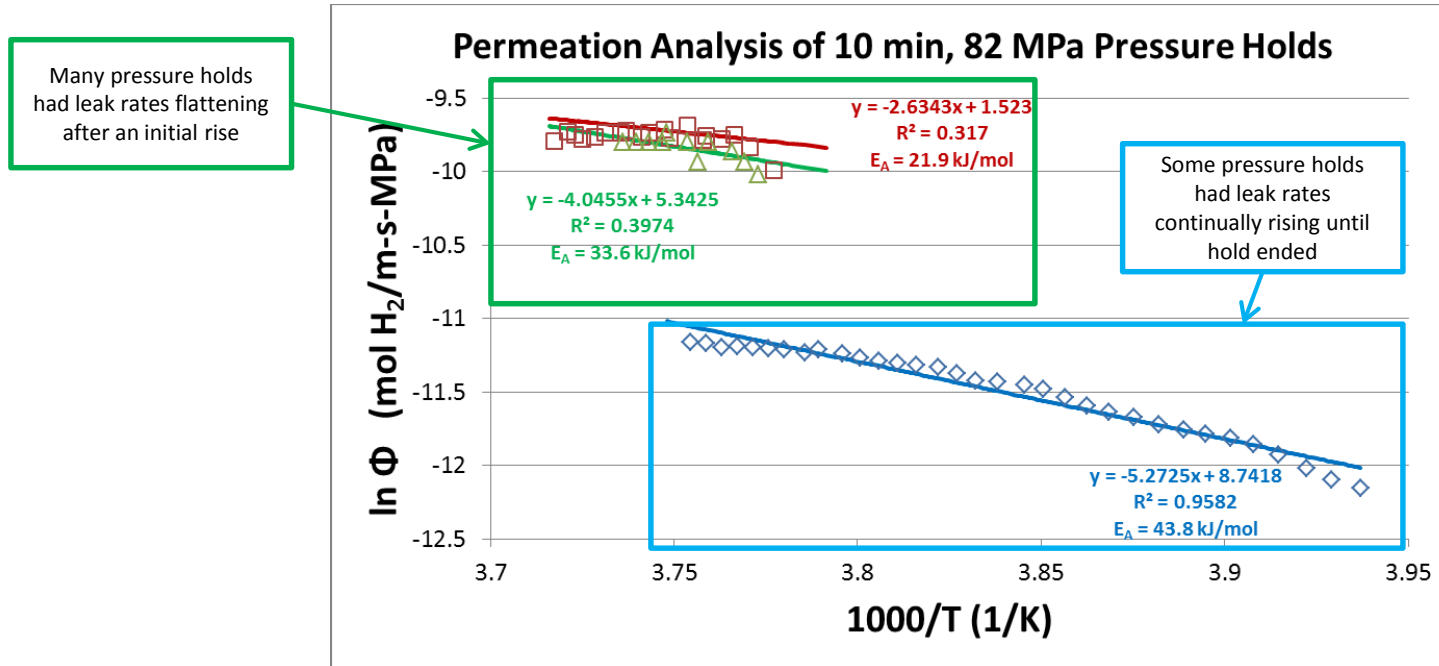
- Permeation compared to 10 minute pressure holds to determine a steady-state permeation result while hose warms up

- Strong permeation correlation in some cases – typically pressure holds done immediately after cold cycles
- Weaker permeation correlation in many cases, often when hold does not immediately follow cold cycles
- Data is scarce for H₂/Polyoxymethylene combinations
- Some comparable polymers (unstressed) shown
 - Sandia National Laboratory report, 2013
- Recorded permeation 4 to 6 orders of magnitude higher than typical unstressed polymers

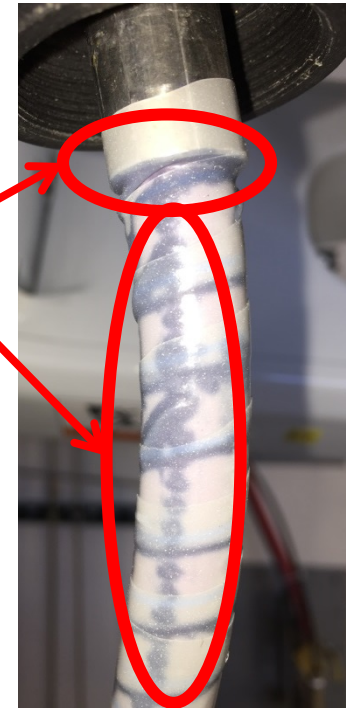
After – 1000 cycles

-**Indication** seen on edge of hose crimp. May be due to gap between tape and fitting.
-**Clear indications** seen on hose outer layer pinpricks at the nozzle-end crimp, around hose circumference
-No visible physical damage observed on hose surfaces, including at crimp fitting
-No indications on metal fitting leak detection ports

- Pinpricks designed to relieve pressure between outer and inner layer

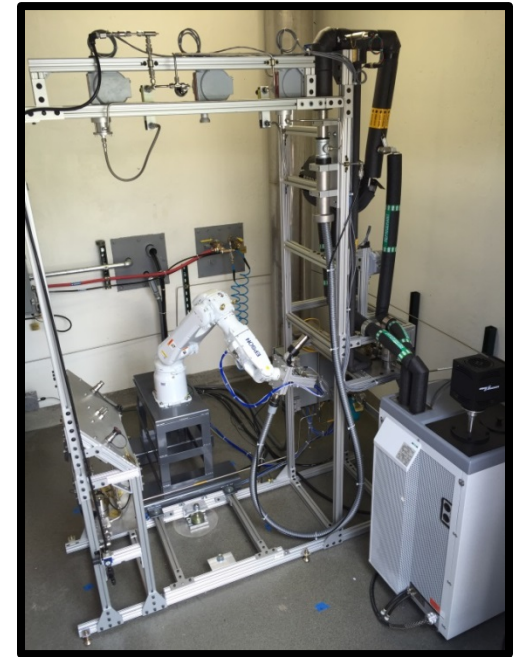
- **Epson six-axis robot installed and programmed with realistic human motions from ‘dispenser’ to receptacles – total distance ~3 feet**
- **Double receptacle system to provide options for greater randomization of paths from dispenser**
- **High repeatability, over torque tripping capability, anchored frame and calibration help reduce stresses on nozzle and receptacle**
 - Focus on crimped hose end connections and their ability to remain sealed under bending/twisting stress while cold.
 - Nozzle and other components are replaced as needed if they wear out.
