Hydrogen Component Validation

Danny Terlip
National Renewable Energy Laboratory
7 June 2017

Project ID #TV019

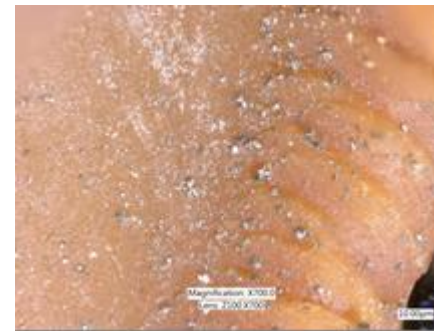
Failed valve seal

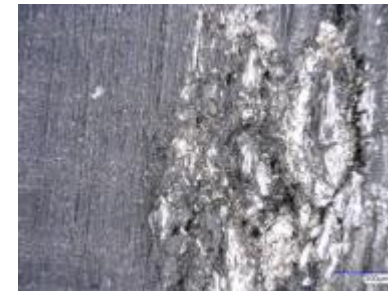
Failed rider band

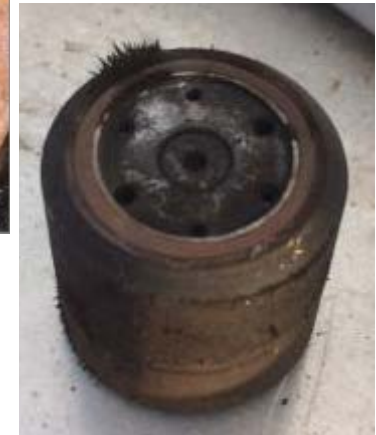
Failed check valve

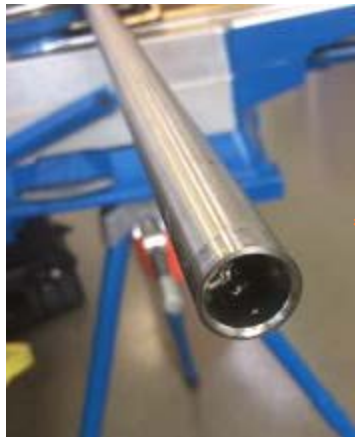
Tubing cut, beveled and threaded

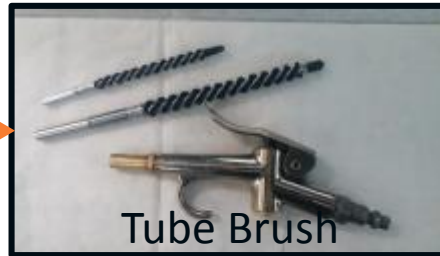
Tube Brush

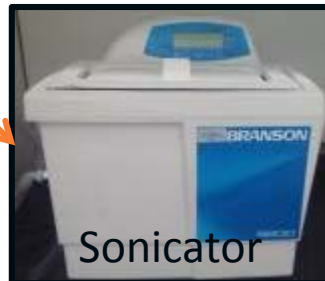
Sonicator

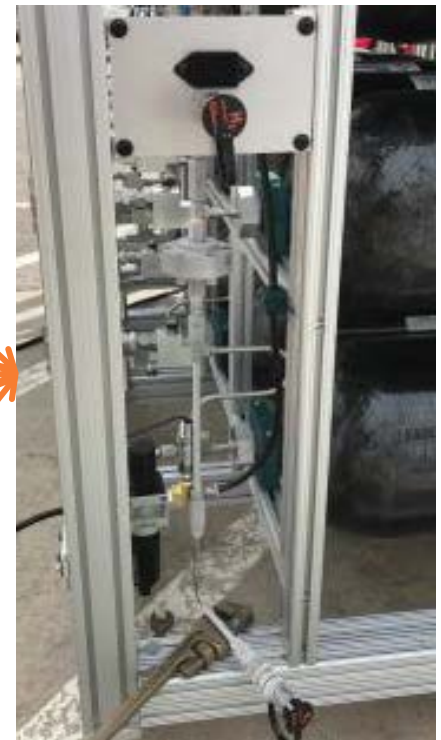
Hydrogen passed through tube with filter collection

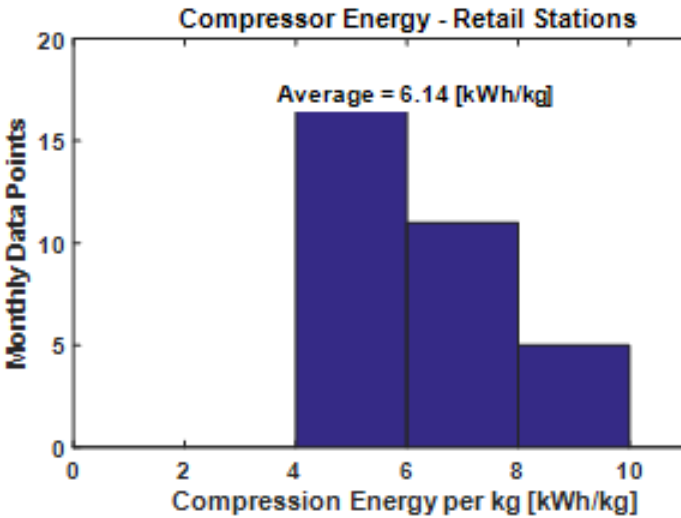
NRELOpRETAIL_inf_35
Created: Dec-21-16 11:15 AM | Data Range: 2014Q4-2016Q3

HITRF: 6.5 kWh/kg
Retail: 6.14 kWh/kg

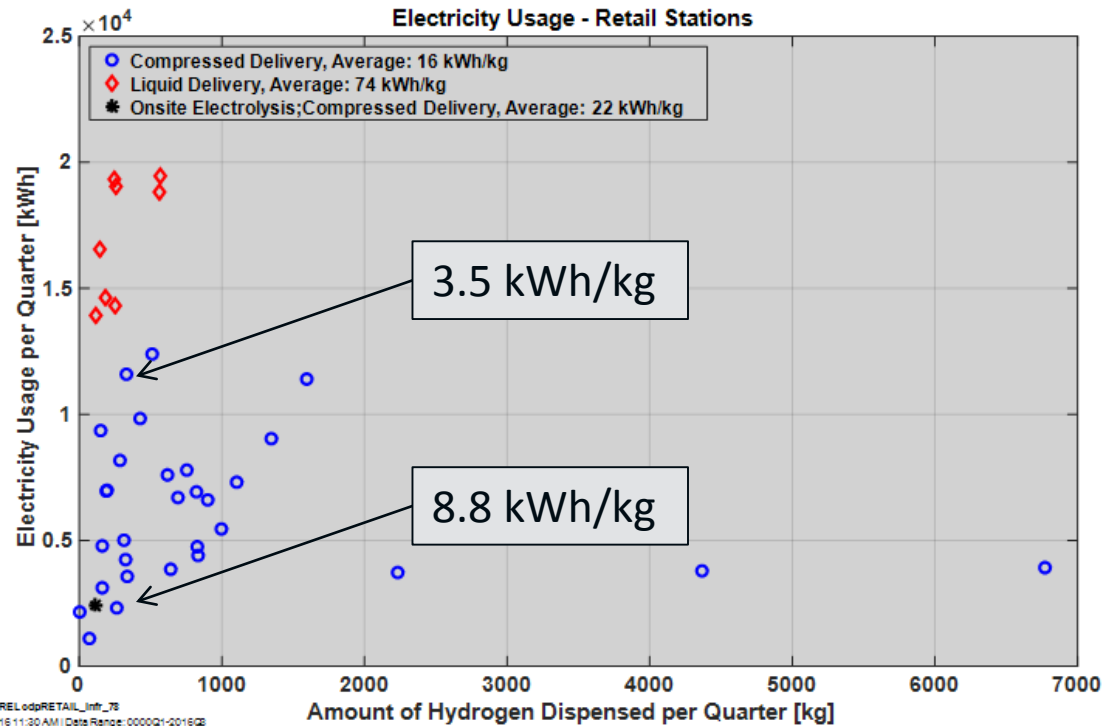
NRELOpRETAIL_inf_75
Created: Dec-21-16 11:20 AM | Data Range: 0000Q1-2016Q3

HITRF: ~ 6 kWh/kg*
Retail: 3-9 kWh/kg

*90MPa compression and chilling only

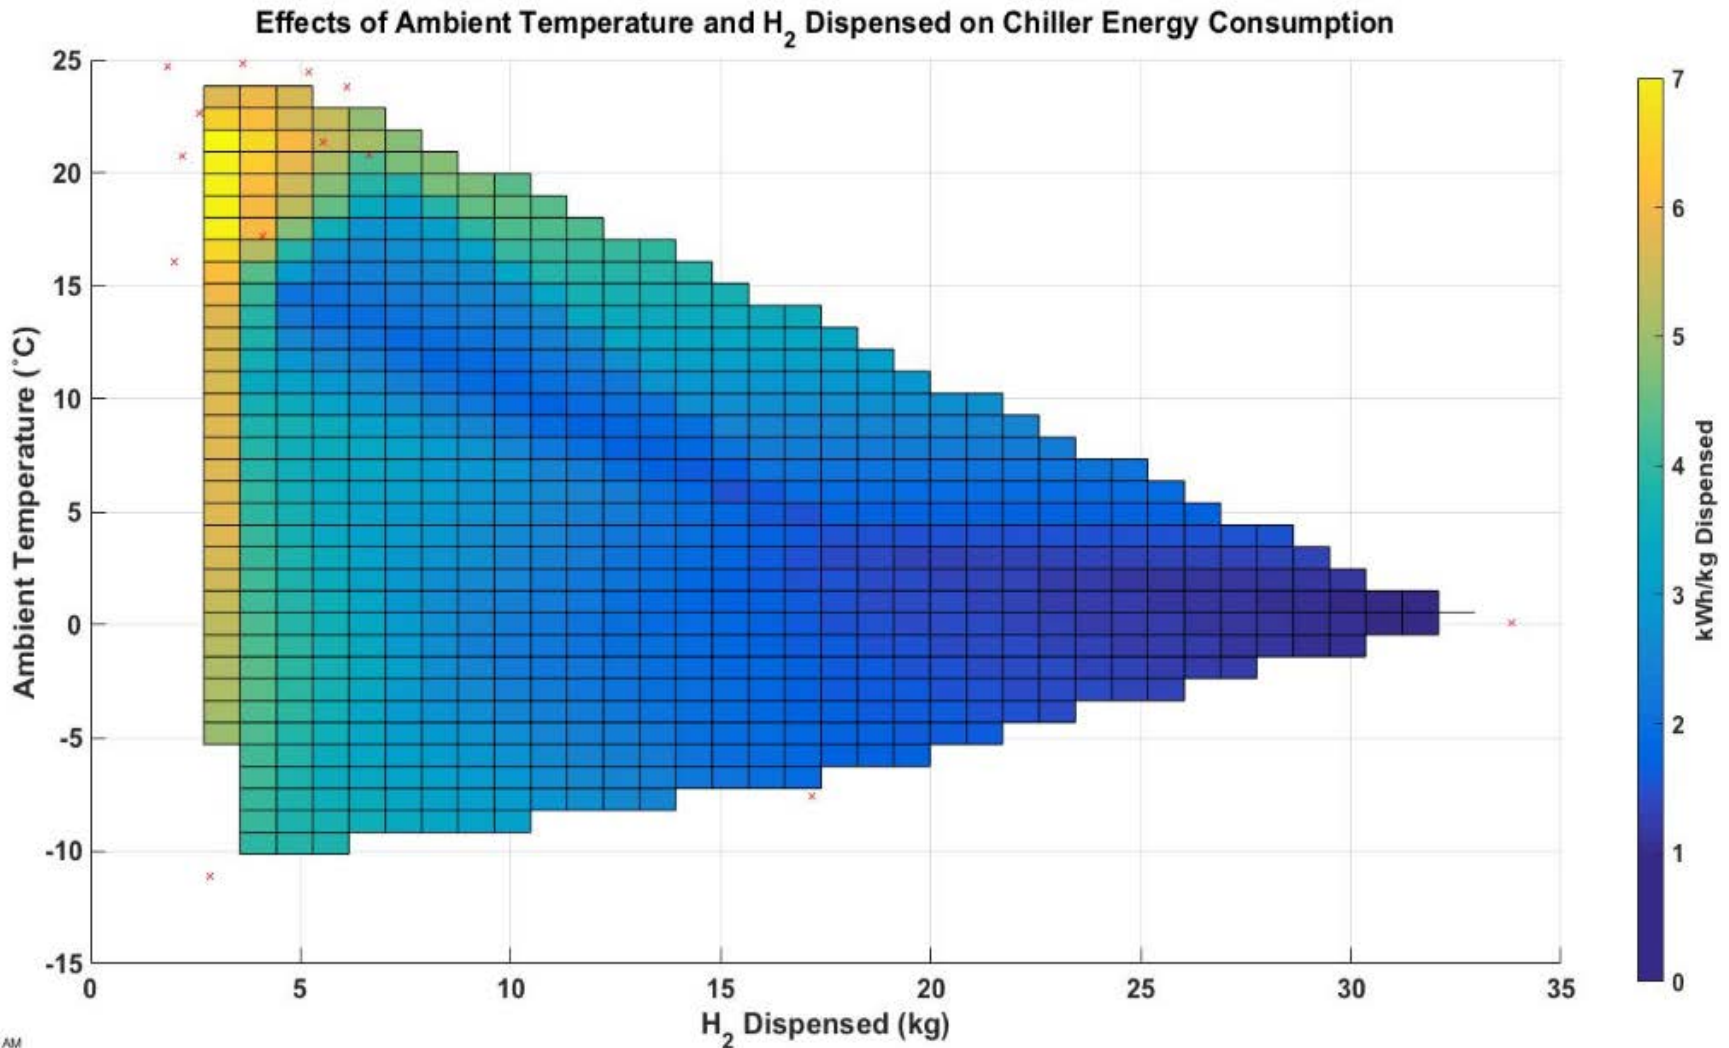
Compressor efficiency is constant, yet chiller efficiency variable

- **Energy consumption for major station components quantified**
 - Chiller performance shown to be highly dependent on ambient temperature and station throughput, ranging from <1 kWh/kg to 7 kWh/kg
 - Compressor performance found to be constant around 4-6 kWh/kg
- **Metal particulates found to be common in failed parts collected from stations**
- **Effect of tube cleaning techniques on reducing metal particulates quantified** – plugging with a tube brush does not require significant additional effort, yet it can reduce metal particulates generated during tube cutting, beveling and threading

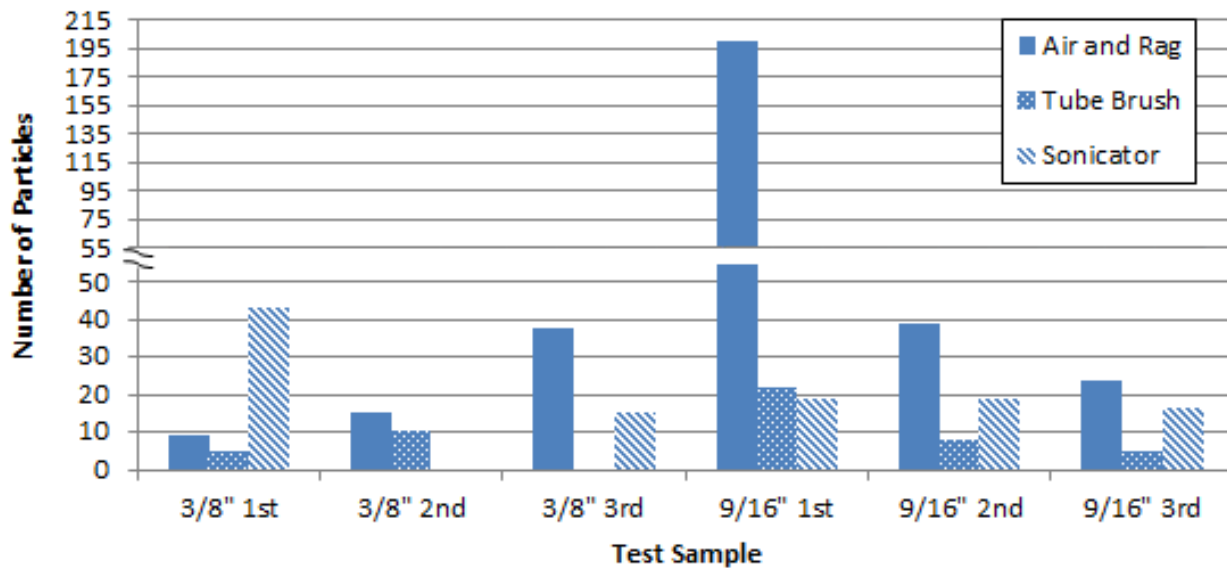
Filter Particle Collection Results

Tube Cleaning Results Show Impact of Cleaning Methods on Number of Particulate Collected

- Air and Rag method worse than Tube Brush and Sonicator
- The number of particles collected on filters for the 3/8" OD and the 9/16" OD show more particles on the 9/16" tubing, but means and medians were not outside of the standard error

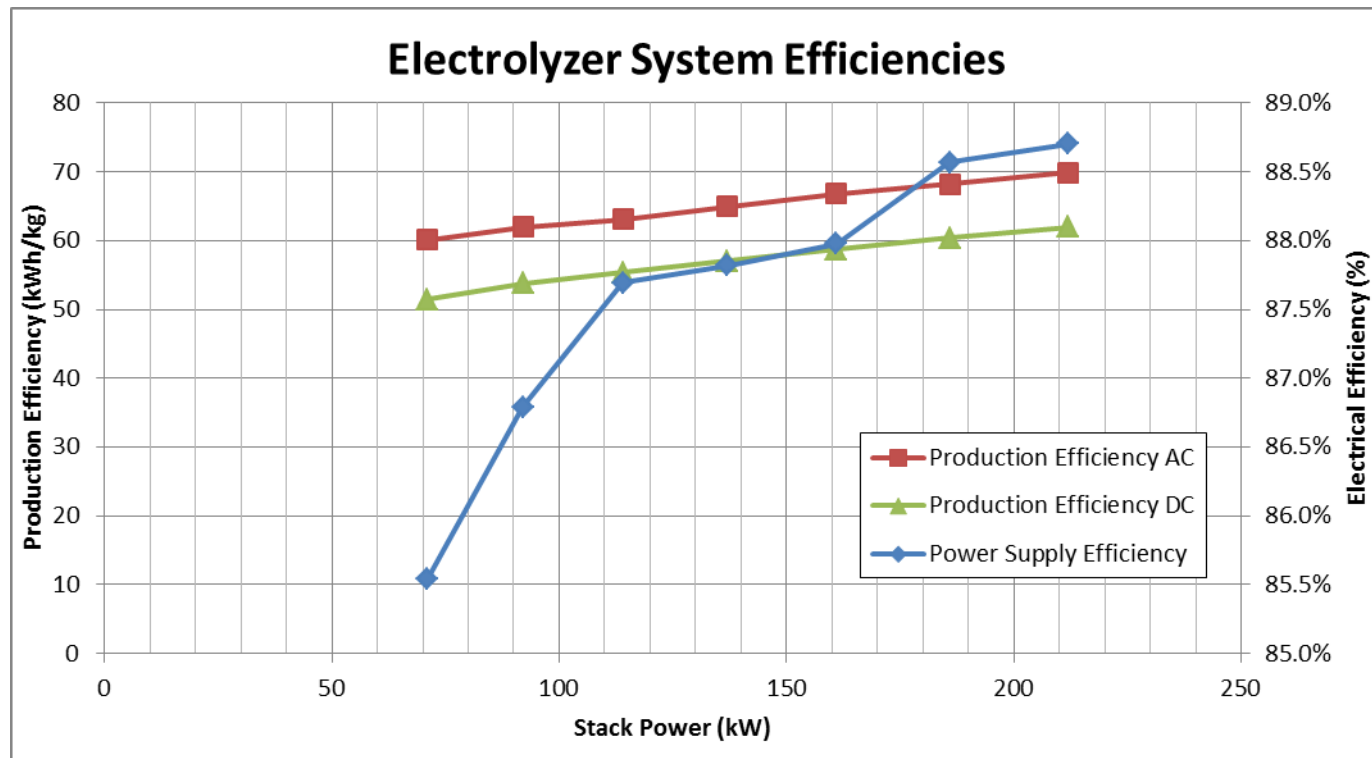
The INTEGRATE project TV031 is looking into ways to improve PEM electrolysis system efficiency when operating in a variable power supply environment, which may generate additional revenue streams. The efficiency used in Slide 8 were taken from the following data.
