Brett Kimball – P.I. Automated Dynamics, Part of Trelleborg Group April 29, 2019

Project ID: ta004

3-Year Project Objective: Design and Validate pipe coupler for FRP Hydrogen Delivery for <u>yet to be installed pipes</u>, without use of elastomeric seals

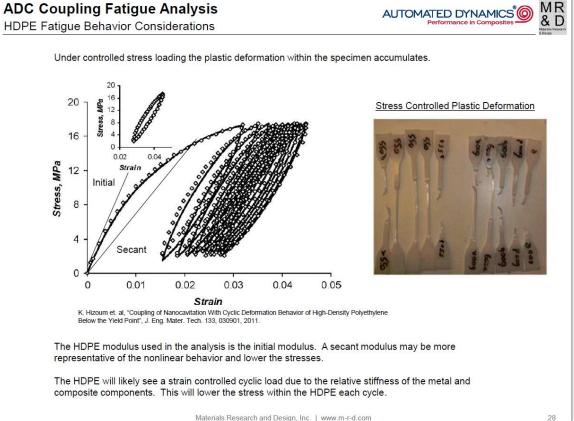
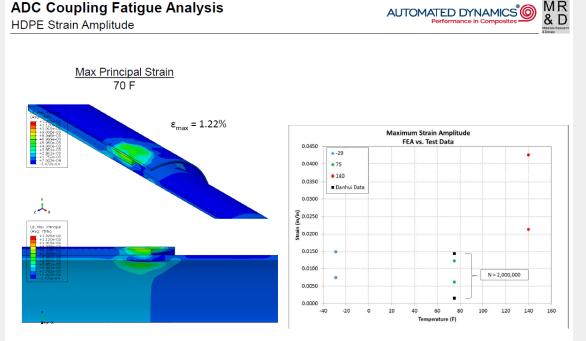
At room temperature, the HDPE fatigue strain in the electrode port is within the bounds from literature. This suggests the HDPE has a life greater than N = 2,000,000. At 140 F the HPDE is 1/4 the stiffness leading to 4 x the strain.

The composite pipe shows small negative margins in the transition region. The pipe is still supported by the coupling in this area. The fatigue strength envelope was computed based on R = 0.1 test data making the analysis conservative.

The E-glass/HDPE layer of the coupling has negative margins for the cold condition. This layer is back by steel and therefore the inplane failure of this layer should not compromise the fatigue life of the part.

The HDPE components show positive margins for the 75 F and 140 F temperature conditions. At -29 F, the HDPE shows fatigue failure in all regions. This is not a concern if the cold condition is the temperature of the environment and not the temperature of the H2 gas.

MR&D believes the HDPE in the electrode port will come to a stress-strain equilibrium, where the stress is below the referenced fatigue strengths (2125 ksi) and the elongation is below the reference fatigue strain (200%).

Modifications to the electrode port have been provided to improve the HDPE fatigue margins. These modifications will also mitigate any creep issues that may occur in the electrode port region during hydrostatic testing (ASTM 2992 Procedure B).

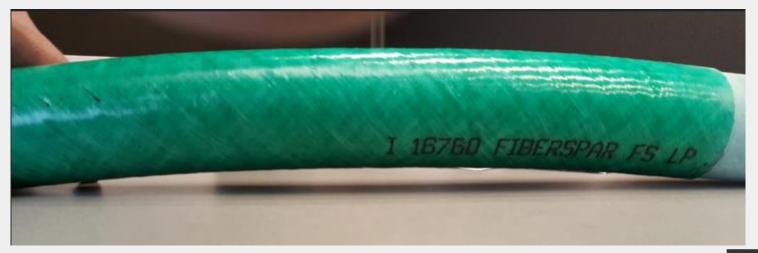
- Use of curved pipe in manufacturing is a significant challenge
 - Straight pipe (i.e. not previously spooled) was not possible for this program
- Assembly
 - Extreme precision required (differences <0.002" diameter) for quality fits.
