## III.11 700 bar Hydrogen Dispenser Hose Reliability Improvement

Kevin Harrison (Primary Contact), Owen Smith  
National Renewable Energy Laboratory (NREL)  
15013 Denver West Parkway  
Golden, CO 80401-3305  
Phone: (303) 384-7091  
Email: Kevin.Harrison@nrel.gov

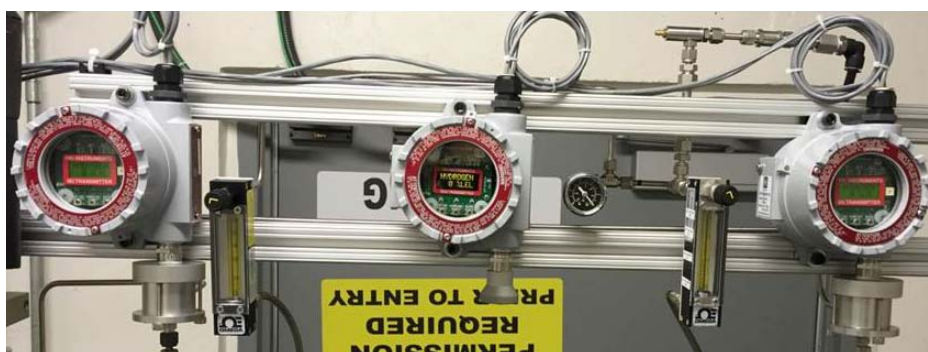
**FIGURE 2.** Leak detection system with fixed-area detector and two vacuum pump active sampling detectors

The hose reliability test stand features a leak detector system consisting of open-area combustible gas detectors and two active vacuum pump sampling systems (Figure 2). The Venturi vacuum pump aspirates air from two sampling chambers installed around both crimp fittings at the hose

ends. The aspirated air passes through a cell attached to a combustible gas detector and a flowmeter set at 400 mL/min. The sampling chambers are not airtight; thus, a constant suction flow is created instead of a stable vacuum. The system has been measured to have a delayed response of 1.5 seconds on the dispenser-side hose end and a delayed response of 9.5 seconds on the nozzle-side hose end due to the pickup tubing and flow rate. The hydrogen levels detected are accurate as measured by calibration gasses at 25% and 50% lower flammable limit (LFL).
