Materials Issues and Experiments for HTE and SO₃ Electrolysis

High Temperature Steam Electrolysis Stack Post-test Evaluation and Electrode Development

Materials Degradation Studies for High Temperature Steam Electrolysis Systems

SO₃ Electrolysis: Reduced Temperature Sulfur-Iodine Cycle

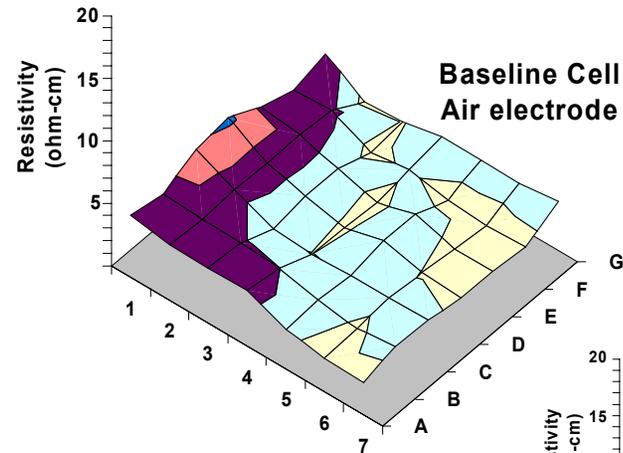
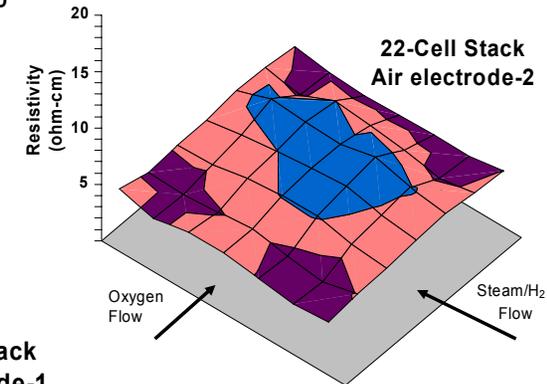
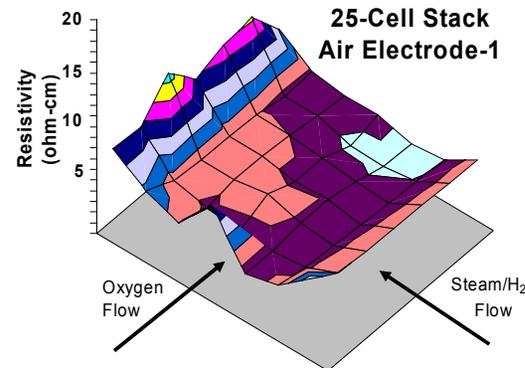
Resistivity maps for oxygen electrodes show degradation at hydrogen exit of cell

- Baseline Cell (untested) reasonably flat resistivity. 2-6 ohm-cm
- 22-cell stack (200-h) higher resistivity but reasonably flat. 3-7 ohm-cm
- 25-cell stack (1000-h) large growth in resistivity toward hydrogen/steam exit of the cell. 11 – 12 ohm-cm

- 4-point resistivity measurements show
 - Oxygen electrodes degraded along the seal at the hydrogen exit of the stack
 - Steam/H₂ electrodes degraded at the hydrogen exit of the stack
 - The bipolar plate had a highly resistive chromium compound
- Raman micro-spectroscopy identified monoclinic zirconia, Cr-Al₂O₃ crystals, and Cr-spinel forming in the surface of electrodes
- APS X-ray fluorescence and transmission identified Cr diffusing into the electrode toward the interface and electrode thickness variations
- SEM analysis verified edge degradation via delamination and Sr segregation in the oxygen electrode
- SEM analysis of steam/H₂ electrodes identified Al and Si impurities in areas that showed high resistivity in 4-point measurements
- Pr₂NiO₄ with ceria interlayers show promise
- Perovskite compositions show potential for use as steam electrodes for HTSE

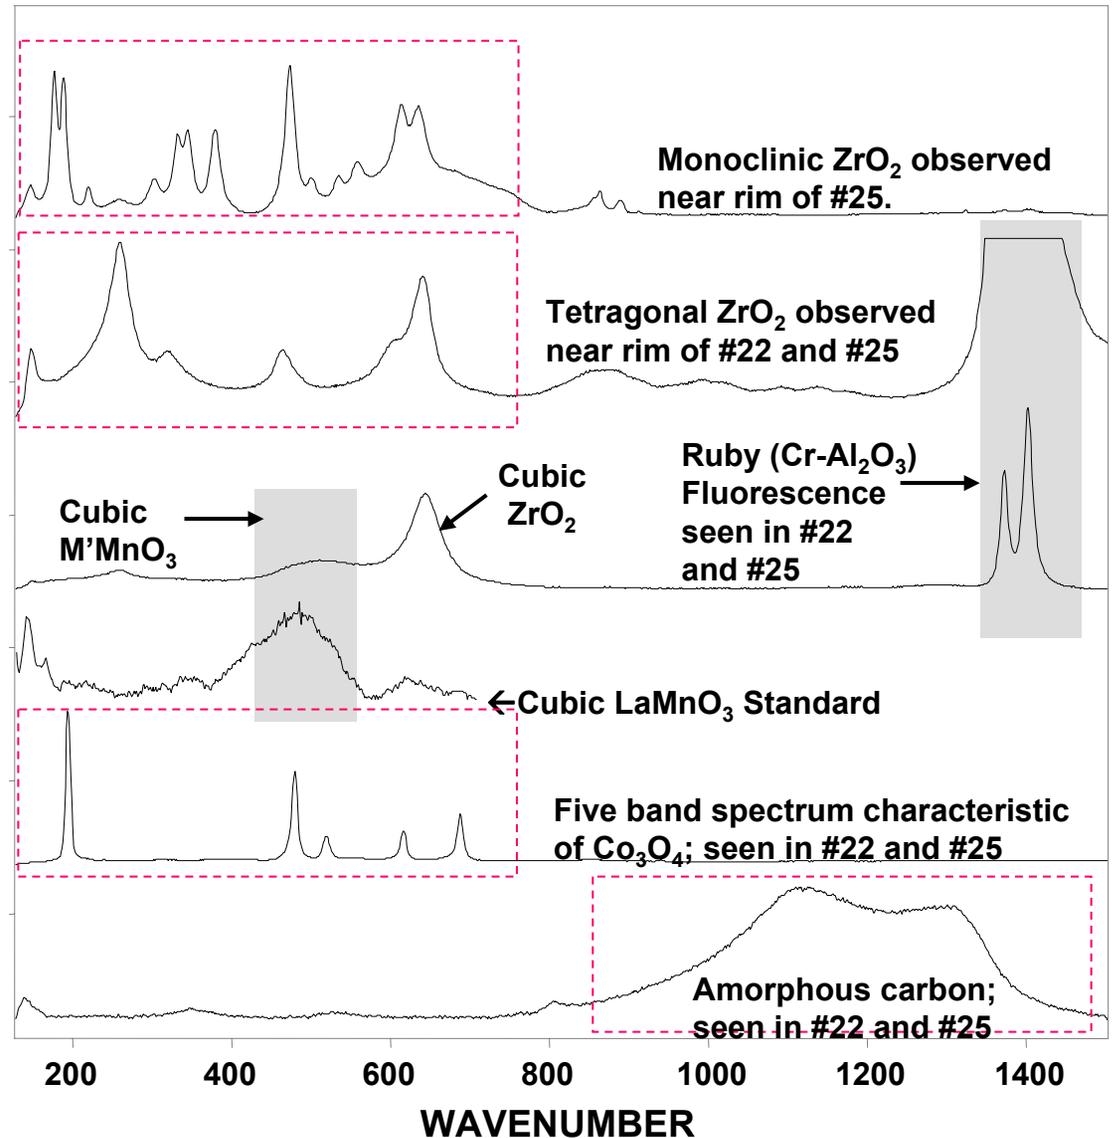
Raman micro-spectroscopy on oxygen electrodes identifies unexpected phases

- Monoclinic zirconia observed on exposed edges of the ScSZ plate

- Chromium reacted with Al in sealant near edge of electrode

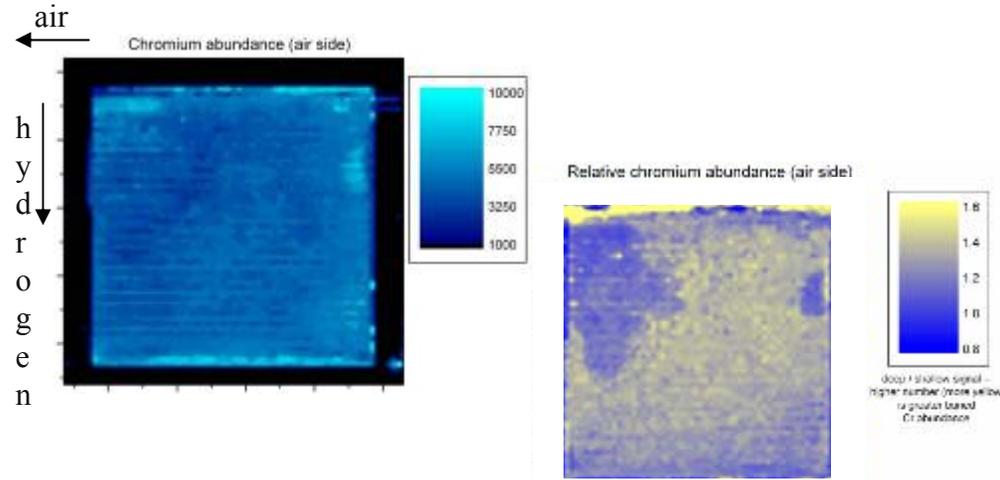
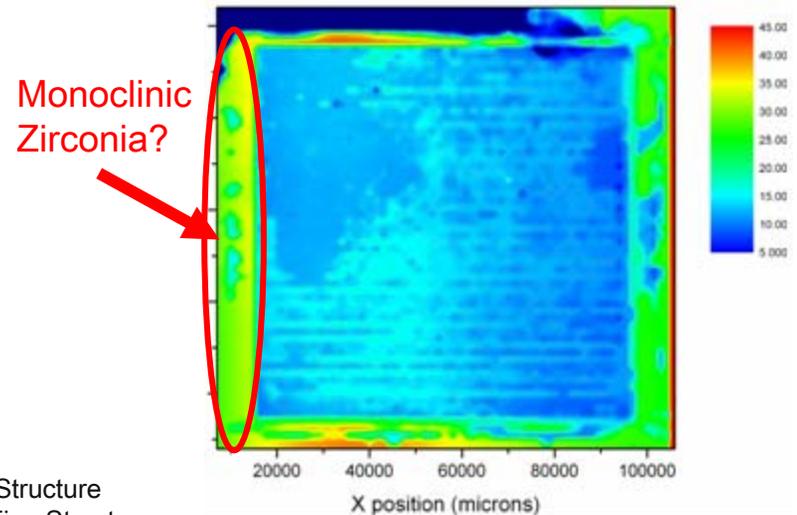
X-ray fluorescence and transmission show Cr migration and thickness variations in the cell

- Cr deposits along edges of sealant
- Cr deposited only in electrode region and not on zirconia \Rightarrow solid state diffusion
- Gas flow direction is evident by Cr-deposition pattern
- Cr has migrated into the electrode towards electrolyte interface
- Thickness variation in electrode
- Increased transmission near known degraded edge
- Increased transmission near oxygen seal
- Would like to use XANES & EXAFS determine **chemical state of elements** in areas of interest

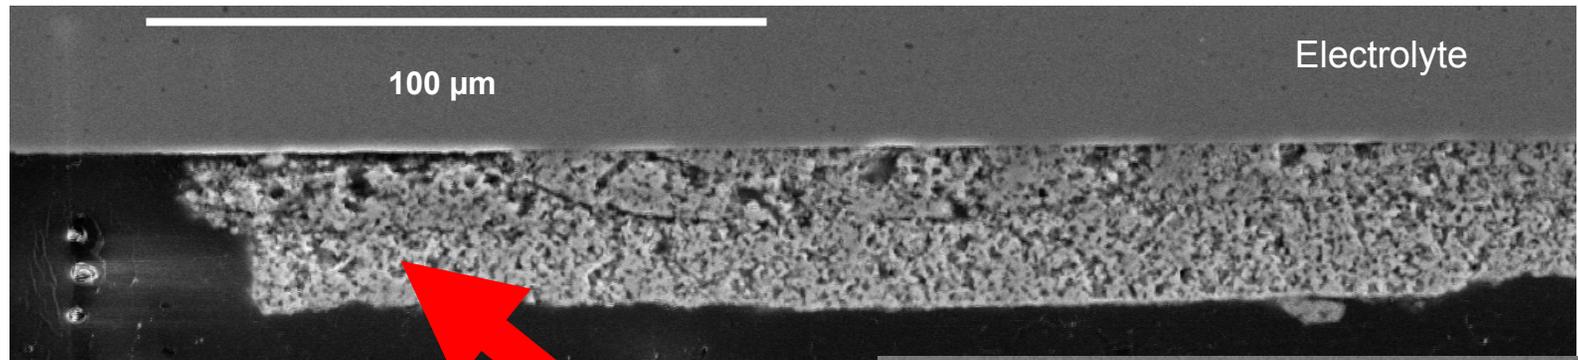
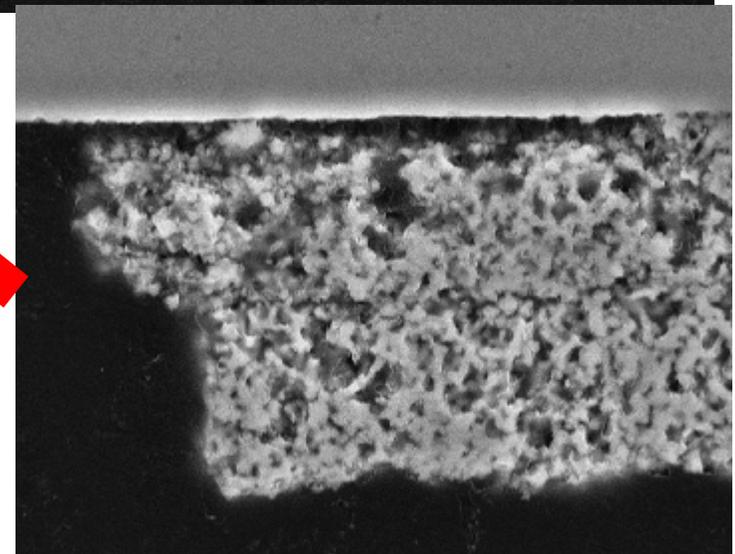
SEM analysis of oxygen electrode shows delamination in the oxygen electrode

- Delamination near the edge of the oxygen electrode was found where high resistance was measured with the 4-point probe
- Internal defaults were also seen near the edge

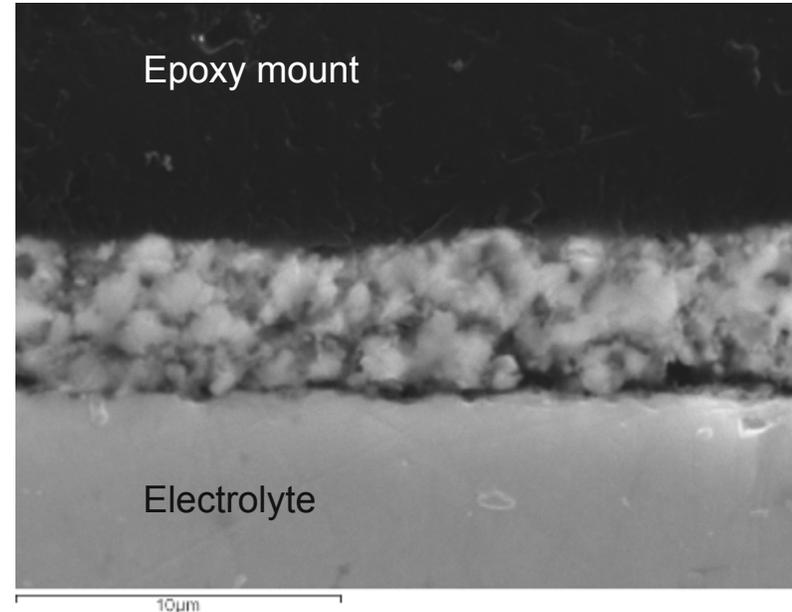
SEM analysis of steam-hydrogen electrode identifies Si and Al contamination

- **Area with low resistivity on 4-point probe maps:**
 - Al present at electrode/bond layer interface
 - More Al near the sealed edge (Al:Ce = 0.05 – 0.25)
- **Area with high resistivity on 4-point probe maps (at the edge):**
 - More Si found near where bond layer was removed (Si:Ce = 0.05 – 0.24)
 - Al found throughout (Al:Ce = 0.16 – 0.29)

- **Increased contaminants near the sealed edges indicate that the seal material may be the source of Si and Al**

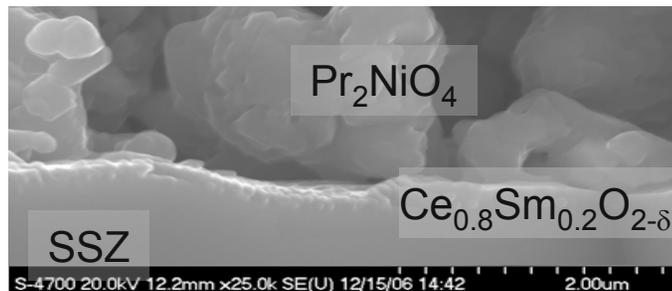
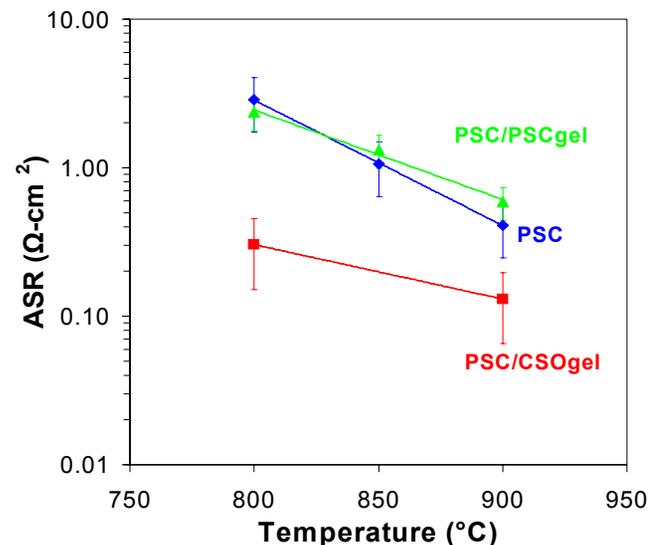
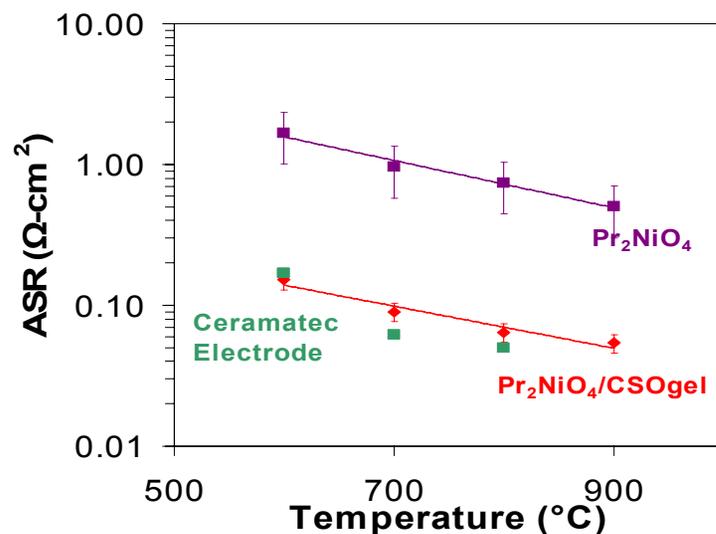
High temperature electrolysis oxygen electrodes improve with CSO interlayer

- Addition of a CSO interlayer improves performance of PSC electrodes
 - No secondary phases found by XRD
- CSO interlayers improve the performance of Pr_2NiO_4
- The roughness on the top of the ceria layer may contribute to the improved performance

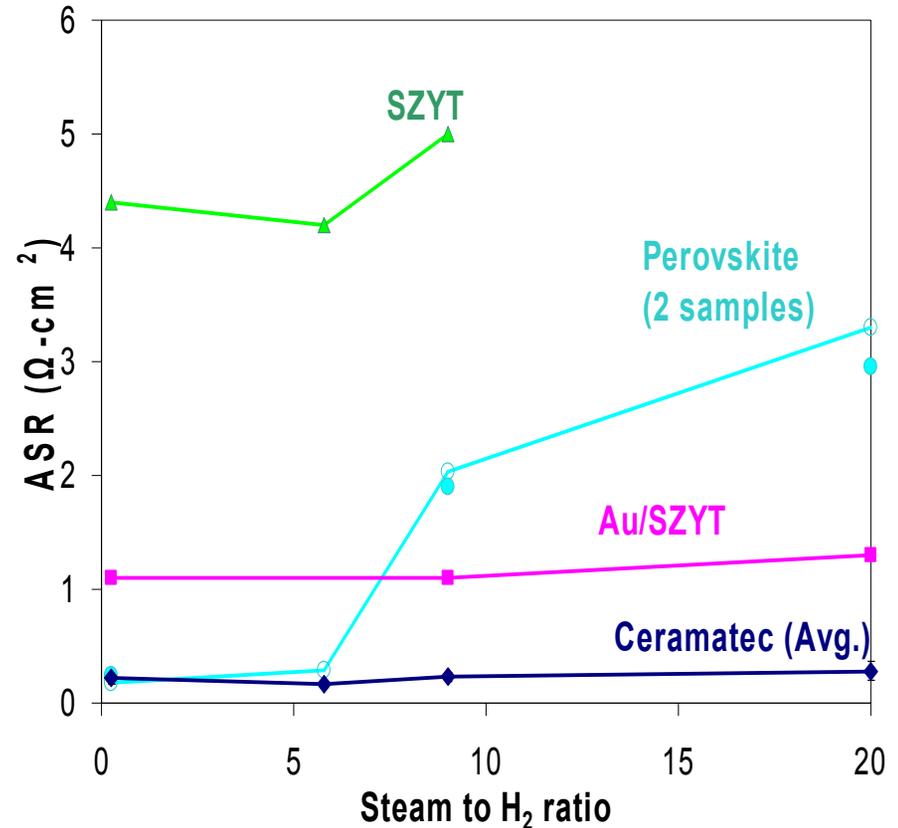
Increasing steam concentration increases ASR of steam/H₂ electrodes

- ASR results for ZYT, LSCM, and Nb₂TiO₇ follow the same trend

Temperature = 830°C

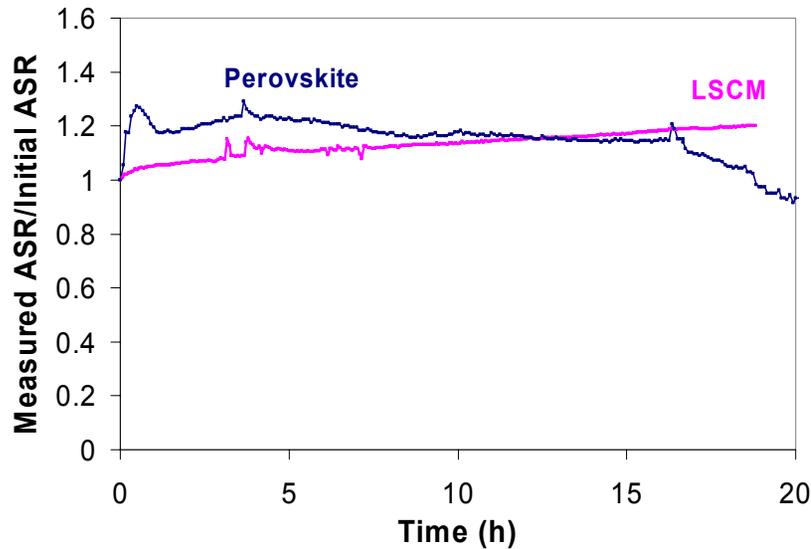
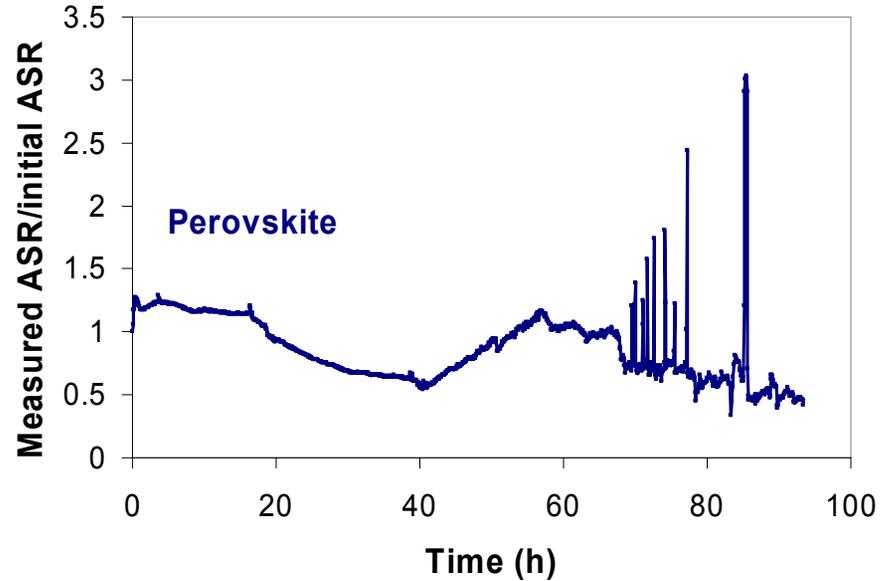
Steady state performance of steam/hydrogen electrodes shows that oxides may replace Ni-YSZ

- Temp = 830°C
- Current density = 200 mA/cm²
- Feed gas = H₂
- Steam to H₂ ratio = 6

- Degradation of the perovskite sample is due in part to exfoliation of the counter electrode, which was made out of the same material
 - Exfoliation also occurred with Pt and Ni-CeO₂ counter electrodes

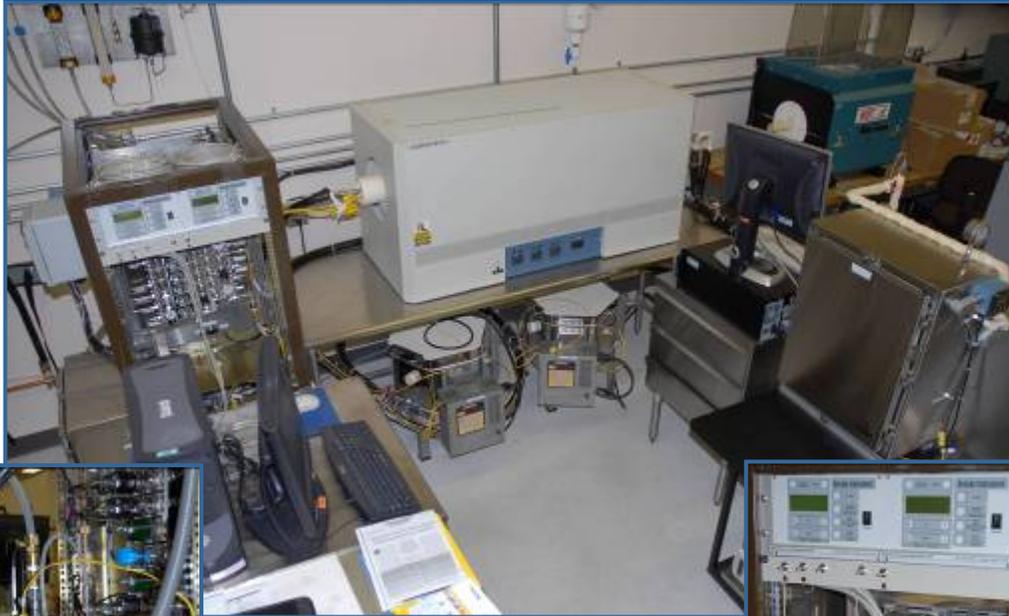
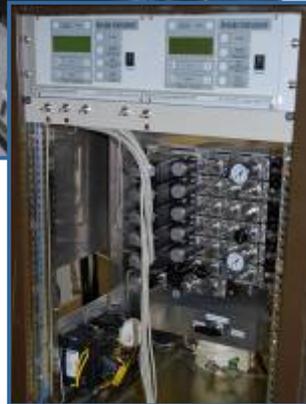
**High temperature
steam electrolysis
corrosion test stand**

- **Three independent furnaces**
- **Three sets of parallel gas supply lines**
 1. $\text{H}_2\text{O}/\text{H}_2/\text{N}_2$ (steam provided by heated water bath)
 2. Air/O_2
- **Gas mixtures set with mass flow controllers**
- **Automatic data logging**
- **H_2 and O_2 gas safety systems:**
 - Trace He injection to detect H_2 - O_2 gas cross-mixing
 - Interlocked H_2 and O_2 monitors in laboratory

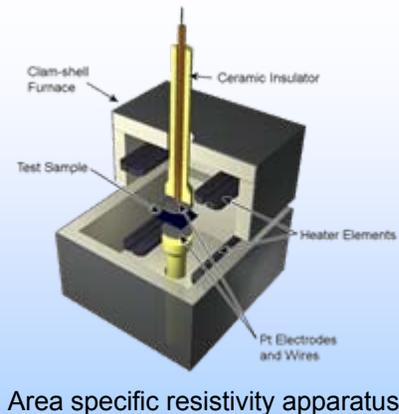
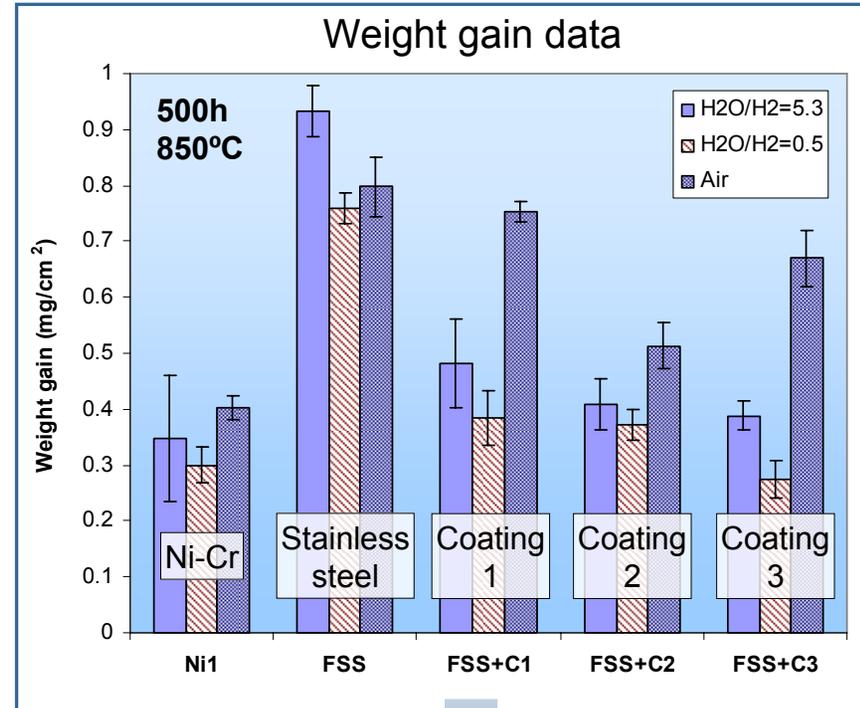
Initial corrosion test results (1)

- 500 h tests completed at 850°C with the following gas mixtures:
 - $H_2O/H_2 = 5.3, 0.5$
 - Dry air
- **Sample characterization is ongoing:**
 - **Scale microstructures and thickness**
 - **Scale chemistry**
 - **Scale resistivity as a function of temperature:**

- **Ni-Cr alloy base metal more corrosion resistant in both H_2O/H_2 and air than ferritic stainless steel**
- **Proprietary Ceramatec coatings effective in reducing corrosion in H_2O/H_2 ; less effective in air**

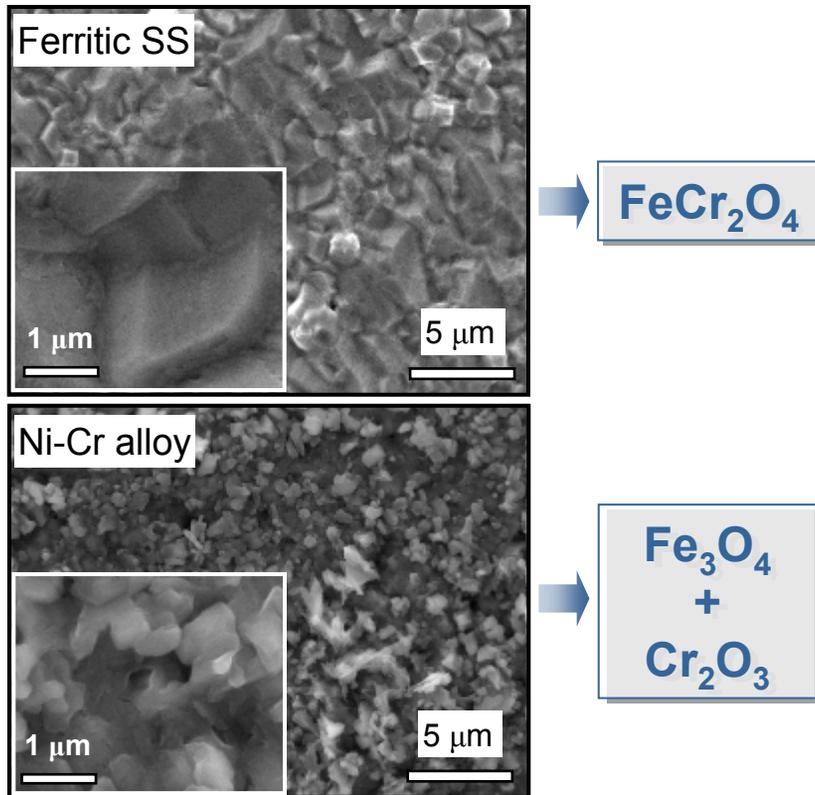
In $\text{H}_2\text{O}/\text{H}_2$:

- Ferritic stainless steel forms chromite (FeCr_2O_4)
- Ni-Cr alloy forms duplex layer of magnetite (Fe_3O_4) and chromia (Cr_2O_3)

Surface microstructures of uncoated stainless steel and nickel alloy specimens and results of x-ray diffraction phase analysis (187 h @ 825C; $\text{H}_2\text{O}/\text{H}_2 = 0.9$)

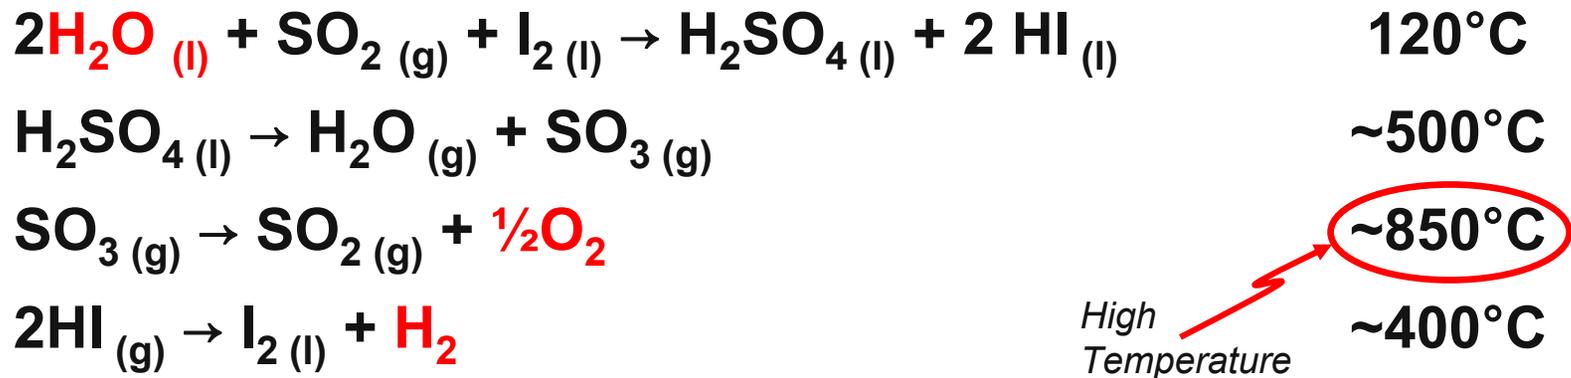
Sulfur-Iodine cycle to produce hydrogen:

Reduce temperature by electrochemical reduction (electrolysis)

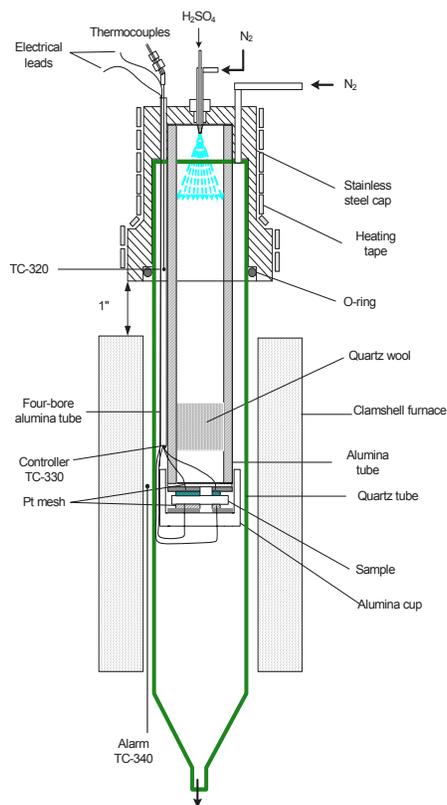
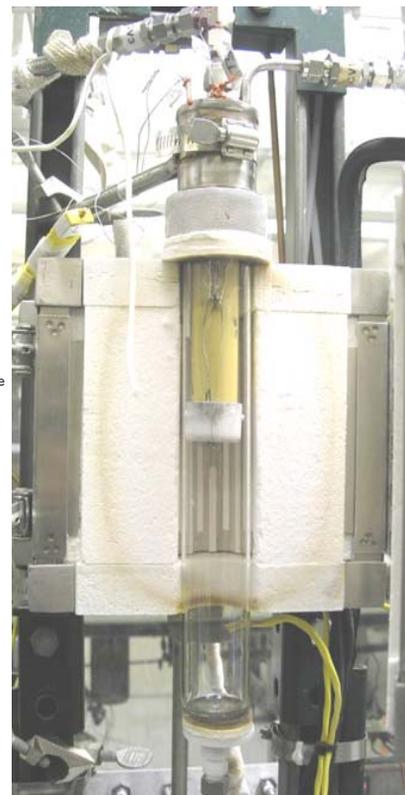
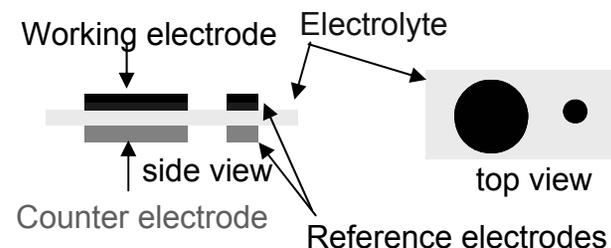
SO_3 electrode test fixture

- H_2SO_4/H_2O mixture is sprayed into sample tube above the cell
- O_2 and SO_2 monitored by mass spectrometry

- Electrochemical cell was shown by cyclic voltammetry to reduce some SO_3 to SO_2

- Electrochemical test stand built to test SO₃ electrodes
- Cell containing Pt electrodes showed electrolysis by cyclic voltammetry
- Periodic element chart was developed to identify possible candidates for SO₃ electrode materials

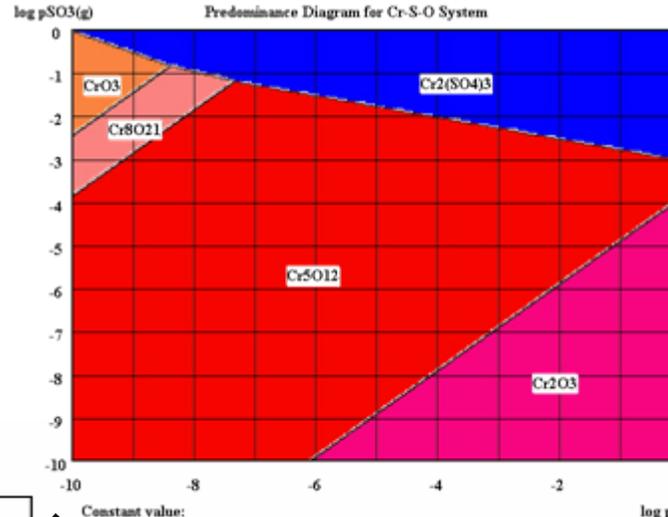
Stability diagrams help identify candidate electrode elements

- Calculated predominance diagrams illustrate stable phases in SO_2 - SO_3
 - Blue = Sulfate *undesirable*
 - Red = Oxide
 - Yellow = Metal

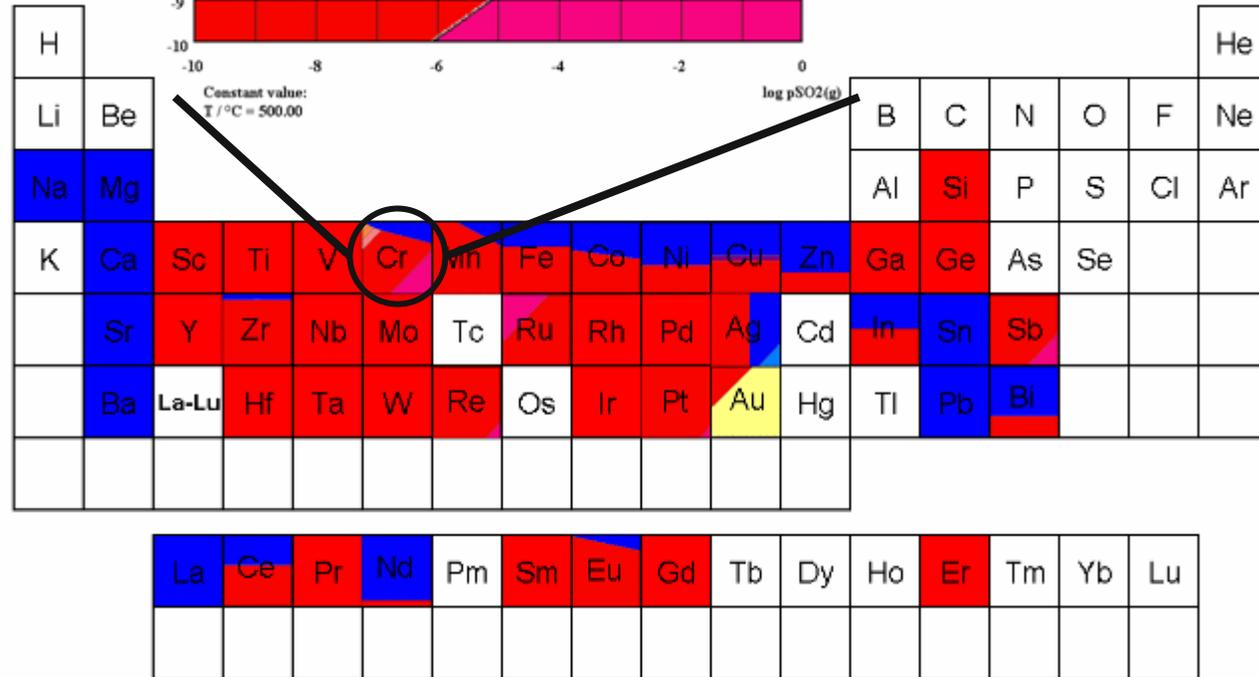
Example:
Chromium
Predominance
Diagram

- Gold is only stable metal
- Traditional SOFC electrodes are not stable in SO_2/SO_3
- Candidate oxide has been identified, fabricated and tested as electrodes, others being fabricated
