Corrosion and Crack Growth Studies of Heat Exchanger Construction Materials for HI Decomposition in the Sulfur-Iodine Hydrogen Cycle

Bunsen Wong
General Atomics
May 15, 2007

IFT\ P2007-019

Project ID #
PDP31

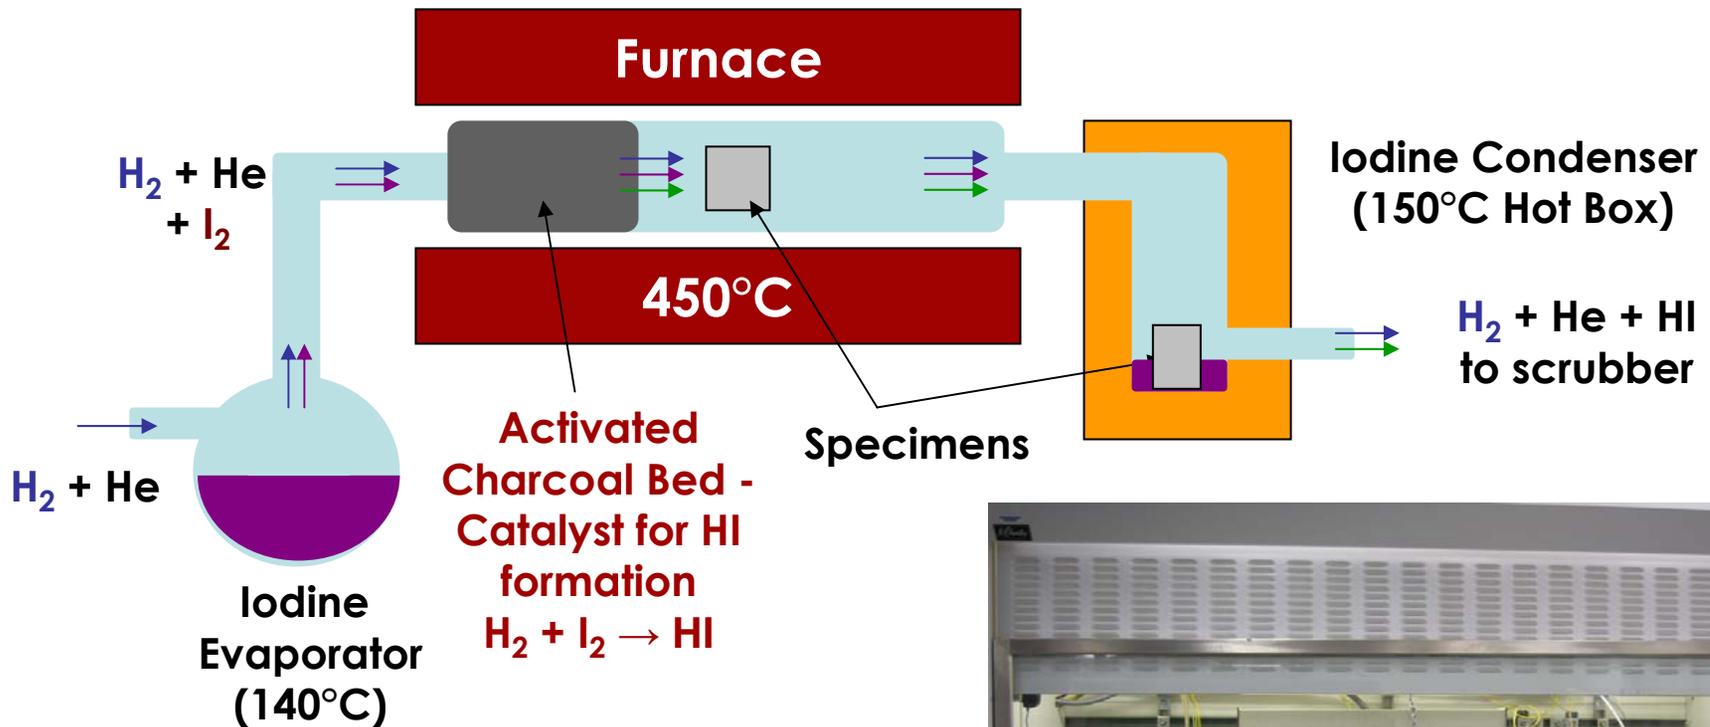
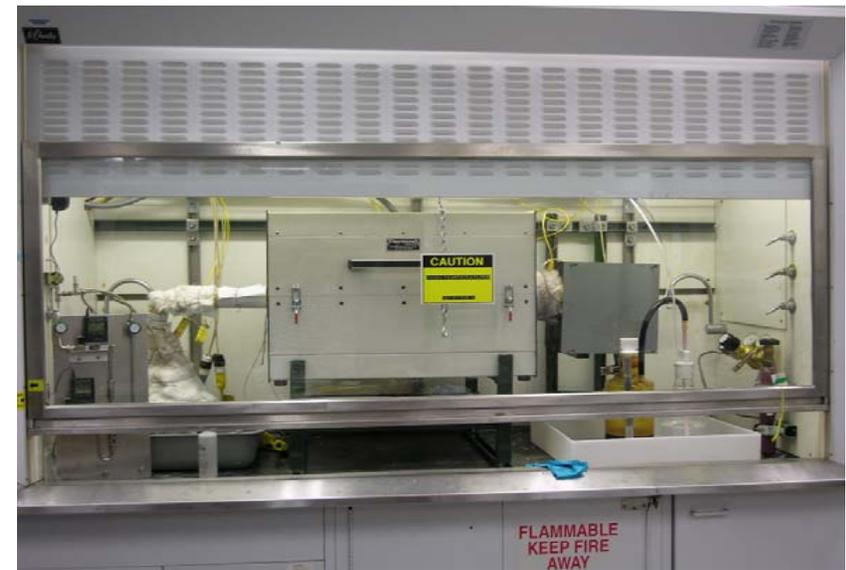
The HI decomposition materials test system replicates the HI gaseous decomposition environment

- Eliminates the need to procure expensive HI gas
- Test materials for both HI decomposition and iodine condensation

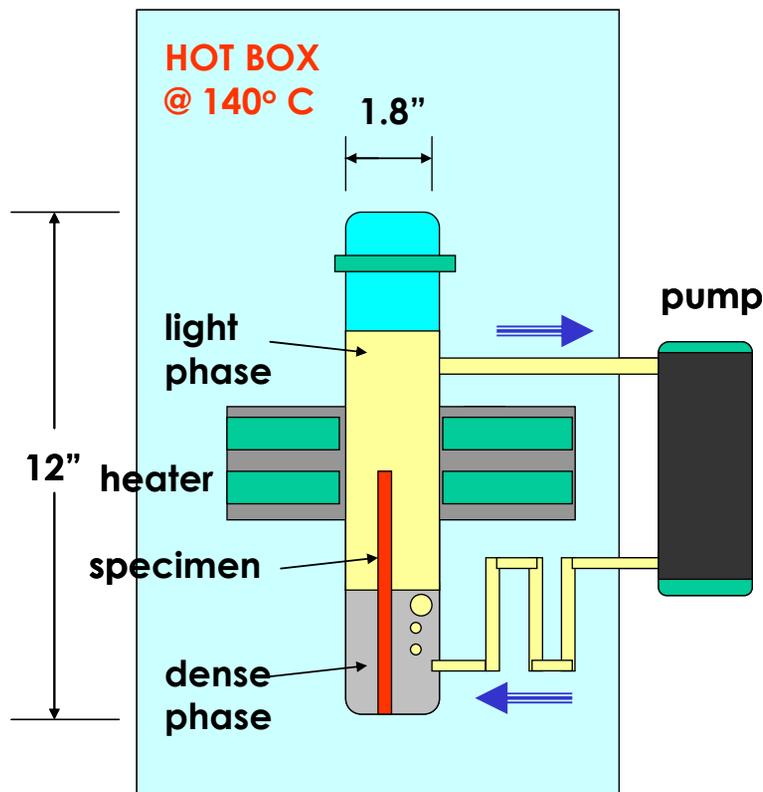
The acid (HI_x ; $\text{HI}_x + \text{H}_3\text{PO}_4$) circulating system enable materials testing in a dynamic environment

- Corrosion behavior can be radically affect by agitation
- System can handle two phase liquids: H_3PO_4 - HI - H_2O (light) I_2 rich (dense)

- The light phase is pumped into the bottom of the capsule. It rises to the top due to density difference
- Processed and Ta coated parts, stress corrosion and tensile specimens have been tested in this set up

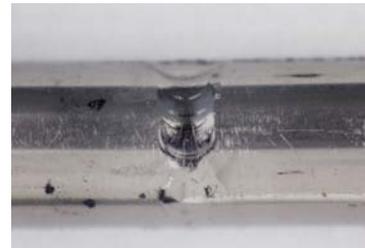
A Ta-10W tube section with a Ta weld

0 hr

178 hr

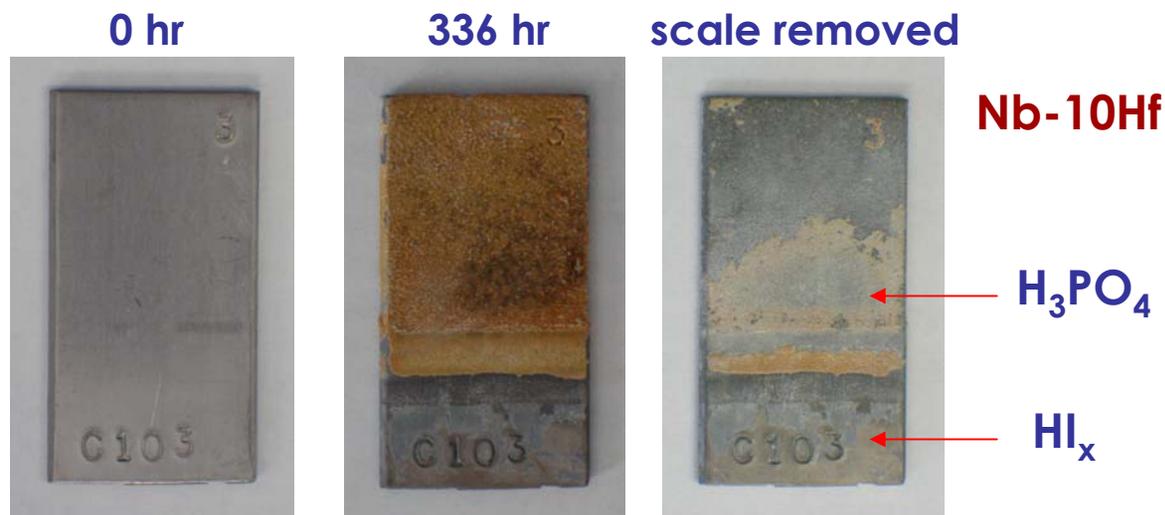
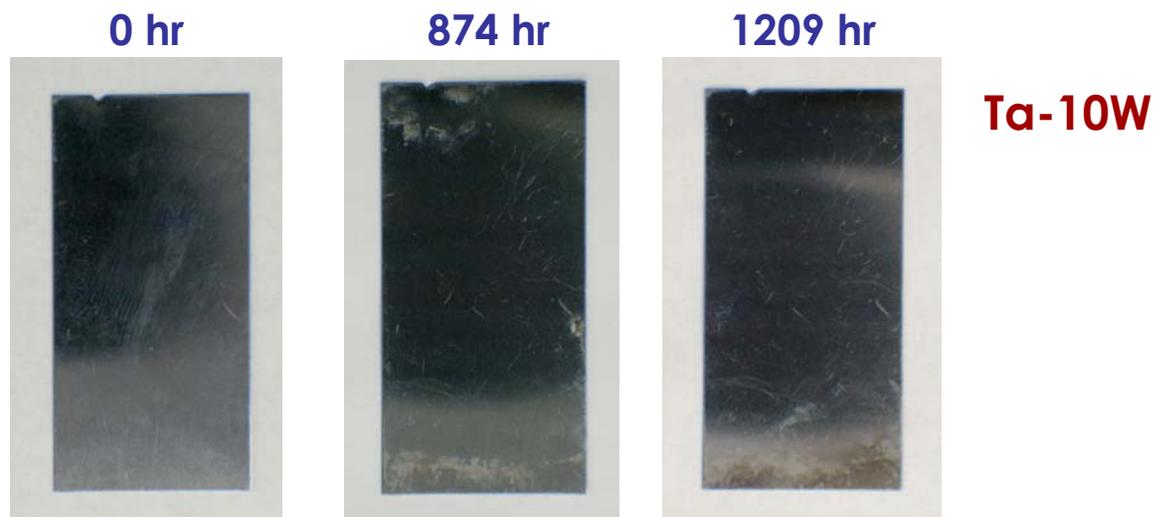
Materials that can handle HI_x at high temperature may not be suitable for Iodine Separation

- Nb alloys showed noticeable corrosion in the $HI_x + H_3PO_4$ mixture at $120^\circ C$

- Ta alloys are the only metals which can handle the iodine separation acid complexes

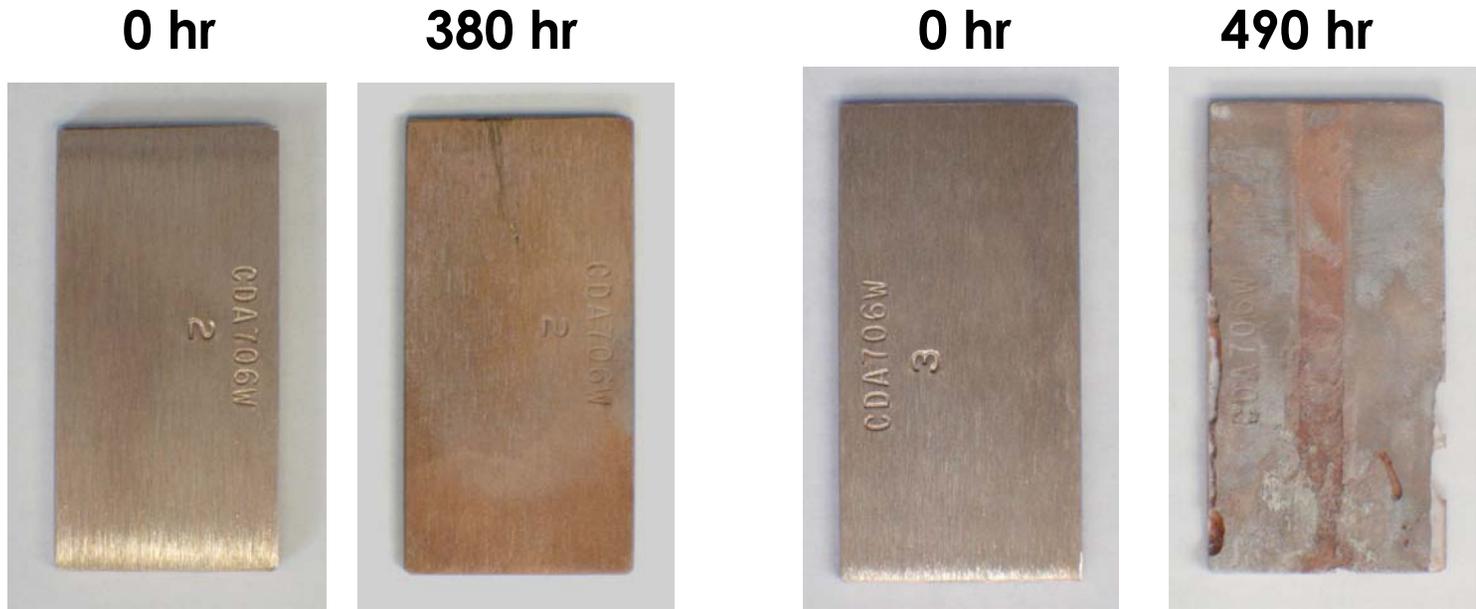
C706
Cu-Ni

However, contaminants (I₂, HI) additions lead to unanticipated corrosion of materials

H₃PO₄-3HI-5H₂O
(wt%) at 250°C

H₃PO₄-14.4HI-0.7I₂-16.1H₂O
(wt%) at 190°C

- Only Ta based alloys were not affected by HI and I₂ additions in H₃PO₄
- Cross contamination of chemicals and corrosion products will be the key issue in the longevity of components

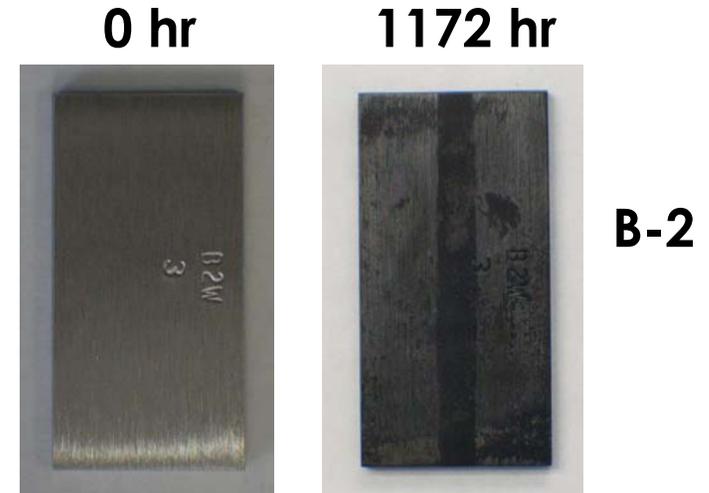
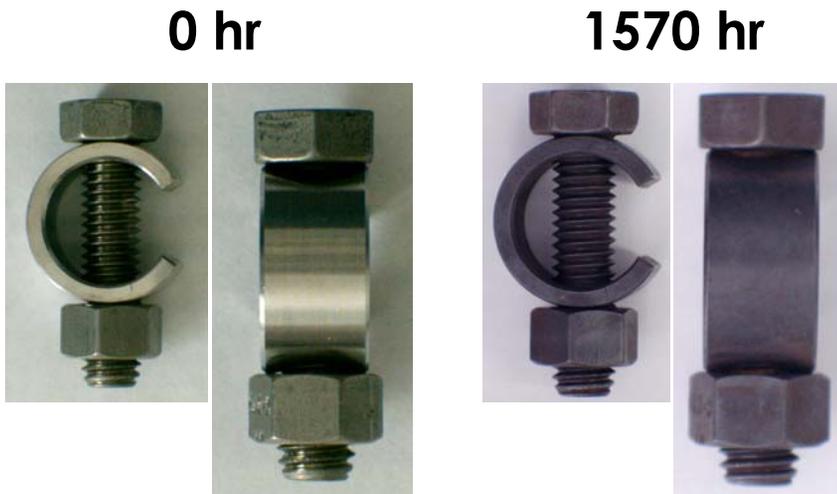
Hastelloys showed the best corrosion performance in the HI decomposition environment ($\text{HI} + \text{I}_2 + \text{H}_2$)

hours	mpy
B-2	1172	2.55
C-22	1570	10.70
C-276	1220	13.50

- Stress corrosion testing of C-22 and C-276 U-bend and C-ring specimens did not show any crack initiation

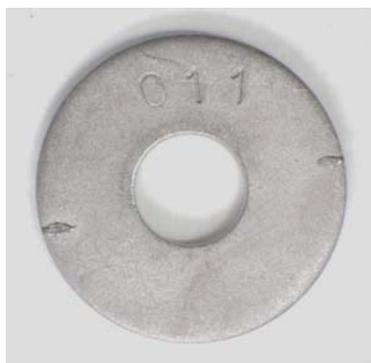
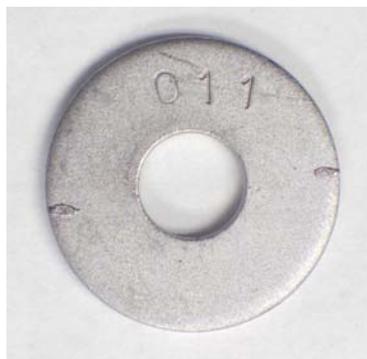
0 hr

294 hr

- Ta plated washer showed no sign of corrosion after immersion in $\text{HI}_x + \text{H}_3\text{PO}_4$

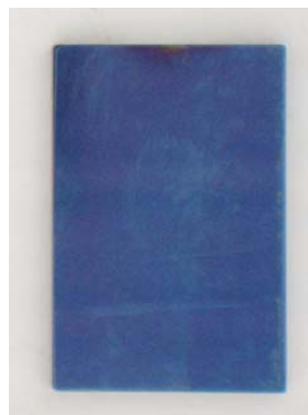
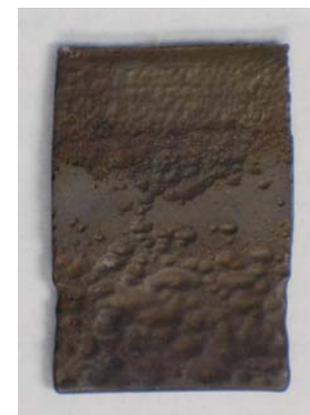
- Cr-Mo steel coupon coated with sputtered Ta and then anodized. Severe corrosion took place after immersion in $\text{HI}_x + \text{H}_3\text{PO}_4$

0 hr

399 hr

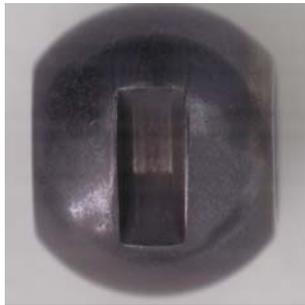
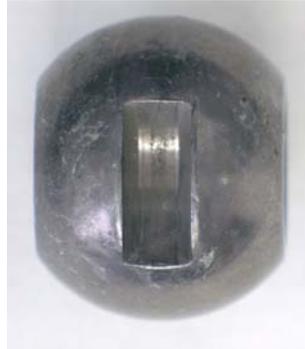
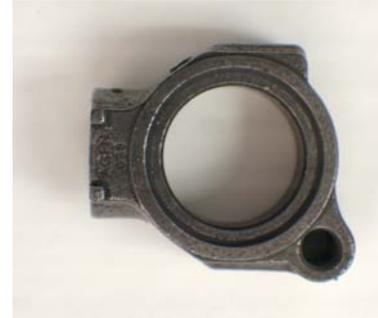
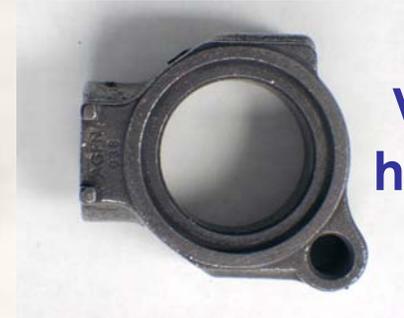
Performance of Ta coated components such as fittings and valves have also been evaluated

- Most valves parts did not show any sign of corrosion

0 hr

1160 cycles (88 hr)

1160 cycles

Valve ball

Valve housing

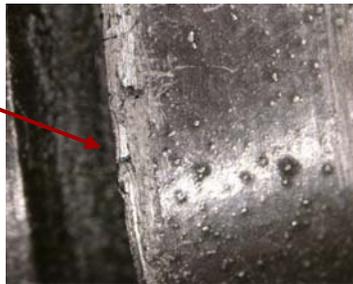
- Testing did reveal incorrect assembly can lead to damage in the Ta coating

Damaged fitting during installation

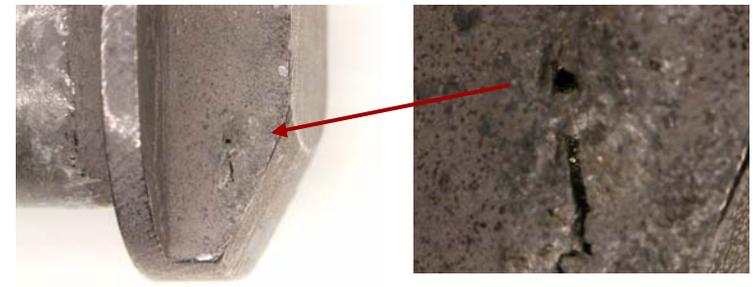
Incorrectly installed valve drive bolt
