Improved Accelerated Stress Tests (ASTs) Based on Real World FCV Data

UTC Power Corporation

Project ID: FC015

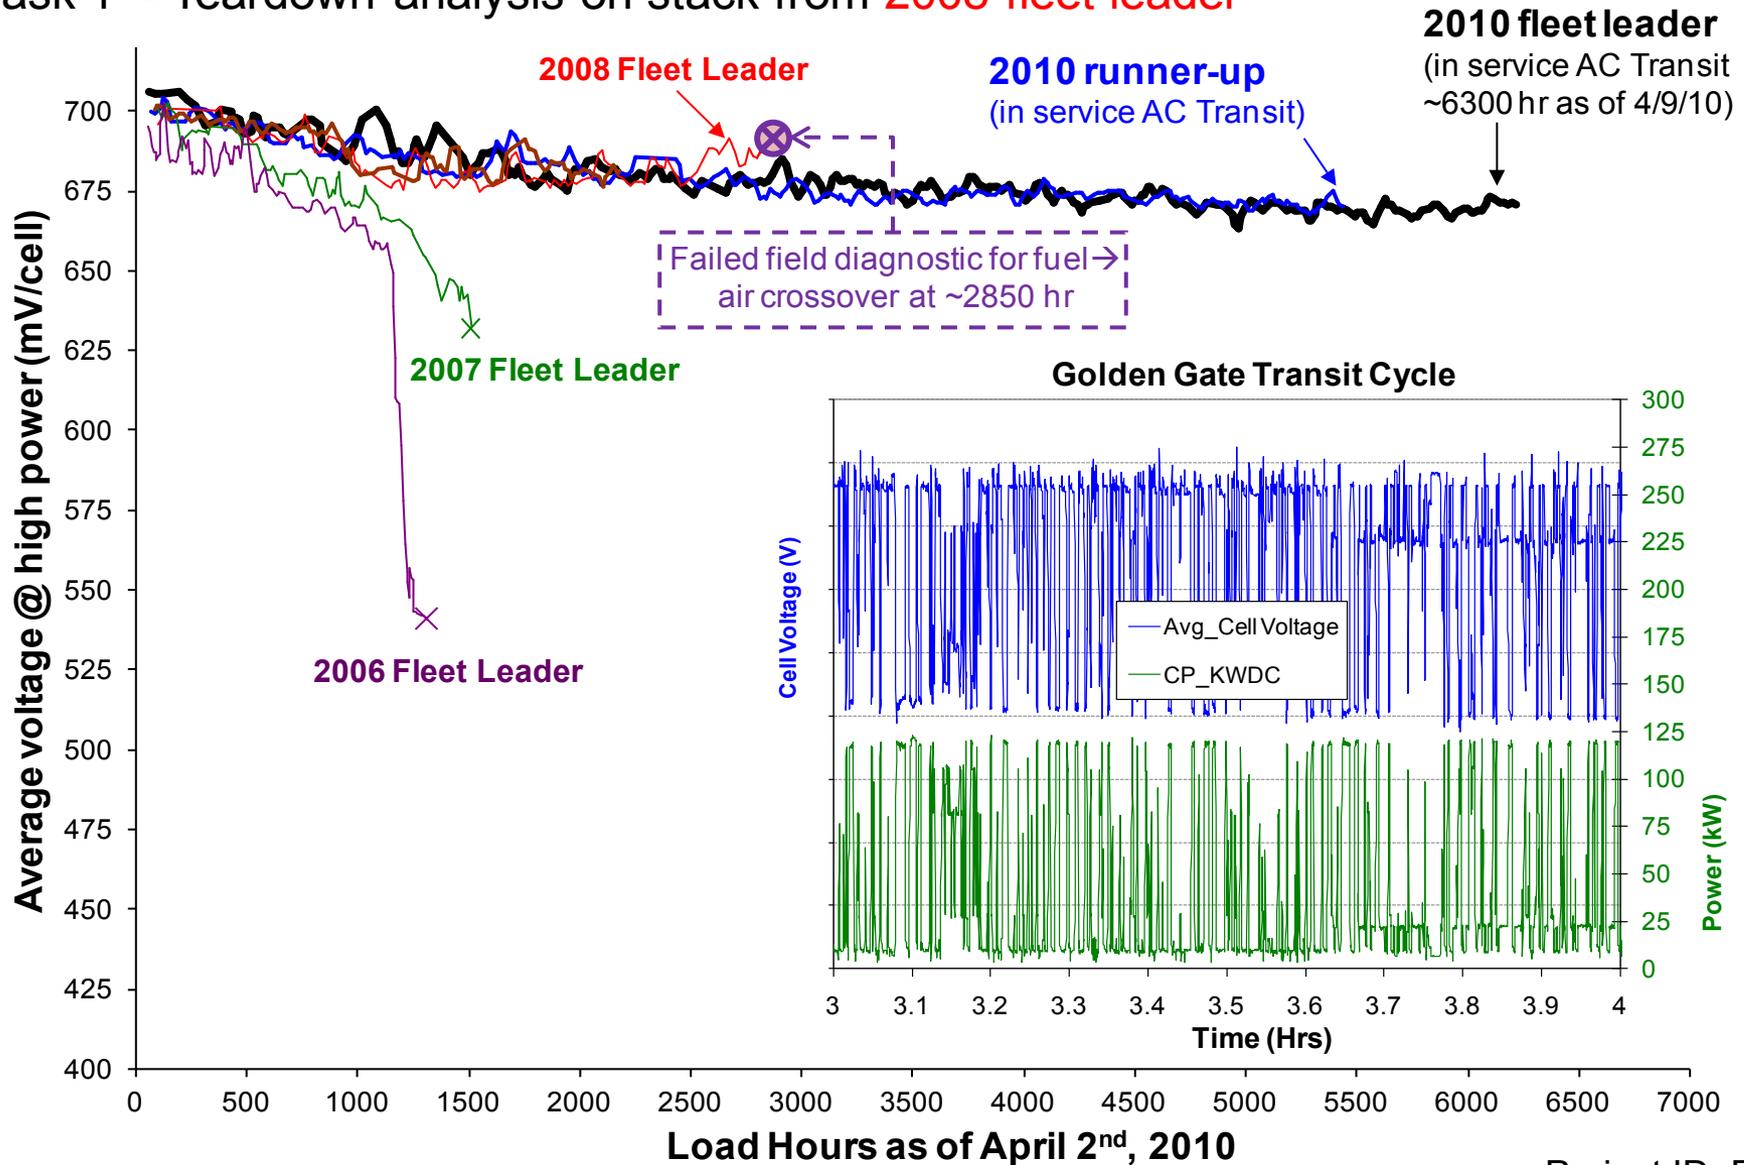
Task 1 - Teardown analysis on stack from **2008 fleet leader**

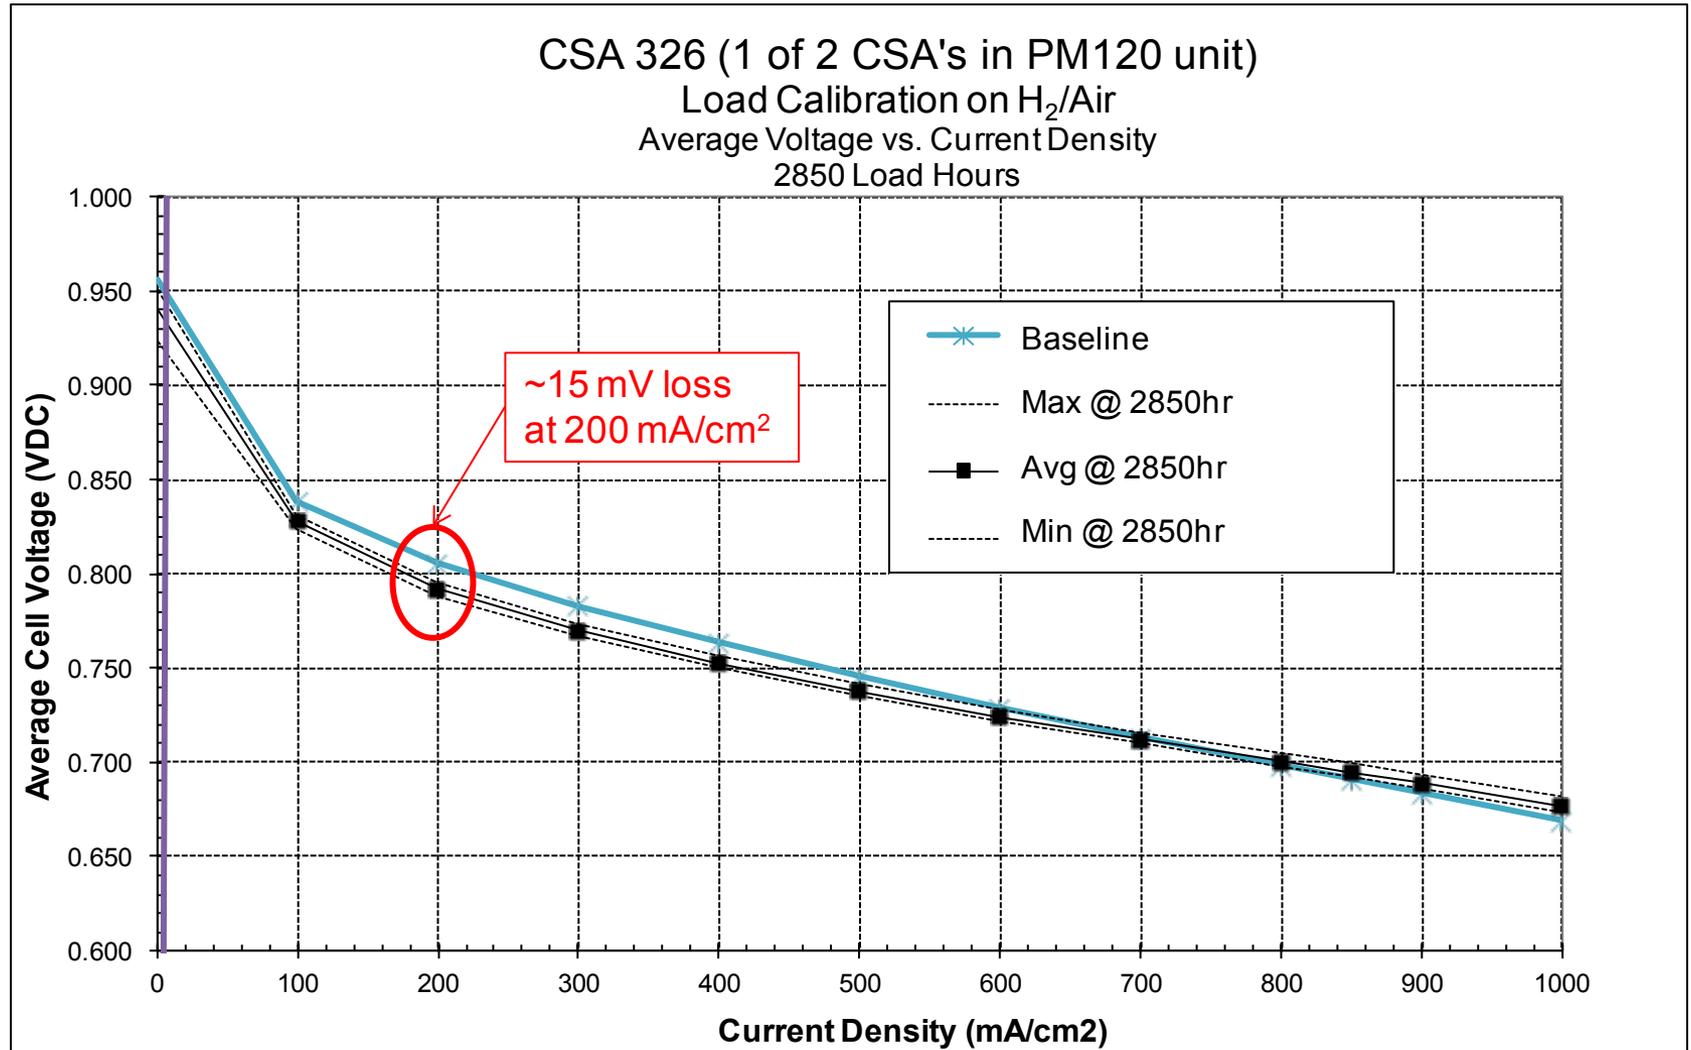
Analysis of performance loss in field-operated stack @ 2850hr on test stand

- Small but measurable performance decay in field operated unit at 2850 hrs
- Catalyst decay AST leads to ~18mV voltage loss (@0.2A/cm²) which is in agreement with that observed in 2850hr bus stacks (~15mV)
- ECA loss measurements consistent with TEM and XRD analyses

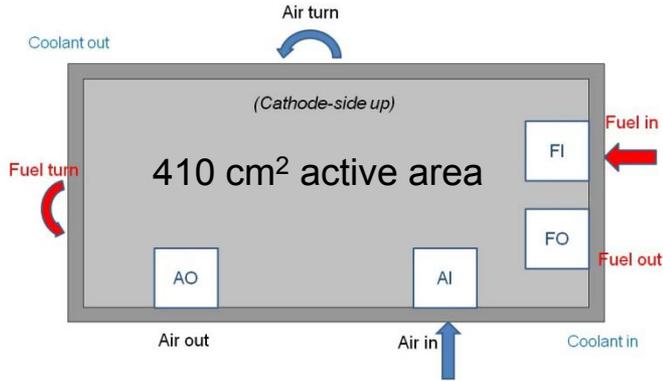
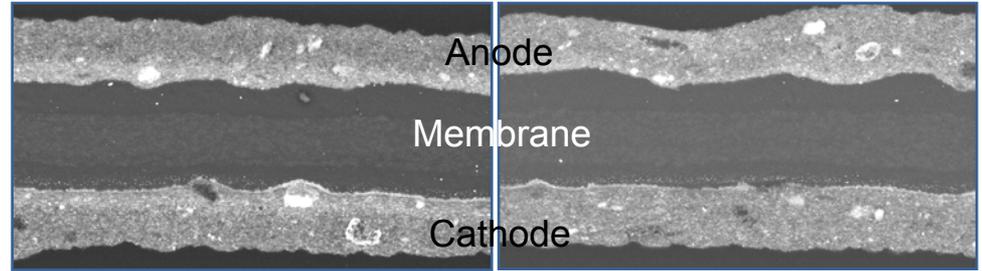
ECA & XRD Baseline vs. 2850 hr

- 50%-75% Cathode ECA loss
- Less ECA loss on anode

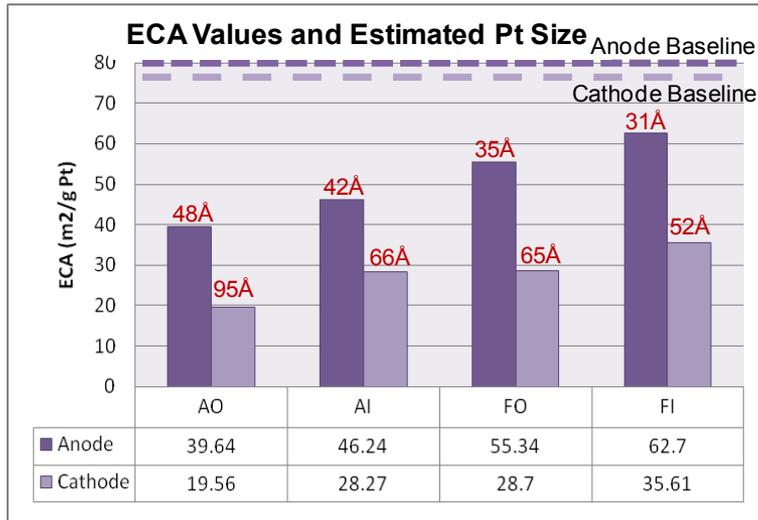
ECA measurements performed on subscale sections at indicated locations (calculated particle size shown in red)

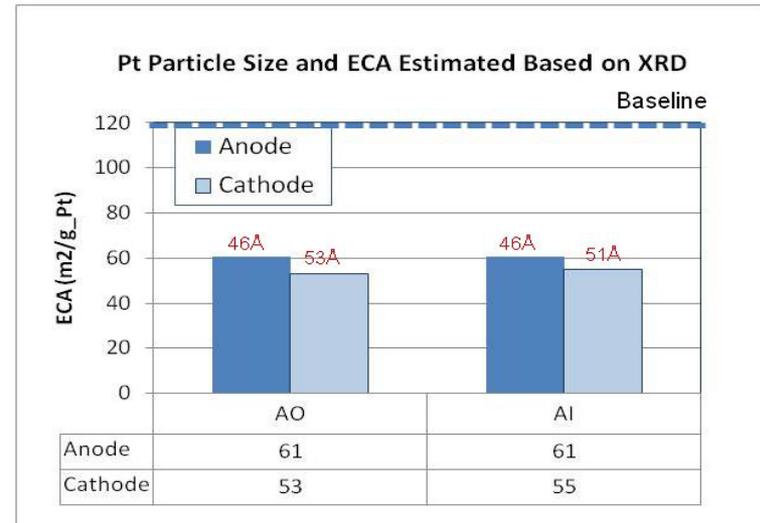
Avg. XRD particle size measurements (ECA calculated) at AO and AI

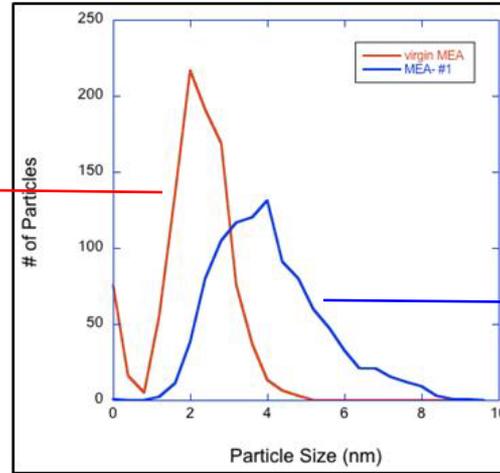
Baseline cathode = ~2nm
2850 hr cathode = ~4nm

TEM results consistent with ECA & XRD analyses

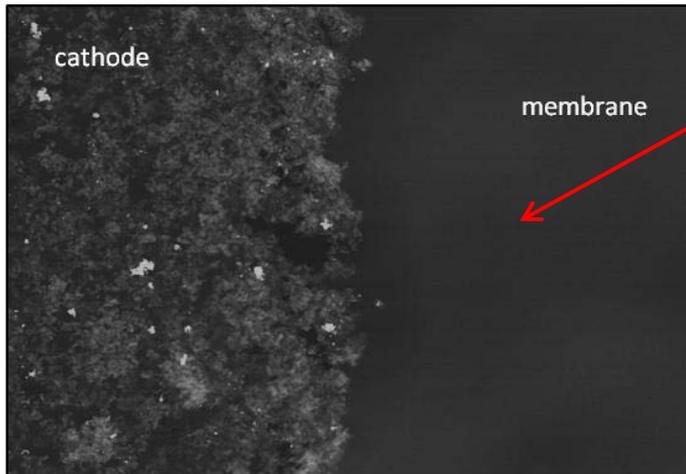
No Pt observed in membrane of virgin MEA

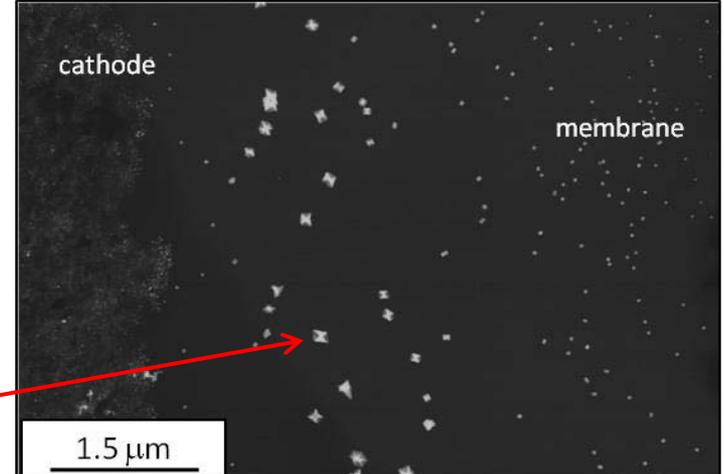
Pt precipitation in cathode membrane

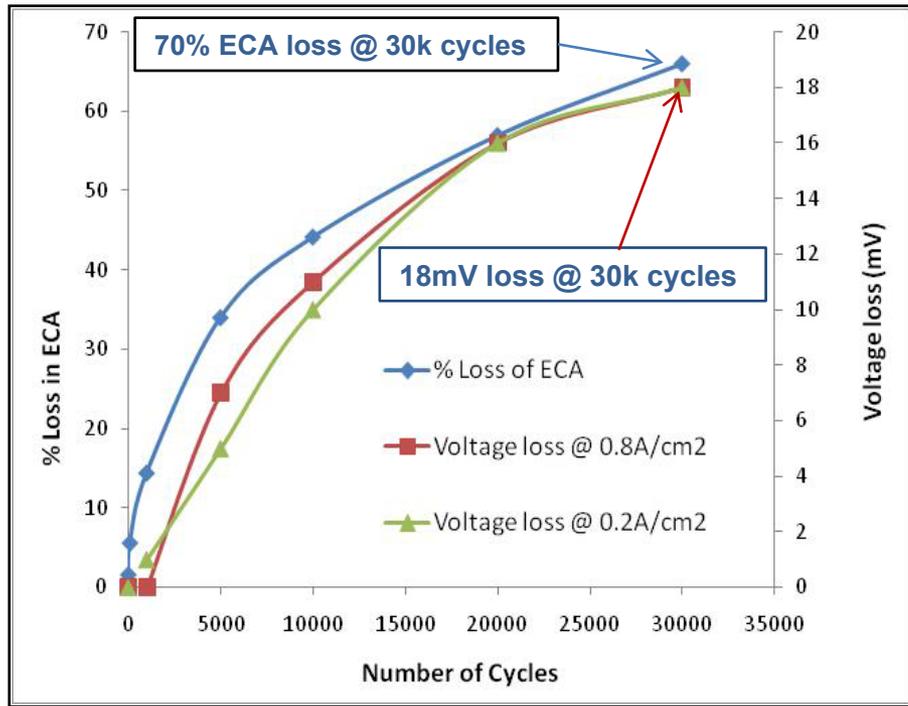
DOE AST#1 – PGM decay

Cycle	Triangle sweep cycle: 50 mV/s between 0.6 V and 1.0 V. Single cell 25-50 cm ²
Number	30,000 cycles
Cycle time	16 s
Temperature	80°C
%RH	Anode/Cathode 100/100%
Fuel/Oxidant	Hydrogen/N ₂ (H ₂ at 200 sccm and N ₂ at 75 sccm for a 50 cm ² cell)
Pressure	Atmospheric pressure

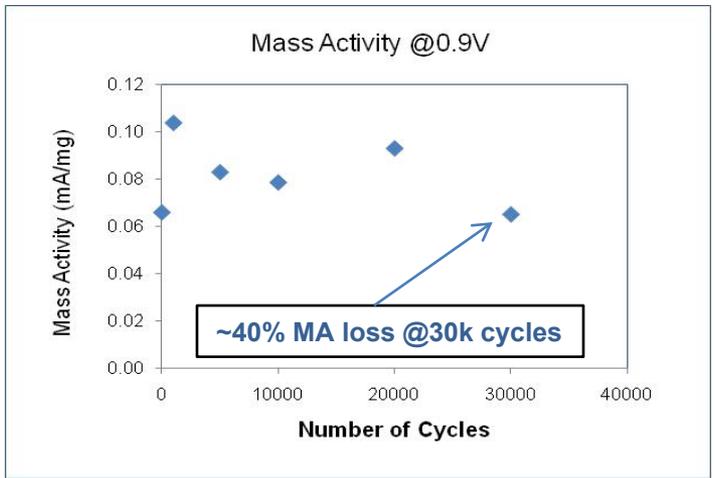
Observed @ 30k cycles	DOE Target @ 30k cycles
~70% ECA loss	≤40% loss of initial area
~18 mV loss @ 0.8 A/cm ²	≤30 mV loss at 0.8 A/cm ²
~40% loss of activity	≤40% loss of activity

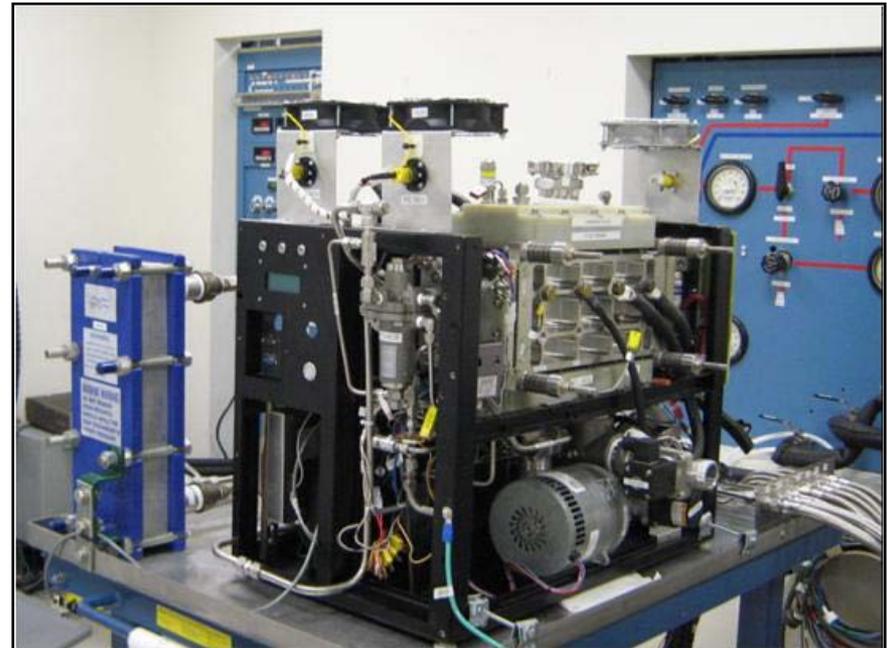
- Modular 5 kW unit (20-cell short stack)
- Equivalent system to bus
- Built-in reactant, coolant, and ventilation control systems
- Built in fuel cell controller, power distribution system

- Installed on test stand – anticipating 4/15 start

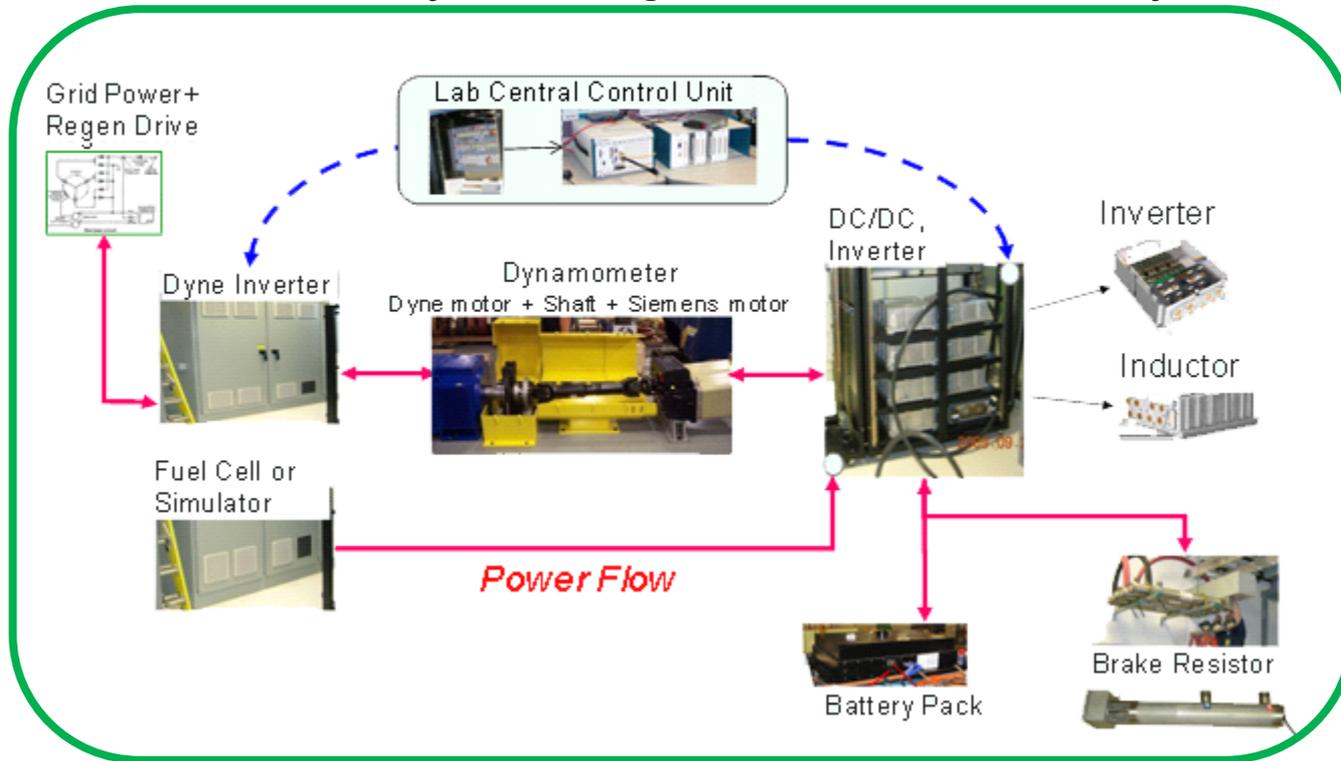
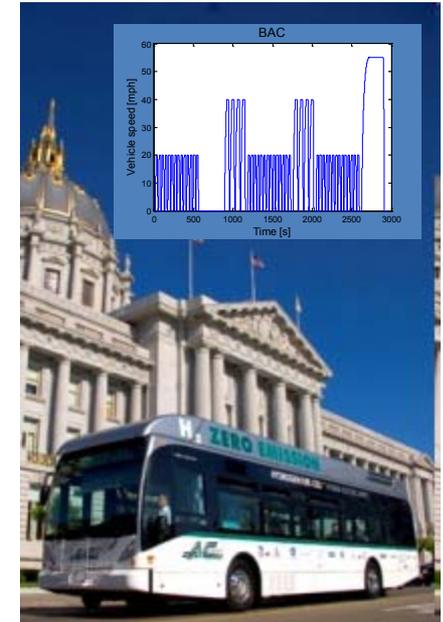
Full Scale Fleet Hybrid Integration and Test Facility

Fuel Cell Hybrid Vehicle (FCHV) integration testing

- Drive-cycle operation
- Power management software / hardware verification
- Comparison with actual fleet data
