# Materials Solutions for Hydrogen Delivery in Pipelines

Secat, Inc.

2010 U.S. DOE Hydrogen Program Annual  
Merit Review and Peer Evaluation Meeting  
Arlington, VA

Project ID – PD047

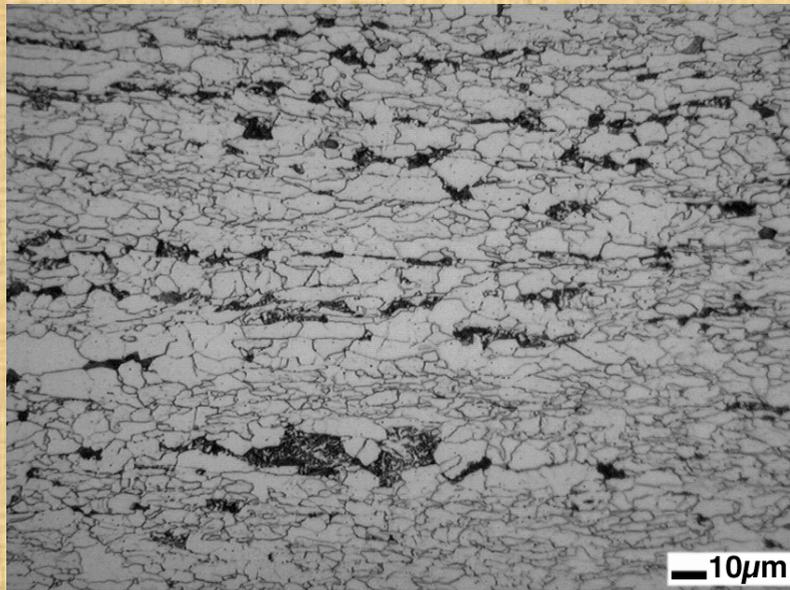
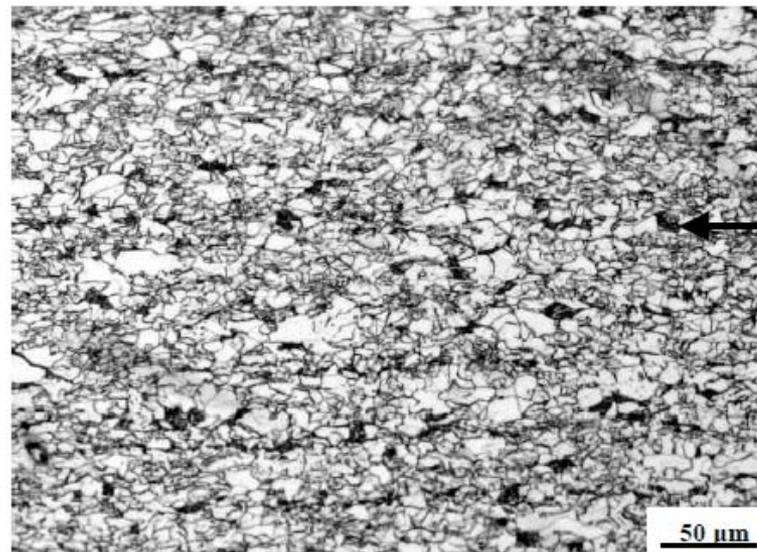
Alloy A (X70) – Polygonal Ferrite/Upper Bainite (Upper Bainite ~ 8%)

Upper Bainite

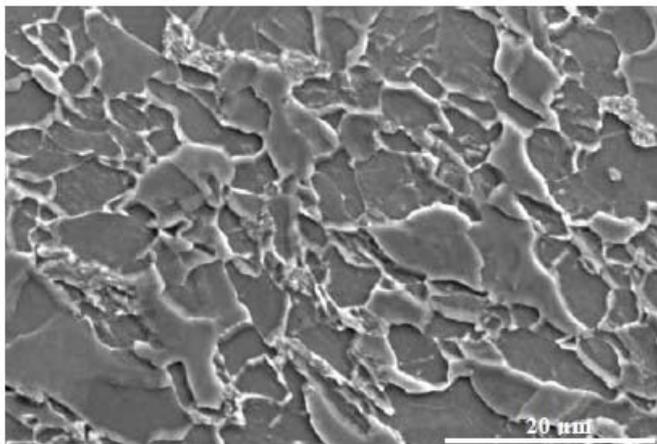
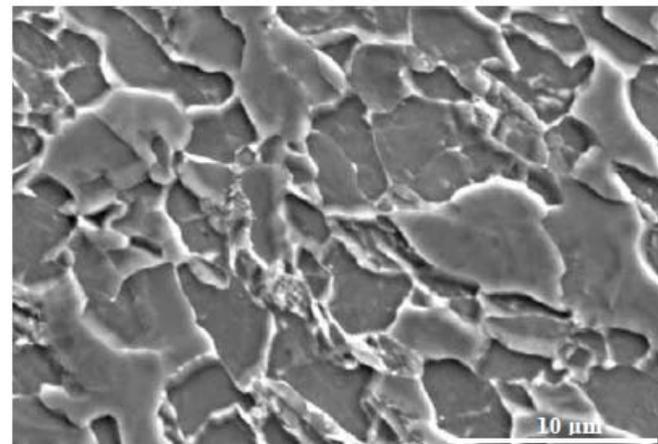
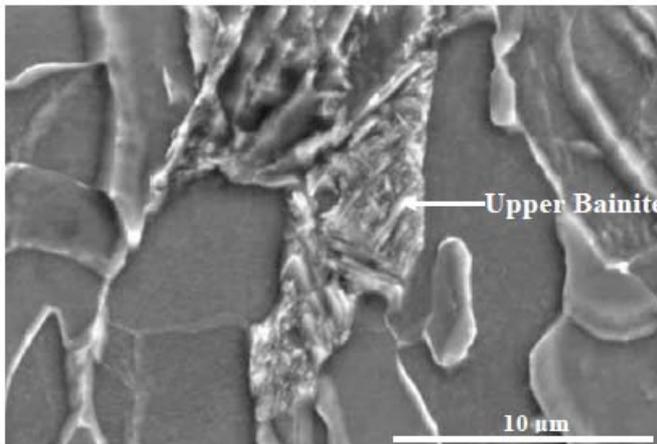
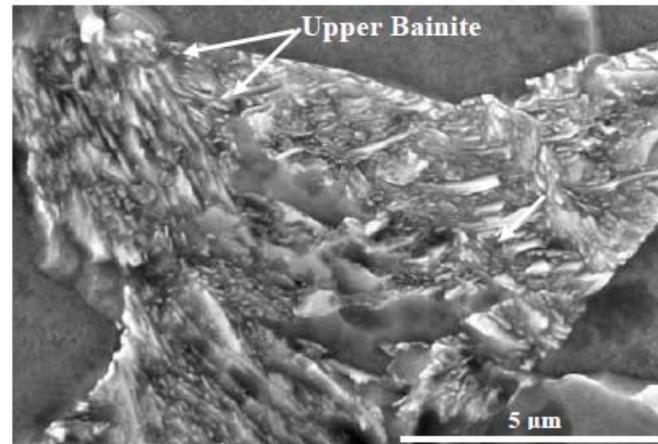
Alloy A (X70) – Polygonal Ferrite/Upper Bainite (Upper Bainite ~ 8%)  
SEM Analysis

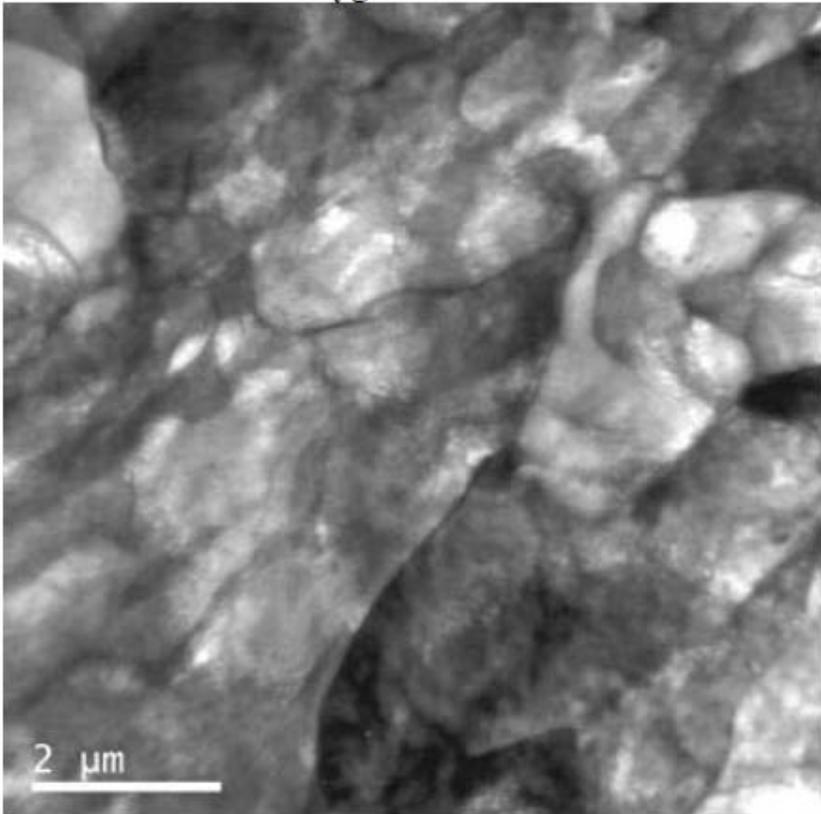
Alloy A (X70) – Polygonal Ferrite/Upper Bainite (Upper Bainite ~ 8%)  
TEM Analysis

Polygonal Ferrite

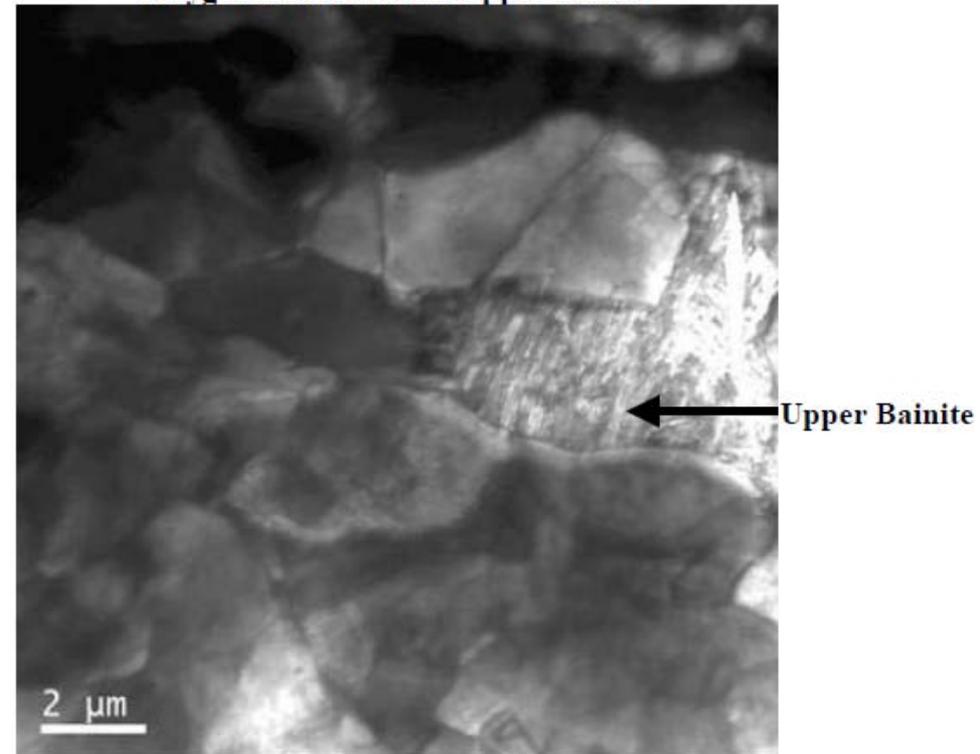
Polygonal Ferrite with Upper Bainite

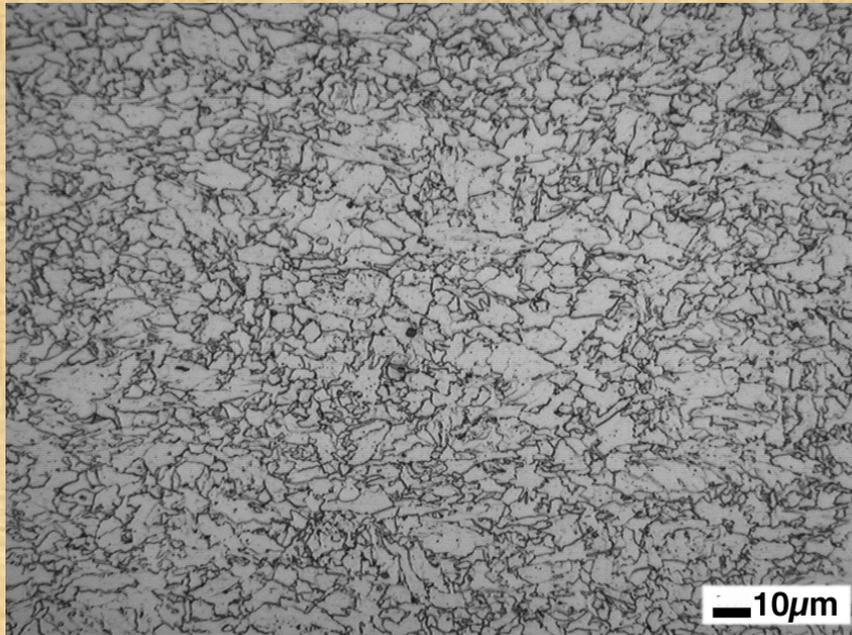
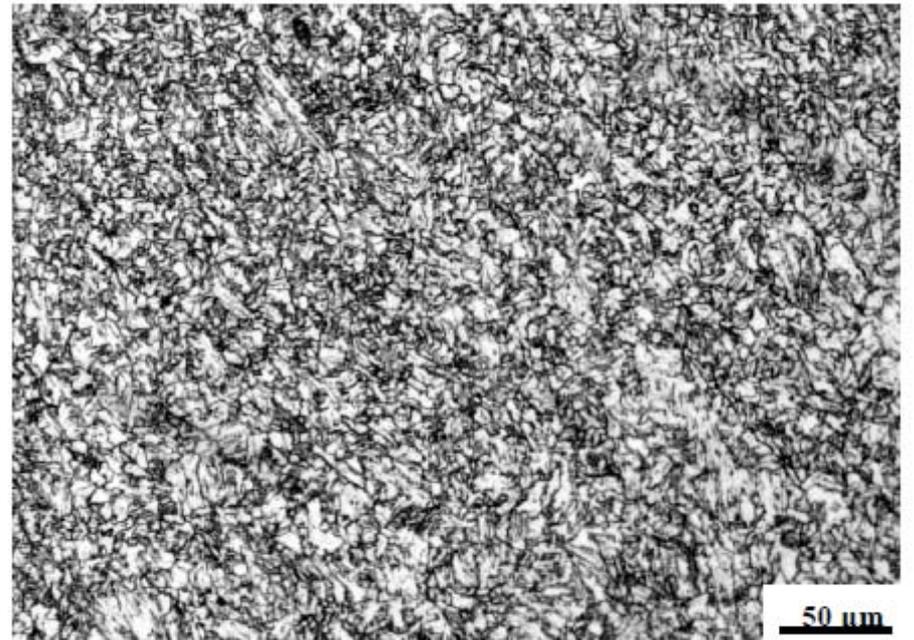
Alloy B (X70/X80) – Polygonal Ferrite/Coarse Acicular Ferrite (type of Bainite) ~ 10%, Optical Light Microscopy

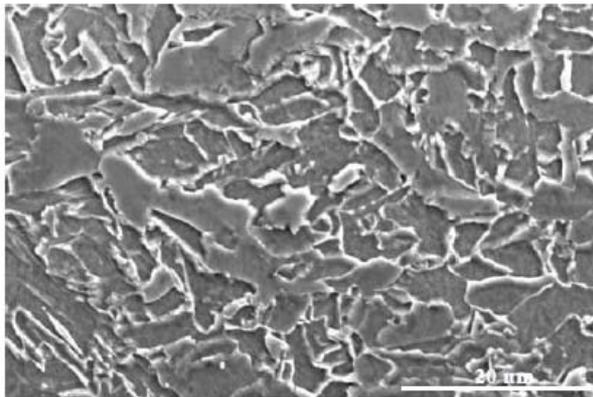
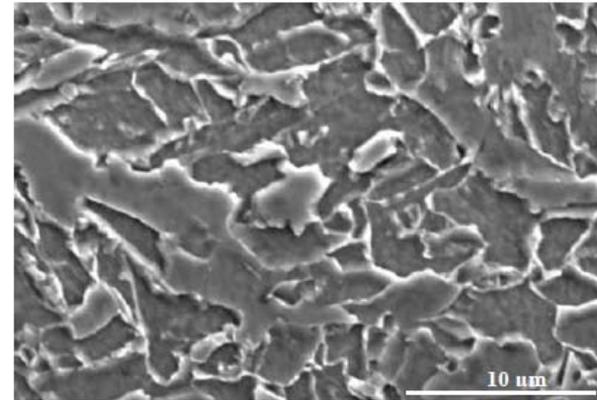
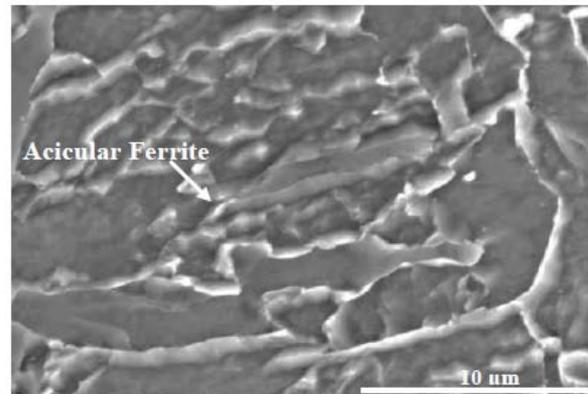
Alloy B (X70/X80) – Polygonal Ferrite/Coarse Acicular Ferrite (type of Bainite) ~ 10%. SEM Analysis

Coarse Acicular Ferrite is more apparent in TEM micrographs

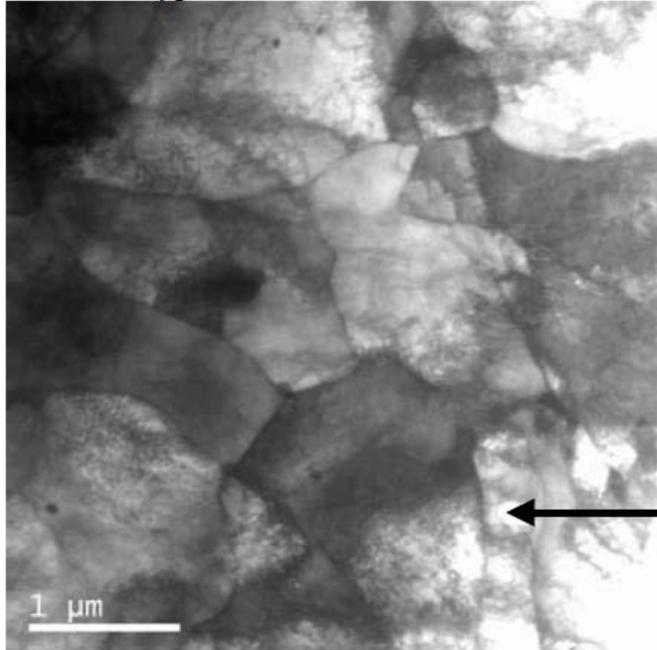
Alloy B (X70/X80) – Polygonal Ferrite/Coarse Acicular Ferrite (type of Bainite) ~ 10%, TEM Analysis

Polygonal Ferrite + Acicular Ferrite

← Acicular Ferrite

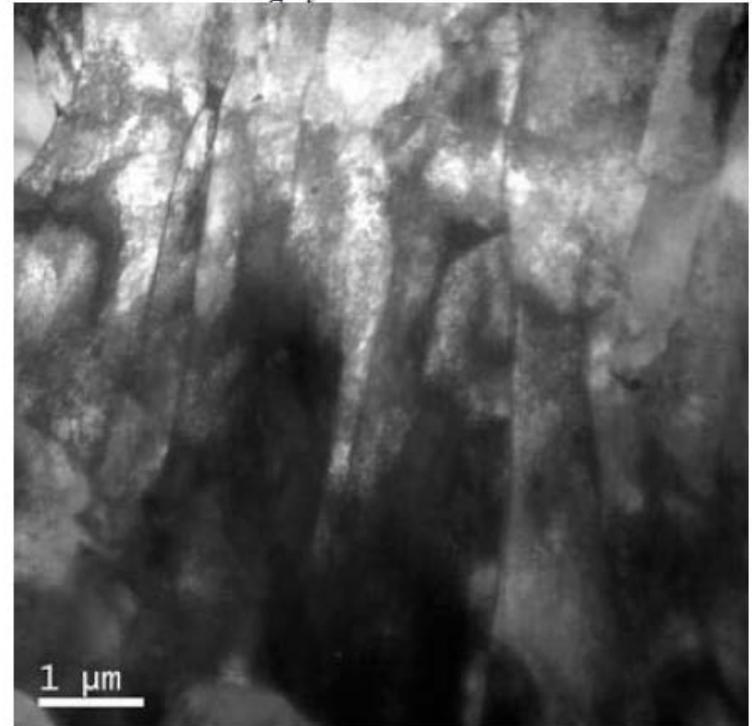
Largely Acicular Ferrite

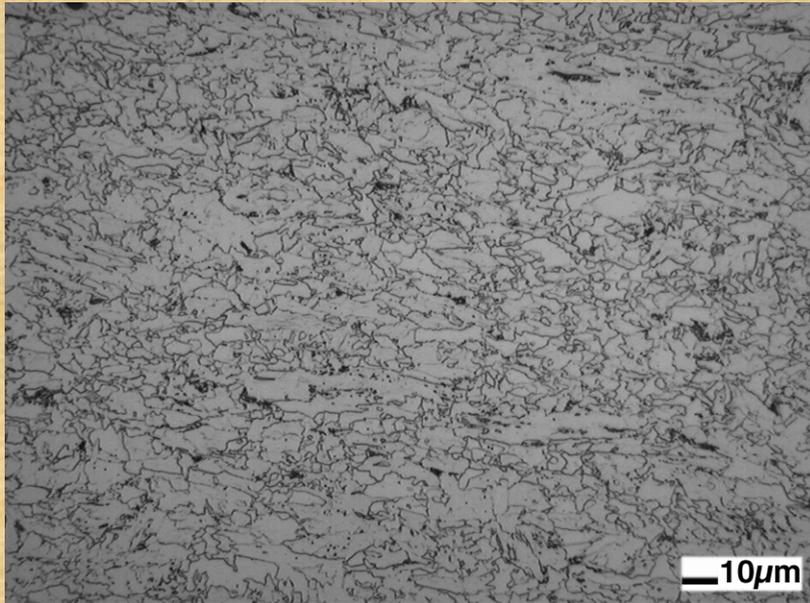
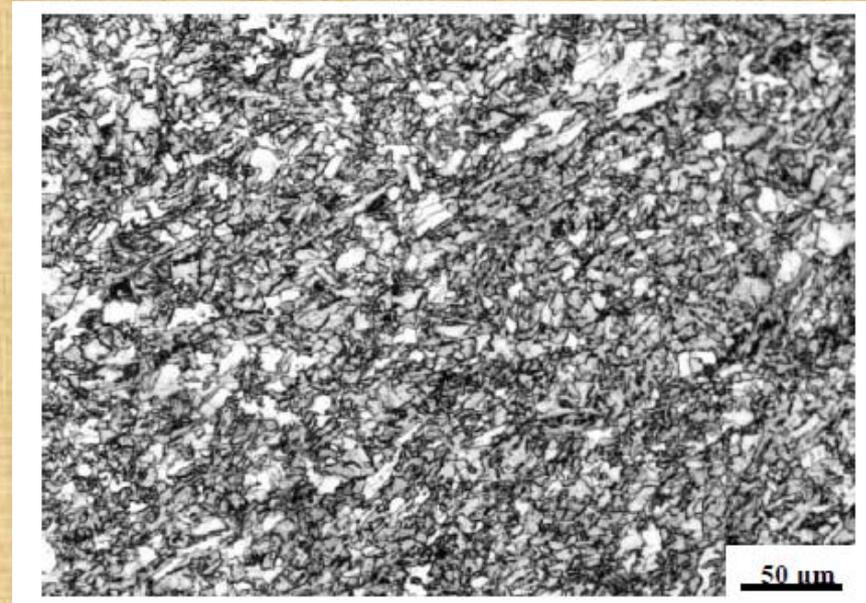
**Alloy C (X70/X80) – Polygonal Ferrite/Coarse Acicular Ferrite (type of Bainite), plus Upper Bainite ~ 10%, Optical Light Microscopy**

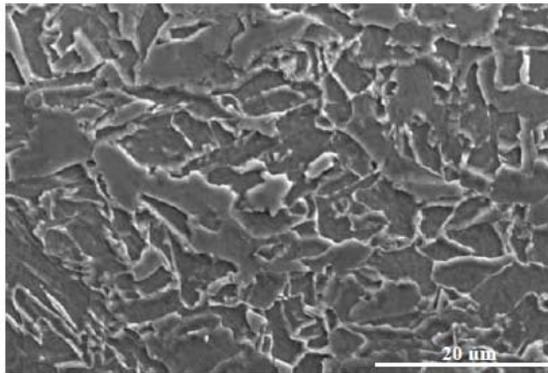
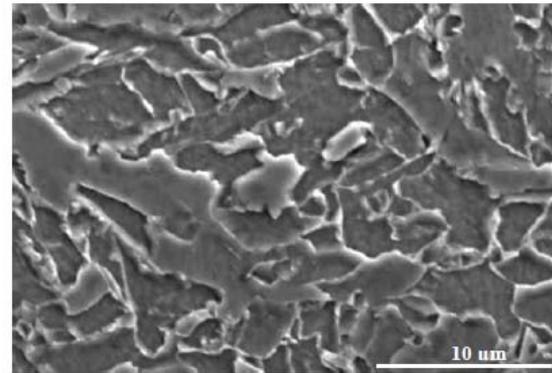
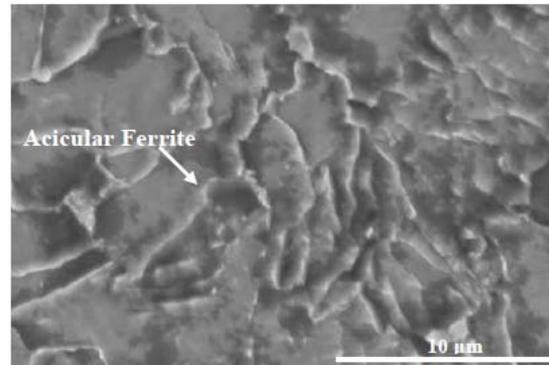
Alloy C (X70/X80) – Polygonal Ferrite/Coarse Acicular Ferrite (type of Bainite), plus Upper Bainite ~ 10%, SEM Analysis

Coarse Acicular Ferrite is more apparent in TEM micrographs

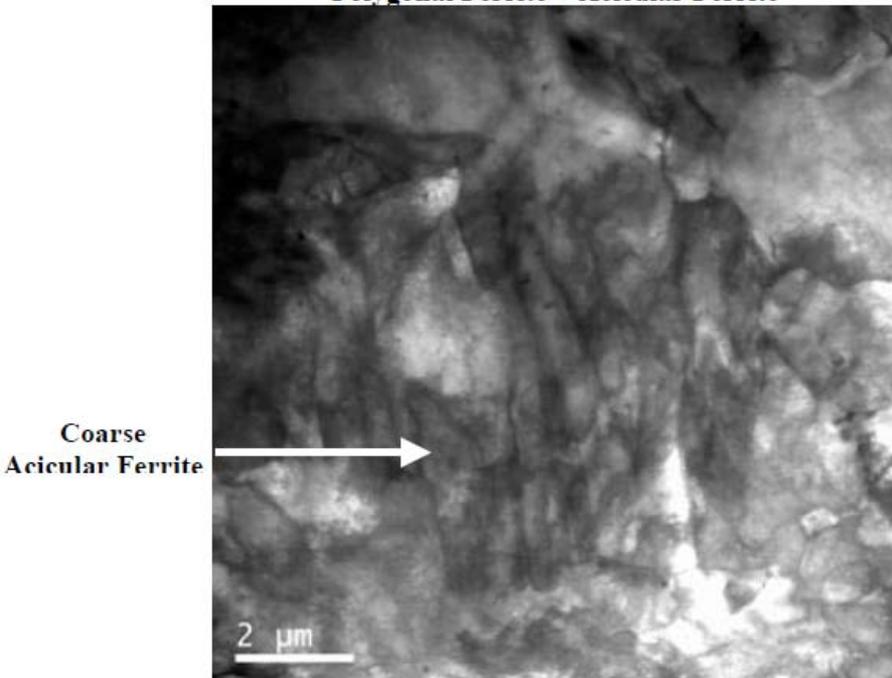
Alloy C (X70/X80) – Polygonal Ferrite/Coarse Acicular Ferrite (type of Bainite), plus Upper Bainite ~ 10%, TEM Analysis

Polygonal Ferrite + Acicular Ferrite

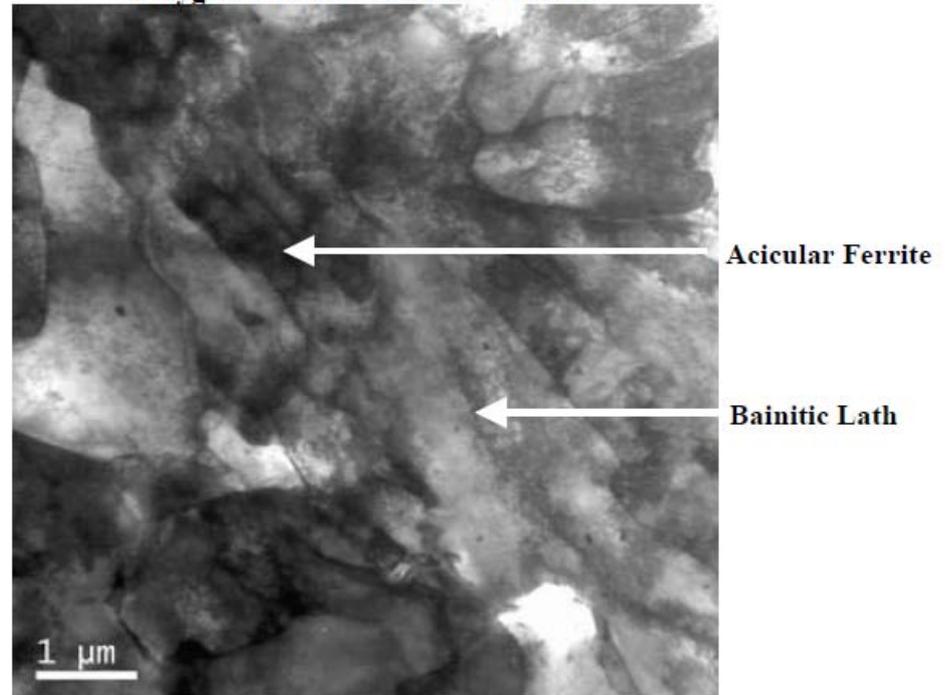
Polygonal Ferrite + Acicular Ferrite

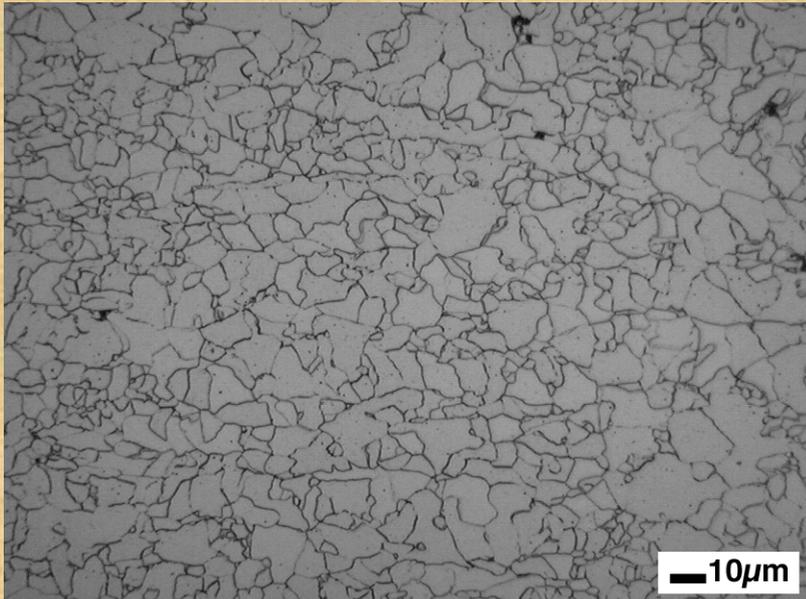
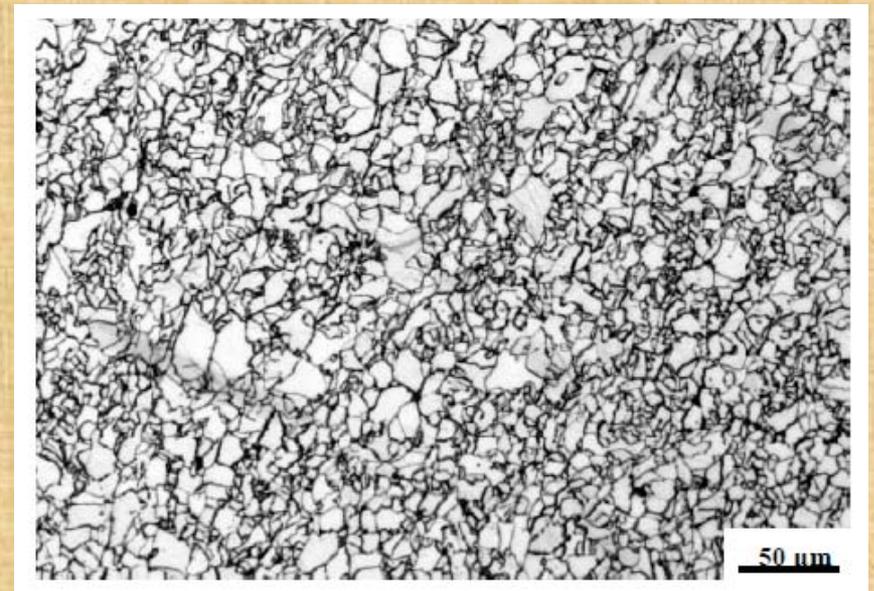
Alloy D (X52/X60 HIC) – Polygonal Ferrite – 100%  
Optical Light Microscopy

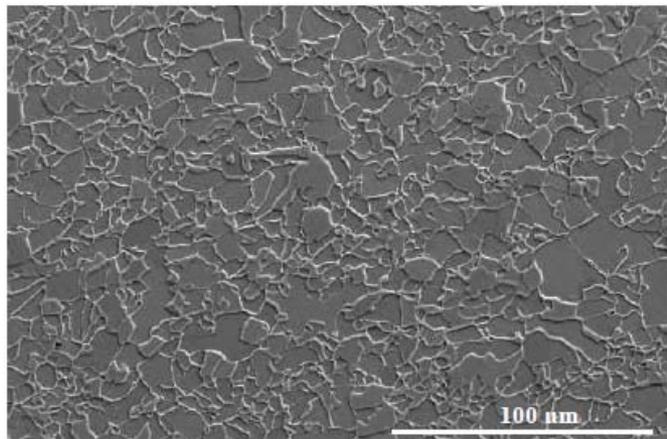
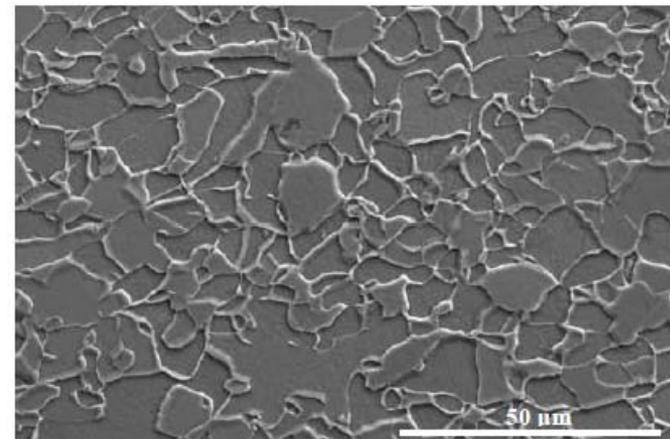
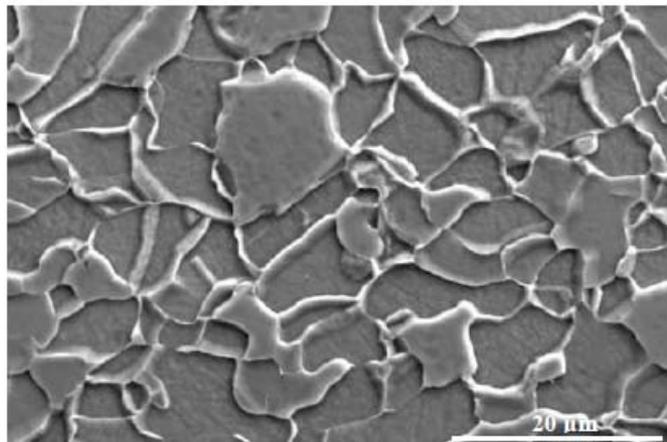
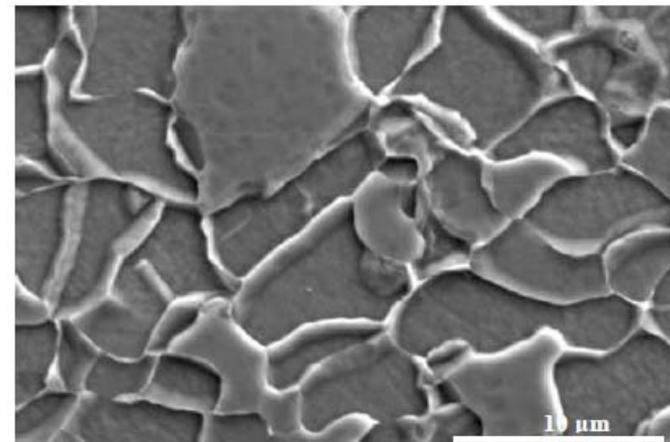
Alloy D (X52/X60 HIC) – Polygonal Ferrite – 100%

## SEM Analysis

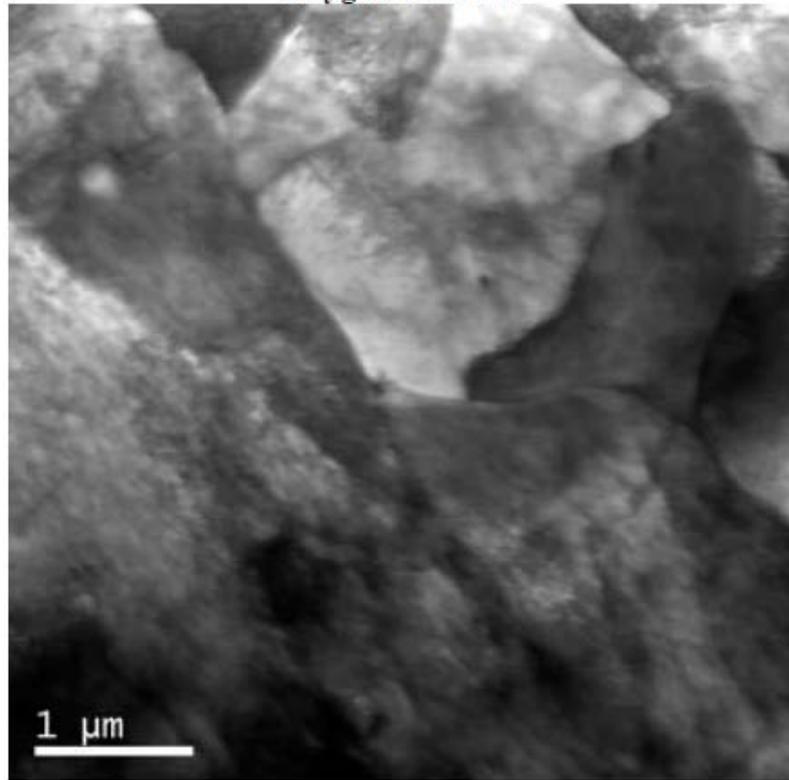
Alloy D (X52/X60 HIC) – Polygonal Ferrite - 100%  
TEM Analysis

Polygonal Ferrite

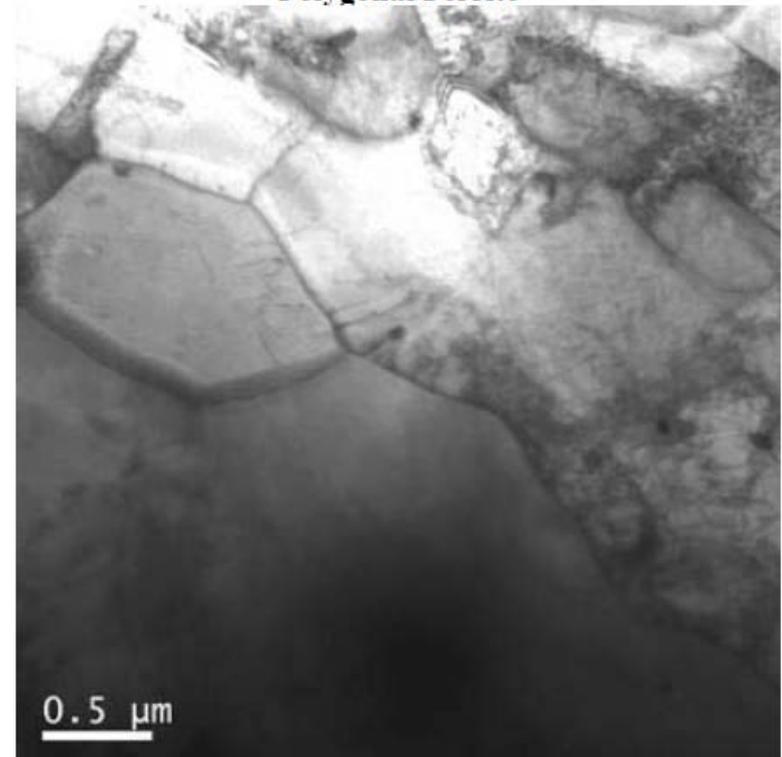
Polygonal Ferrite

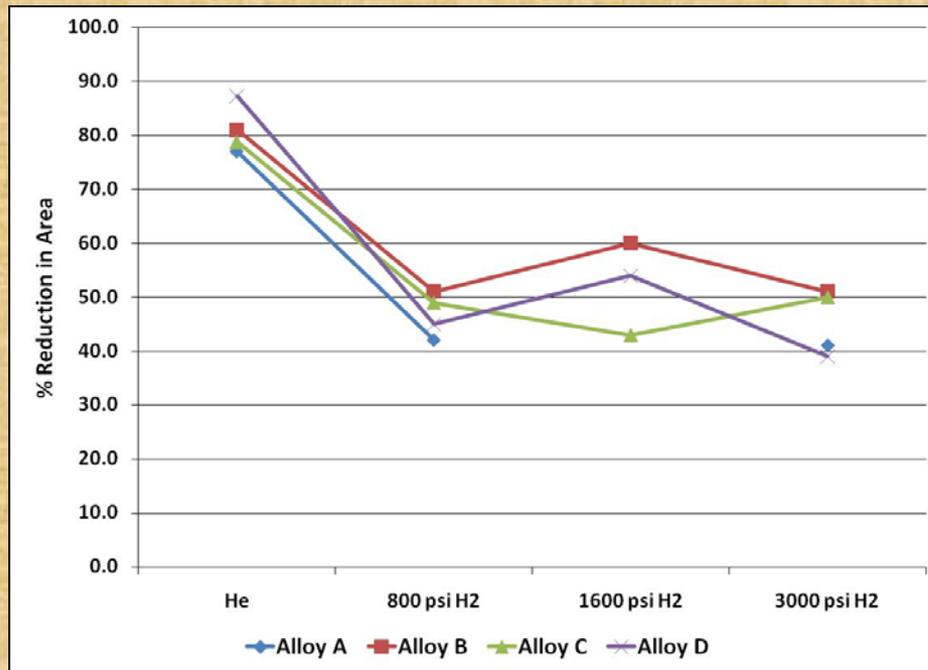
# Technical Accomplishments – *In-situ* Tensile Testing Results in Gaseous Helium and Hydrogen

## Reduction in Area, $10^{-4}$

- Increasing pressure appears to decrease resistance to hydrogen effect. There maybe a potential threshold pressure for a given microstructure.
- Effect of strain rate and hydrogen pressure is complex and maybe dependent on microstructure.
- Even though there are changes to the reduction in area and fracture toughness how much change is required to deem a microstructure not suitable for service?
- Even though the polygonal ferrite/coarse acicular ferrite microstructure appears to perform the best, does this mean that the other microstructures would not be suitable for service?
- What is the effect of the actual oxide surface layer that is produced in the production of steels? Will it improve the test results? To what magnitude?

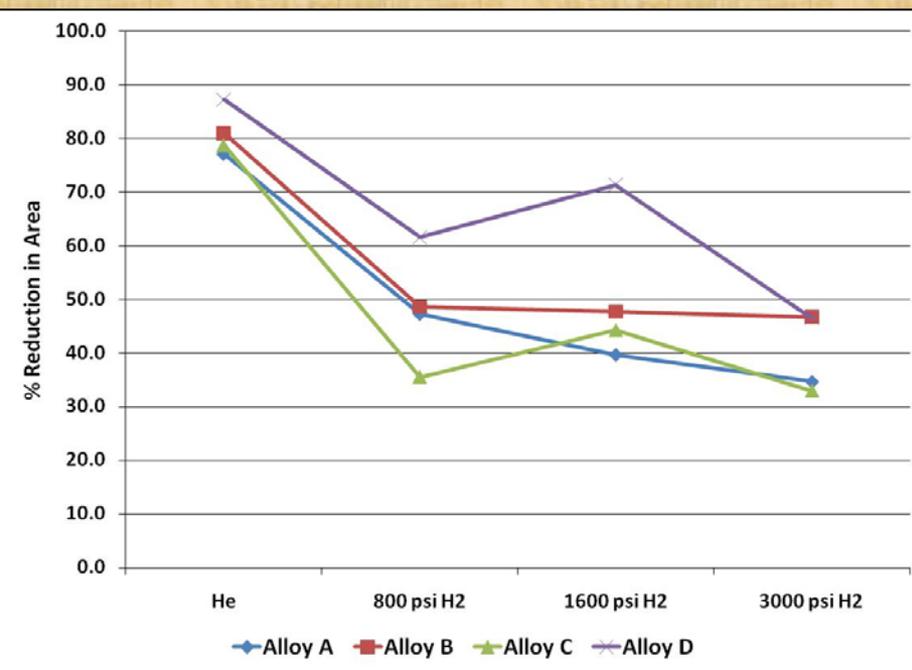
## Reduction in Area, $10^{-5}$

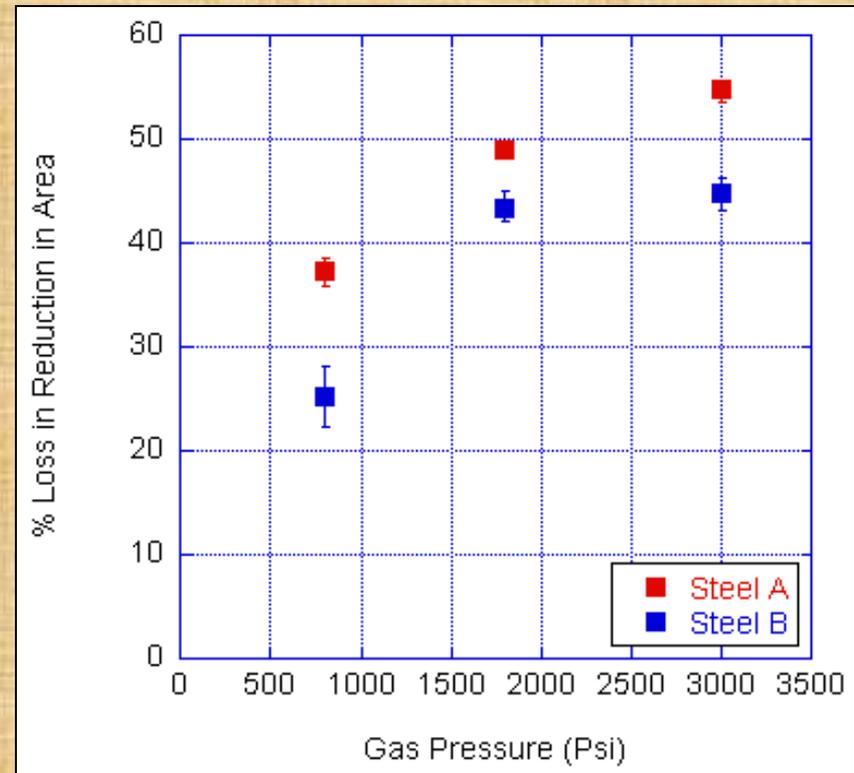
# Technical Accomplishments - Additional Statistical Tensile Tests Performed on Steels A and B

% Loss in Reduction in area is defined as

$$\left( \frac{\%RA(He) - \%RA(H_2)}{\%RA(He)} \right) * 100$$

Observed % loss in RA is lower for Steel B at all pressures

•Pre-yield Strain rate =  $1 \times 10^{-5}$ /sec

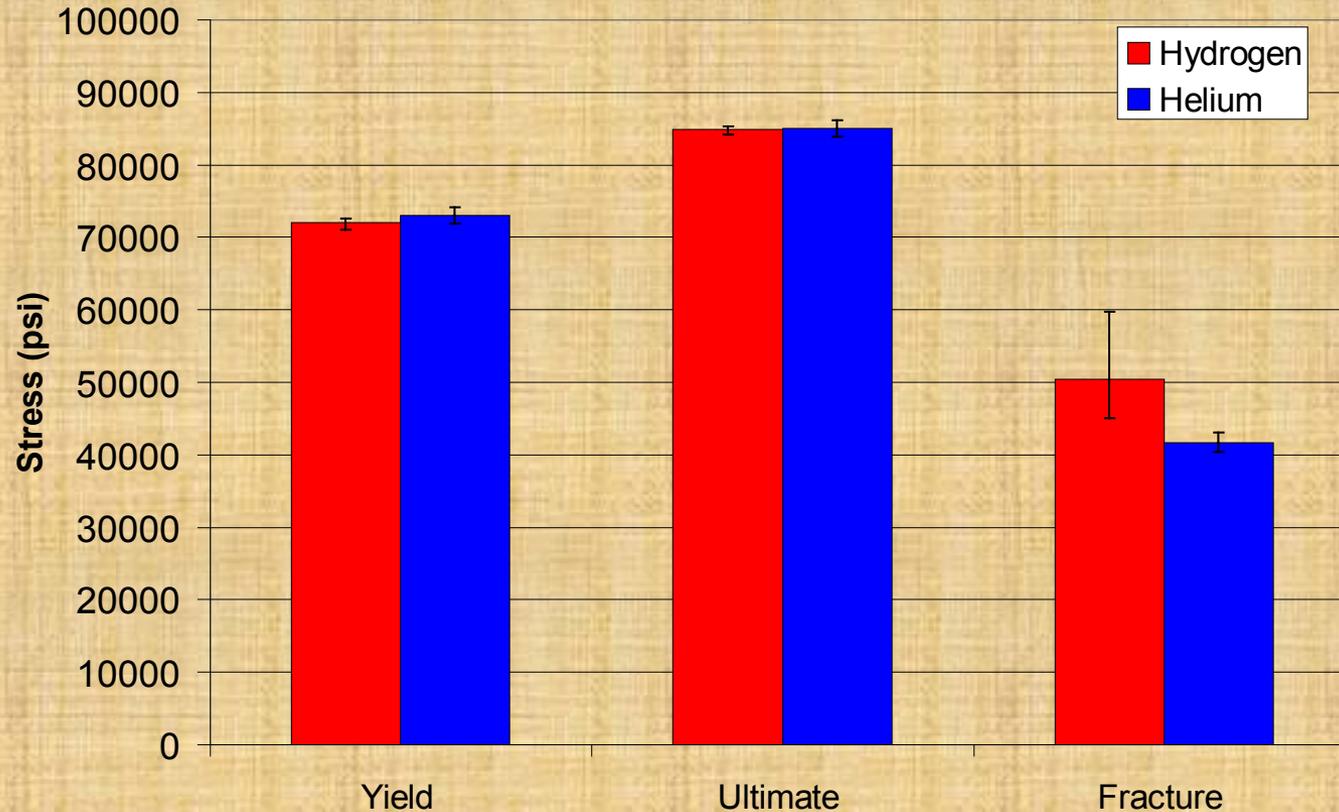
# Technical Accomplishments - Yield and Ultimate Strength Alloy B Not Affected by Hydrogen

- Fracture stress is affected by the presence of hydrogen

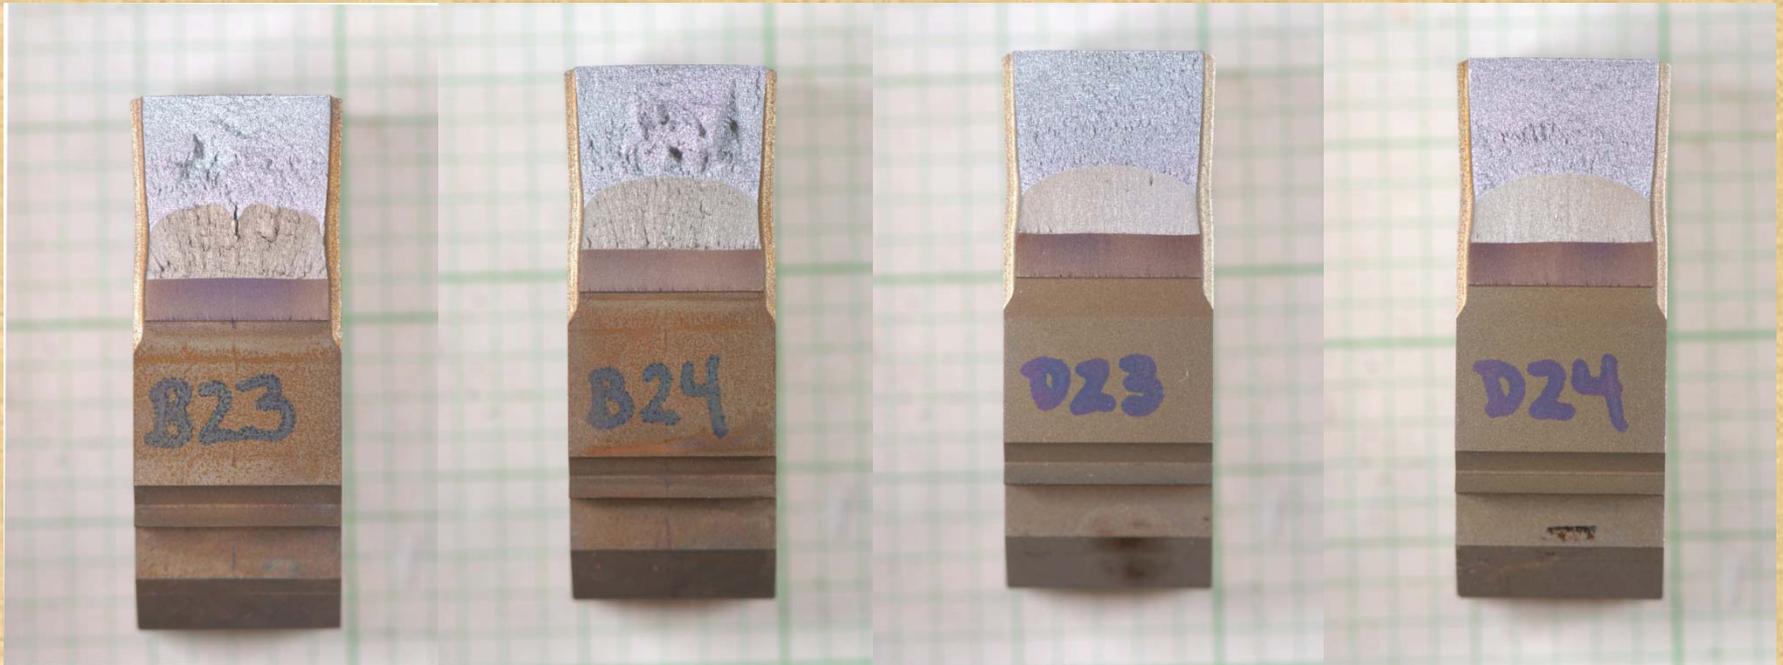
# Technical Accomplishments - Fracture Toughness Test Results – Alloy B and D, 800 psi

- Note separation in Alloy B23 fracture.
- Maybe related to microstructural banding of chemically segregated centerline.

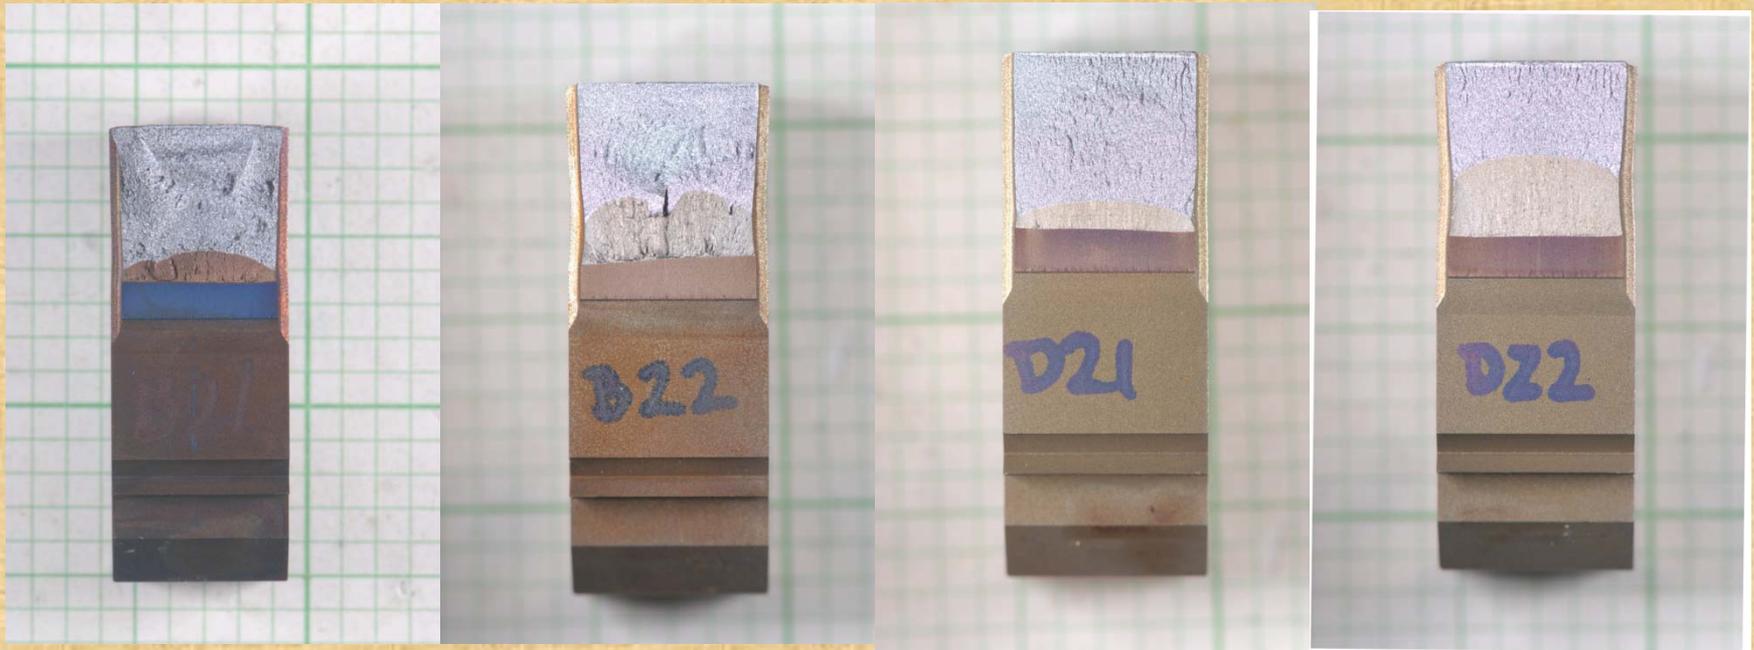
# Technical Accomplishments - Fracture Toughness Test Results – Alloy B and D, 3000 psi

•Note separation in Alloy B22 fracture.  
Maybe related to microstructural banding  
of chemically segregated centerline.

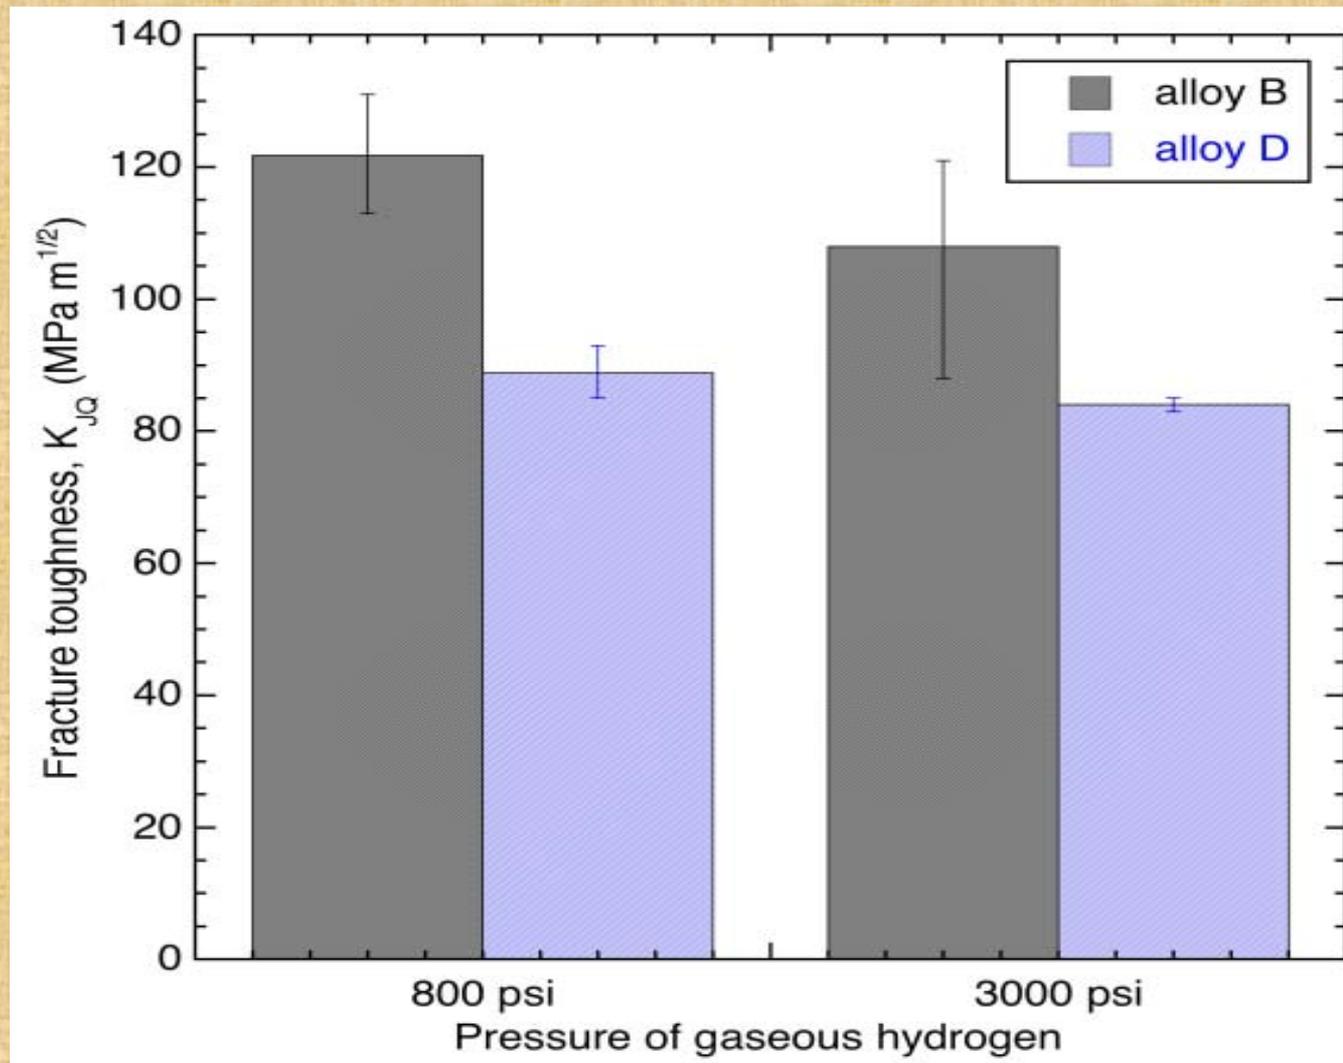
# Technical Accomplishments - Fracture Toughness Test Results – Alloy's B and D, $K_{JIC}$ vs. Pressure, Average Values

- Increasing yield strength **does not** appear to necessarily result in decreased fracture toughness due to the effect of hydrogen in the 800-3000 psi pressure range tested. Microstructure dependent. This may be different than what others have reported at higher pressures.

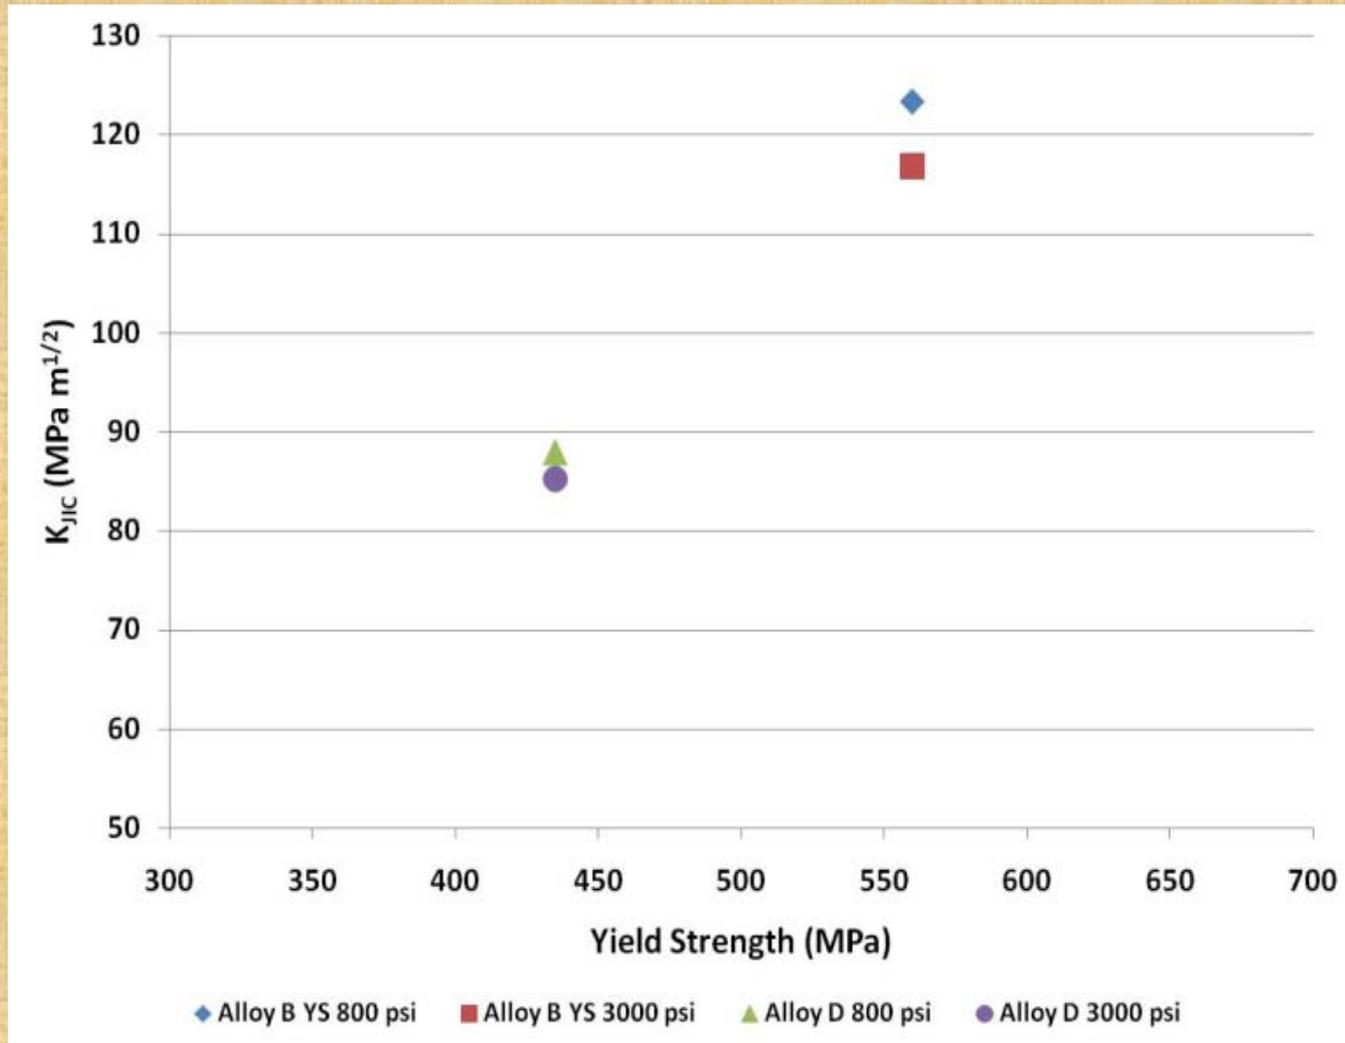
# Technical Accomplishments - Fracture Toughness Test Results – Alloy's B and D, $K_{JIC}$ vs. Actual Yield Strength, Average Values

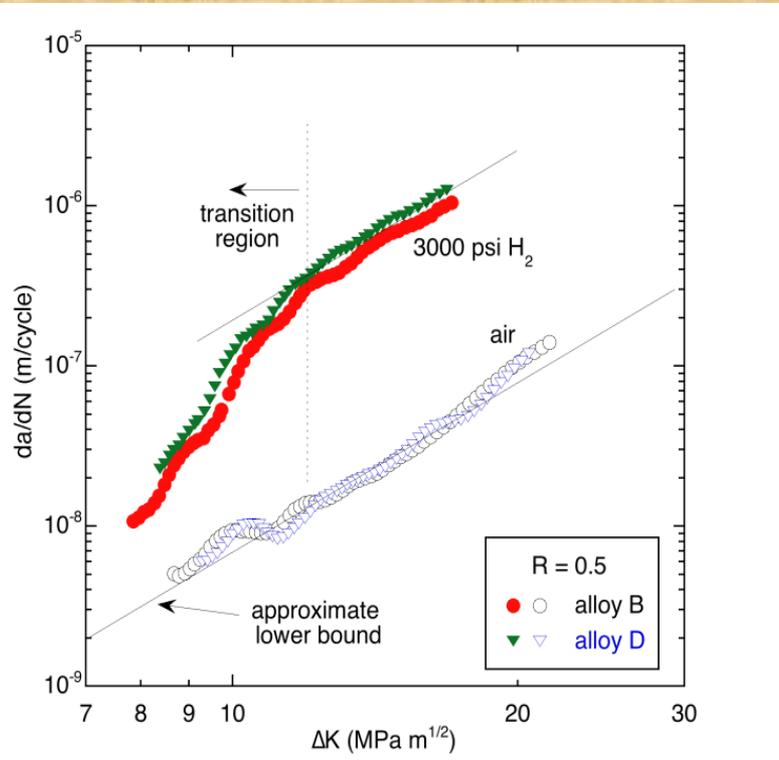
## FATIGUE CRACK GROWTH OF ALLOY B AND ALLOY D IN GASEOUS HYDROGEN AT PRESSURE OF 3000 PSI, COMPARED TO FATIGUE IN AIR

- R-ratio values of 0.1 and 0.5 performed similarly in the fatigue testing for the two microstructures tested.
- At relatively high  $\Delta K$  ( $>12$  MPa m<sup>1/2</sup>) the FCGR is about 20 times greater than air, however at lower  $\Delta K$  the FCGR starts to converge for both air and H<sub>2</sub>.

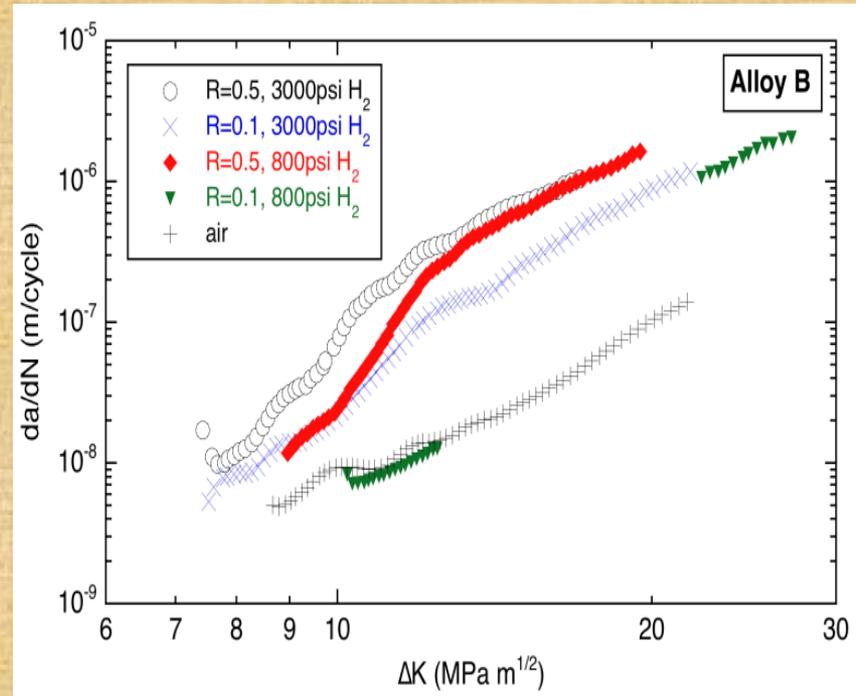
## MEASURED FATIGUE CRACK GROWTH RATES FOR ALLOY B
