# 700 bar Hydrogen Dispenser Hose Reliability Improvement

**National Renewable Energy Laboratory  
DOE 2016 Annual Merit Review  
June 9, 2016**

**Project ID  
PD100**

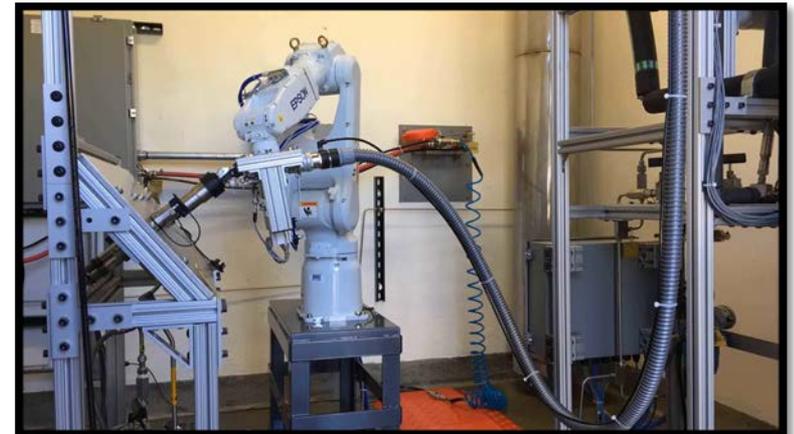
- By working closely with the original equipment manufacturers, the hose reliability project aims to improve the reliability and thus reduce the cost of 700 bar hydrogen refueling hose assemblies by identifying points of failure.
- NREL has designed a high-cycling test apparatus that unifies the four stresses to which the hose is subjected (Pressure, Temperature, Time and Mechanical) to reveal the compounding impacts of high volume FCEV refueling will be revealed.
- The work includes performing physical and chemical analysis on pre- and post-cycled hose material to understand any relative changes in its bulk properties and possible degradation mechanisms.

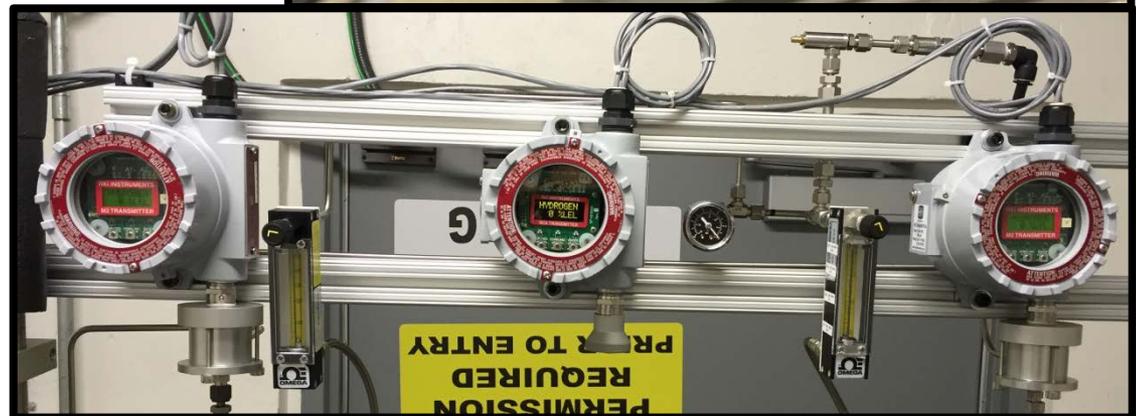
- Vacuum pump sampling system installed on crimp fittings
- Constant flow 400 mL/min around hose crimp fittings through hydrogen detectors

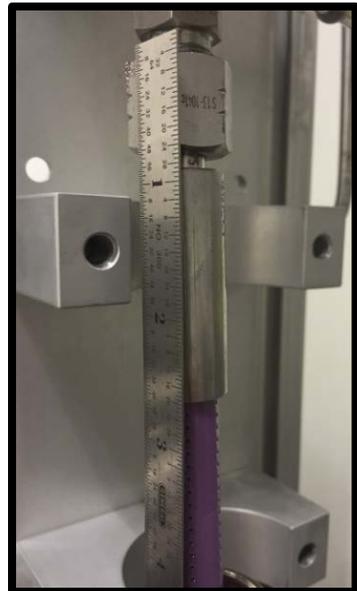
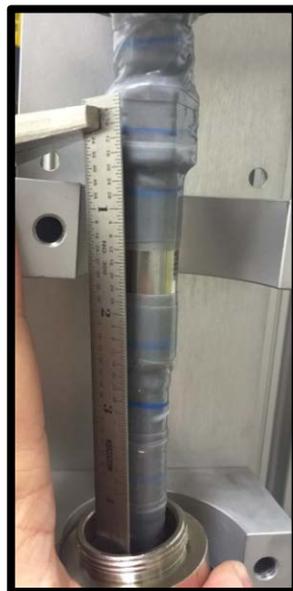
- Handheld detectors confirmed leak from vicinity of hose end at dispenser but not exact location
- Hydrogen detection tape installed over hose crimps, metal fittings and secondary leak sources (valves)
- Comparison photographs after several leaking cycles may show exactly where leak occurs

**Chemochromic tape that darkens when exposed to hydrogen leaks.  
- Provided by Element One, Inc.**

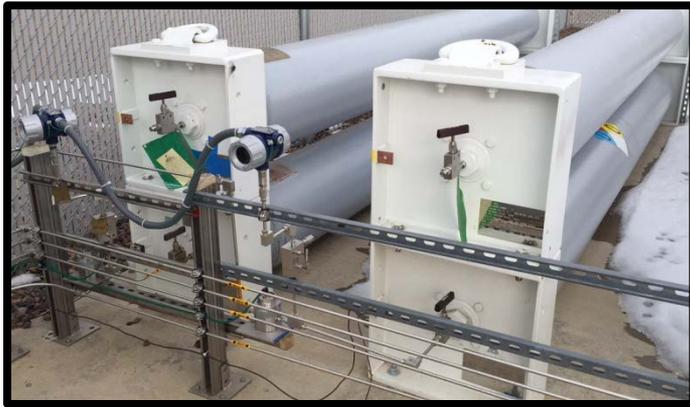
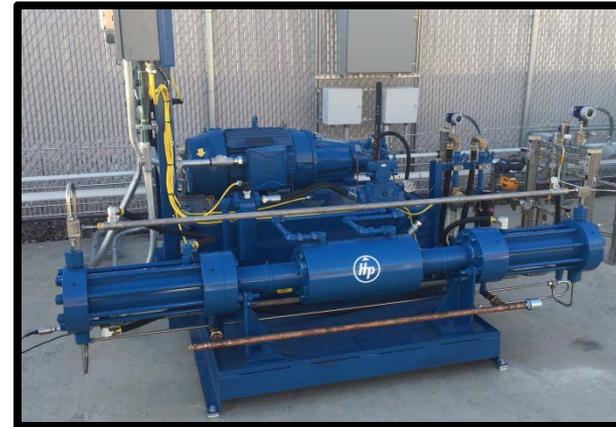
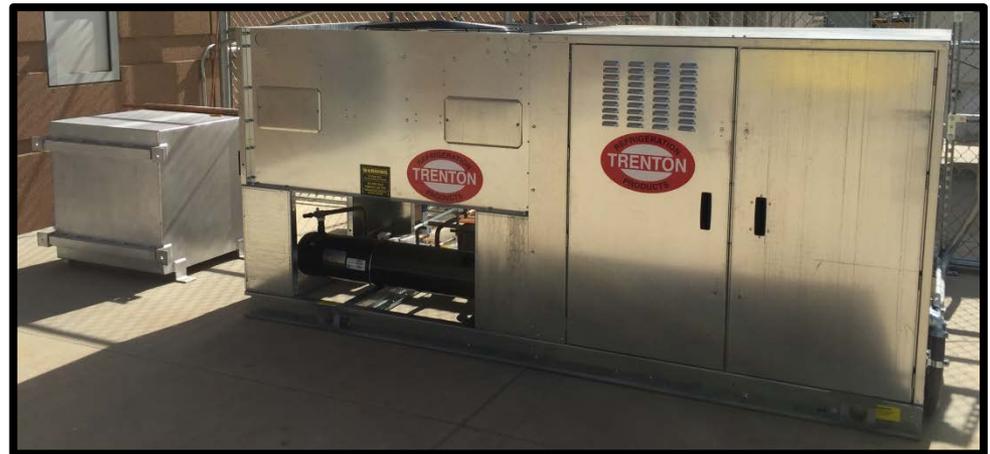
- Additional high pressure storage tanks – 32 kg @ 875 bar (Total 60 kg)
- High pressure compressor – up to 20 kg/hr to 875 bar

- 16 hp chiller and heat exchanger – will provide  $-40^{\circ}\text{C}$  at hose with higher flow
- Together, the station upgrades allow for increased cycle rate, higher target pressure, higher flow rates and less downtime due to shared projects

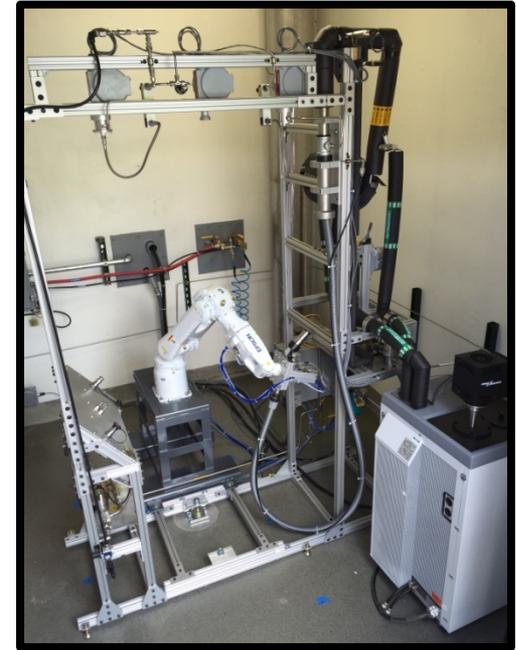
- **Epson six-axis robot installed and programmed with realistic human motions from ‘dispenser’ to receptacles – total distance ~3 feet**
- **Double receptacle system to provide options for greater randomization of paths from dispenser**
- **High repeatability, over torque tripping capability, anchored frame and calibration help reduce stresses on nozzle and receptacle**
  - Focus on crimped hose end connections and their ability to remain sealed under bending/twisting stress while cold.
  - Nozzle and other components are replaced as needed if they wear out.
