# 700 Bar Hydrogen Dispenser Hose Reliability Improvement

National Renewable Energy Laboratory

DOE 2017 Annual Merit Review

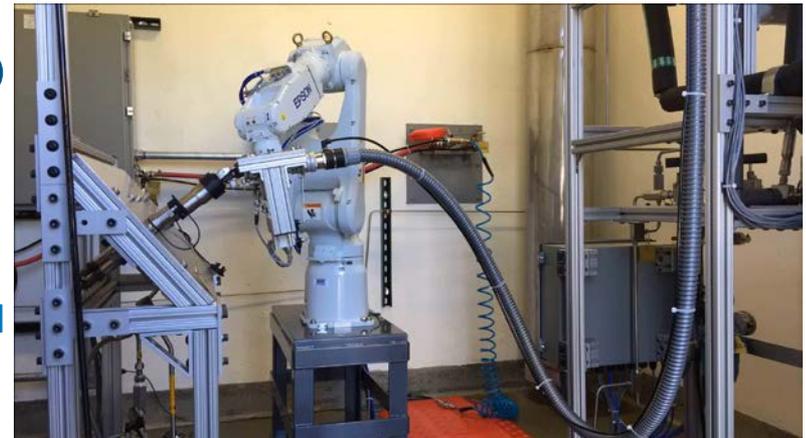
- By working closely with the original equipment manufacturers, the hose reliability project aims to improve the reliability and thus reduce the cost of 700 bar hydrogen refueling hose assemblies by identifying points of failure.
- NREL has designed a high-cycling test apparatus that unifies the four stresses to which the hose is subjected (Pressure, Temperature, Time and Mechanical) to reveal the compounding impacts of high volume FCEV refueling will be revealed.
- The work includes performing physical and chemical analysis on pre- and post-cycled hose material to understand any relative changes in its bulk properties and possible degradation mechanisms.

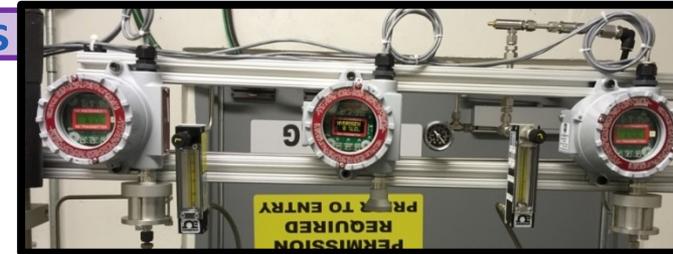
- ‘Dispenser’ subsystem based on commercial dispensers
- Tankless flow control for low-mass, pre-cooled cycles
- Active leak sampling at hose interconnections

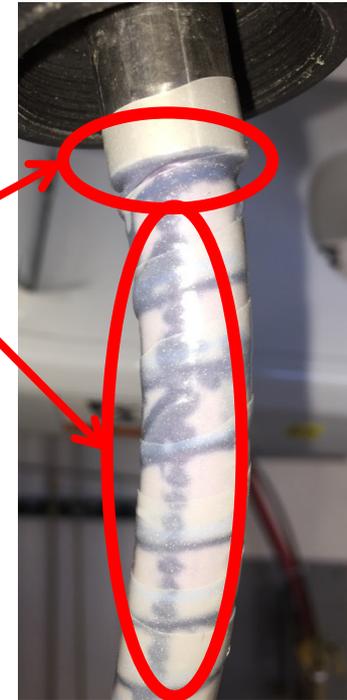
## After – 1000 cycles

-**Indication** seen on edge of hose crimp. May be due to gap between tape and fitting.  
-**Clear indications** seen on hose outer layer pinpricks at the nozzle-end crimp, around hose circumference  
-No visible physical damage observed on hose surfaces, including at crimp fitting  
-No indications on metal fitting leak detection ports

- Pinpricks designed to relieve pressure between outer and inner layer

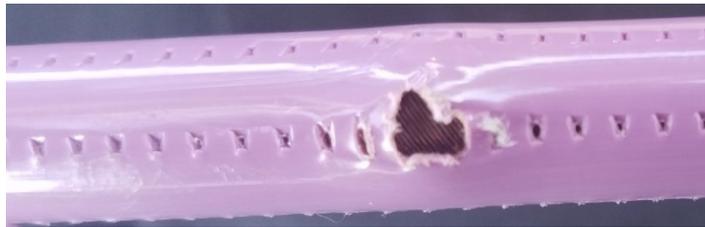
- 1-year old hose below failed at 1700+ cycles at 12-18” from nozzle.
- Wire braiding intact, indicating pinhole leaks instead of large rupture

- Similar failure seen on another hose at 1000+ cycles, official cause blamed on silicon dioxide and metal dust
  - Bubbles/occlusions in outer layer reported on some hoses
  - Crimp fitting leaks that fail pressure holds are still much more common than through-wall leaks
  - Replacement time reported at about 700 cycles for one operator
- **California station operators have requested we share data and findings with them, particularly interested in any evidence of damage to inner layer from internal dust particle or external wear from wire braiding**

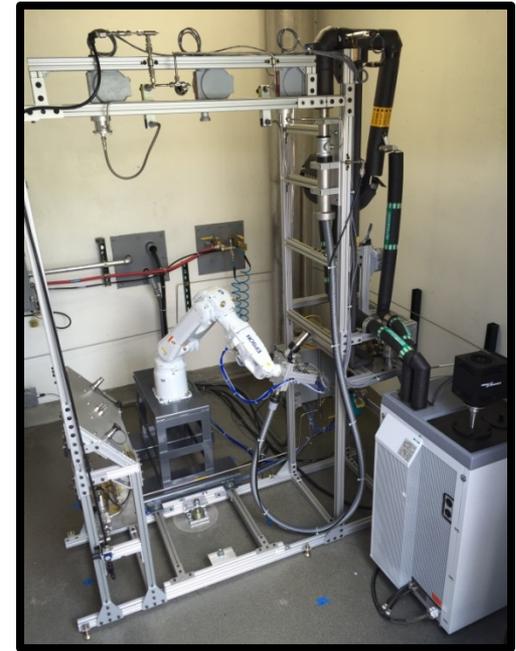
- **Epson six-axis robot installed and programmed with realistic human motions from ‘dispenser’ to receptacles – total distance ~3 feet**
- **Double receptacle system to provide options for greater randomization of paths from dispenser**
- **High repeatability, over torque tripping capability, anchored frame and calibration help reduce stresses on nozzle and receptacle**
  - Focus on crimped hose end connections and their ability to remain sealed under bending/twisting stress while cold.
  - Nozzle and other components are replaced as needed if they wear out.

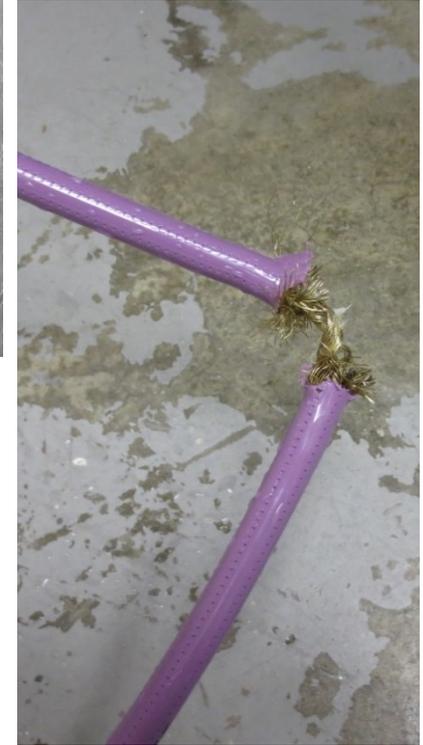
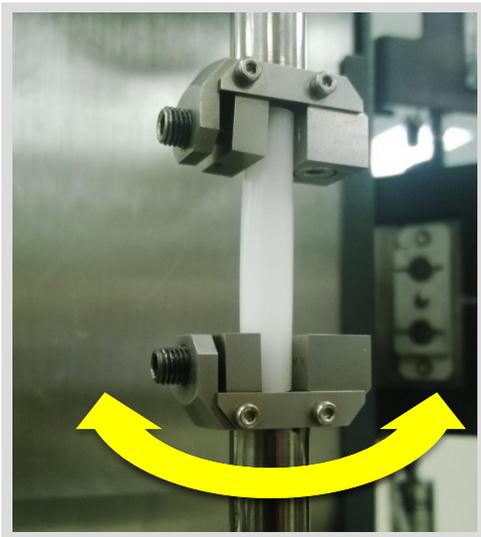
SEM imaging

- Physical – hydraulic bursting (SNL), rheology, scanning electron microscopy
- Chemical – FTIR, DSC, XDS, XPS, TGA
