Fuel Cell Powered Airport Ground Support Equipment MT011

Hydrogen Cargo Tractor Fleet

Zero Emission Airport Ground Support Equipment

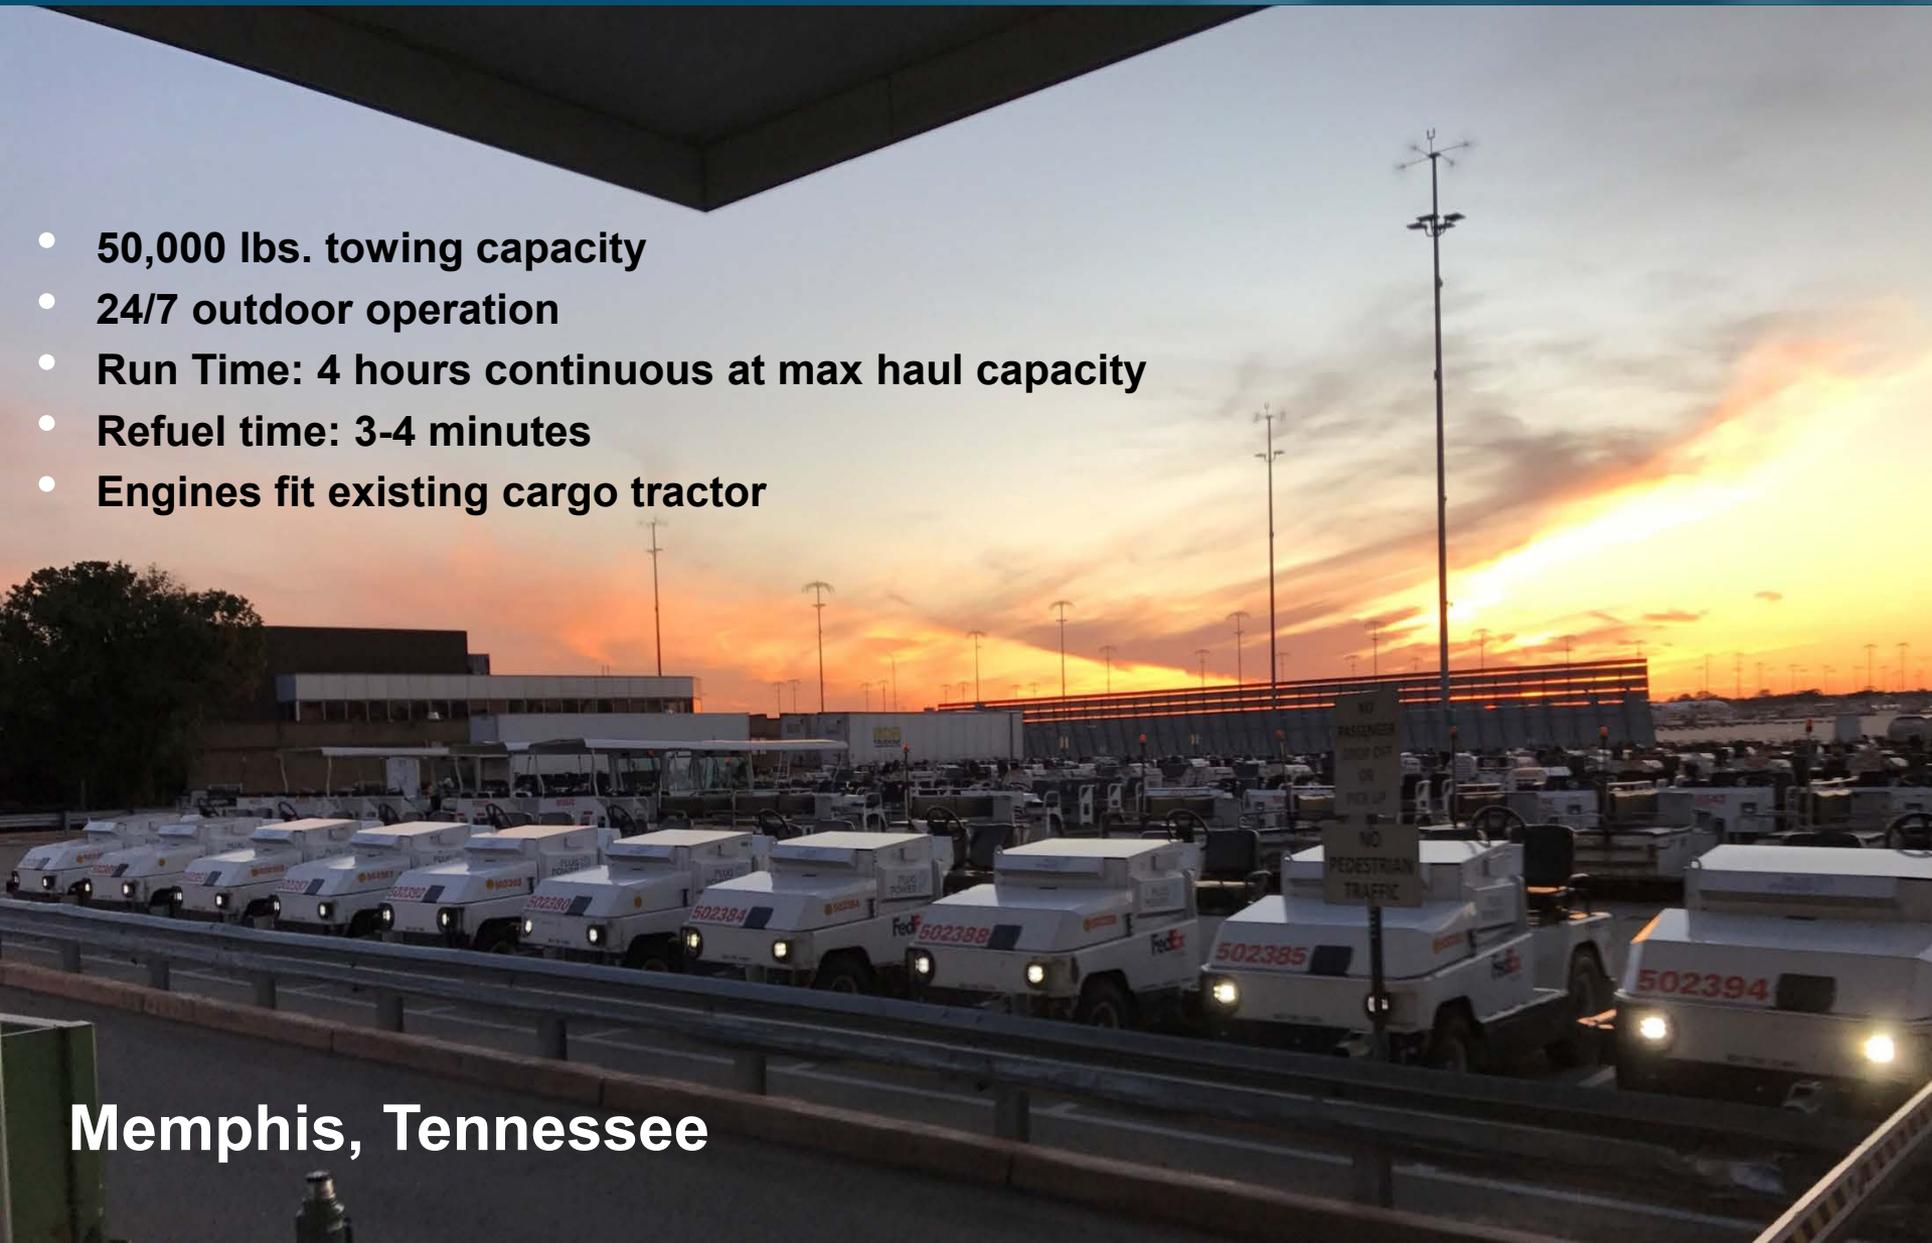
- 50,000 lbs. towing capacity
- 24/7 outdoor operation
- Run Time: 4 hours continuous at max haul capacity
- Refuel time: 3-4 minutes
- Engines fit existing cargo tractor

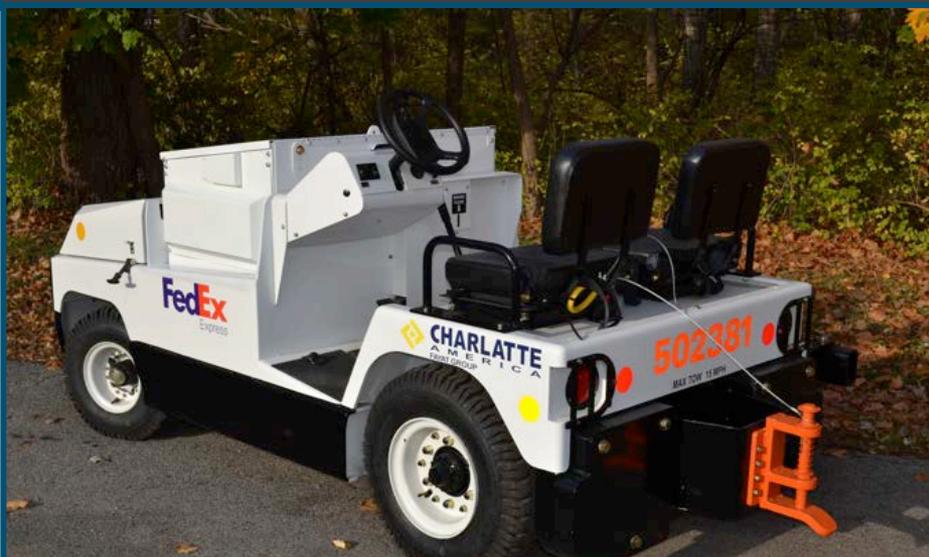
FedEx Express has deployed a fleet of **hydrogen fuel cell** cargo tractors at Memphis SuperHub

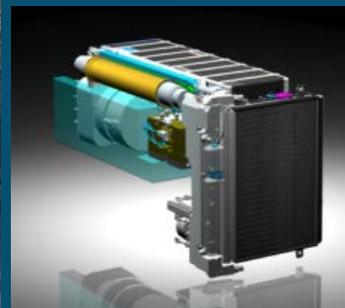
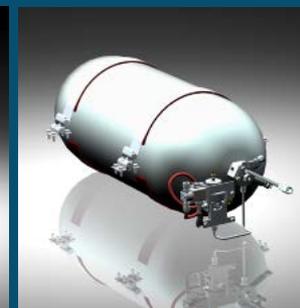
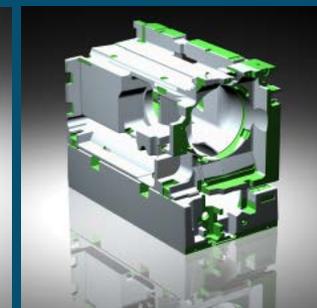
Fuel Cell System Architecture

Power:
Fuel Cell /
Li-Ion Battery

Energy
Storage:
H2 Tank

Tractor
Traction:
Ballast

- Towing Capacity: 50,000 lbs.
- Voltage: 80VDC
- Power: 22 kW
- 100% Outdoor Operation
- Energy Storage: ~54 kWh (3.6 kg H2)
- Hybrid PEM FC / Li-Ion Battery
- 4,000 lbs. for traction

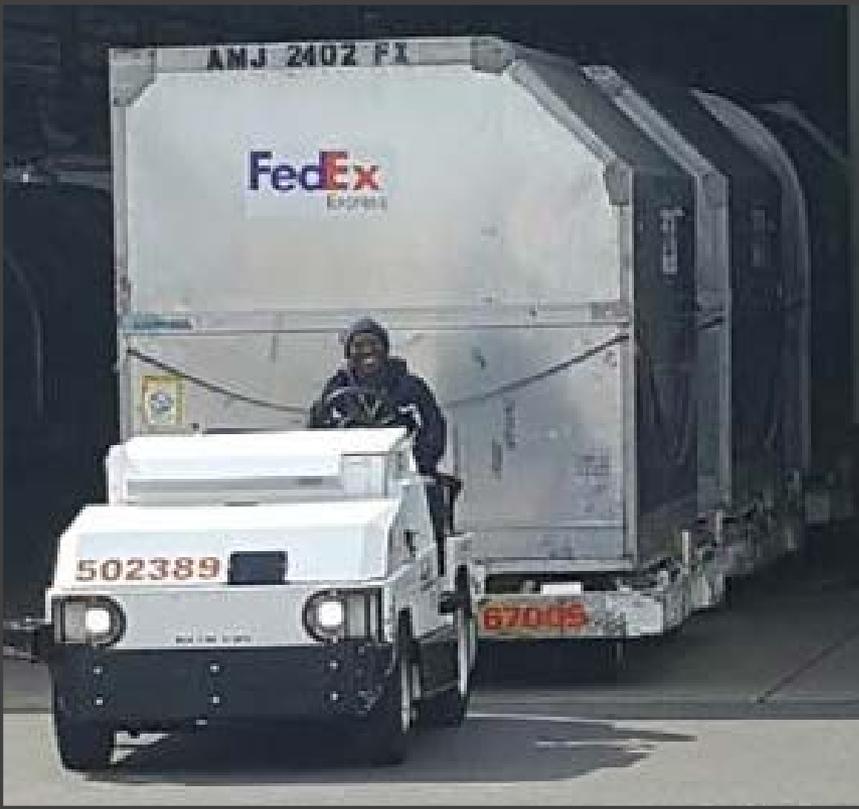
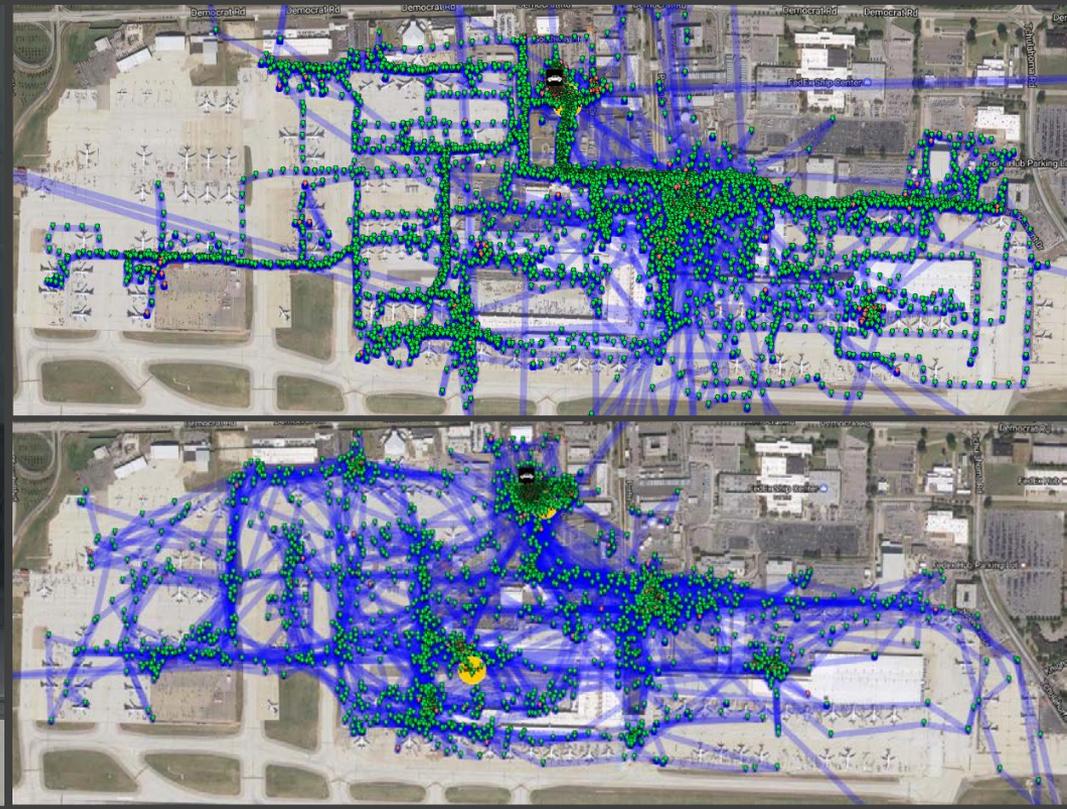
Experience in Toughest Domestic Airport

- Capable: Usage throughout the airport in all applications
 - All routes, all use cases, no limitations
- Reliable: Greater availability than diesel tractors
- Serviceability: All operational issues resolved same day
- Easy Fueling: 3-4 minute fills from liquid station on airport ramp
- Rugged: Withstands shock of tractor/dolly collisions

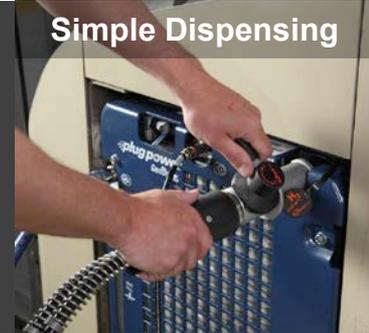
GSE Fuel Solution: Liquid H2 Infrastructure

- H2 Capacity: 15,000 gallons (4000 kg)
- Liquid temp: -253 deg C
- Liquid Pressure: 5 PSI
- Gaseous Storage: 60 kg (scalable)
- Gaseous Pressure: 350 bar (5,000 PSI)
- Dispensing Time: 1 kg/min

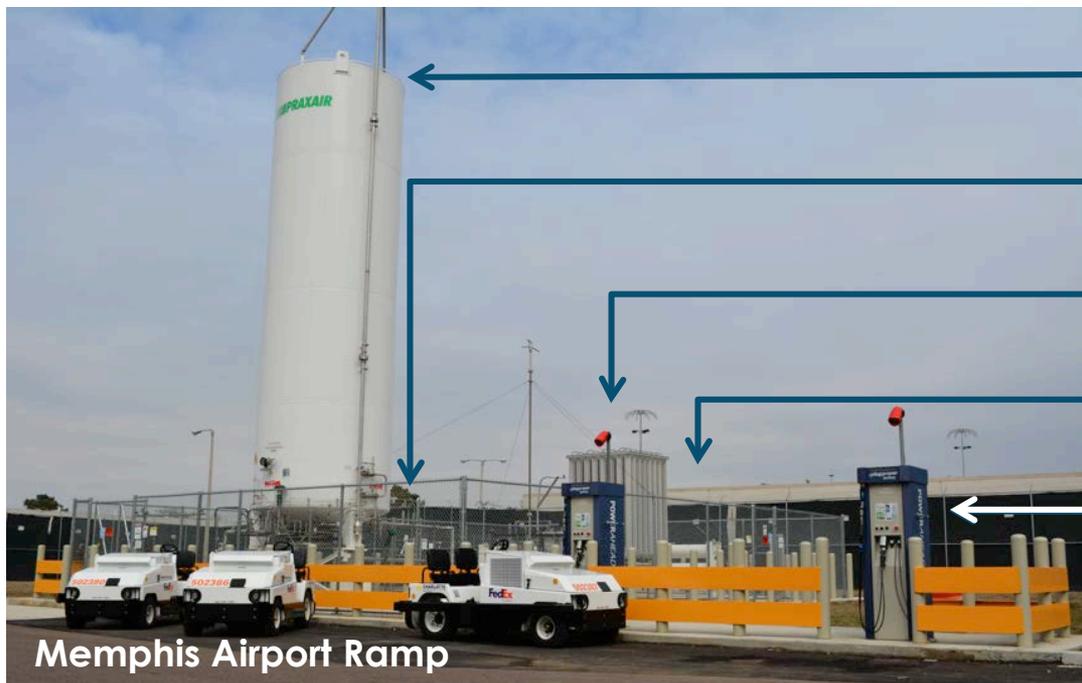
Mobile Refuelers can bring hydrogen from station to assets at airport gates.
