# 2020 DOE Hydrogen and Fuel Cells Program Review presentation

## Dispenser Reliability: Materials R&D

Project ID # in013

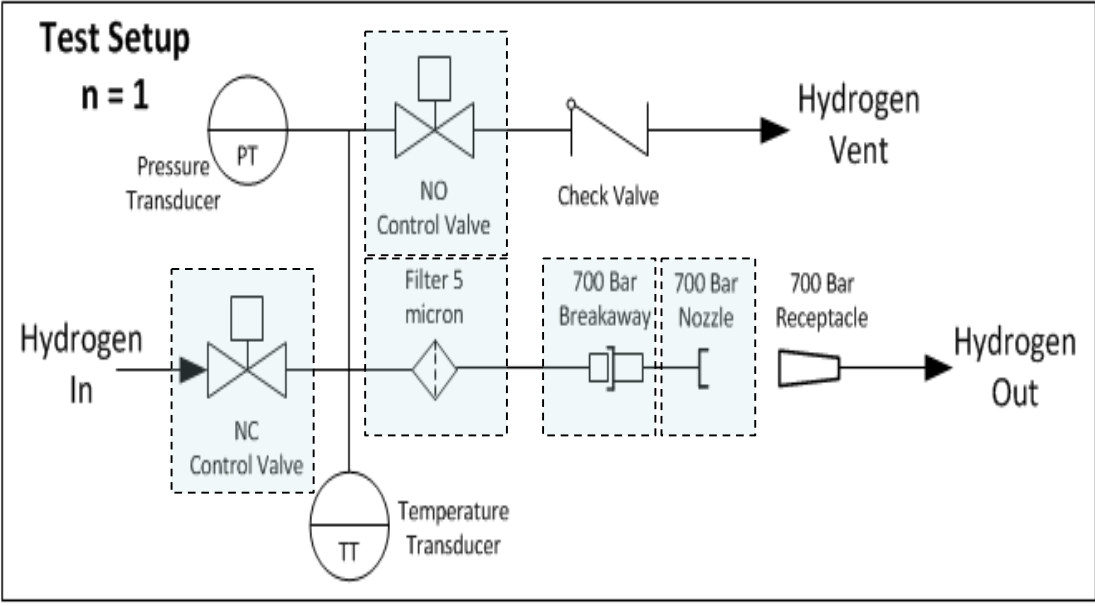
Measure the mean fills between failures (MFBF) and mean kilograms between failures (MKBF) of hydrogen components subjected to pressures, ramp rates, and flow rates similar to light duty fuel cell electric vehicle fueling at -40°C, -20°C, and 0°C\*

Devices Under Test (DUTs):

Nozzles, breakaways, normally closed valve, normally open valve, filter

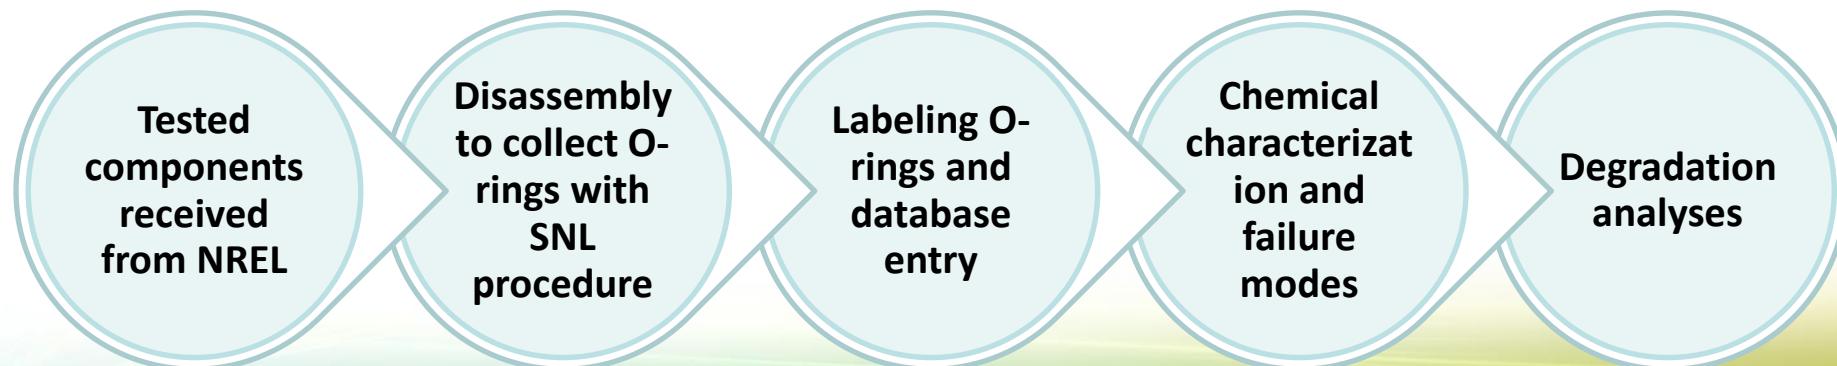
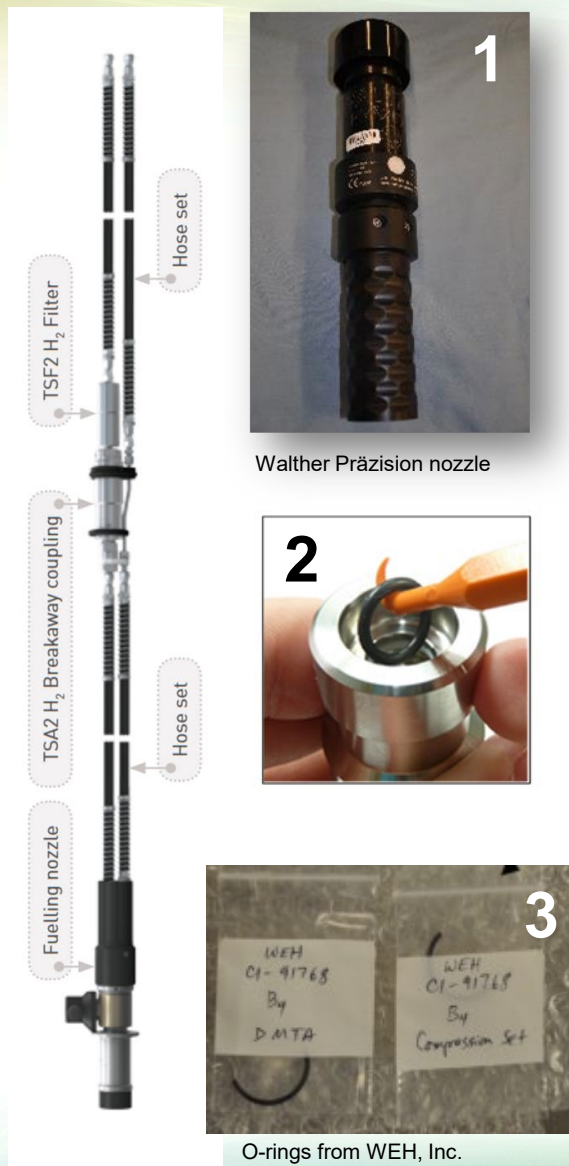
Same sequence of steps used to process both exposed and unexposed components

1. Pictures taken of whole components received from NREL with NREL designation clearly depicted
2. Component disassembled carefully with special tools so as to not alter polymer physical form
3. Polymer O-rings retrieved bagged individually and assigned special combination of letter and number to indicate component source, entered into database
4. Polymer pictures taken and stored along with whole component pictures
5. Specimens subjected to non-destructive testing first, followed by destructive testing

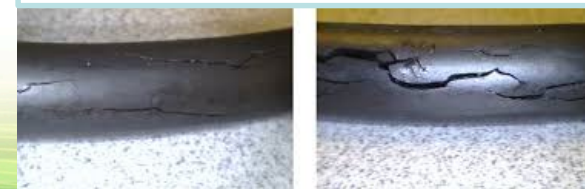
Keyence images of typical damage seen in polymer O rings after H<sub>2</sub> gas exposure

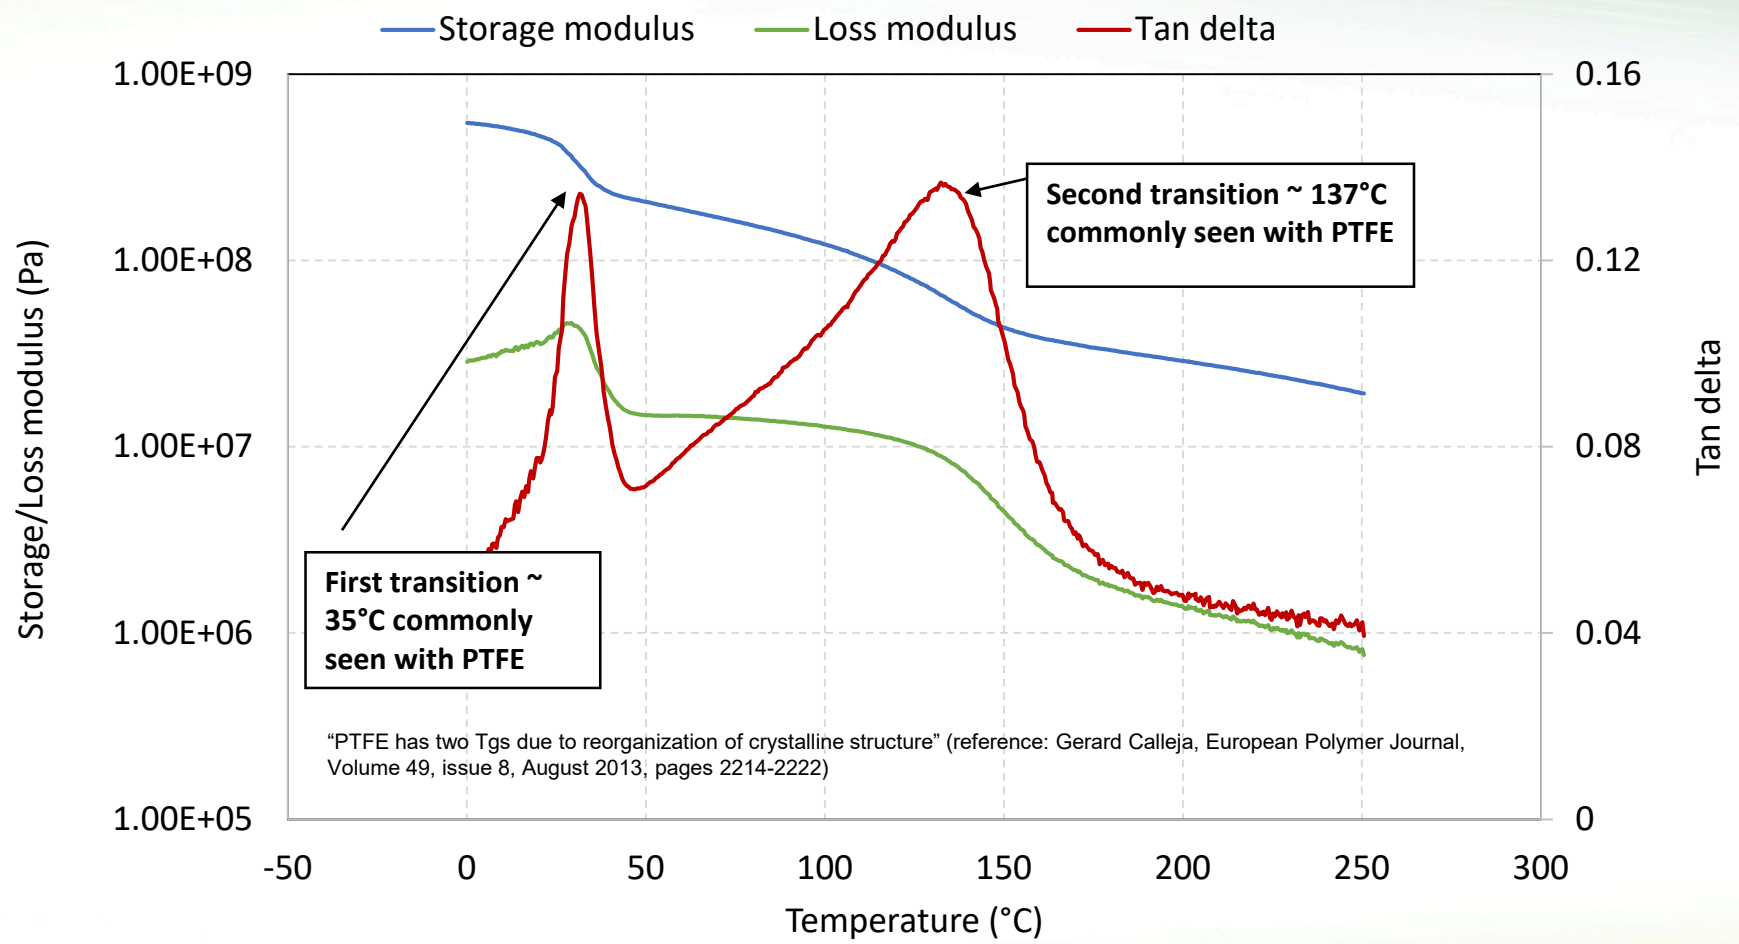
H2 FIRST, PTFE thin gasket DMTA, 0.5% strain, 1 Hz, 5°C/min heating

**Glass transition temperature and modulus shifts reflect polymer microstructural changes in response to exposure to H<sub>2</sub>**

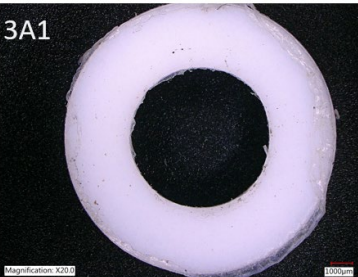
NC049-B:  
H<sub>2</sub> exposed,  
failed at 99  
cycles, -40°C

**Significant increase in fraying and deposit of metallic and non-metallic debris with H<sub>2</sub> exposure**

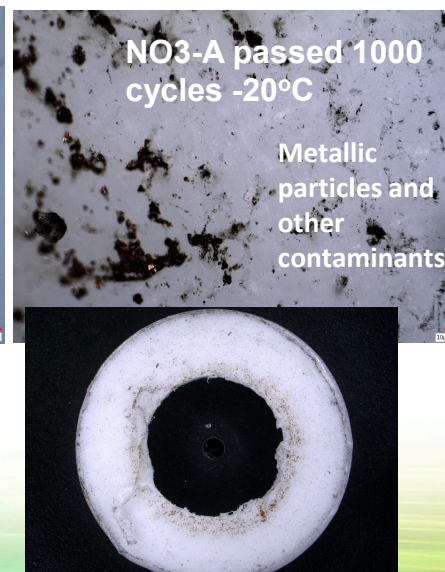
**ATR-FTIR demonstrates** no polymer chemical structural changes for PTFE O-rings in normally open valves NO-A after exposure to H<sub>2</sub>

- PTFE O-rings in NO-A and NO-B show different types of damage
- The NO-B rings are cleaner but show greater fraying
- The NO-A PTFE show fraying and embedded metal particles and discolorations for the same number of cycles

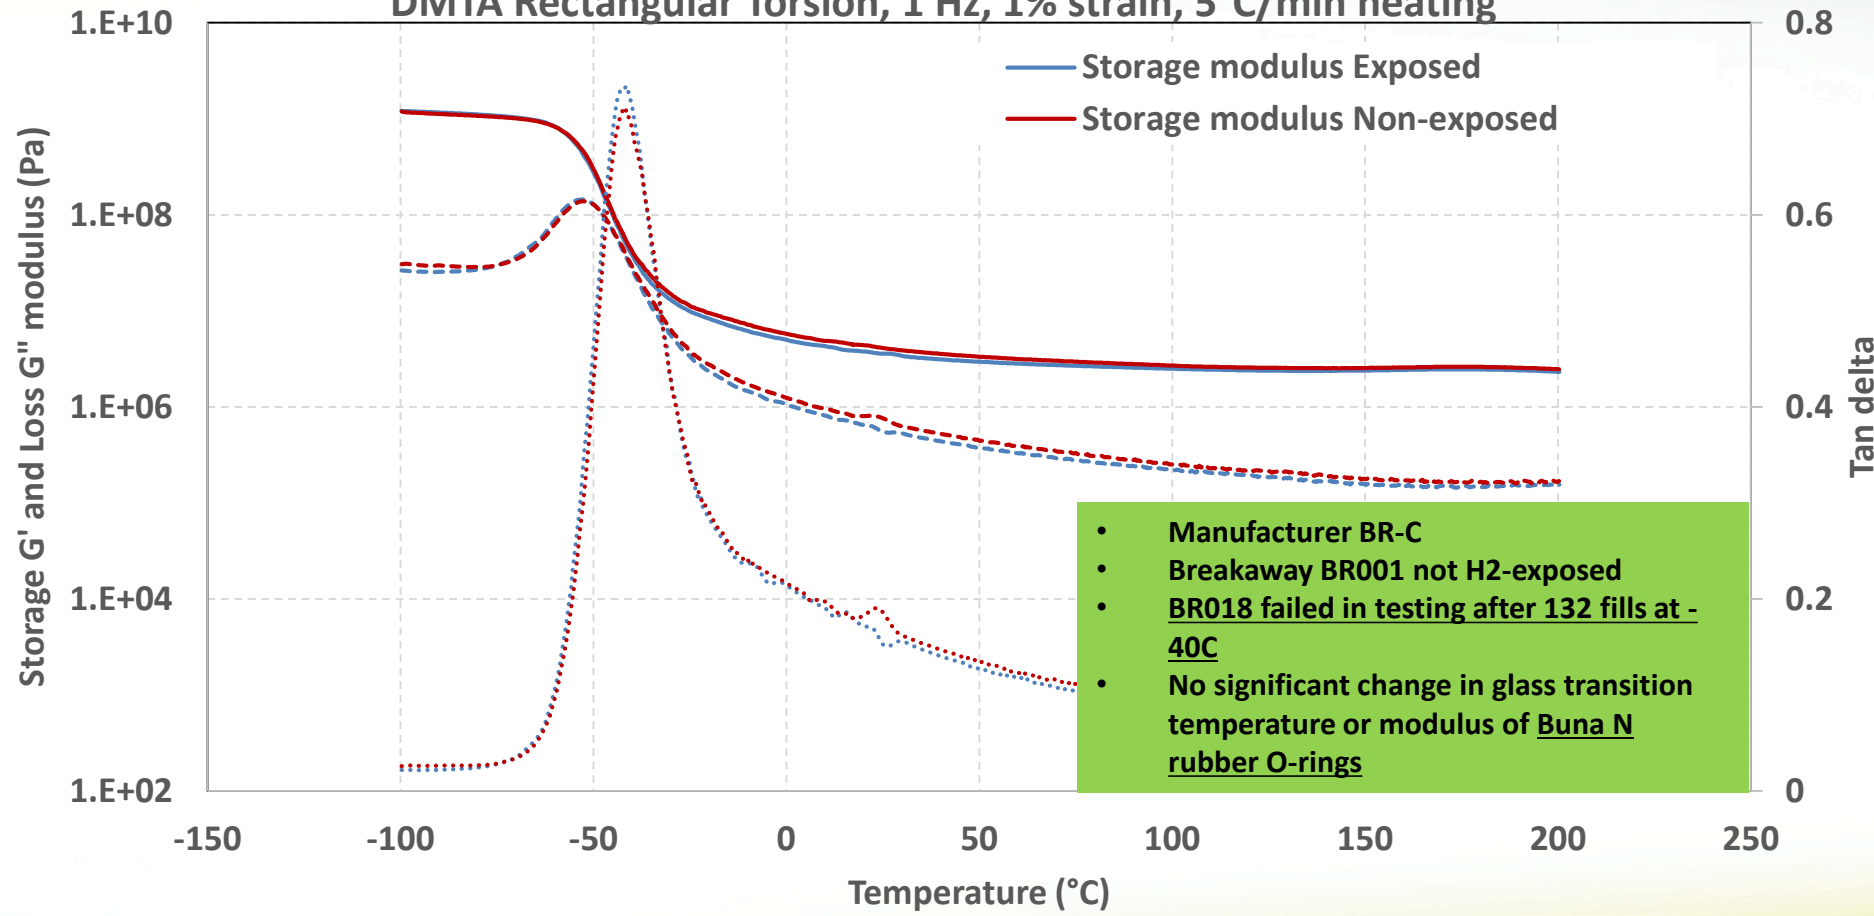
H2FIRST BR18-C Buna N O-ring, compared to similar Buna N O-ring BR01-C  
DMTA Rectangular Torsion, 1 Hz, 1% strain, 5°C/min heating

• Change in Buna N thermomechanical properties not reason for breakaway failure

**DMTA demonstrates** that polymer chemical properties changes are not responsible for early failure of buna-n found in breakaway BR-C:

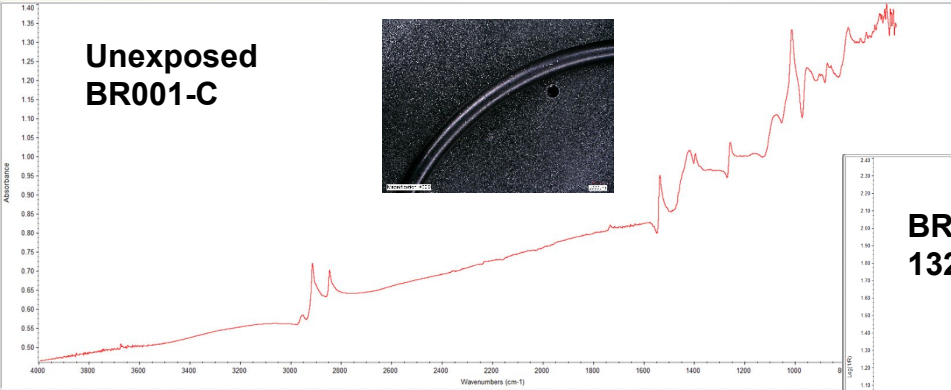
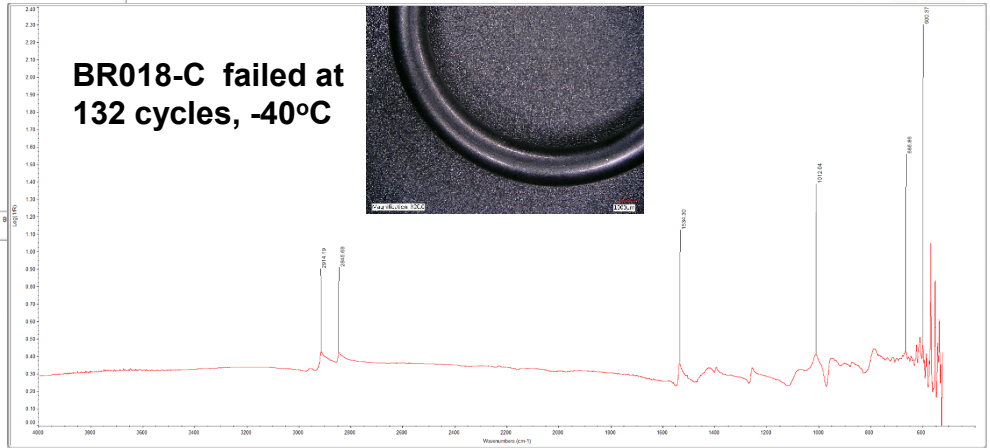
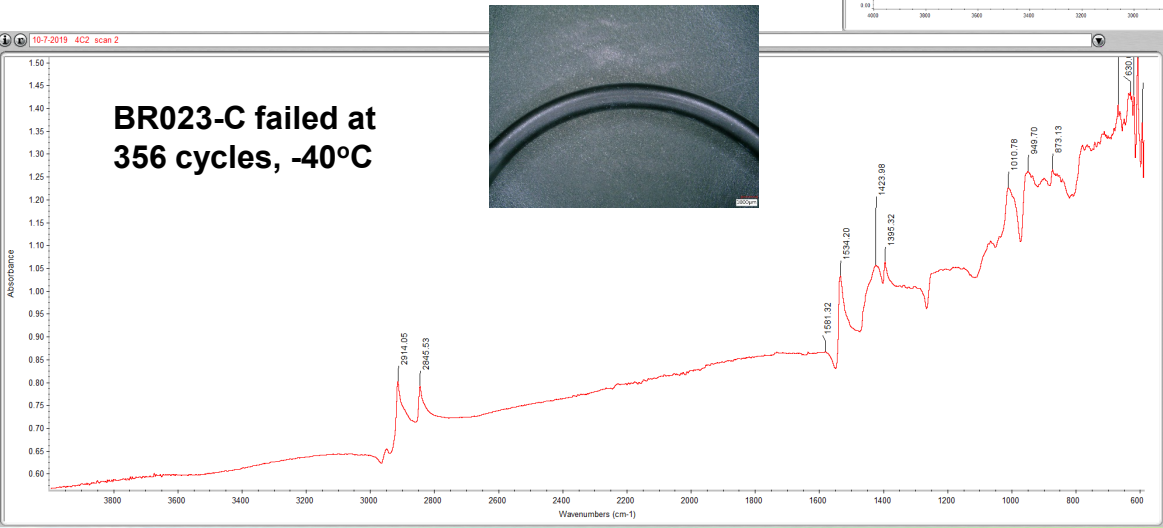
**ATR-FTIR demonstrates no polymer chemical structural changes for Buna-N O-rings in breakaway BR-C after exposure to H<sub>2</sub>**

- ATR-FTIR spectra for Buna O rings from these failed breakaways do not show significant chemical differences
- No physical damage seen with any of the Buna N O-rings in the optical images

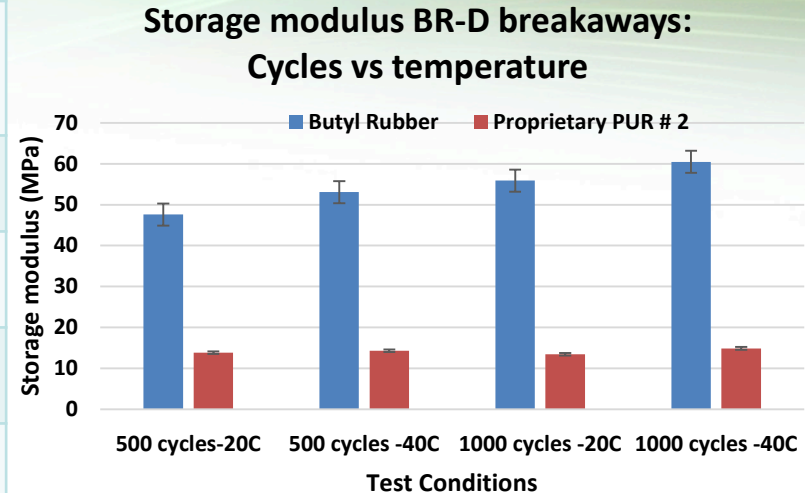
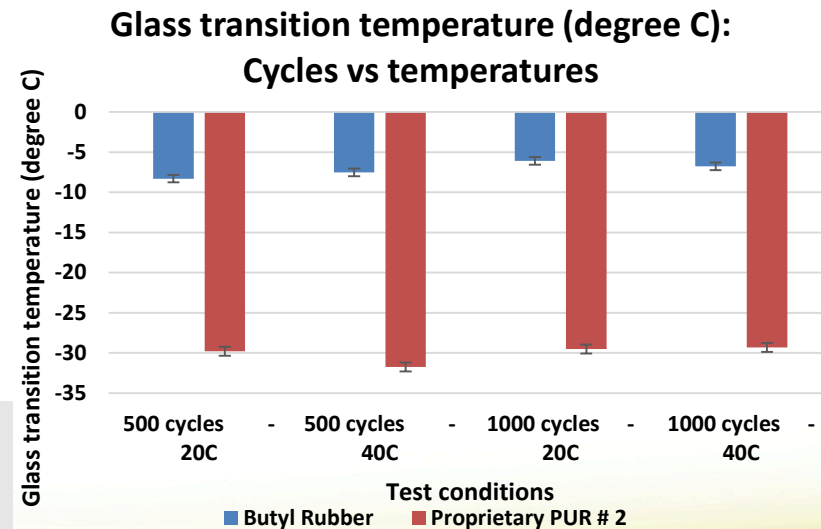
**DMTA demonstrates** chemical changes to butyl rubber in breakaway with trends based on number of cycles and exposure temperature

- All the BR-D breakaways passed under test conditions shown
- Storage modulus of butyl rubber O-rings increases with more cycles and lower exposure temperatures
- Glass transition temperatures are steady under test conditions

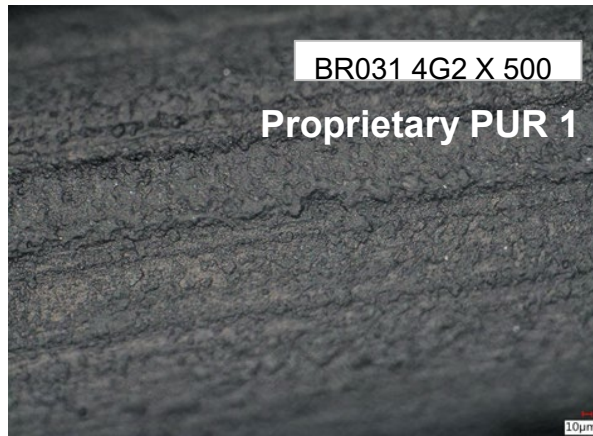
**Optical microscopy shows increased blistering of Buna-N and increased wear of PUR with additional cycles**

**BR031-D (top row) passed 1000 cycles, -40C**

**BR048-D (bottom row) passed 500 cycles, -40C**

**At -40C test temperature, blisters in Buna N, PUR# 2 and wear in PUR# 1 is greater at 1000 cycles vs 500 cycles  
This indicates an effect of number of cycles: greater the number of cycles, greater the damage**

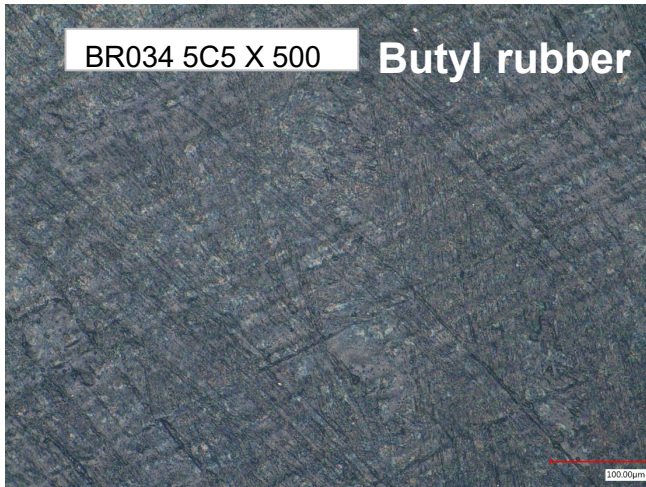
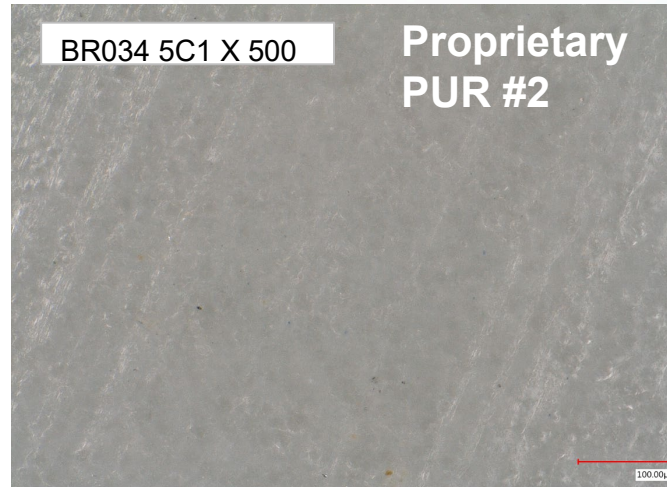
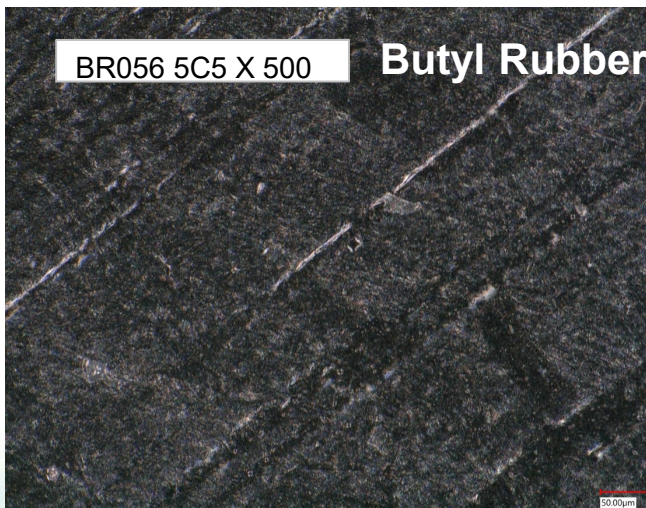
**Optical microscopy shows** less damage to polymers cycled at  $-20^{\circ}\text{C}$ , independent of number of cycles

BR034-D (top row) passed 1000 cycles,  $-20^{\circ}\text{C}$   
BR056-D (bottom row) passed 500 cycles,  $-20^{\circ}\text{C}$

- No significant increase in damage with increased number of cycles at  $-20^{\circ}\text{C}$ .
- Damage increased with cycling at  $-40^{\circ}\text{C}$
- Effect of test temperature and the number of cycles is evident for these breakaways and the polymers within

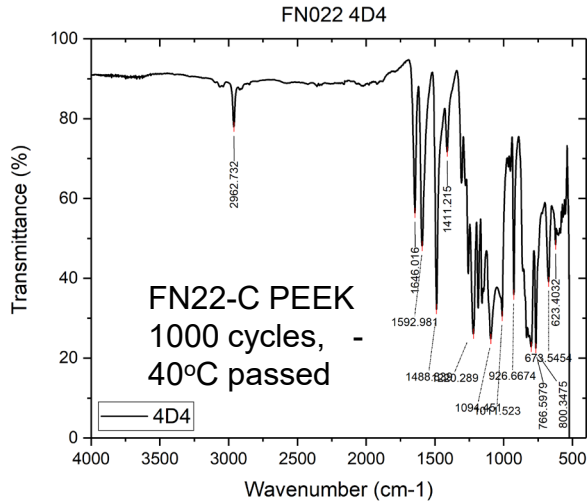
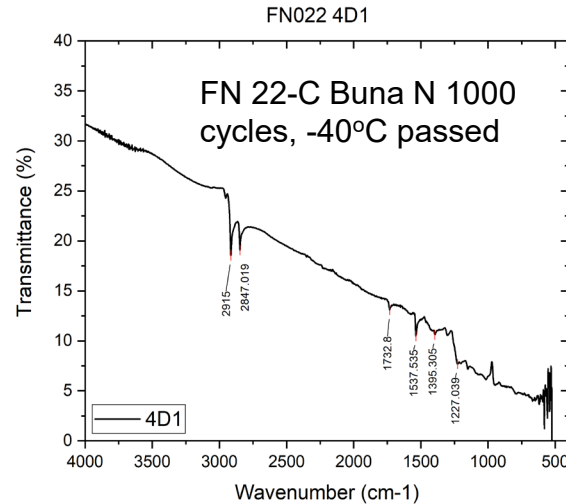
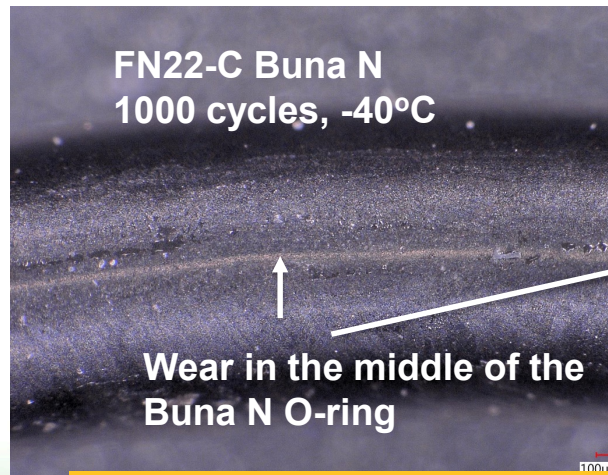
## FTIR spectra and optical microscopy of polymers from fueling nozzle

Increasing number of cycles at -40°C shows increased wear in Buna N

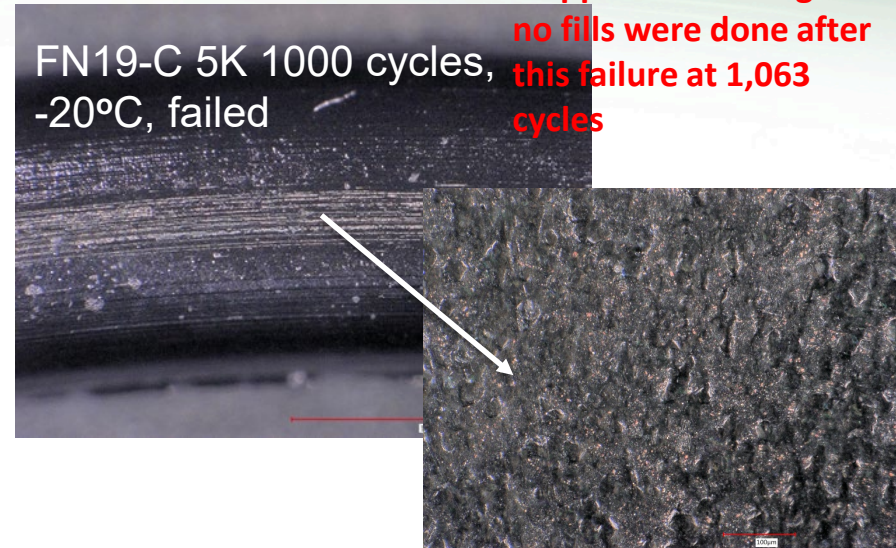
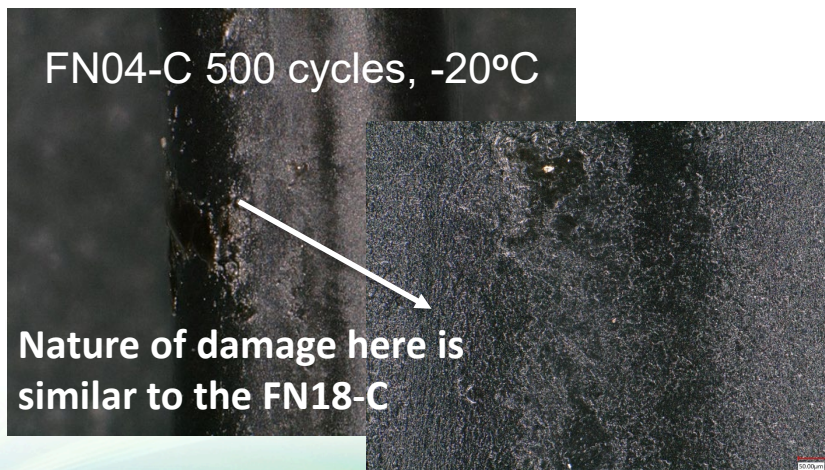
Extent of blistering and wear, leading to failure, can vary for the same component exposed to the same conditions

Leak from the nozzle stopped the testing and no fills were done after this failure at 1,063 cycles

- Two fueling nozzles tested at -20°C from FN-C were compared for degradation modes (top row)
- Extent and nature of wear is different
- For FN19-C, extreme pitting and wear is seen with the Buna N rubber whereas with FN18-C had blisters
- FN19-C failed at 1000 cycles
