V.H.4 Improved Accelerated Stress Tests Based on Fuel Cell Vehicle Data

Tom Madden (Primary Contact), T.T. Aindow, Andrew Alarcon

UTC Power Corporation
195 Governor's Highway
South Windsor, CT 06074
Phone: (860) 727-2834
E-mail: thomas.madden@utcpower.com

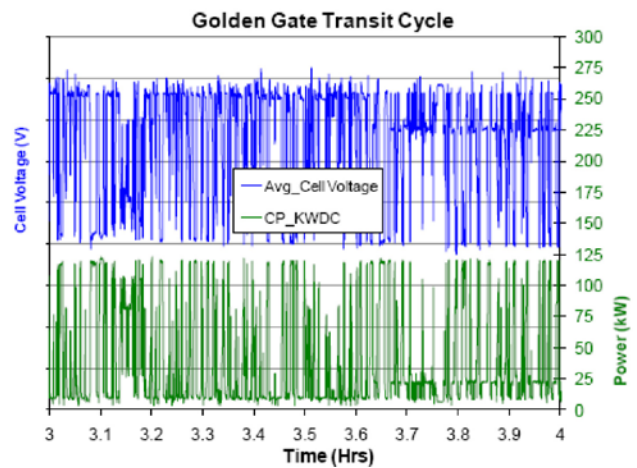
FIGURE 2. Typical drive cycle experienced by buses at Alameda-Contra Costa Transit (AC Transit) expressed in power draw (green trace) and individual cell voltage from the fuel cell stack.

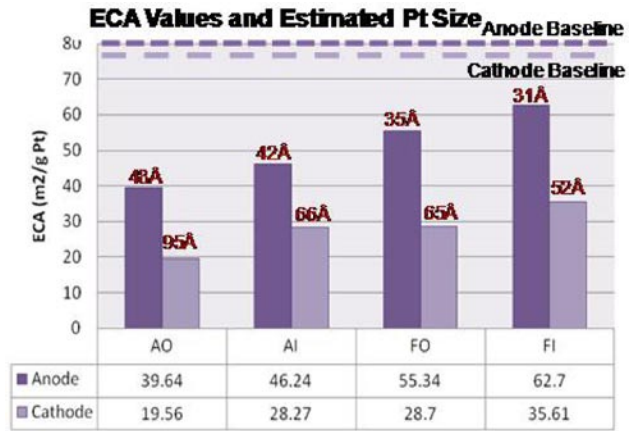
FIGURE 4. ECA data obtained from a 2,850 h cell using cyclic voltammetry. Baseline values are averages from unused samples. Pt particle sizes estimated from XRD are given at the top of the bars (from 2010 DOE Annual Merit Review FC015 – June 8[th] 2010).

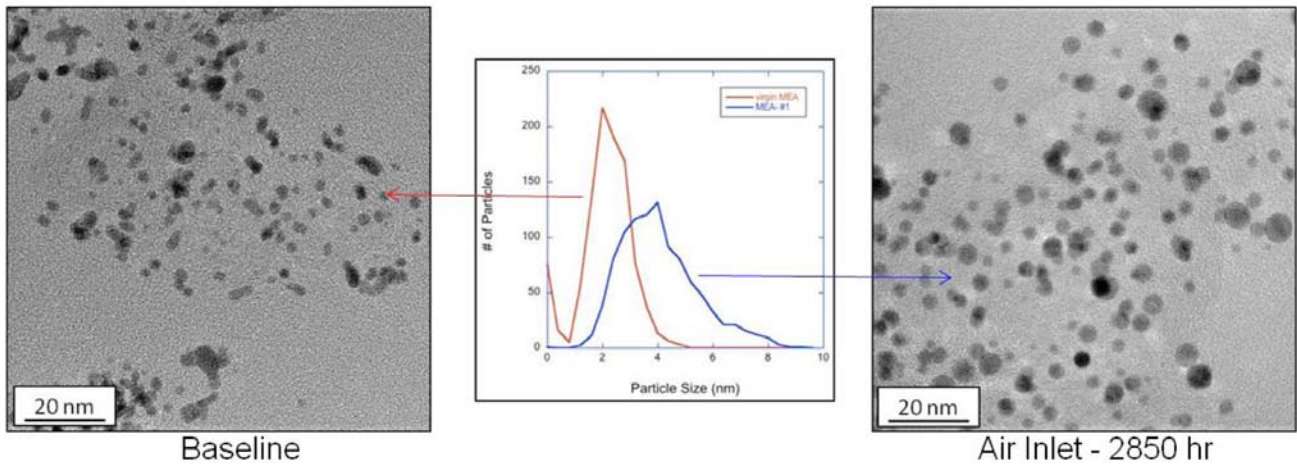
PGM catalyst decay was also investigated using TEM techniques. Analysis on BOL and EOL MEAs were performed at ORNL. Images obtained from baseline and 2008 fleet leader samples are shown in Figure 5. It

FIGURE 5. TEM Cathode Catalyst Images for Baseline and 2,850 h Catalyst Samples from Air Inlet Region

is clear from these images that Pt particle coarsening has occurred. ECA measurements and TEM analysis of the catalyst at the air inlet are in qualitative agreement.

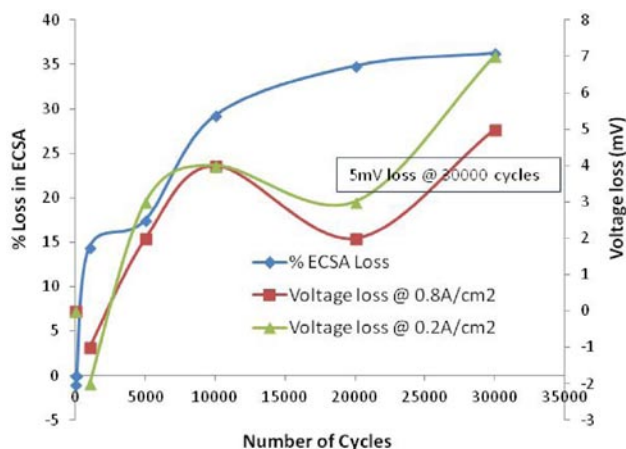
FIGURE 6. Diagnostics Results from PGM Decay AST

Catalyst AST testing has been completed on the BOL MEA. The ECA and voltage loss are shown in Figure 6. It has been concluded that surface area, voltage and mass activity loss after 30,000 cycles at 0.6-1.0 V is ~37%, ~5 mV and ~20%, respectively. Comparison between these results and the DOE 2012 targets for catalyst is shown in Table 2. Post-mortem analyses on the AST-degraded electrodes are ongoing.
