III.5 Demonstration of Full-Scale Glass Fiber Composite Pressure Vessels for Inexpensive Delivery of Cold Hydrogen

Andrew Weisberg (Primary Contact),
Salvador Aceves, Tim Ross, Blake Myers
Lawrence Livermore National Laboratory (LLNL)
P.O. Box 808, L-260
Livermore, CA 94551-0808
Phone: (925) 422-0864
E-mail: weisberg1@llnl.gov

Subcontractor:
Spencer Composites Corporation (SCC), Sacramento, CA

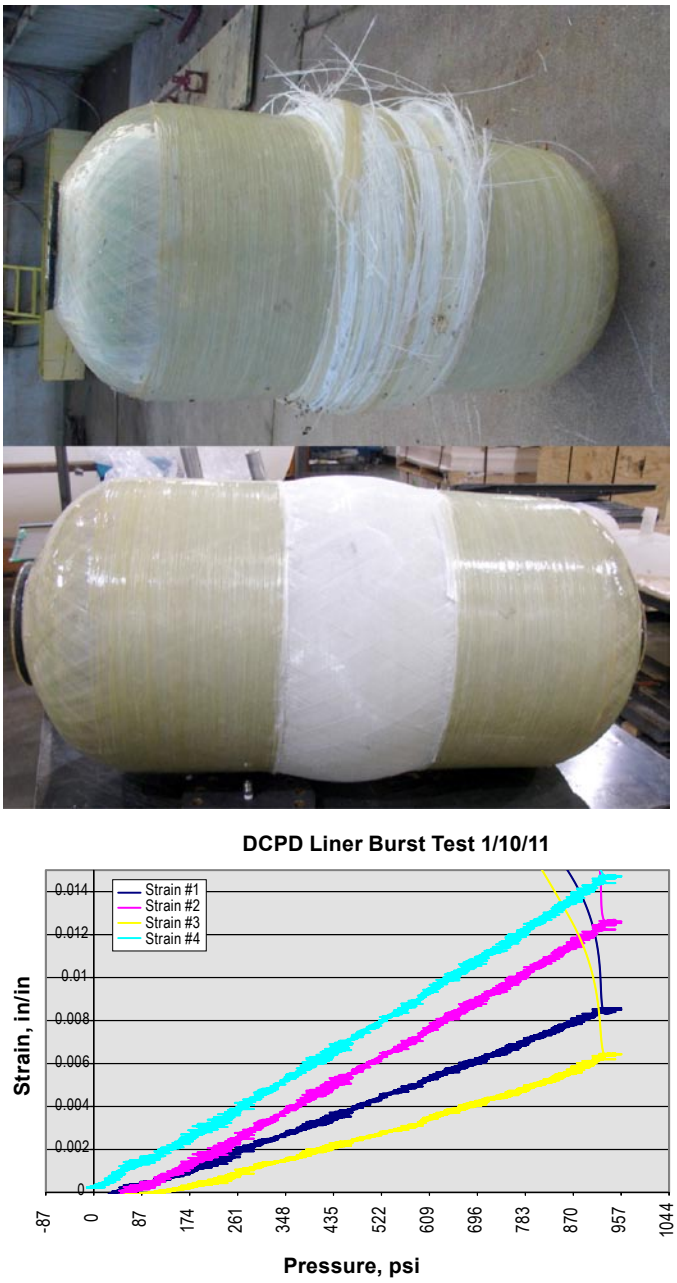
The first successful burst test of a full-scale (23" diameter, length over 50" that can satisfy ASME Code X certification requirements for all greater lengths) is illustrated in Figure 1. This test was performed with pressurized water to meet permit requirements at SCC's facility in Sacramento, CA. Testing CPVs filled with compressed hydrogen over a period of weeks is planned to prove that full-scale CPVs do not permeate at maximum operating pressure.

FIGURE 1. Successful Burst Test of Trailer-Scale CPV – Figure 1 shows a 23" diameter glass fiber composite pressure vessel that was burst tested with compressed water at ambient temperature. The photograph above shows the CPV after burst was declared, with its composite overwrap layer shredded. The vessel did not actually rupture, but lost most of its pressure and no fluid escaped. This is a very unusual outcome, due to the unprecedented toughness of SCC's liner material. The middle photograph shows the bulge that formed in the unruptured liner, which accounts for an internal volume increase of roughly 3%, and is enough to explain the depressurization due to the relative incompressibility of water. The bottom figure illustrates four strain gage traces during this test, which prove this CPV's manufacturing is adequate for designs that 'burst' at any pressure within the capabilities of plumbing seals.

In January of 2011 the first good liner emerged from this tool to wind glass composite around, and then to burst test into the article shown in Figure 1. That burst test vindicated the improved liner molding process, because it ended in an unprecedented CPV failure mode, which might be called burst without rupture. Just because all the water remained inside after a loud noise and a big pressure drop does not mean this mode is really safer, since gaseous contents would not have dropped in pressure with just a little midriff bulge. But the survival of the liner in that bulge region does prove that the liner remained ductile under rapid straining to over 11% strain. Since design hydrogen delivery pressures only call for 3% liner strain, the liner component that has caused this project so much trouble has been proven to operate beyond its requirements at full scale.

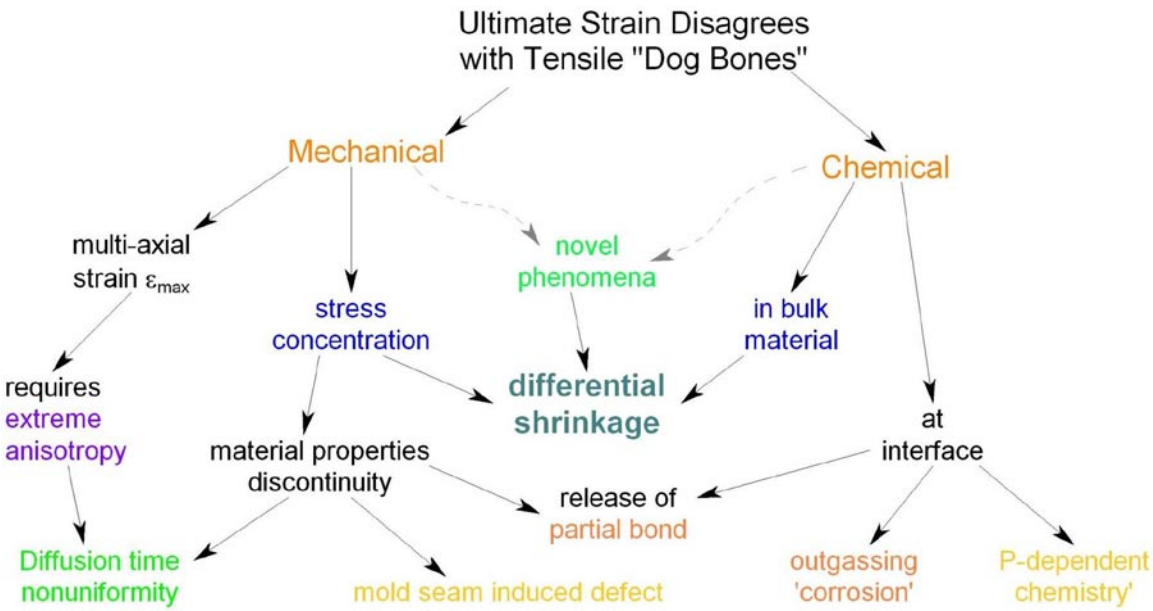
FIGURE 2. Tree Diagram of Hypotheses for Premature Liner Rupture - Figure 2 illustrates all the possibilities LLNL and SCC hypothesized to account for obscure failures observed in burst testing 3" and 21" diameter CPVs and unwrapped liners. For over two years experimental liner material formulations passed tensile testing at 8-9,000 psi ultimate stress and roughly 18% strain, yet failed when built into CPV liners at strains as low as 0.3%. These materials are not brittle, and most formulations were capable of toughness roughly 30-fold above epoxies. The materials failed as liners 'prematurely' despite passing every toughness test with an ASTM drop tower impact. Hypotheses in orange type were proven partially correct, yellow type were proven incorrect, and green type were verified. The odd conjecture shown in purple type was proven to be a result of the unprecedented solidification mechanisms of this material, while the hypothesis in teal type was found to be an unexpected part of that mechanism.

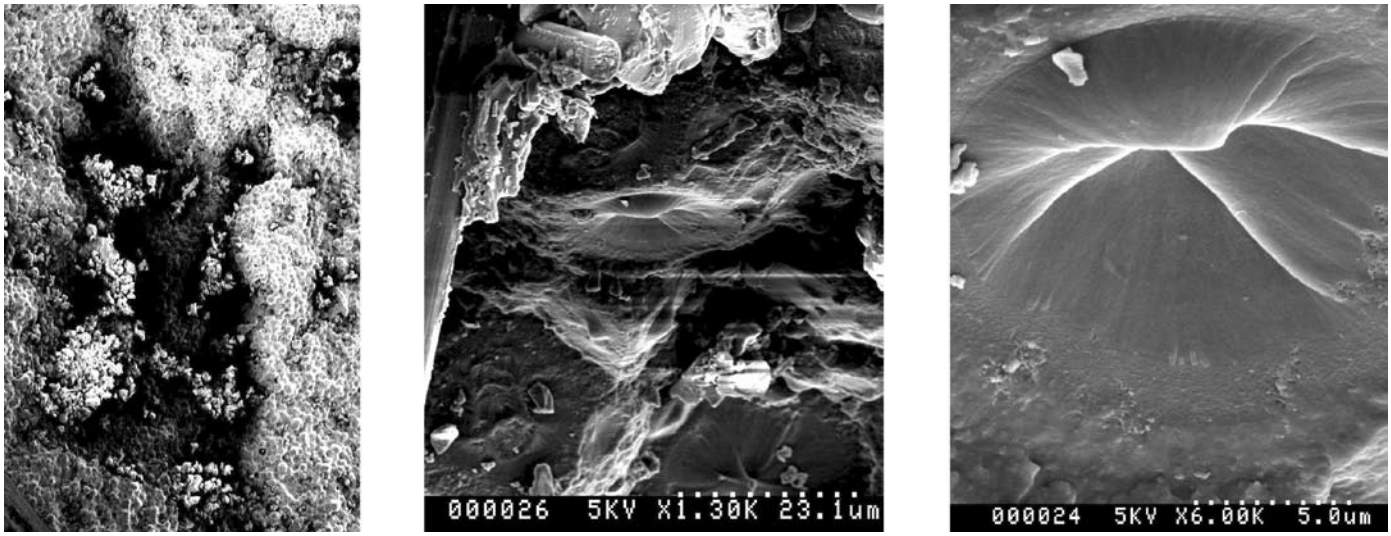
The correct diagnosis was based on SEM imaging of the entire crack surface from the failed 23" liners. The cracks forked, with forks not left on the failure surface being those that didn't run faster than those that formed the surface. These 'diving' forks were later seen on examination with low power optical microscopy, saving considerable time in the SEM. The direction that the 'tines' of these forks pointed must be the crack propagation direction, so the crack initiation region was localized between a single pair of forks whose tines pointed away from each other. In that region, shiny surfaces gave way to slight localized frostiness; presumably before the crack propagation ramped up to high speed and could take advantage of orders of magnitude stress concentration at its crack tip. Those frosty regions are represented by the SEM sequence that appears in Figure 3, which focuses in on the "smoking gun" feature found on the complex surface of a diving fork.

That feature is a crater sticking up into a void, but not like craters seen in geology or astronomy. New materials have new failure modes, and this one occurred when the resin was a weak gel. Earlier SEM diagnosis had already determined that the forked cracks in the vicinity of crack initiation were not running in the maximum strain energy release direction (perpendicular to local tension), but went curling around with geometries that might be seen on the surface of puddings that had dried from neglect. The crater feature in question has sharp edges, but these could not have formed when ejecta blew into the void it sticks up in. Gas erupted through the surface of a weak gel into that void, then the gel shrank to form facets on the crater. Although density

measurements have long shown a 6% densification of this resin upon solidification, how that shrinkage was distributed in space did not appear to matter. After LLNL's diagnosis, it was clear that the plastic was cracking itself just where it ran out of more liquid for a wave of catalysis to solidify.

FIGURE 3. SEM Photographs of Liner Crack Surface – Figure 3 shows the "smoking gun" sequence of SEM photographs of a particular portion of the surface whereat a full scale (21" diameter) liner cracked inside of an early-2010 burst CPV. None of these features are visible in an optical microscope, and the sequence of photographs taken at the same point on the failed specimen increase in magnification from left to right. This particular spot was close to the origin of the crack that ruined this liner, causing the test CPV to leak below 800 psi and 0.7% nominal axial strain. The detective work that found the crack origin vicinity is based on forks in the cracked surface, whereat branches of the crack that did not succeed in forming part of the final separation surface dive beneath the surface on view. The origin of the crack must be somewhere between the two forks whose branches point away from that region. Looking into a fork of the crack, in the middle photograph shards of 2.7 micron glass fiber are visible which have been blown into a diving fork branch. On the wall inside that branch the odd "flying saucer" that appears centered in the micrograph at right initially resisted interpretation (since SEM views do not have darkness reflecting tilt angles as optical views do), but many attempts to view it at different angles convinced SEM operators this is a crater with sharp radial ridges.

Knowing what went wrong did not initially make it clear how to fix it. Another wave of dozens of 3" bottles became the front line for variations in the mold tool and resin pour sequence. Control was taken over where catalysis started, and care taken to never let the catalysis wave pass through liquid resin up against a solid wall, either of the mold or of previously solidified plastic. A technique was found to locate defective regions of castings without breaking them and to prepare the shards for SEM imaging, that is shown in Figure 4. But the next question was whether the project could afford to rebuild the 23" tool to incorporate these necessary improvements. The answer appeared to be no, before a real customer for such CPVs showed up in late summer of 2010. The customer could and did pay for a new tool which LLNL's liner mold fit into, but wanted CPVs built faster than SCC had any confidence they might pass ASME certification. This led to an extreme scramble to get LLNL development done on the tool the customer paid for, before the customer got its parts.

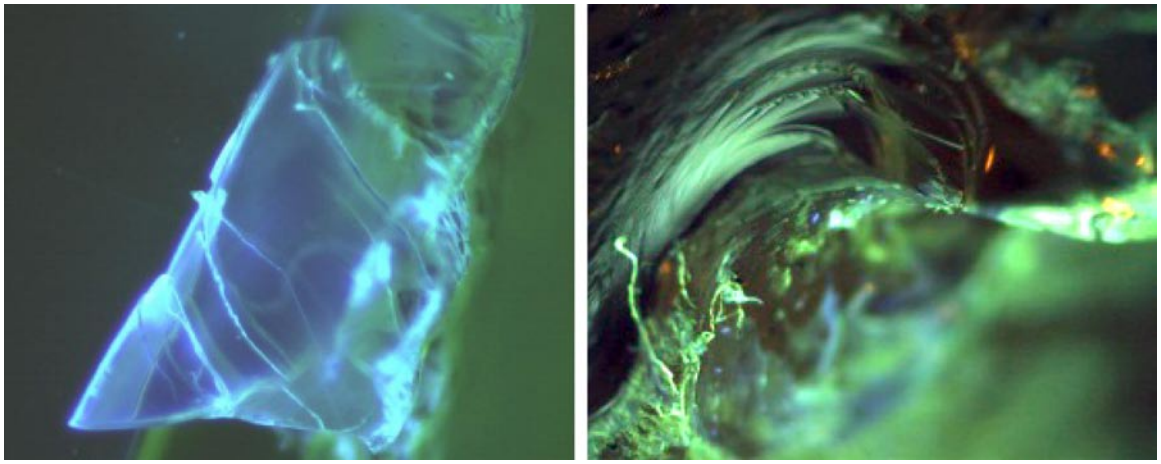
Further surprises were in store when the happily undestroyed vessel in Figure 1 was cut into to see how well its liner's end dome was cast. If the vessel had burst in a more normal way, the region wherein more 'defects' were found might have been lost. Instead Figure 4 shows failure surfaces that have nothing to do with the performance of the CPVs LLNL and SCC are building, and everything to do with the nature of the new material we are developing. Composites built with this material as a matrix have all the right properties, including fiber 'translation' (material tensile strength divided by raw fiber strength) over 90% and no strength loss at 77 K. Castings built with it, however, can have localized frosty regions whereat catalysis ran out

of resin. This generation of 23' liners just happens to have one of those regions in a ring on its outer mold line (OML, casting terminology for exterior molded surface). The 3" liners that were cracking had several such regions on their inner mold line (IML, interior surface), and that surface goes into tension when the liner inflates, whereas the OML region on the 23" liners goes into compression.

The defective regions were actually visible to the naked eye, with the aid of a flashlight, when looked at through the polished edge of the burst success liner end dome cut out segment. They appear as a tenuous frostiness, which LLNL has come to term 'nanocracking', since any frosty region on a cast surface has the kind of frosty surface shown in Figure 3 when examined in the SEM. Once cast into the part, the penetrant dye that visualizes these regions in Figure 4 cannot get in to detect them, but when bar shaped specimens cut with this region in the middle were broken, the dye can be used to decorate the cracks. A forked crack is visible in the left micrograph of Figure 4, which was broken in tension at extreme elongation. A much more complex swirl appears in the right hand micrograph which failed at a few percent strain in torsion.

FIGURE 4. Observed Cracks in Specimens of Successful Liner – Figure 4 shows the splendid images resulting from two crude strength tests performed in a vise. These photographs are taken at low magnification with an optical microscope (commonly called a macroscope), in a combination of ultraviolet and visible illumination. SCC developed a diagnostic technique to make defective liner casting regions visible without a SEM, using a penetrating fluorescent dye. While the SEM cannot image regions likely to initiate cracks buried within cast parts, this technique cannot image defects directly on surfaces. Since the successful liner had not broken during burst testing, it made a fine vehicle to see whether defective regions could be found before they triggered cracks. This 'experiment' was conducted in January of 2011 by plunging an industrial vibratory cutter into the dome region of the unruptured yet burst CPV, then taking the wedge cut from the dome through a band saw to cut test specimens. The specimen at left was pulled with a vise grip pliers, and failed at over 100% strain, while the one at right was twisted and failed at several percent strain. They both failed in the millimeter-thick circumferential region where cloudy fuzziness is visible when polished edges of the wedge were illuminated by flashlight, on which the band saw cuts were centered to produce test specimens 3" long by roughly 0.3" square.
