Hydrogen Component R&D

2016 DOE Annual Merit Review
Hydrogen Safety Codes and Standards

Project ID # SCS002

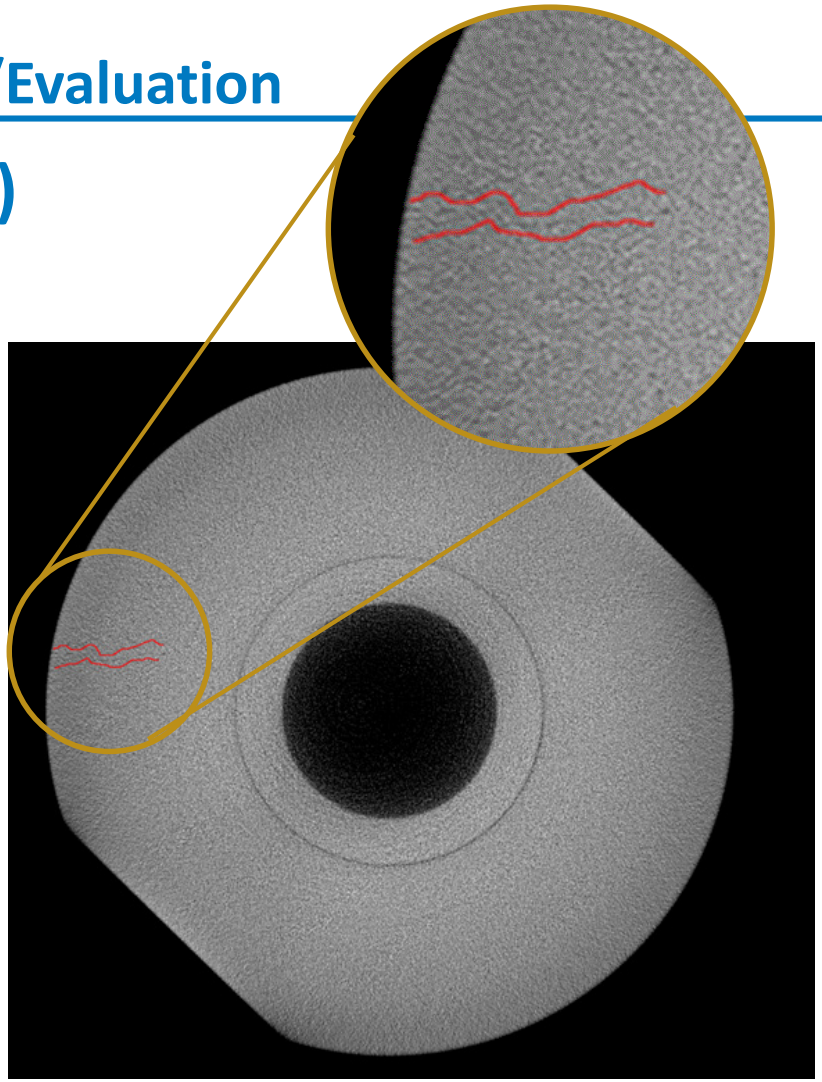
S/N 586381, slice 98, 8.5659 mm (Nikon Metrology Inc.)

- X-Ray technique capable of detecting subsurface flaws and inclusions
- Top view images taken at intervals of .02 mm, defect is visible over ten image slices (defect size ~ 0.2 mm long x 6.2 mm deep)
- Defect is detected on 440C relief valve nozzle S/N 586381 after three-year operation in hydrogen service at NREL's Wind-to-Hydrogen demonstration facility
- Two pressure relief valves were selected for testing, one with known crack and one free from preexisting condition
- Post test CT Scan is being conducted to determine overall crack growth rate and inspect for further crack initiation

Result: Defect size did not result in sufficient stress concentration to accelerate crack growth to failure over 10 years equivalent accelerated life test.

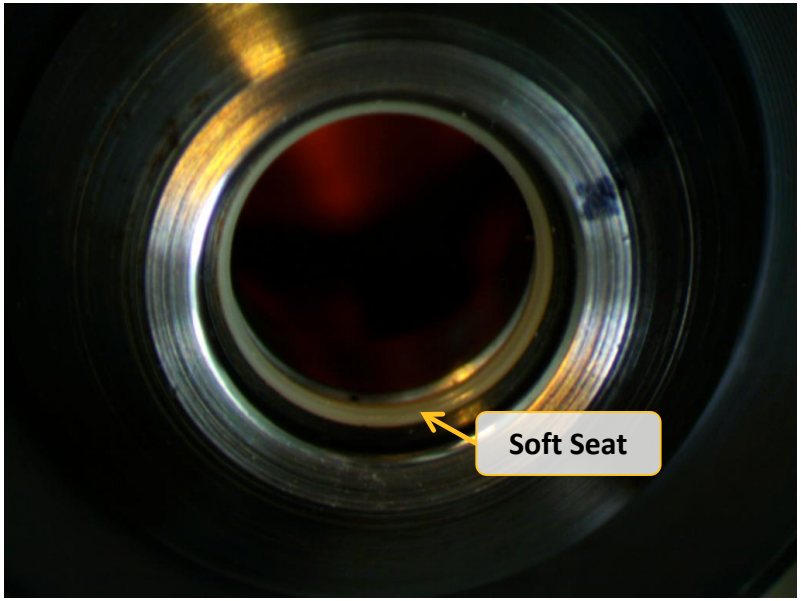
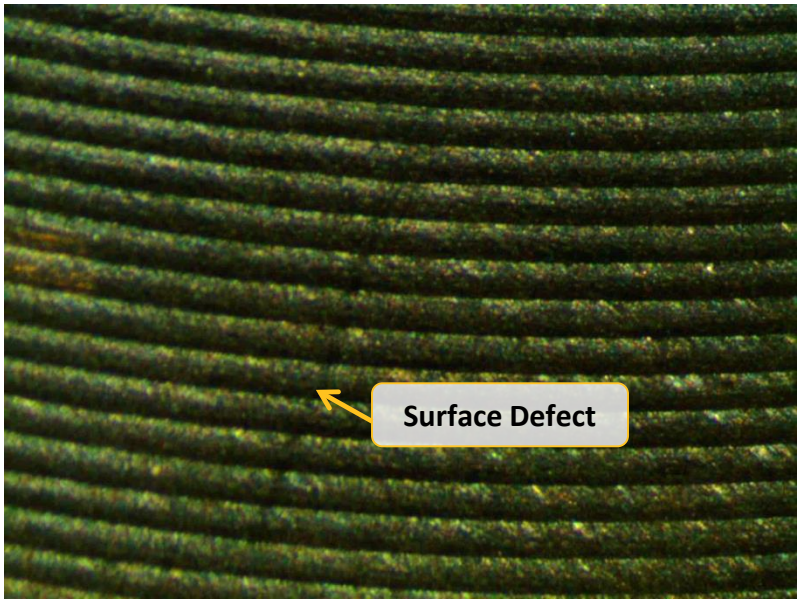
Relief valve nozzle S/N 586381 (NREL photo)

- Relief valve has been in service for three years and shows evidence of operational and/or installation wear
- Documented condition of nozzle at start of accelerated life cycle testing

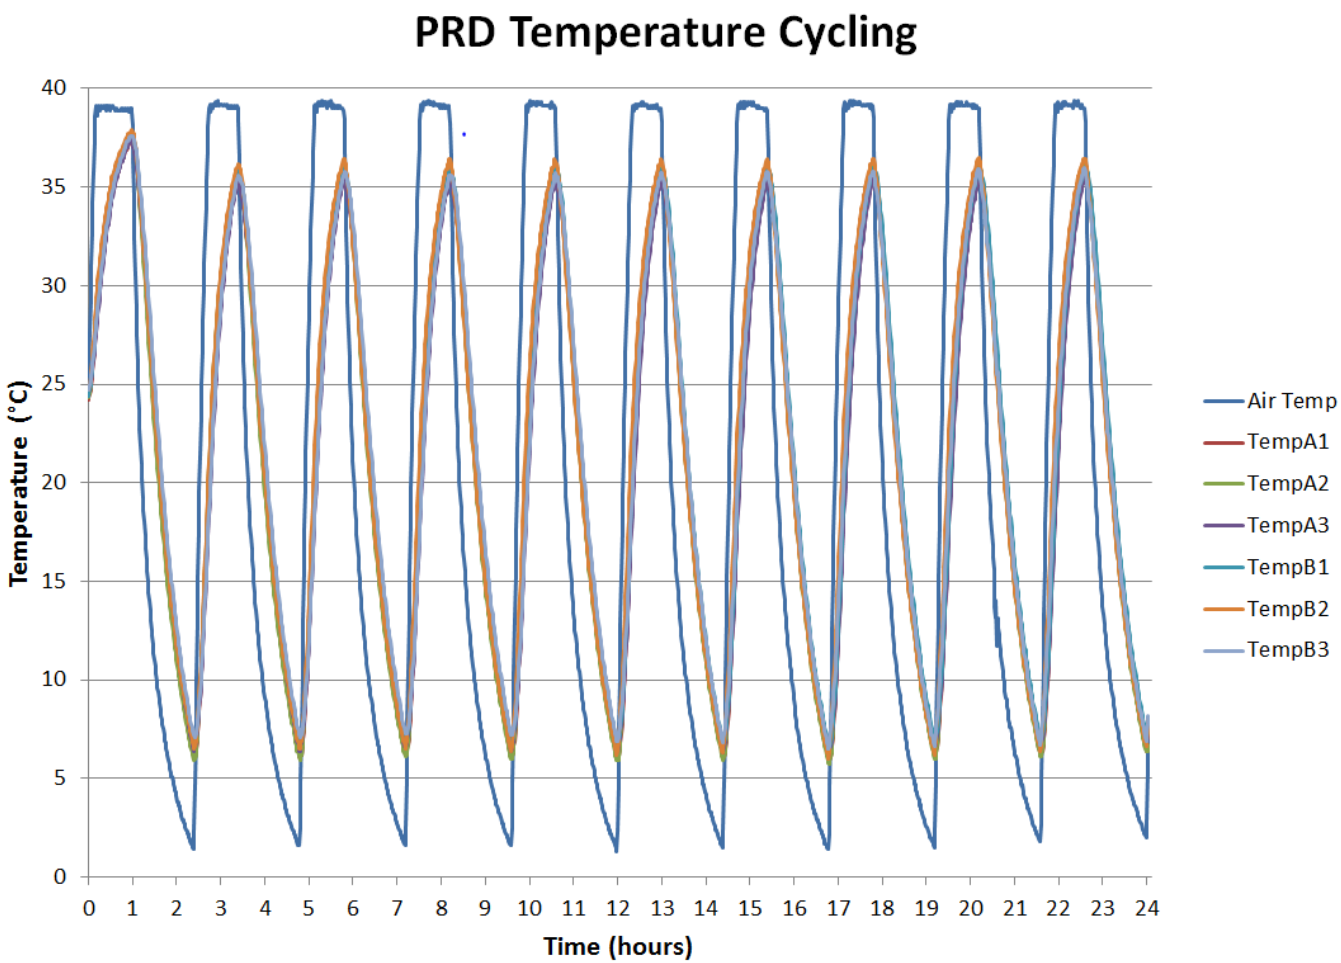
Automated PLC temperature control provides repeatable and reproducible operation over the planned temperature extremes

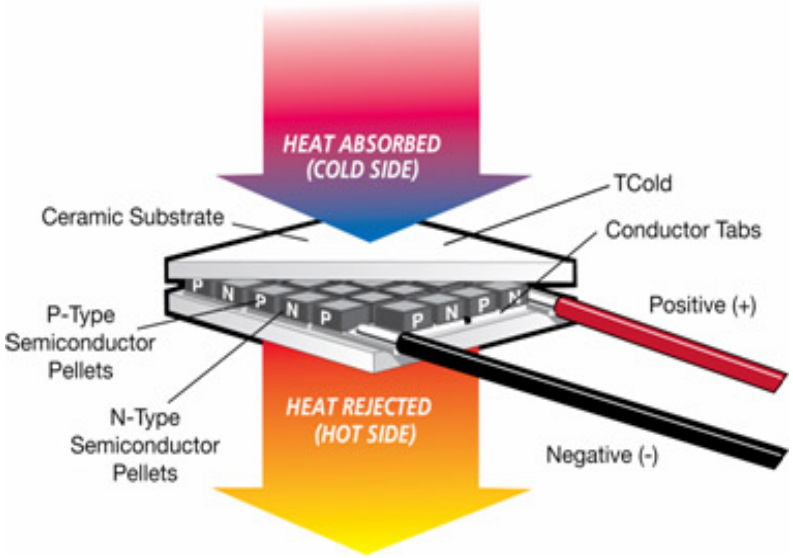
Lesson learned from thermal cycling testing root cause failure analysis: TEC failure is caused by differential thermal expansion between the brittle semiconductor material and the stainless steel base material

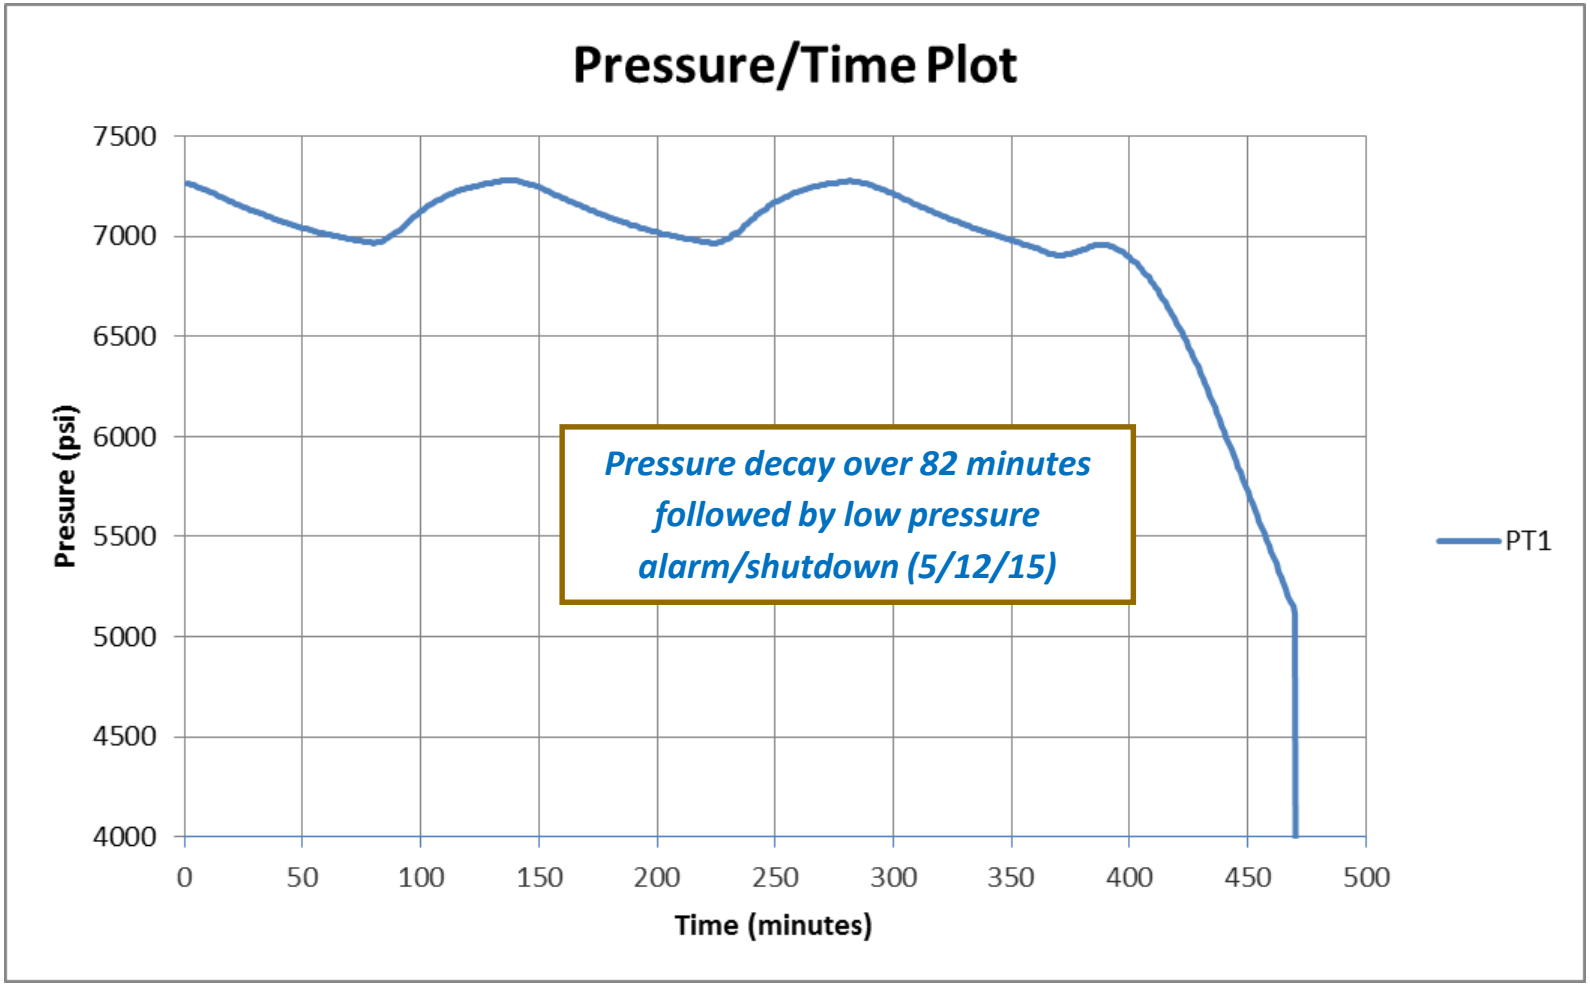
Upset condition encountered after 1200 cycles. Leak was detected in vent line. After depressurization and restart, valve was able to reseat and temperature cycle testing continued.
