700-bar Hydrogen Dispenser Hose Reliability Improvement

Kevin Harrison (Primary Contact), Owen Smith
National Renewable Energy Laboratory
15013 Denver West Parkway
Golden, CO 80401-3305
Phone: (303) 384-7091
Email: Kevin.Harrison@nrel.gov

Fiscal Year (FY) 2018 Objectives

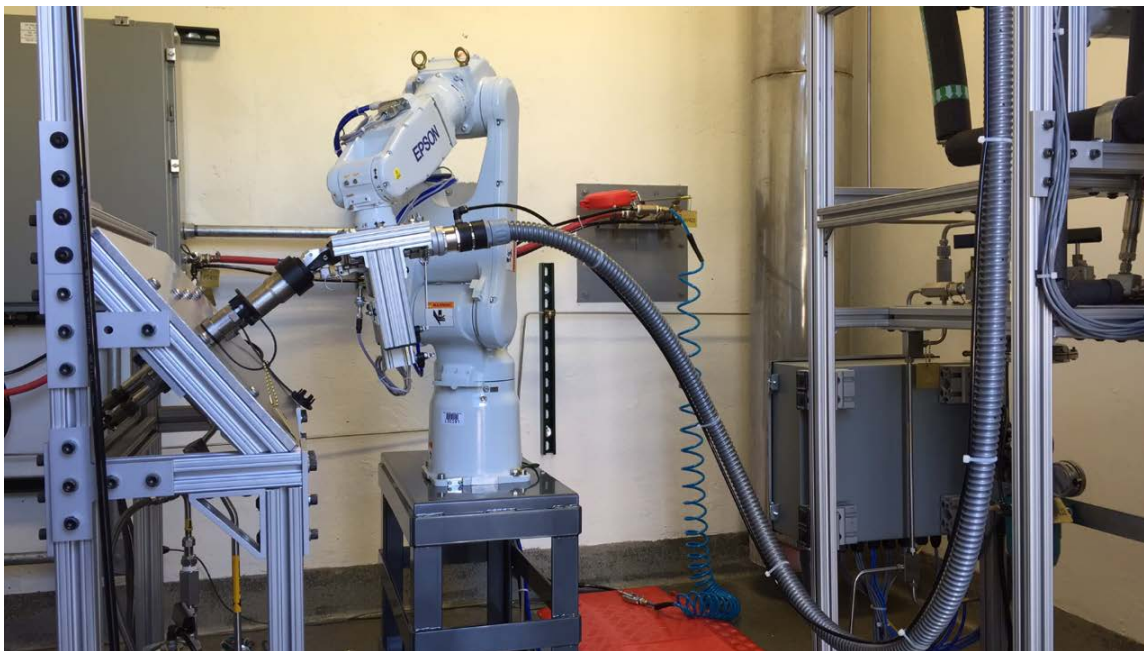
A hose reliability test stand, shown in Figure 1, was developed to support full 700-bar fueling simulation capabilities. The test stand uses a six-axis robot with pre-programmed motion paths to capture realistic stresses resulting from human interaction with the hose assembly while maintaining a compact footprint to safely operate in the high-pressure test bay, which offers a safe and controlled environment to test components to failure under high pressure while minimizing dangers to personnel or equipment. The test stand closely mirrors an actual dispenser in its design and pressure-ramping capabilities. A tankless control algorithm was successfully developed using the interaction of an air-loaded pressure regulator on the dispenser side of the test apparatus and flow control valves on the vehicle side. In FY 2018, upgrades were performed on the stand to add hydrogen recirculation capability and boost flow rates from 200 g/fill to 3–5 kg/fill.

Figure 1. Hose reliability test stand
