# Fuel Cell Powered Airport Ground Support Equipment MT011

# Hydrogen Cargo Tractor Fleet

# Zero Emission Airport Ground Support Equipment

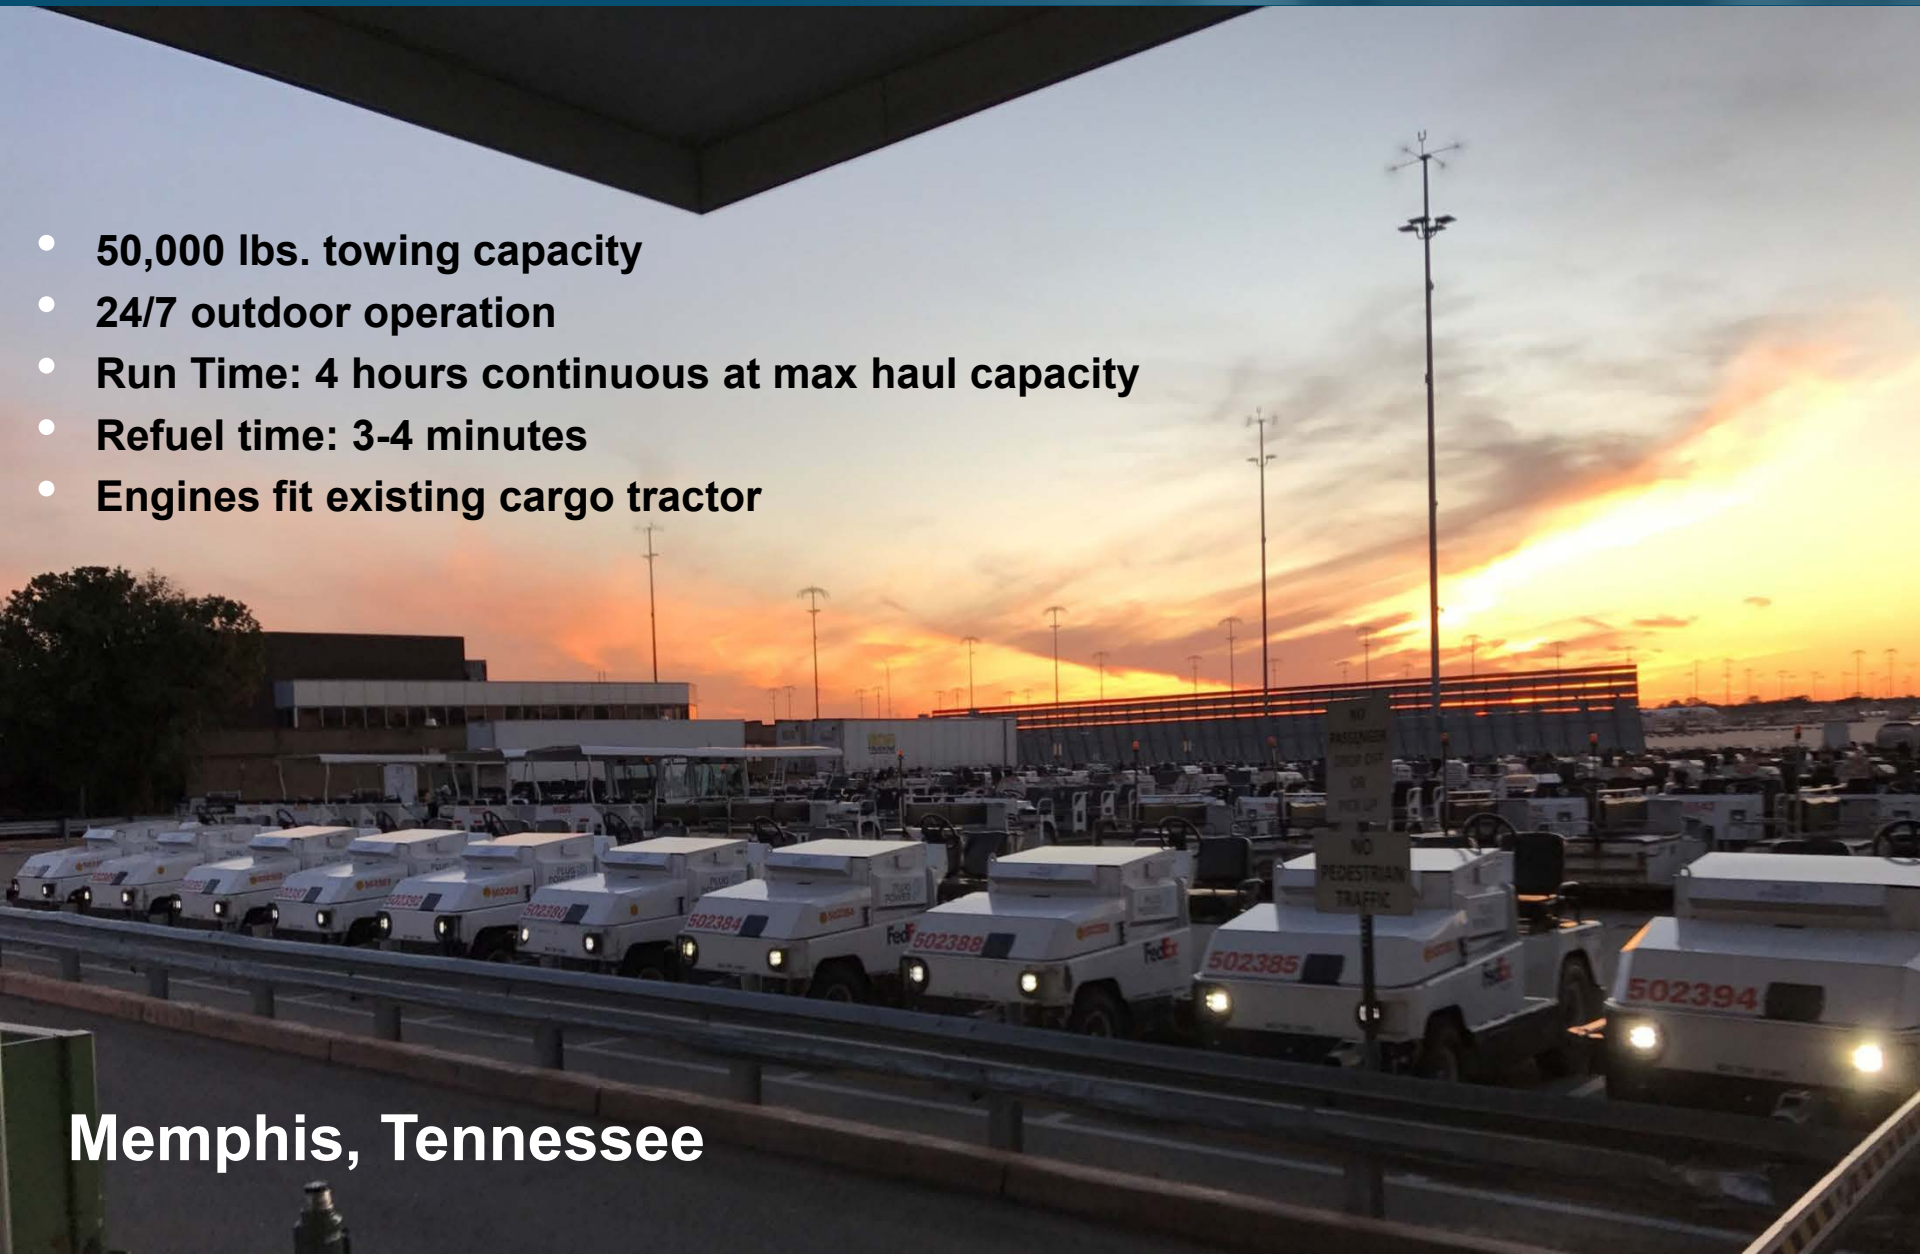
- 50,000 lbs. towing capacity
- 24/7 outdoor operation
- Run Time: 4 hours continuous at max haul capacity
- Refuel time: 3-4 minutes
- Engines fit existing cargo tractor

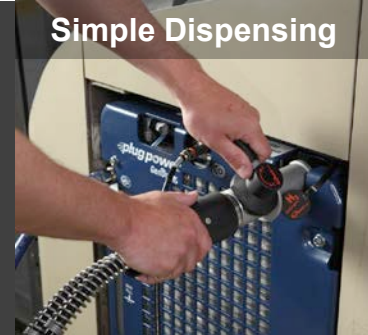
# GSE Fuel Solution: Liquid H2 Infrastructure

- H2 Capacity: 15,000 gallons (4000 kg)
- Liquid temp: -253 deg C
- Liquid Pressure: 5 PSI
- Gaseous Storage: 60 kg (scalable)
- Gaseous Pressure: 350 bar (5,000 PSI)
- Dispensing Time: 1 kg/min
