# Composite Technology for Hydrogen Pipelines

**Barton Smith, Barbara Frame,  
Lawrence Anovitz, Timothy Armstrong**  
*Oak Ridge National Laboratory*

**Annual Merit Review  
Arlington, Virginia  
June 11, 2008**

**Project ID #: PD19**

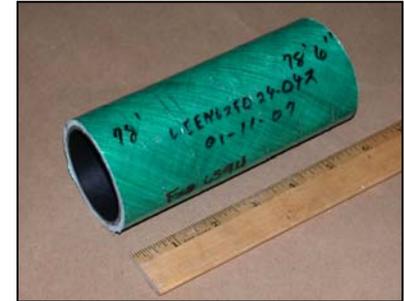
Pipeline test specimens

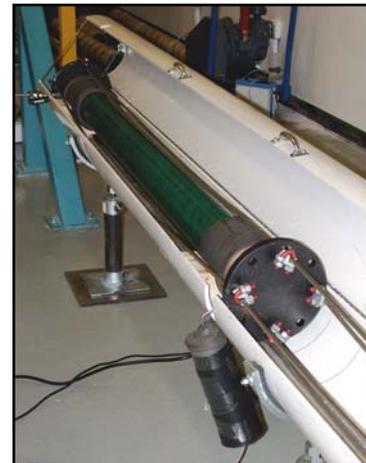
Leakage measurement at ORNL

- Leakage from end cap seals is not a significant contribution to total leak rate
- Product loss due to permeation
  - $dn/dt = 7 \times 10^{-4} \text{ mol/h} \rightarrow 2 \times 10^{-2} \text{ mol/d}$
  - Pipeline under test contained approx. 55 mol H<sub>2</sub>
  - Loss due to barrier tube permeation and end cap seal leakage was 0.03% per day, about 20 times less than that predicted using permeation coefficient for PE-3408 liner

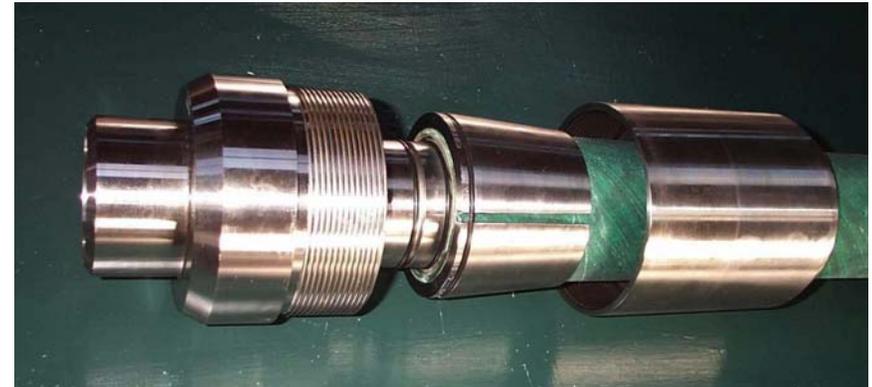
FiberSpar connector with compressive o-ring seals

- **Task 3: Joining and sensor technologies**
  - Indirect evaluation of hydrogen leakage through **Fiberspar LinePipe™** connectors showed very low leakage rate ( $<3 \times 10^{-6}$  mol/s)
  - Collaborative effort with SRNL to assess joint loading, pipeline flexure, and pressure/temperature cycling on hydrogen leakage for both Fiberspar and PolyFlow connectors

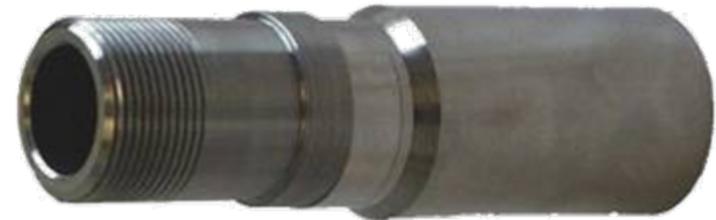
PolyFlow swaged connector

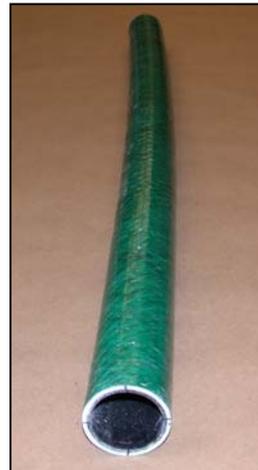
4-pt bending test specimen

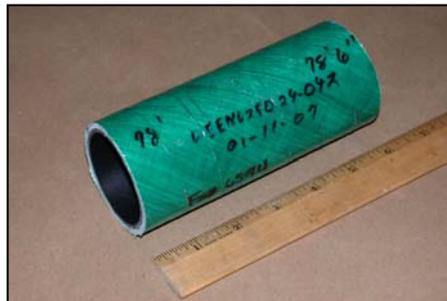
Compression test specimen

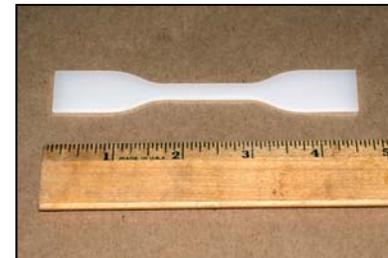
Tensile-test specimen of liner material

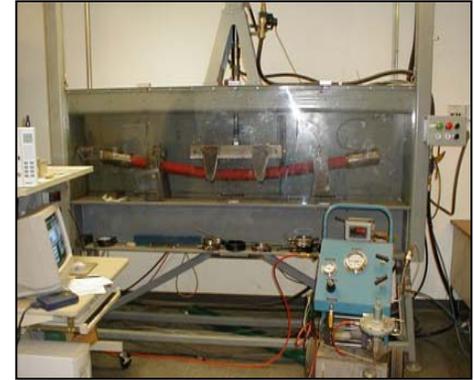
4-pt bending test at Fiberspar

- **Post-exposure testing of pipeline specimens and materials**
  - 4-point bending test to assess laminate cracking
  - Short-term pressure burst test (ASTM D1599)
  - Parallel plate compression test (ASTM D2412)
  - Tensile tests and DMA of liner, matrix resin, glass filaments
- **No statistically significant differences between as-received, air-exposed and hydrogen-exposed pipeline specimens and materials**

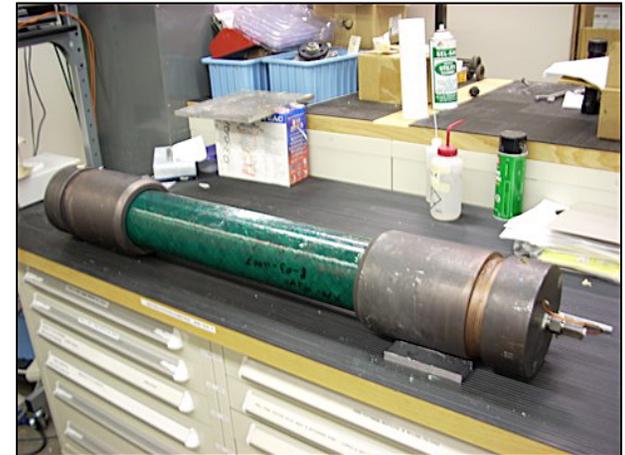
1-meter pipeline specimen instrumented for blowdown testing

- **Guidance: API 15S - Qualification of Spoolable Reinforced Plastic Line Pipe\***
  - **Fill specimen with hydrogen to pressure rating, heat specimen to temperature rating, and hold these conditions until pipeline structure is saturated with gas**
  - **Following hold period, de-pressurize specimen at a rate not less than 1000 psi/min**
  - **Examine specimen liner for evidence of blistering or collapse**
