V.G.4 Research and Development for Off-Road Fuel Cell Applications

Michael T. Hicks

IdaTech, LLC
63065 NE 18th Street
Bend, OR 97701
Phone: (541) 322-1040
E-mail: mhicks@idatech.com

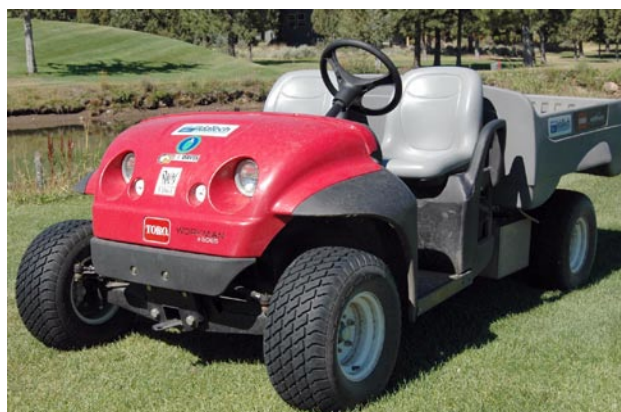
FIGURE 1. TV-1 on Golf Course

Toro® determined that the IdaTech FCS 3000 fuel cell system matched the operational requirements of the Workman® Model e2065. As a result, a Toro® Workman® Model e2065 light-duty maintenance truck was received and retrofitted to house an IdaTech FCS 3000 fuel cell system. The model e2065 unit was designated test vehicle-one (TV-1).

System run time = 318 hrs
Total fuel feed = 474 liters

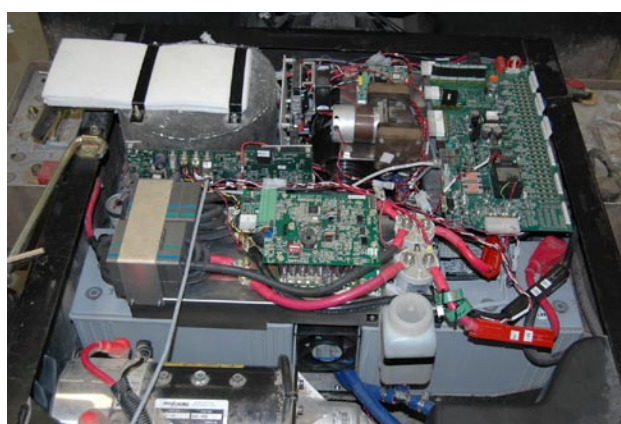
FIGURE 2. Upgraded IdaTech Liquid Fueled Fuel Cell System Installed in TV-1

Three fuel cell systems were assembled and all three passed operational testing. One fuel cell system, while sitting next to the vehicle, was used to charge the batteries. After successfully demonstrating that the fuel cell system could charge the batteries, the fuel cell system was reconfigured and installed into the vehicle. The vehicle has accumulated 63.5 hours of off-road operation at the River's Edge Golf Course. A photo of TV-1 on the golf course is shown in Figure 1. During the summer of 2008, TV-1 accumulated 62 hours of maintenance duties. During the winter an upgrade was performed on the fuel cell system. Wiring connections were reduced, a smaller, lighter DC-to-DC converter on studier sheet metal support and onboard data acquisition were incorporated. Every ten seconds data is stored on a replaceable memory card. The installed upgraded fuel cell system is shown in Figure 2. TV-1 has accumulated the following statistics:

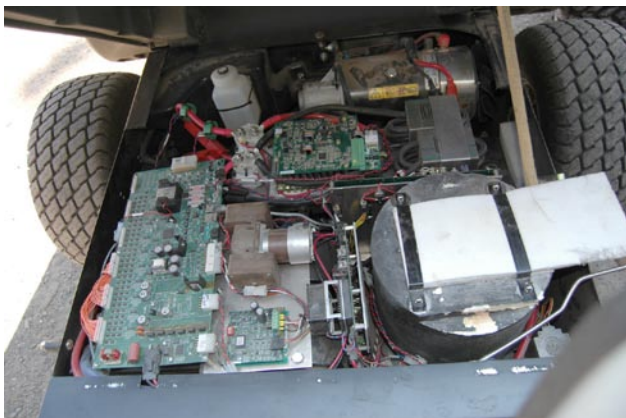
FIGURE 3. IdaTech Liquid Fueled Fuel Cell System Installed in TV-2

A second vehicle, designated TV-2, was procured from Toro® which Toro® has designated an MDE model (Mid-Duty Electric). The new vehicle design incorporates front wheel shocks and an accessible area under the front hood. An upgraded fuel cell system was installed in the vehicle. The batteries were placed two in front and two in the rear compartment. This eliminated the "saddle bag" batteries external to the rear compartment in the first vehicle. The vehicle rear compartment was modified to provide ease of removal of the whole system for maintenance. Onboard data acquisition was added with data collection every 10 seconds on a memory card. The fuel cell system installed in TV-2 is shown in Figure 3. The second vehicle was deployed at The High Desert Museum (HDM) Wildlife and Living History south of Bend, Oregon. This field trial differed in that the terrain was flatter, the operators more educated and the vehicle accumulated more operating hours. The vehicle is

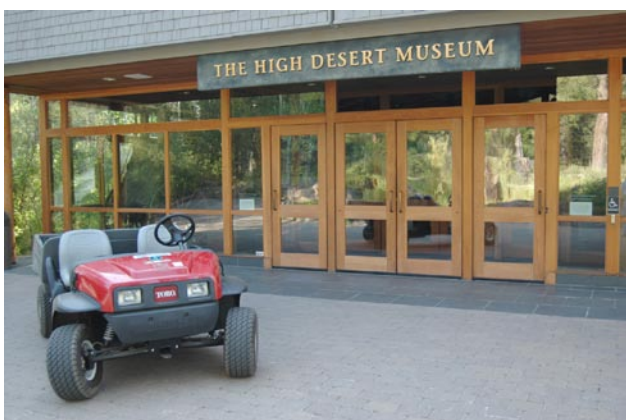
FIGURE 4. TV-2 at the High Desert Museum

shown in front of the HDM in Figure 4. TV-2 has accumulated the following statistics:

System run time = 368 hrs
 Total fuel feed = 315 liters
 Total energy = 149 kW-hrs
 Total thermal cycles = 63
