VI.6 In-line Quality Control of PEM Materials

Mainstream Engineering
200 Yellow Place
Rockledge, FL 32955

Contract Number: DE-SC0013774

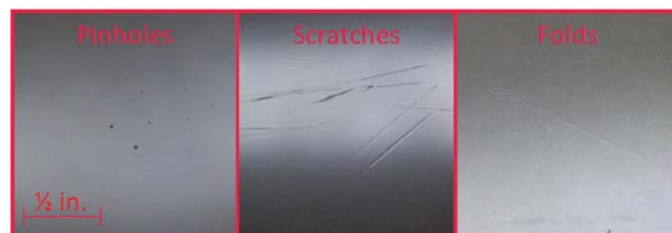
FIGURE 1. Membrane samples illustrating each of the main defect types including pinholes, scratches, and folds taken edge-lit with a compact camera

The Phase I Small Business Innovation Research project evaluated three initial target defect types including pinholes, scratches, and folds (creases) that were identified as feasible from baseline ultraviolet-visible spectroscopy. A pinhole is defined as a small hole that penetrates completely through the membrane and is less than 1 mm in size, as shown in Figure 1. Pinholes commonly occur from mechanical damage to the membrane, the presence of bubbles in the coating that have subsequently burst, dirt or fibers that have been subsequently removed in the processing leaving a void, or dewetting spots in the membrane coating process. A scratch is a surface defect where part of the membrane has been eroded or removed, as shown in Figure 1. Scratches commonly occur due to mechanical damage in the coating line from the presence of dirt particles or rough surfaces on the rollers. A fold is a defect where the membrane has been creased or overlapped on itself causing surface as well as thickness abnormalities, as shown in Figure 1. Folds commonly occur due to issues in handling. Additional defects are possible in the membrane including bubbles, dirt or undissolved polymer particles and gels. These are easily detectable using our approach but were not present in significant and controlled numbers in the commercially available membrane samples used for validation of the process on the web line. In Phase II, Mainstream will obtain samples with controlled sizes of these defects for additional validation and optimization of our inspection equipment.
