# UNLV Research Foundation High Temperature Heat Exchanger Development

Anthony E. Hechanova, Project  
Manager

University of Nevada, Las Vegas

PDP 24

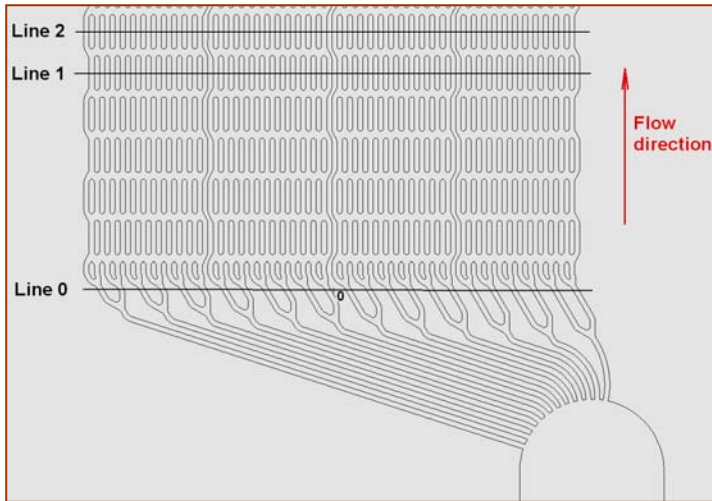
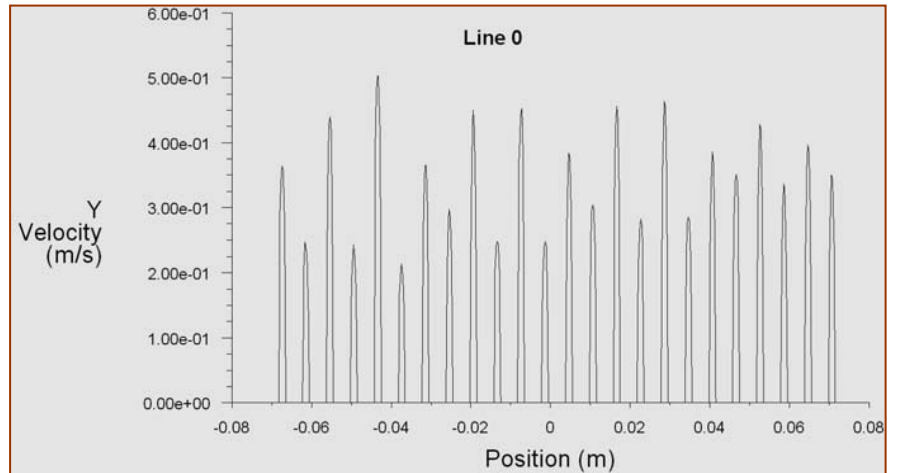
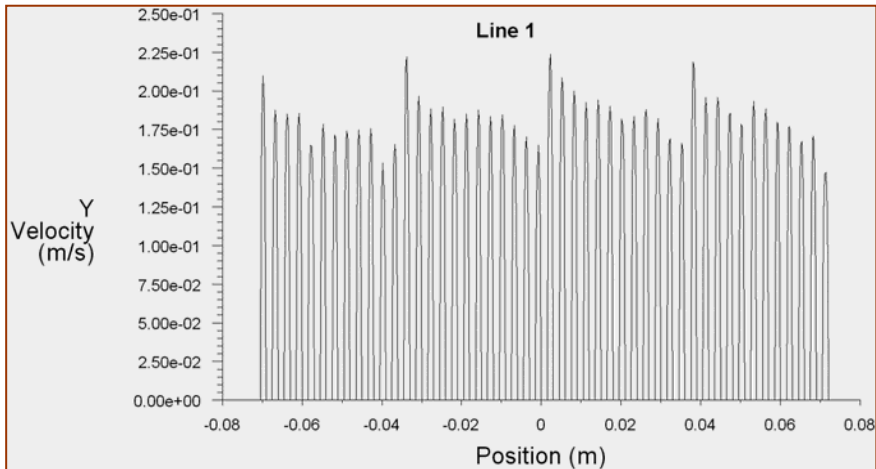
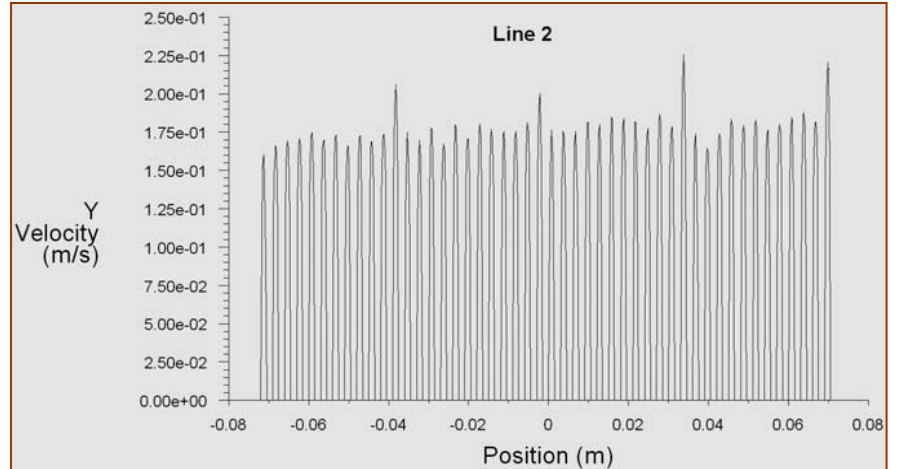
# Offset Strip Fin Heat Exchanger: Velocity Distribution in Liquid Salt Section

- Offset Strip Fin Heat Exchanger (UCB design)
  - *Optimized design*
  - *Mass flow rates distribution in the inside channels are close to uniform distribution. The configuration of the inlet manifold for the liquid-salt part is acceptable if a maximum difference of 15% could be tolerated.*

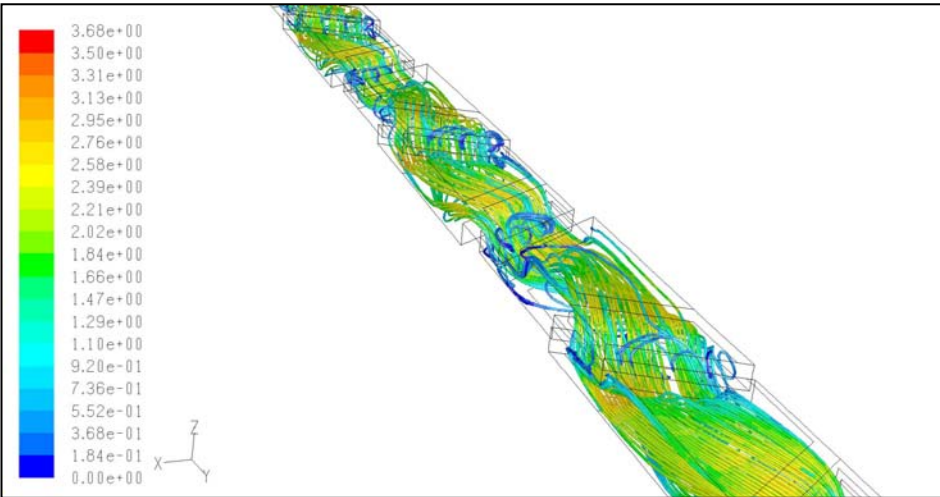
**Two hexagonal layers  
under 50% of layers overlapping**

# Compact Heat Exchanger for Chemical Reactions (Ceramatec, Inc. design): Reacting Flow Streamlines (velocity magnitude, m/s)

- Because of non-uniformity of the flow distribution among the channels for the baseline design three improved plate and manifold designs were investigated that resulted in a more uniform flow rate distribution. The most preferable design has the lowest nonuniformity parameter and overall pressure drop.

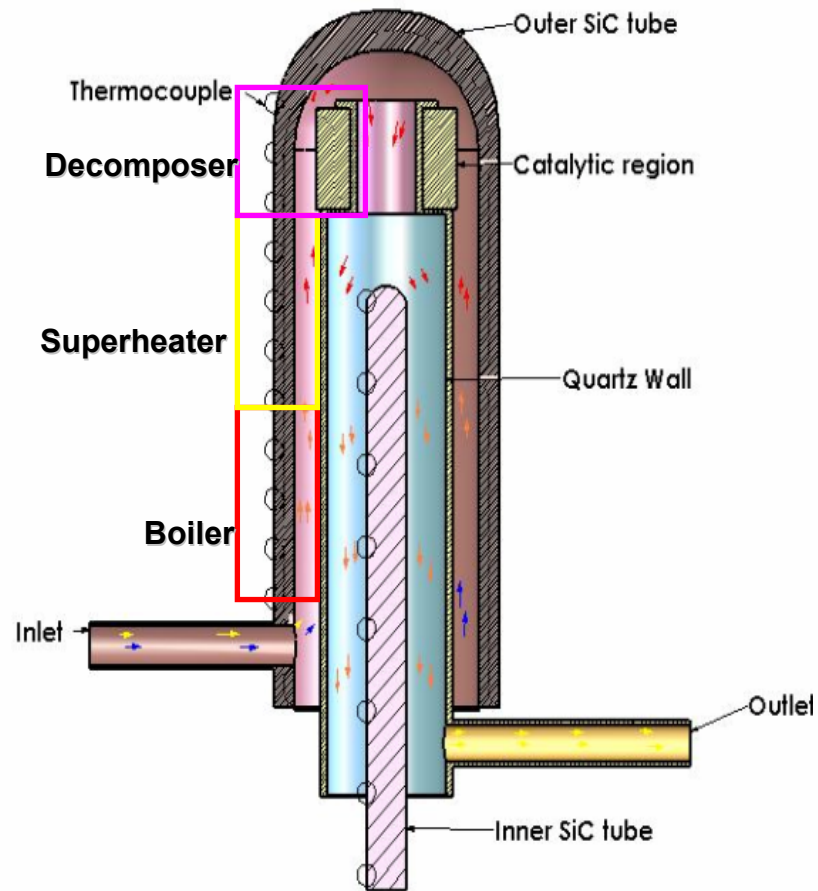
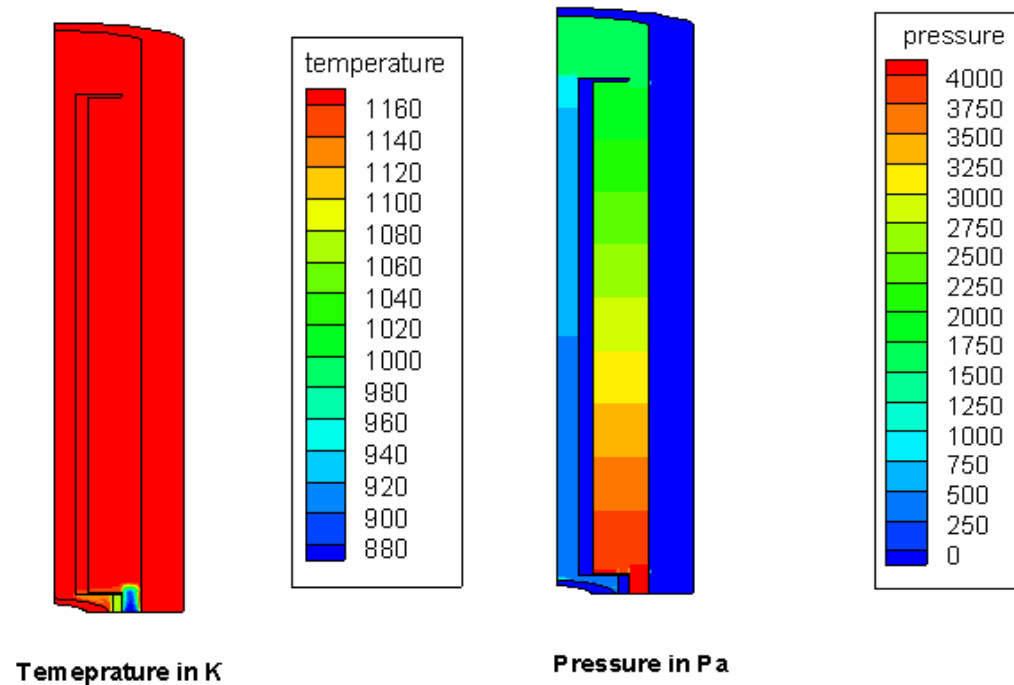
## Temperature and Pressure in the Decomposer

# Bayonet Type Heat Exchanger

- Bayonet Type Heat Exchanger and Chemical Decomposer (SNL design)
  - Calculation of the processes in the bayonet heat exchanger and decomposer for the baseline design and conditions has been completed. The SO<sub>3</sub> decomposition percentage obtained by numerical calculations is found to be in the same range as experimental observations.

- Parametric studies of the bayonet heat exchanger and decomposer for different surface-to-volume ratios, Reynolds number and operating pressures were performed. Results showed that the decomposition percentage increases with an increase in surface-to-volume ratio and operating pressure and a decrease in Reynolds number which agrees with the general observations.

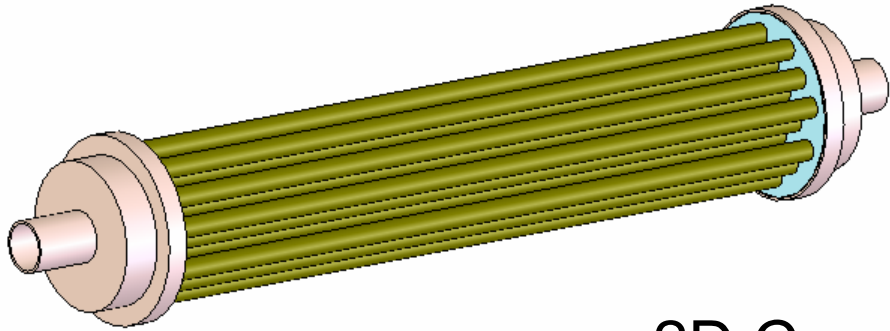
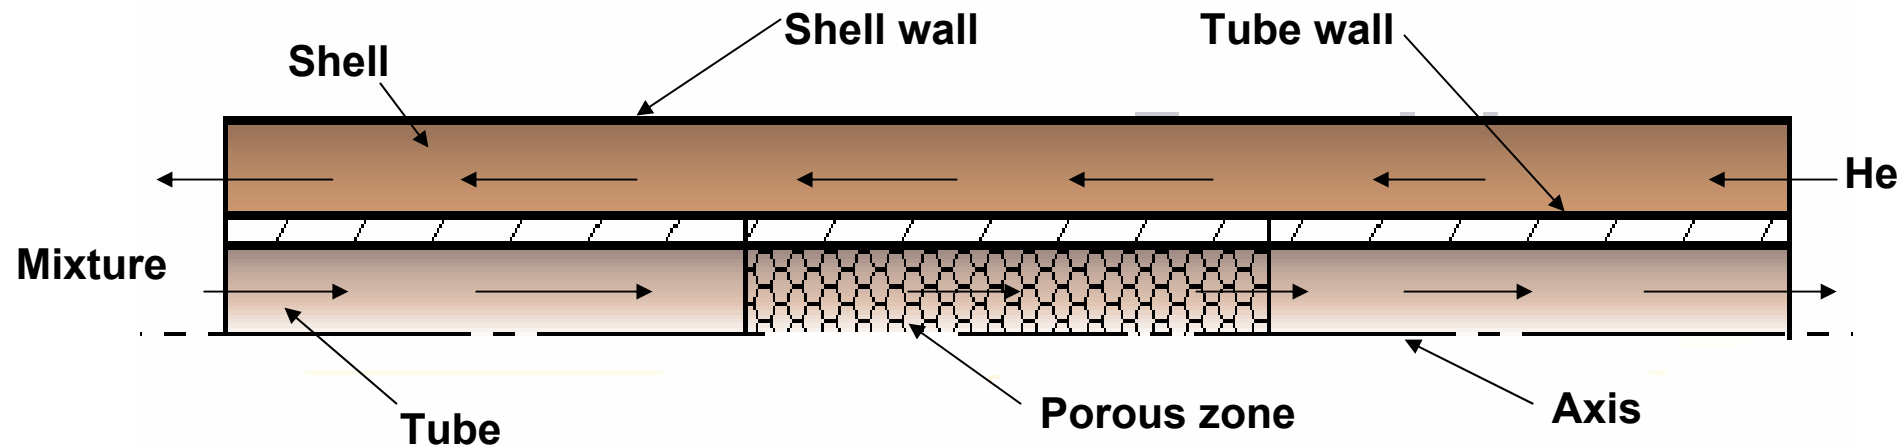
## 2D Counter Flow Model

# Shell and Tube Heat Exchanger and Chemical Decomposer

- Shell and Tube Heat Exchanger and Chemical Decomposer (UNLV/INL design)
  - A shell and tube heat exchanger with a catalytic bed inside the tubes was proposed for SO<sub>3</sub> decomposition. The calculated decomposition for the baseline design and operating conditions is very high for the both counter and parallel flow arrangements (more than 90%). One reason is because the reactant mass flow rate is very low and, consequently, residence time is very high.

- Based on a parametric study, it was found that the SO<sub>3</sub> decomposition percentage decreases with increased Reynolds number and increased tube diameter.

- A parametric study of different mass flow rates of helium passing through the shell was accomplished. The SO<sub>3</sub> decomposition increases as the mass flow rate of helium through the shell increases. A parametric study of different diameters of the shell was also performed.

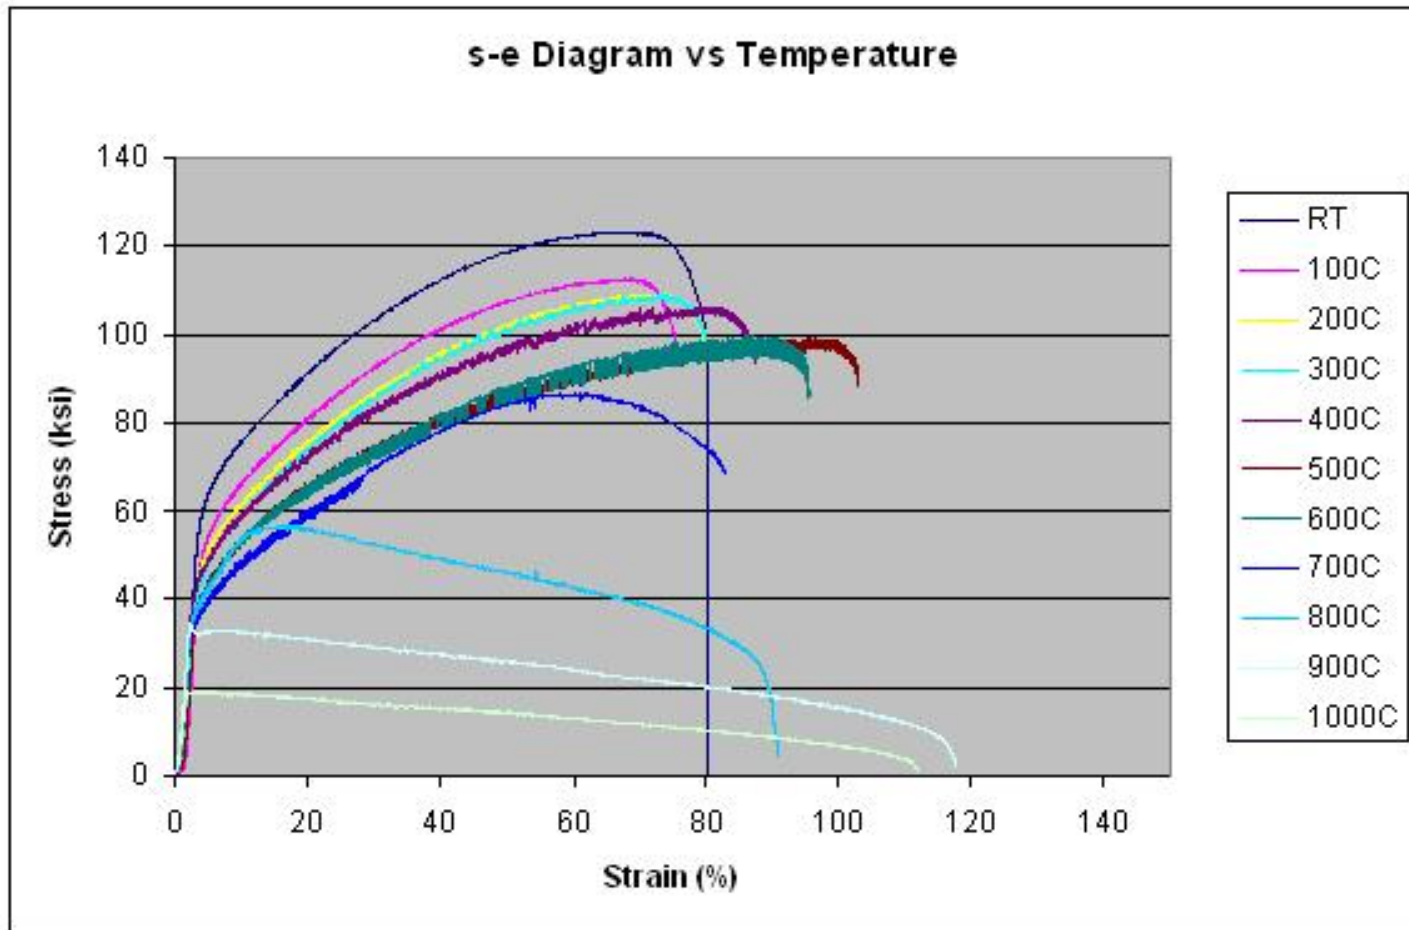
# Superimposed Engineering Stress vs Strain Diagrams at Different Temperatures for Alloy 617

- The tensile parameters (the yield strength (YS), the ultimate tensile strength (UTS), the percent elongation (%El) and the percent reduction in area (%RA) ) of Alloys C-22, C-276, 617 and 718 at temperatures ranging from ambient to 1000 C were completed.

- The reduced ductility in terms of %El and %RA within certain temperature regimes has been attributed to the occurrence of dynamic-strain-aging (DSA) behavior of susceptible materials related to the diffusion of solute elements and their accumulation near the grain boundaries. The reduced dislocation mobility through grain boundaries can lead to reduced plastic strain in terms of failure strain ( $\epsilon_f$ ) or %El. Transmission Electron Microscopy (TEM) was used to determine the dislocation density ( $\rho$ ) in specimens tested in the susceptible temperature regime.

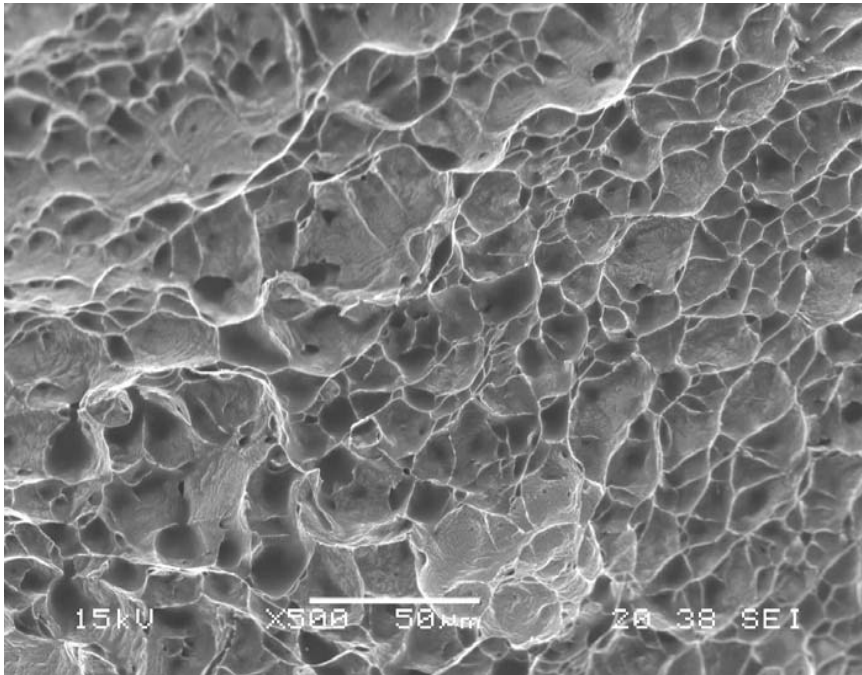
600°C

# SEM Micrographs of Alloy C-276, 500X

- The Scanning Electron Microscopy (SEM) micrographs of Alloy C-276 revealed dimpled microstructures in tensile testing at temperatures up to 600 C, indicating ductile failures. However, brittle failures were seen at temperatures of 700 and 800 C.

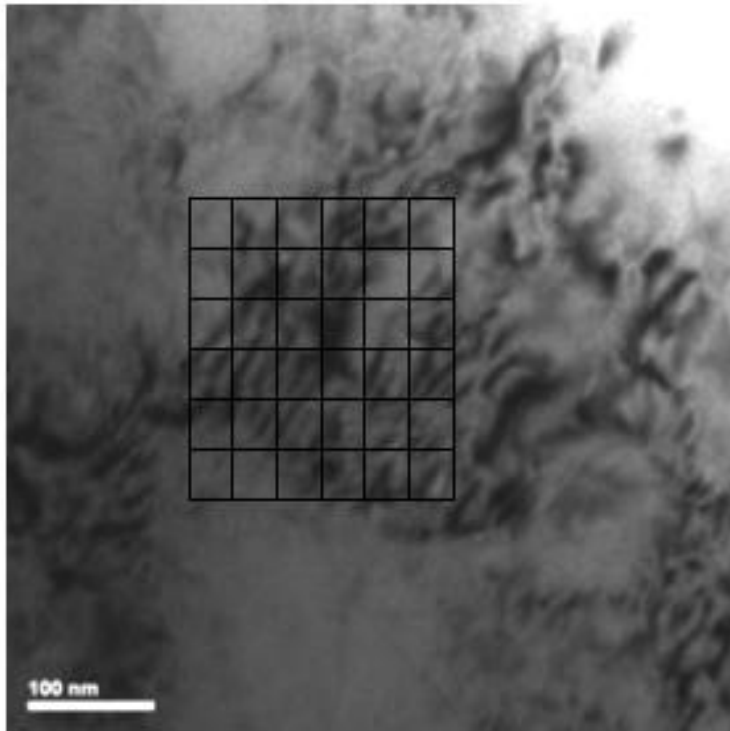
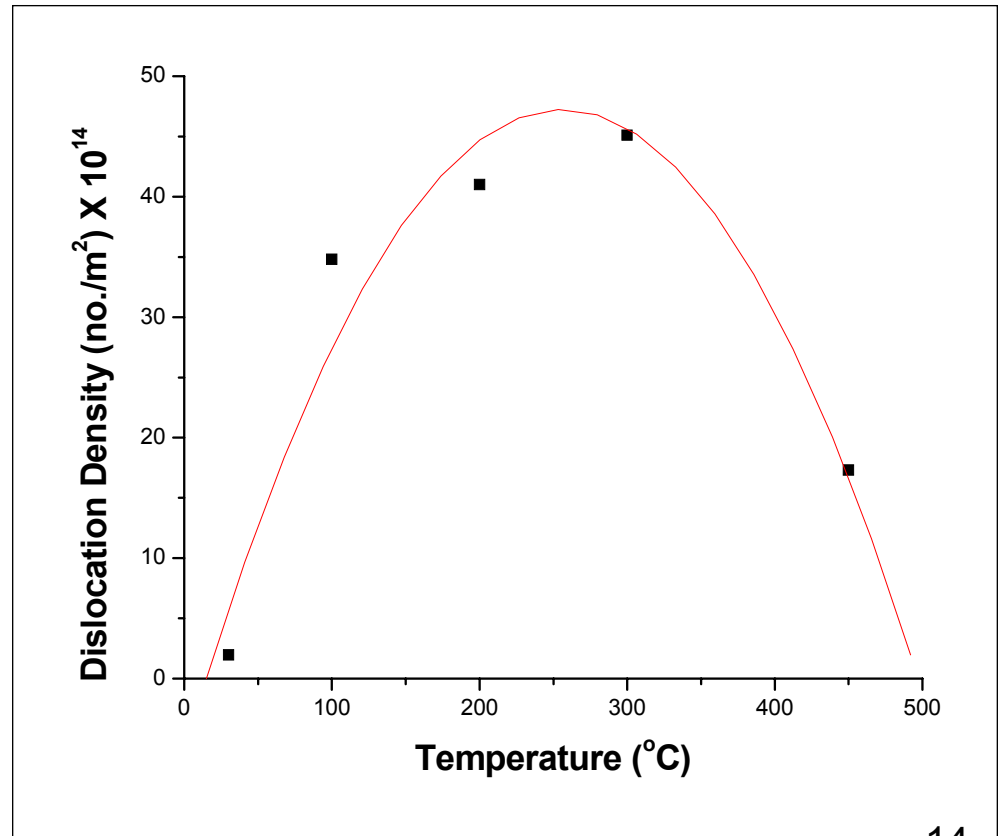
$\rho$  vs. Temperature (C-276)

# Determination of Dislocation Density ( $\rho$ ) by Line Intersection Technique

- Transmission electron microscopy (TEM) was used to characterize dislocations using the resultant micrographs and superimposition of grids onto them. The results indicate that the magnitude of dislocation density ( $\rho$ ) was highest at temperatures in the vicinity of 200 and 300 C (C-276), where reduced plastic strains were noted. The magnitude of  $\rho$  was relatively lower at 450 C due to enhanced dislocation mobility and ease of plastic deformation.

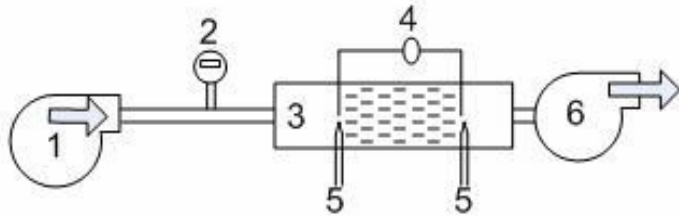
Schematic diagram of experimental rig

# Single-chamber Test Sections and Model Streamlines

- Modeling was completed and prototype (1:3 scale for air and 1:2 for silicon oil) test sections were built with Alloy 6061 and Acrylic sheets (with square-edge-fins and round-edge-fins).

- Air to simulate He and silicon oil to simulate liquid salt were the testing fluids.
- Isothermal and heated tests with air were performed to measure friction factors. Friction factors were calculated and compared with that of the square-edge-fins. The volumetric flow rate was varied and corresponded to a range of Reynolds numbers between 1800 and 2600. The results show that the friction factors of round-edged fins are 40% less than that of the square-edged fins.

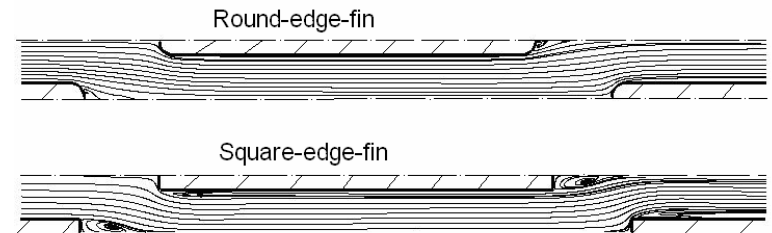
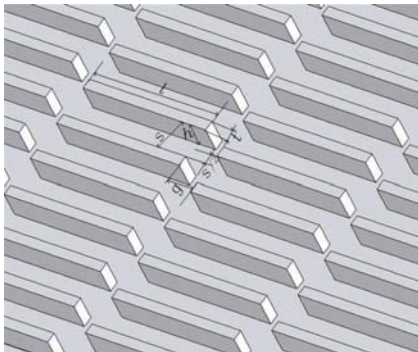
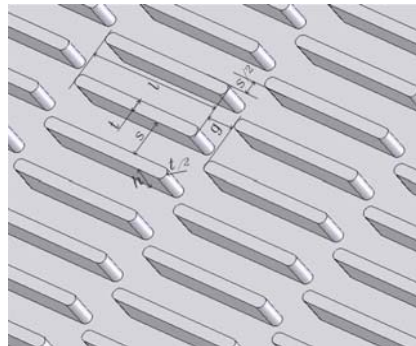
Square-edge-fins    Round-edge-fins

Streamlines  
 $Re=2400$  and isothermal

- The hydrodynamic tests in an isothermal single-chamber test section with 2 cSt and 5 cSt silicon oils were completed. The experiments were performed using Reynolds numbers variations from 50 to 250 to simulate the prototype heat exchanger flow.

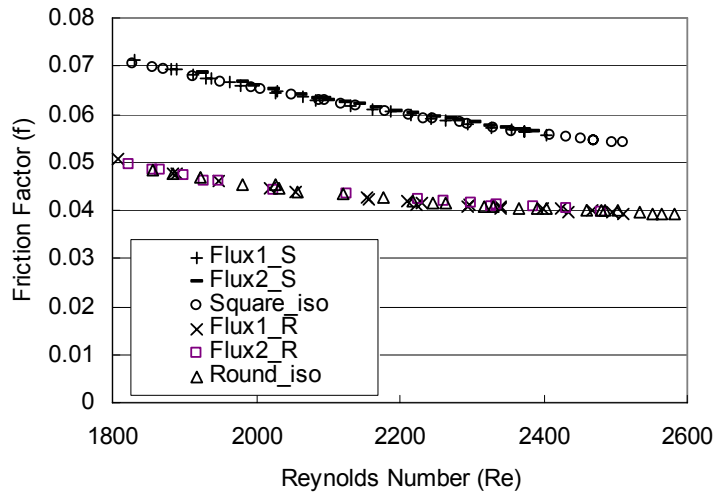
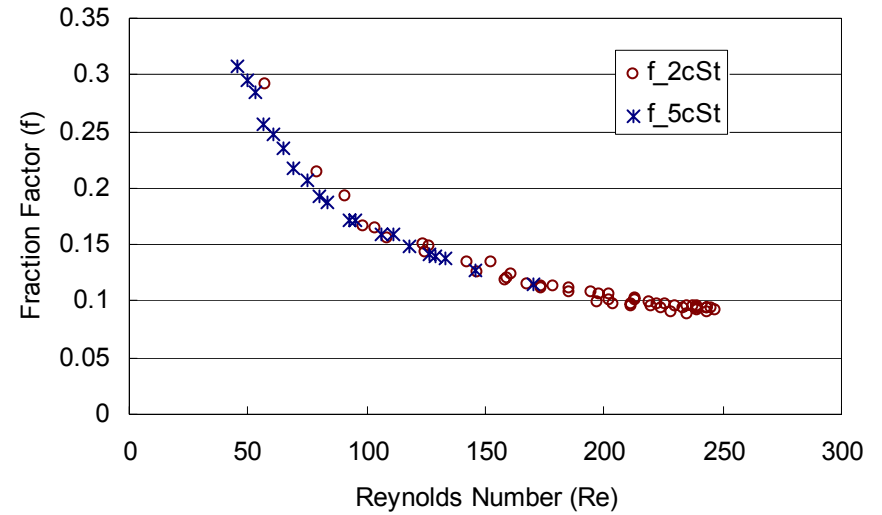
# Friction Factors of Different Fin Shapes Under Isothermal and Heated (Air) Conditions

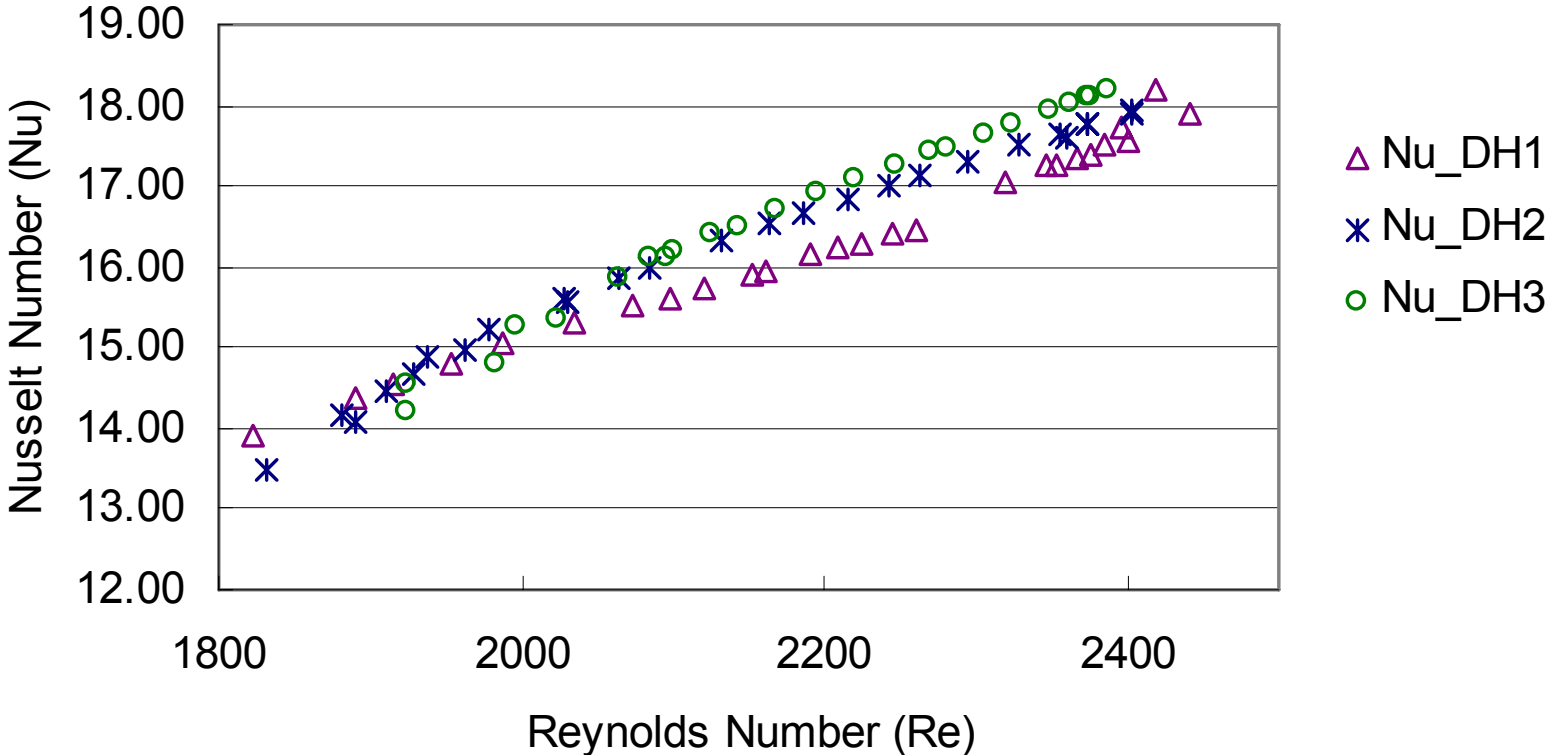
Nusselt Number vs Reynolds Number with Double-heating

# Nusselt Number versus Reynolds Number with double-sided heating (air is working fluid)

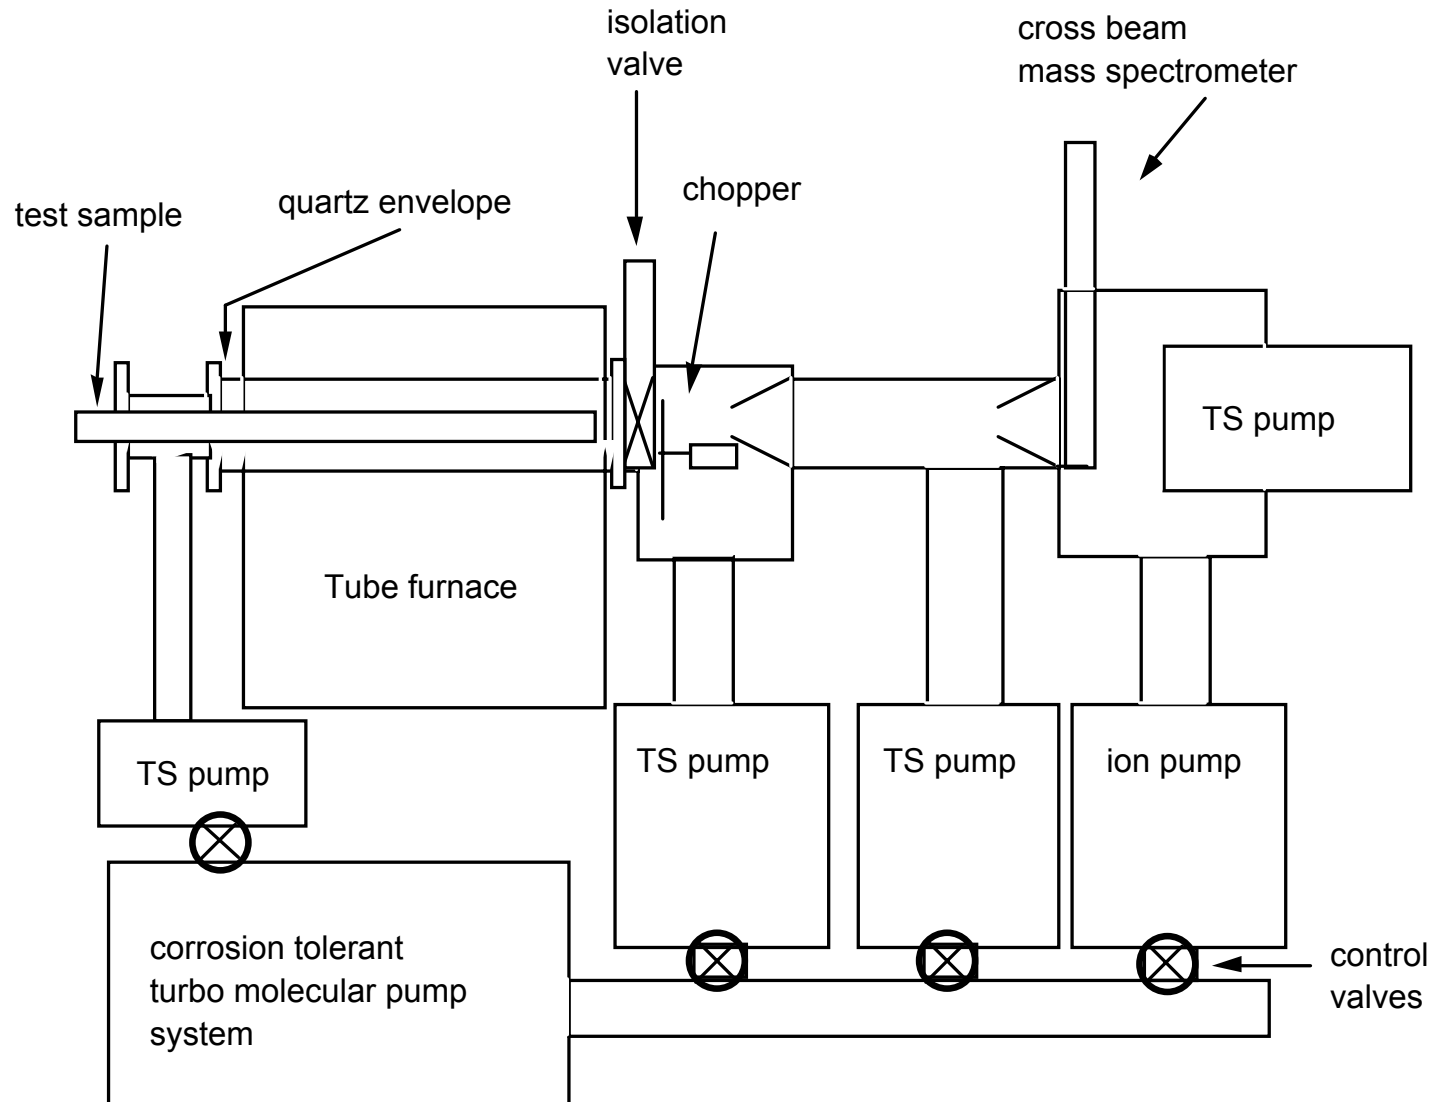
# Proposed Chemical Characterization Facility

- A corrosion-resistant modulated molecular beam mass spectrometer-monitored vacuum furnace facility was designed.
- The vacuum system was designed to tolerate the acidic and halogen containing compounds used the sulfur-iodine thermochemical process.

- The facility will allow a number of materials related studies, measuring permeation and failure with gas pressure loads under chemical and thermal conditions characteristic of the S-I process.

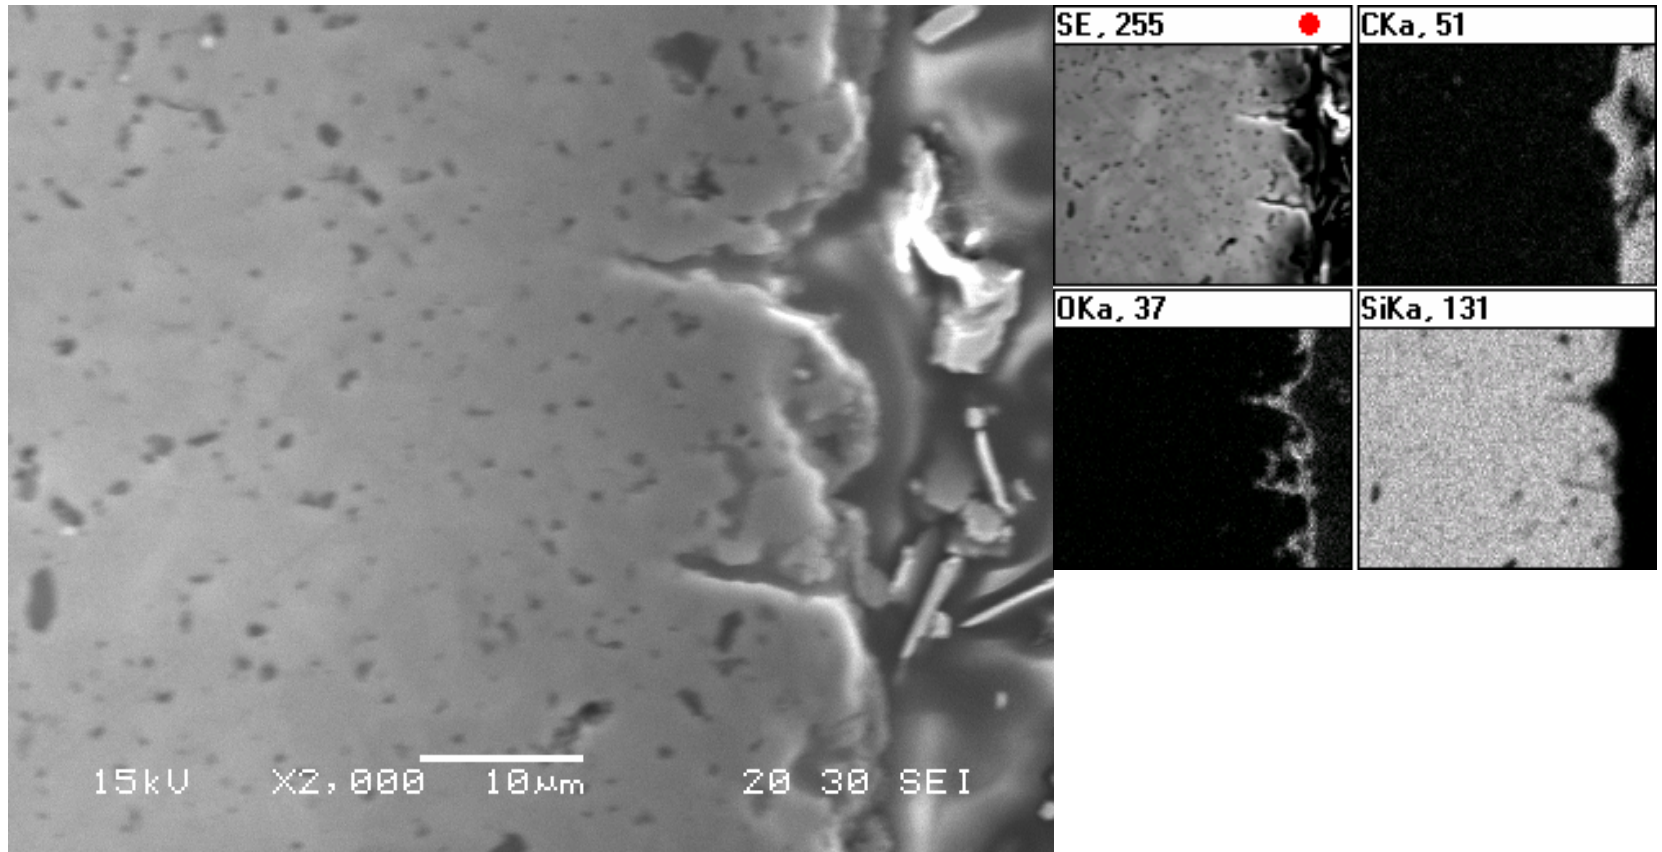
# Cracked Region of Silicon Carbide Exposed to H<sub>2</sub>SO<sub>4</sub> at ~900 C for 1000 hrs.

*Note the oxide in the cracks.*

- X-ray photospectroscopy was used to confirm the formation of a silicon dioxide (silica,  $\text{SiO}_2$ ) layer on corrosion samples supplied by Ceramatec, Inc. A layer of silica on the surface of the materials may act to blunt surface flaws and lead to an apparent increase in strength, as measured.

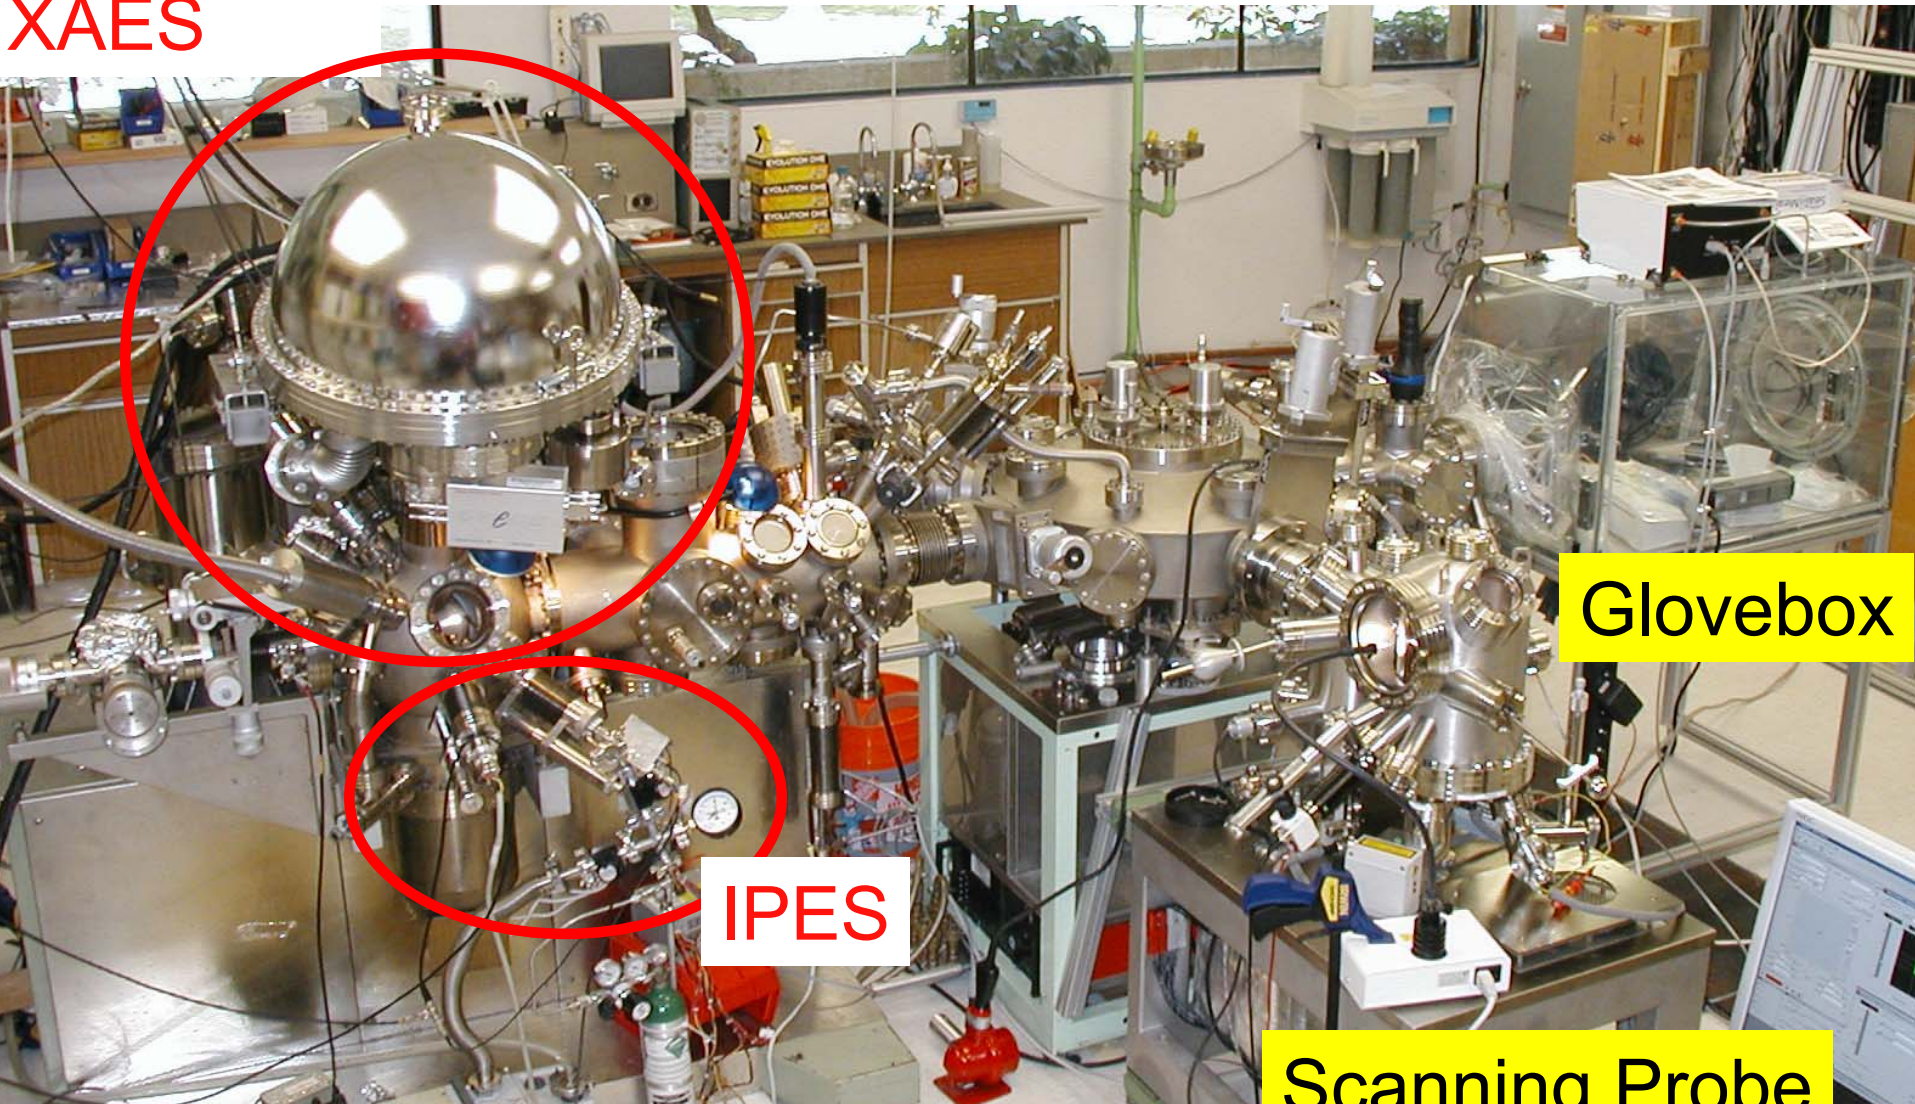
# UNLV Facility

XPS, UPS,  
XAES

- Successfully installed new electron spectrometer, scanning probe microscope, and sample insertion glove box.
- Completed spectral library for commercially available reference compounds.

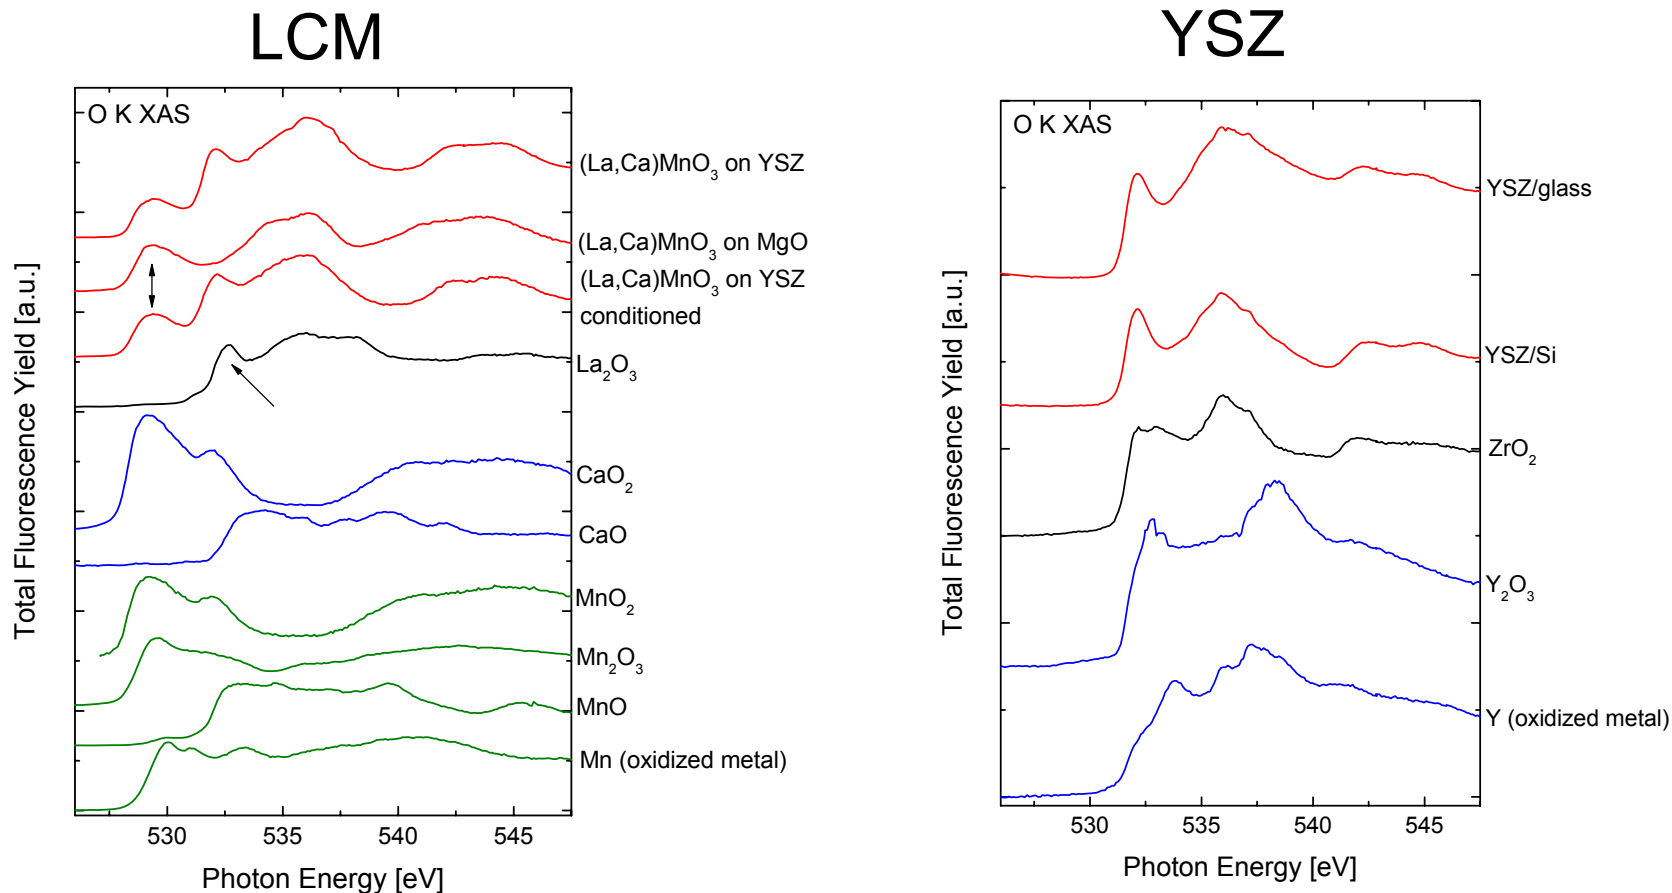
# X-ray absorption spectra of LCM and YSZ films together with the spectra of several reference materials

The spectra show that x-ray absorption is a very sensitive tool to investigate the actual compound and oxidation state of the sample.

- X-ray absorption was found to be a very sensitive tool to investigate the actual compound and oxidation state of the samples.
- As expected, all samples show characteristic signatures of La, Ca, Mn, and O core levels and Auger transitions. Furthermore, significant C and O contaminations were found on the surface. This is not unexpected, since the surfaces were exposed to air after preparation and during additional tests at ANL.

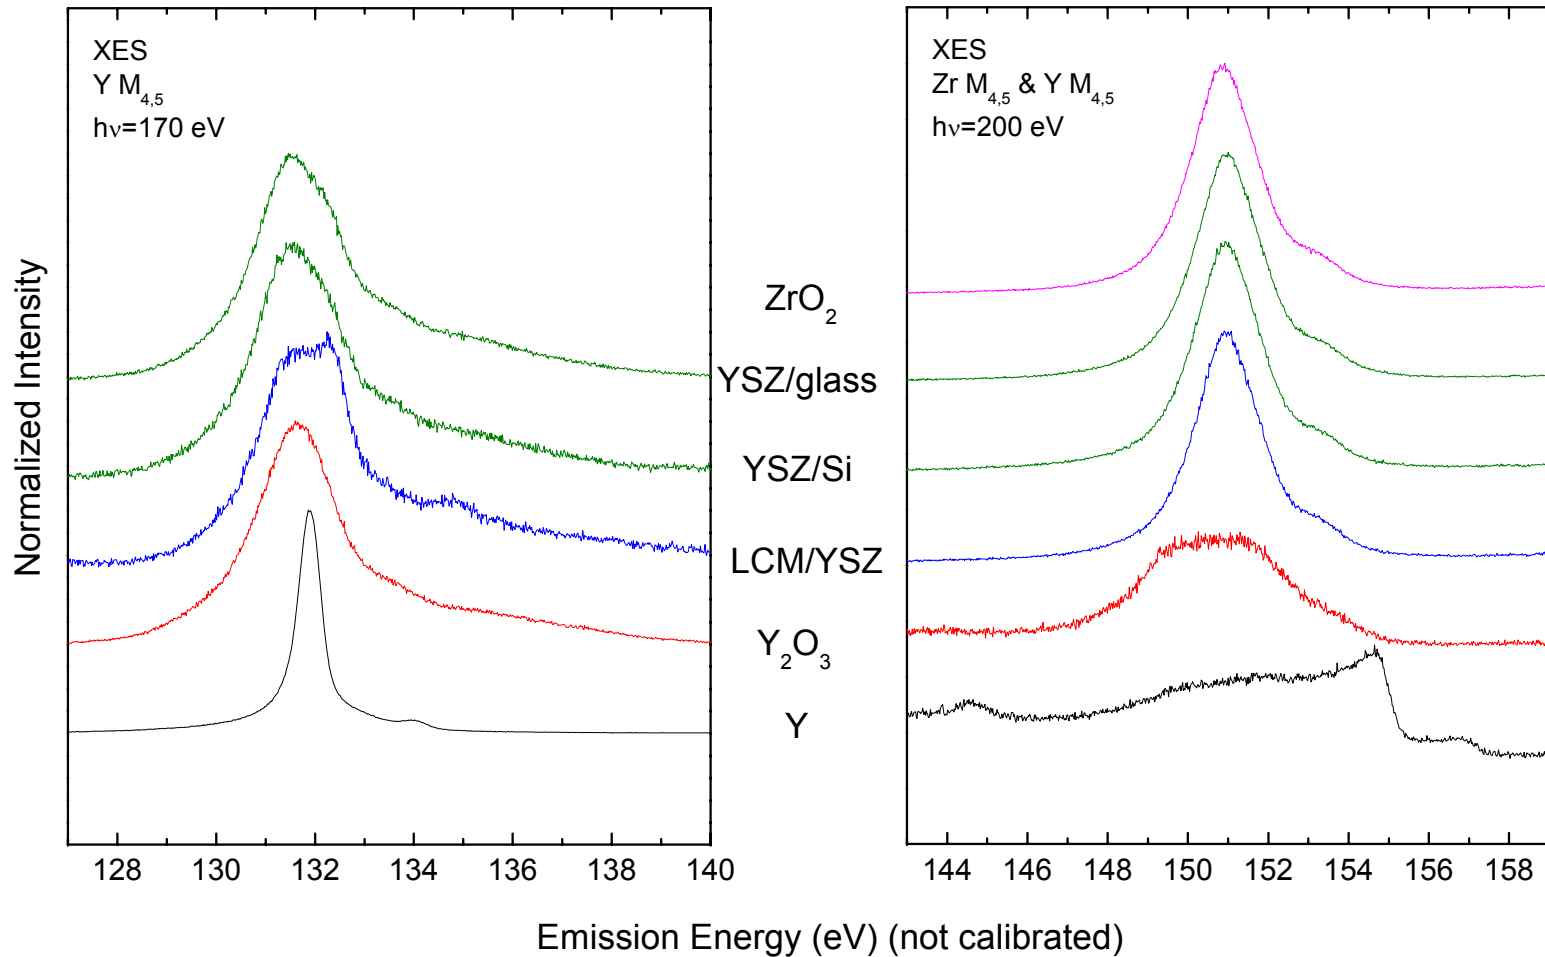
# X-ray emission spectra of LCM and YSZ films together with those of some reference compounds.

The Y M<sub>4,5</sub> emission of the YSZ films is in good agreement with that of the Y<sub>2</sub>O<sub>3</sub> reference.

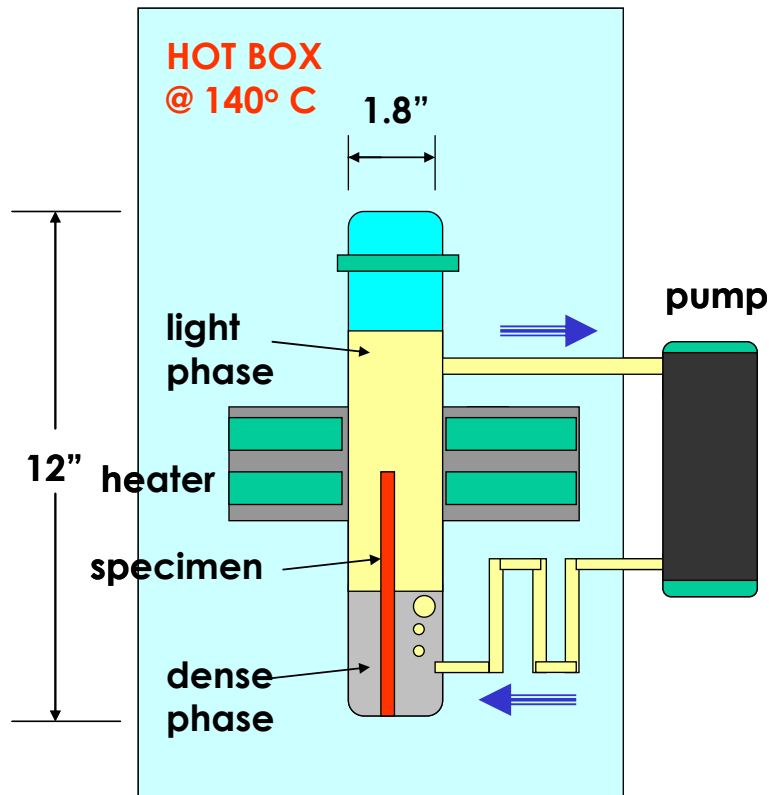
# The acid ( $\text{HI}_x$ ; $\text{HI}_x + \text{H}_3\text{PO}_4$ ) circulating system

- Corrosion behavior can be radically affect by agitation
- System can handle two phase liquids:  $\text{H}_3\text{PO}_4$ - $\text{HI}$ - $\text{H}_2\text{O}$  (light)  
 $\text{I}_2$  rich (dense)

- The light phase is pumped into the bottom of the capsule. It rises to the top due to density difference
- Processed and Ta coated parts, stress corrosion and tensile specimens have been tested in this set up

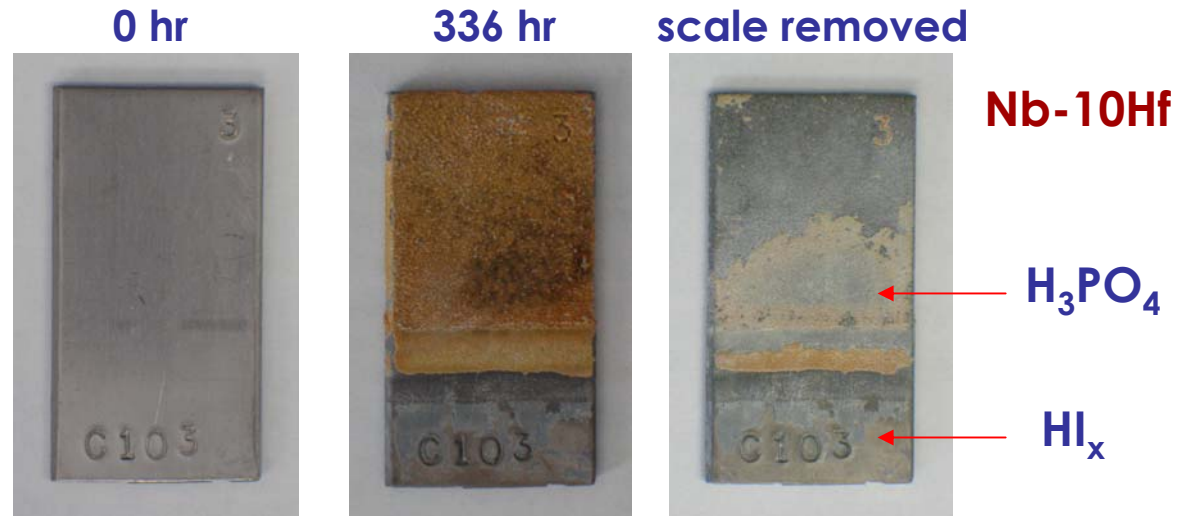
- Nb alloys showed noticeable corrosion in the  $HI_x + H_3PO_4$  mixture at  $120^\circ C$

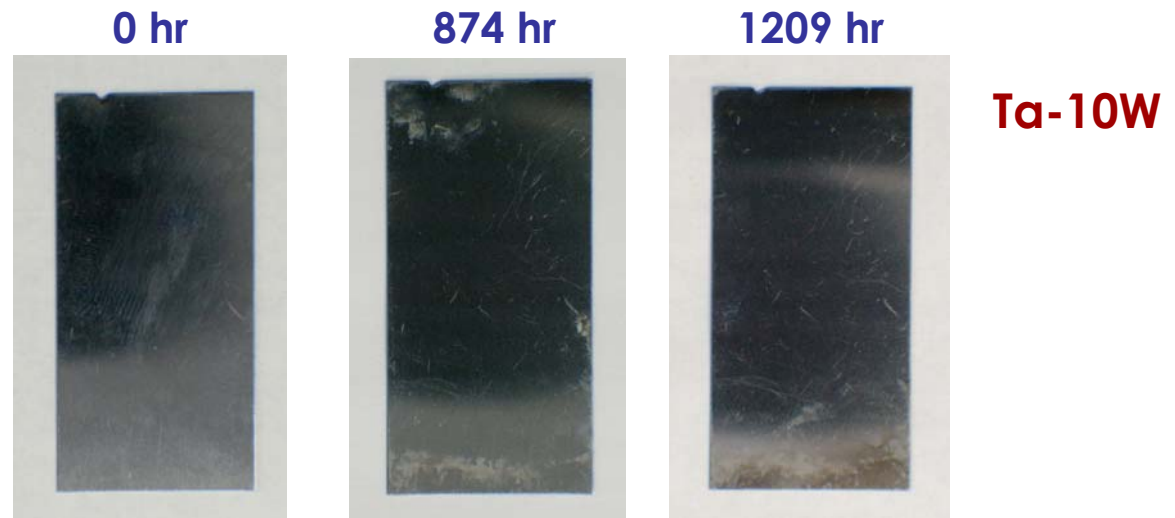
- Ta alloys are the only metals which can handle the iodine separation acid complexes
