# UNLV Research Foundation High Temperature Heat Exchanger Development

Anthony E. Hechanova, Project  
Manager

University of Nevada, Las Vegas

PDP 24

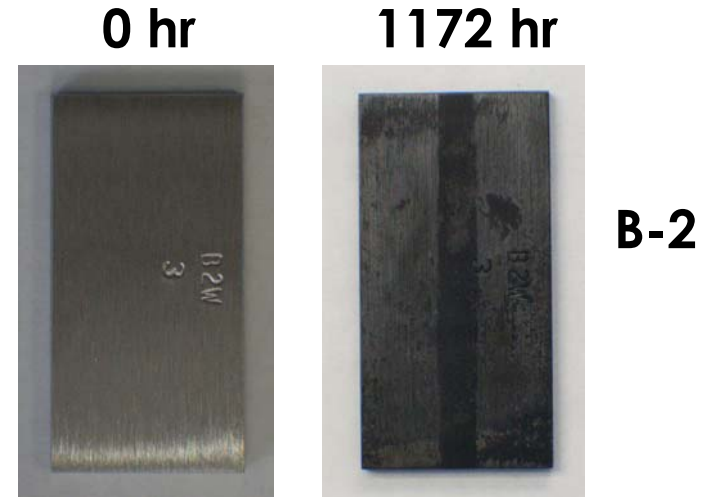
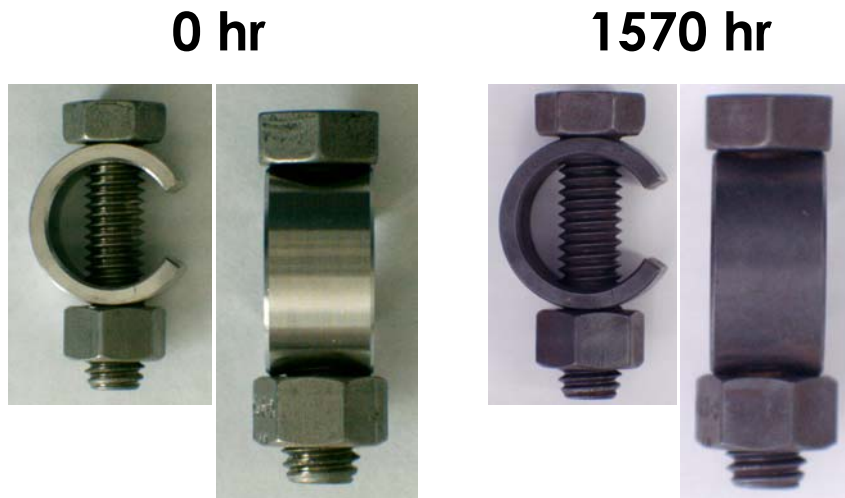
Hastelloys showed the best corrosion performance in the HI decomposition environment ( $\text{HI} + \text{I}_2 + \text{H}_2$ )

hours	mpy
B-2	1172	2.55
C-22	1570	10.70
C-276	1220	13.50

➤ Stress corrosion testing of C-22 and C-276 U-bend and C-ring specimens did not show any crack initiation

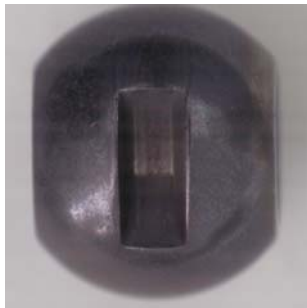
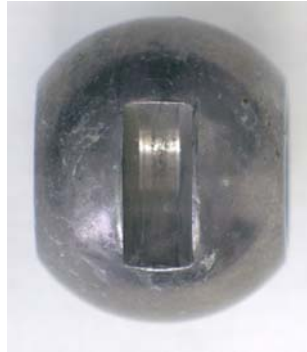
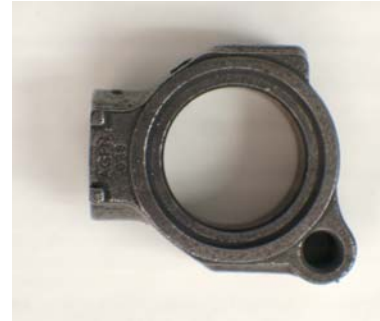
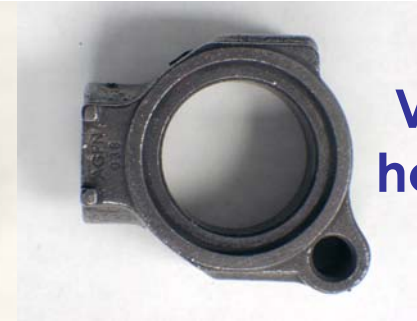
# Ta coated components such as fittings and valves

- Most valves parts did not show any sign of corrosion

Valve ball

Valve housing

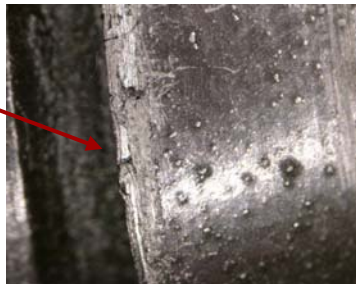
- Testing did reveal incorrect assembly can lead to damage in the Ta coating

Damaged fitting during installation

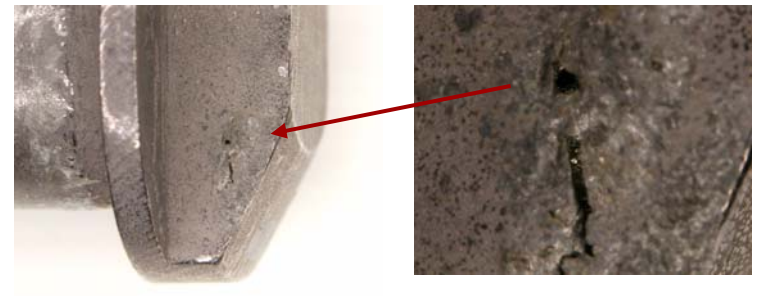
Incorrectly installed valve drive bolt

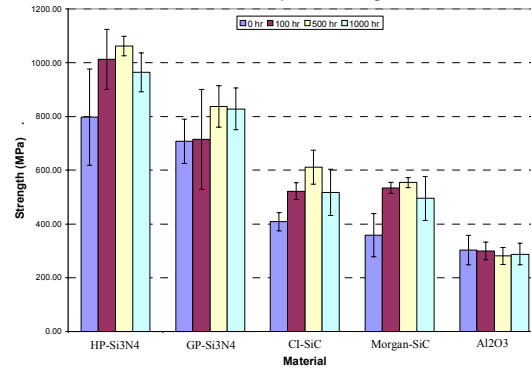
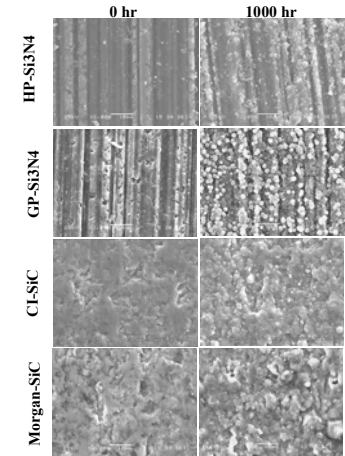
- Corrosion properties:
  - Ceramic materials are resistant to corrosion in high temperature decomposer atmospheres.
  - Silicon Carbide & Silicon Nitride form passive, silica (SiO) films that govern corrosion.
  - Strength of ceramic materials are insensitive to decomposition temperatures.

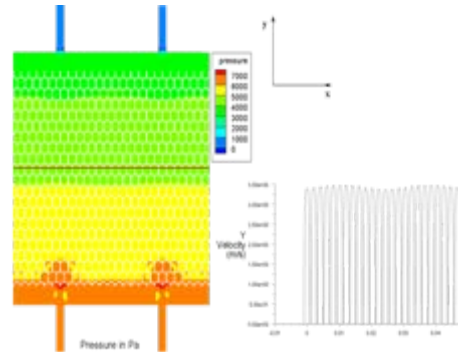
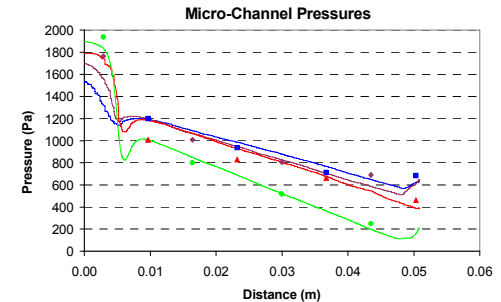
- Heat exchanger models predict:
  - Uniform flow distribution.
  - 60+% single pass conversion.
  - 88% effective.
  - Design S.F > 2.0 for silicon nitride and silicon carbide.
- Fabricated heat exchanger coupons match experimental results within  $\pm 5\%$ .

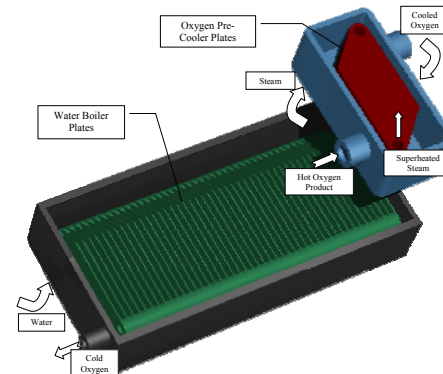
## O<sub>2</sub> Chiller Conceptual Design:

- 2-stage chiller raises steam for electrolysis feed while chilling O<sub>2</sub> to 75 C.

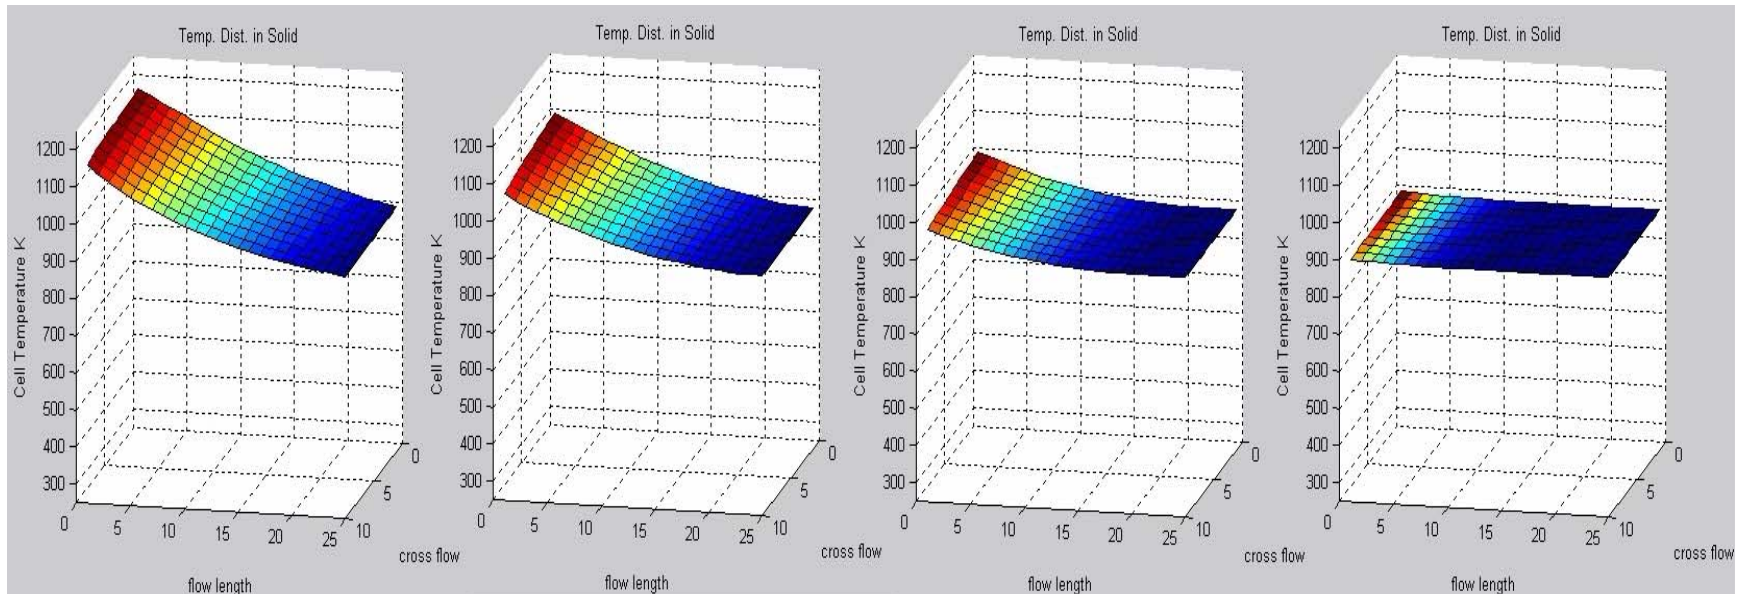
## Cold fluid pump trip transient simulation

- Thermal transient response in offset-strip fin region of intermediate heat exchanger solid using effective porous media model
- Roughly a 4 second transient

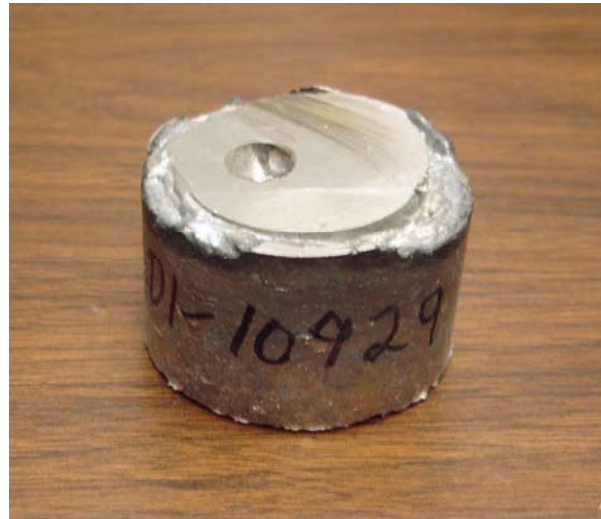
As-received Alloy 617 + 1wt% Pt

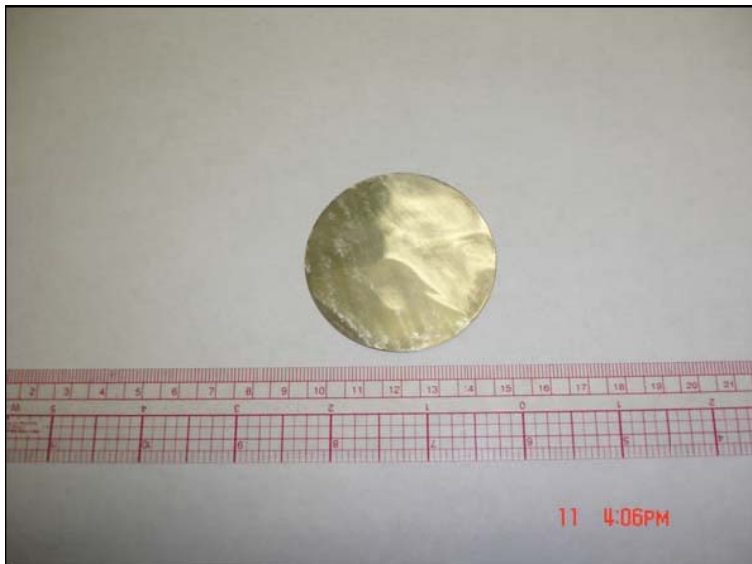
Alloy 617 + 1 wt% Pt, 254  $\mu\text{m}$  thickness disc cut by Wire EDM for catalytic effectiveness testing

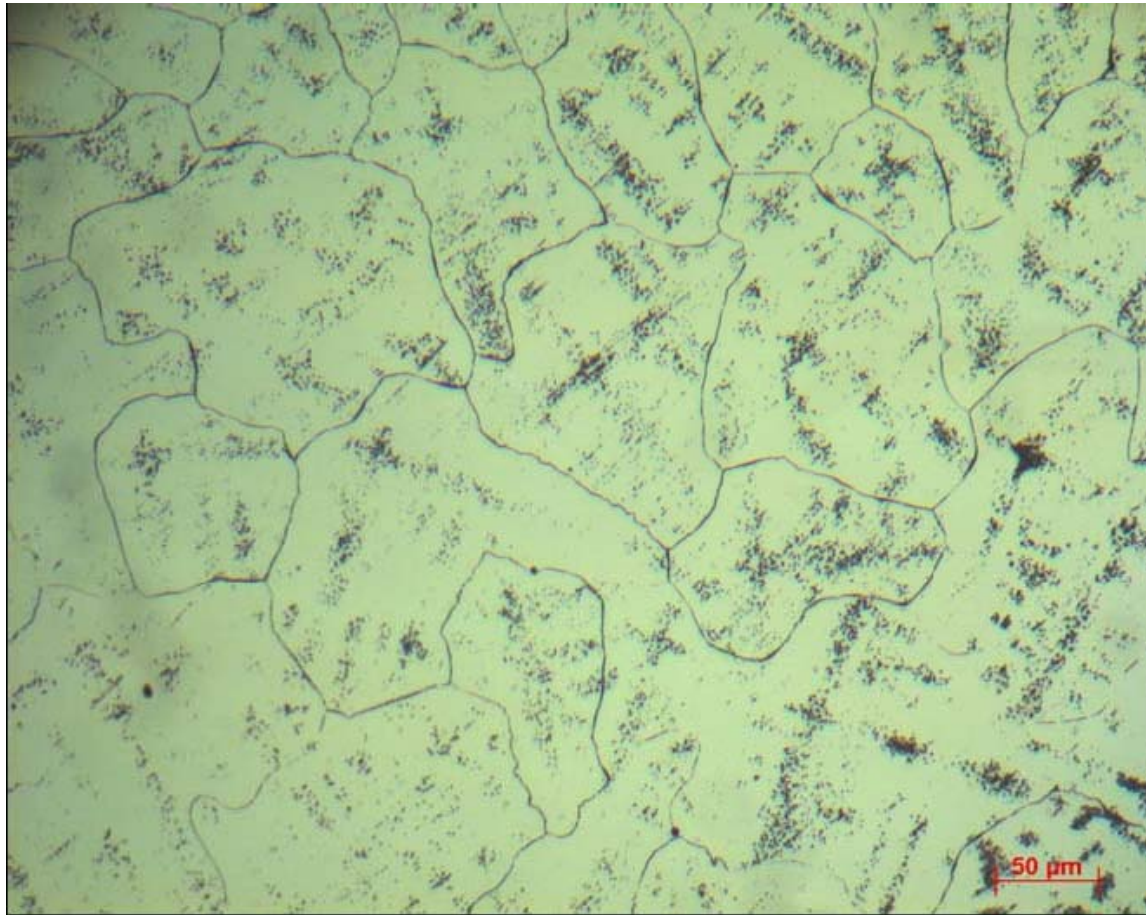
Grain, dendrite and precipitate features of cast Alloy 617 + 1 wt% Pt, 200 X.  
(strong glyceresia - 90 sec; overly etched to reveal dendrite structure inside the grains)

- Based on the previous work, Alloy 800H + Pt chemistry materials were etched with a weak version of glyceresia. For Alloy 617 + Pt chemistry materials, stronger version of glyceresia was used. Each material was etched in 1 minute intervals interrupted with ultrasonic cleansing in an ethanol bath in order to periodically monitor microstructure development via optical magnification at 100 X.

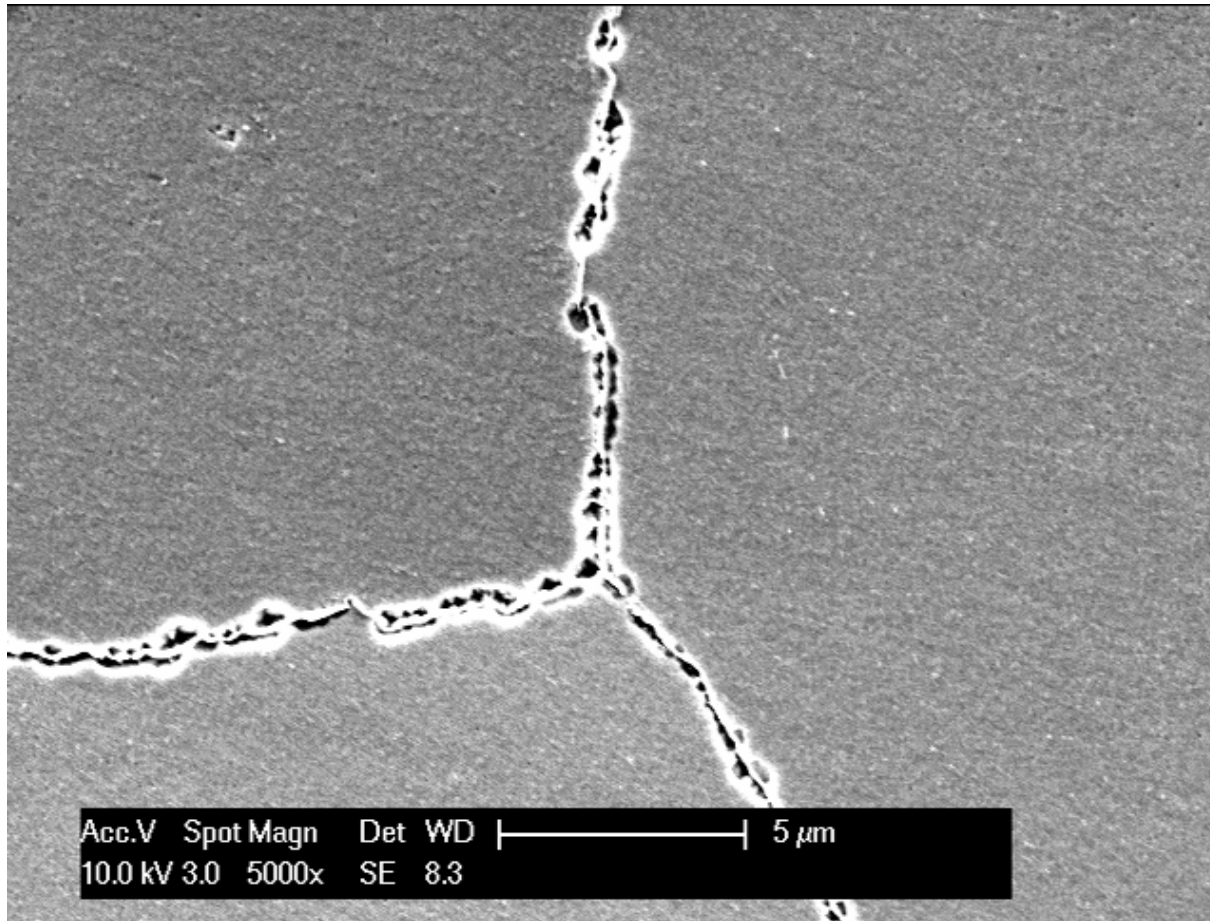
Grain boundaries of cast Alloy 800 H + 5 wt% Pt, 5000 X,  
weak glycergia - 300 sec
