# Fiber Reinforced Composite Pipelines

G. Rawls, J. Gray, and T. Adams

Savannah River National Laboratory

April 2010

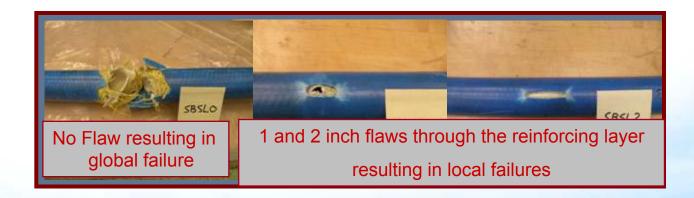
#### Single Layer Reinforcement

- Reduction in burst pressure from unflawed condition to a 2 inch long flaw cutting the reinforcing layer of 75 % for short term burst and multiply layer reinforcement
- With the 2 inch long flaw cutting the reinforcing layer the burst pressure drops below the rated pressure
- The single layer reinforced piping does not provide sufficient redundancy to tolerate third party damage
