## III.6 FY 2008 SRNL Hydrogen Delivery Project—Hydrogen Permeability and Pipeline Integrity/Fiber Reinforced Composite Pipeline

Dr. Thad Adams  
Savannah River National Laboratory (SRNL)  
Materials Science & Technology  
773-41A/151  
Aiken, SC 29808  
Phone: (803) 725-5510; Fax: (803) 725-4553  
E-mail: thad.adams@srnl.doe.gov

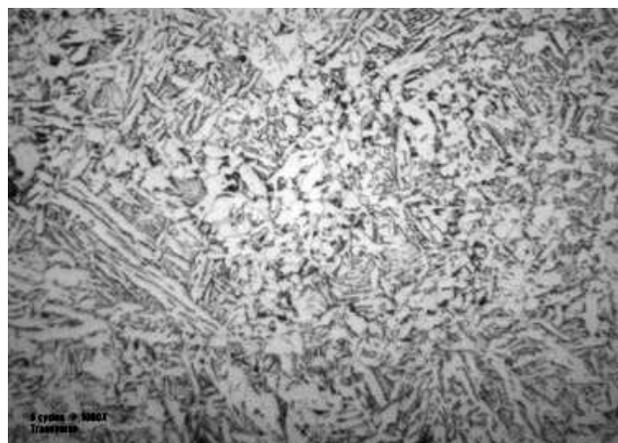
**FIGURE 1.** Photomicrograph of the Microstructure for a 5-Weld Pass GLEEBLE Simulation Sample

A critical issue to understanding the susceptibility of metallic pipeline materials to hydrogen embrittlement is related to the development of a fundamental understanding of the link between microstructural features and hydrogen transport within the materials. Elucidation of the impact of surface structure, microstructure scale, the role of various phases within a multi-phase structure and the impact of traps both reversible and irreversible on the transport of hydrogen in these carbon-steel materials is paramount. As a result, hydrogen transport experiments have been conducted using a common pipeline material A106 Grade B. In an attempt to develop a more fundamental understanding of the impact of the varied microstructural features typical of a weld HAZ, weld simulation samples were prepared using a GLEEBLE thermal exposure system to produce weld HAZ samples simulating 0, 3, and 5 pass welds. Hydrogen transport testing was initiated using the 5-pass weld simulation sample. Characterization of the microstructures of this sample has shown that the 5-pass weld simulation microstructure is comprised of primary ferrite, acicular ferrite and small pearlite colonies (see Figure1).

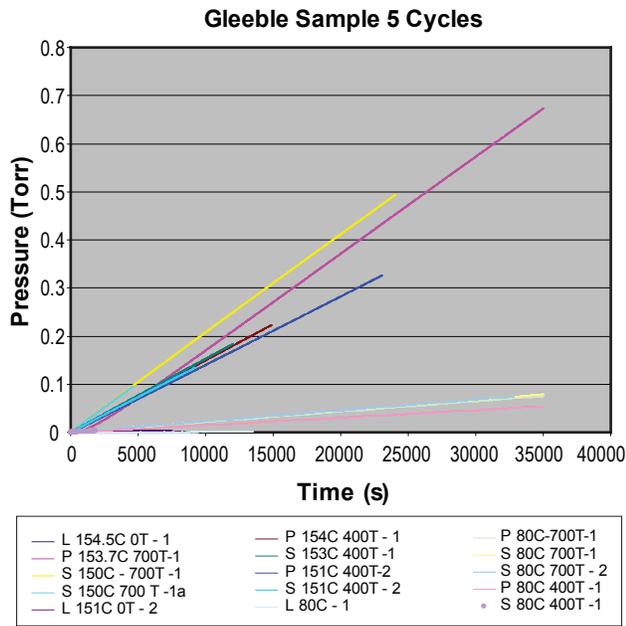
FIGURE 2. Typical Hydrogen Transport Results for 5-Pass Weld Simulation Sample

Hydrogen transport testing to determine the diffusivity of hydrogen in this 5-pass weld sample microstructure using the SRNL permeation test rig was performed at 400 Torr and 700 Torr and temperature of 80°C and 150°C. Typical results from this testing are provided in Figure 2.

Based on the data in Figure 2, the diffusivity ( $D$ ) was estimated by calculating the slope and the intercept of the linear region using a least squares method. These two variables were then used to determine the lag time ( $t_l$ ), i.e., the time at which the line crossed the y-axis at

zero. Lag time,  $t_l$ , was used in the equation:  $t_l = x^2/6D$  to determine  $D$ . From this approach, the diffusivity for hydrogen in the 5-pass weld microstructure was calculated to be in the range of  $1.25 \times 10^{-6} - 3.0 \times 10^{-7} \text{ cm}^2/\text{s}$ . This value for hydrogen diffusivity is comparable to previous measurement from SRNL on actual field welded A106 Grade B pipeline materials and also is in agreement with previously published lower temperature literature values. The results from this work in conjunction with previous literature results indicates that at the lower temperatures  $<200^\circ\text{C}$  the most dominate materials feature affecting hydrogen diffusivity may be surface phenomenon—oxides, surface finish, etc.—and microstructural trap sites. For the microstructural trap sites a reduction in microstructural scale and phase shape—i.e., acicular ferrite—in the HAZ region can potentially result in increased trapping of hydrogen and subsequently lower apparent diffusivities in comparison to the bulk baseline microstructure. However, the role/impact of surface features cannot be ignored and at lower temperatures may play a more significant role in retarding the ingress of hydrogen into the materials.

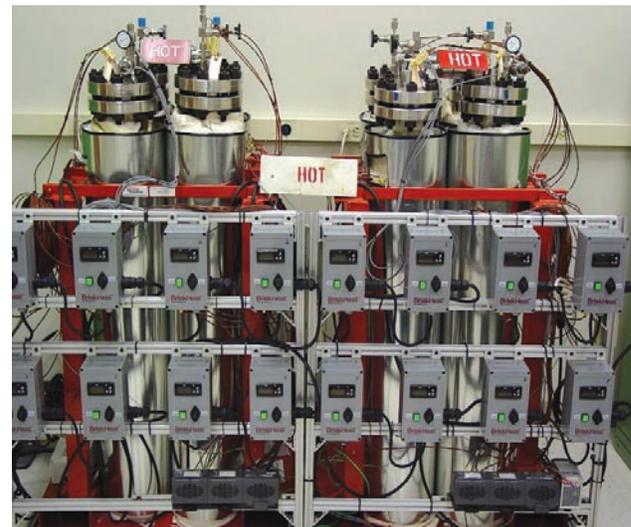
FIGURE 3. SRNL Large Chamber FRP Hydrogen Exposure Station

diameter (OD) FRP pipe and materials test samples—tensile dog-bones, compression rings, DMA test strips—have been exposed to 99.9995% hydrogen gas at nominally 140°F and 1,000 psig in the newly designed, fabricated, and installed SRNL FRP hydrogen exposure station (Figure 3).

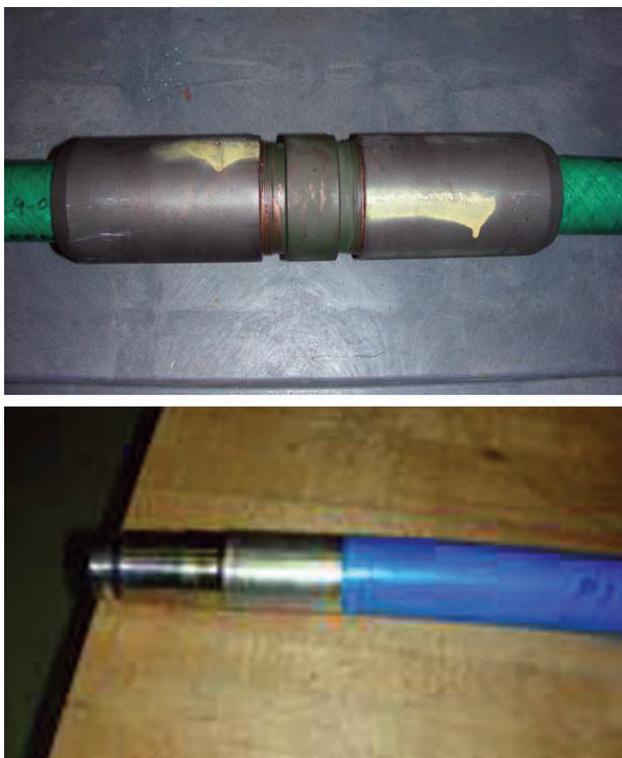
**FIGURE 4.** Typical Commercially Available FRP Joining and End-Fitting Components: (a) Fiberspar Joint Fitting and (b) Polyflow End-Fitting

In addition to the hydrogen exposure testing, leakage testing of commercially available FRP joint components has been initiated. Samples of 2.5” OD FRP piping with attached end fittings and joint fittings form two major FRP ping vendor Fiberspar and Polyflow have been procured (Figure 4). The Fiberspar technology makes use of an o-ring compression mechanical system to maintain seal integrity while the Polyflow uses a high pressure hydraulically crimped technology.

Leak testing for these typical joint/end-fitting components were conducted using two approaches. The first approach used conventional helium detection technology with a leak sensitivity of  $1 \times 10^{-9} \text{ cc/sec}$ . Results from the helium leak rate determination for the Fiberspar o-ring compression system and the Polyflow hydraulically crimped system are as follows: 1) Fiberspar,  $>1 \times 10^{-4} \text{ stdcc/sec}$  at 1atm and room temperature and 2) Polyflow,  $>1 \times 10^{-5} \text{ stdcc/sec}$  at 1 atm and room temperature. Evaluation of these He leak rate values was higher than expected, however, from previous research effort it was known that He leakage rates can be higher than actual hydrogen leak rates due to the
