III.1 Hydrogen Embrittlement of Structural Steels

Jay Keller (Primary Contact), Brian Somerday,
Chris San Marchi

Sandia National Laboratories
P.O. Box 969
Livermore, CA 94550
Phone: (925) 294-3316
E-mail: jokelle@sandia.gov

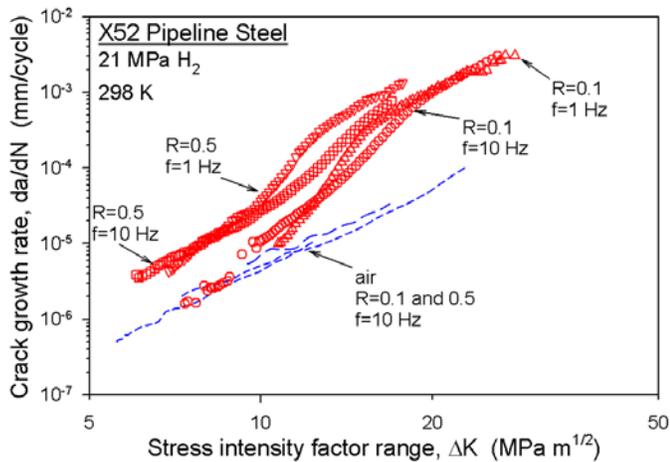
FIGURE 1. Fatigue crack growth rate (da/dN) vs. stress-intensity factor range (ΔK) plots for X52 steel base metal in hydrogen gas and air.

The hydrogen-affected fatigue crack growth relationship (da/dN vs. ΔK) for the structural steel is the basic element in pipeline reliability/integrity models. The ASME B31.12 code requires measurement of the fatigue crack growth relationship for pipeline steels at the hydrogen gas operating pressure. Initial measurements of the fatigue crack growth relationship for X52 steel base metal were conducted in 21 MPa hydrogen gas (the upper limit specified for hydrogen pipelines in the ASME B31.12 code) at a load-cycle frequency of 1 Hz (Figure 1). This load-cycle frequency was selected to balance test effectiveness and test efficiency, since fatigue crack growth rates can be enhanced at lower test frequency but the test duration can become prohibitively protracted. Even at this relatively high load-cycle frequency, measurement of the fatigue crack growth relationship over the relevant range of ΔK could require several days. For example, the duration of the test conducted at a load ratio of 0.5 was 6 days. (Load ratio, R , is the ratio of minimum applied load to maximum applied load.)

Although the accepted trend is that increasing load-cycle frequency leads to lower (i.e., non-conservative) fatigue crack growth rates in hydrogen gas, this trend is predominantly based on fatigue crack growth rates measured for steels at relatively high ΔK , e.g., greater than 15 MPa $m^{1/2}$. The possibility of effectively measuring fatigue crack growth rates at high load-cycle frequency in the lower (and technologically relevant) range of ΔK was explored for the X52 steel in 21 MPa hydrogen gas. Fatigue crack growth rate relationships were measured at 10 Hz for two R ratios (0.1 and 0.5), and the results are compared to the fatigue crack growth relationships measured at 1 Hz in Figure 1. Although the fatigue crack growth relationships at 1 Hz and 10 Hz are not exactly coincident, there are only moderate differences in the fatigue crack growth rates over the ΔK range investigated. These preliminary results suggest that reliable fatigue crack growth relationships may be measured at high load-cycle frequency, which would allow the testing to be conducted more efficiently.

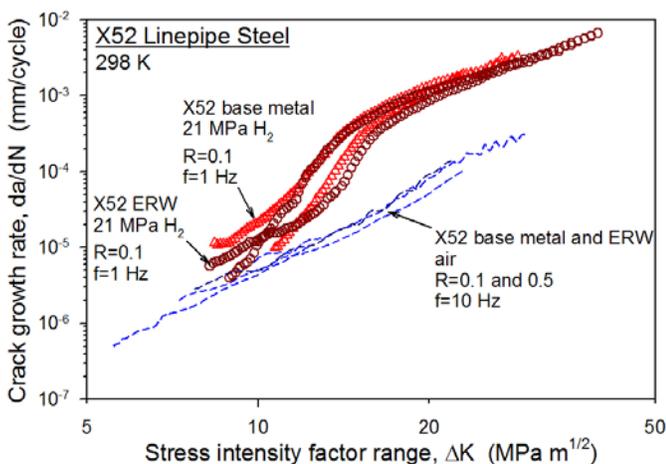
FIGURE 2. Fatigue crack growth rate (da/dN) vs. stress-intensity factor range (ΔK) plots for X52 steel base metal and ERW seam in hydrogen gas and air. Unstable cleavage fracture was observed for the ERW tested in air at $K_{max} > 40 \text{ MPa m}^{1/2}$.

The fatigue crack growth relationship for the X52 ERW was also measured in 21 MPa hydrogen gas. Since steel microstructures in welds are not easily controlled, these weld microstructures can be inhomogeneous. Consequently, it is important to conduct replicate fatigue crack growth tests on welds to characterize potential variability in the data. Figure 2 shows the fatigue crack growth relationships measured for the X52 ERW from replicate tests. These tests were conducted at $R=0.1$ and 1 Hz so that the results could be directly compared to those for the X52 base metal. The following details are notable in Figure 2: 1) the da/dN vs. ΔK relationships for the X52 ERW exhibit significant variability,

2) the da/dN vs. ΔK relationships for the X52 base metal also exhibit variability, and 3) despite the variability in the da/dN vs. ΔK relationships, it is apparent that the fatigue crack growth rates are similar for the base metal and the weld in hydrogen gas.

While microstructure is one salient variable that can contribute to variability in the da/dN vs. ΔK relationships for X52, other variables must be considered as well. For example, the hydrogen test gas was sampled at the conclusion of both tests conducted on the X52 ERW. The leak rates from the pressure vessel were unusually high, and such an abnormal operating condition prompted sampling of the test gas. The hydrogen test gas contained relatively high concentrations of oxygen (>10 vppm) for both tests. Since oxygen is known to inhibit hydrogen uptake into steels, it is

possible that the high levels of oxygen in the test gas affected the results. Additional tests are in progress on the ERW material to clarify whether variability in the da/dN vs. ΔK relationships can be attributed to oxygen in the test gas.

A fatigue crack growth test was also conducted on the X52 ERW in air. Such data serves as a baseline for comparison to measurements on the ERW in hydrogen gas as well as for comparison to measurements on the base metal in air. Test conditions for the ERW in air included $R=0.5$ and a load-cycle frequency of 10 Hz. Figure 2 shows that the da/dN vs. ΔK relationship for the ERW measured in air is similar to the relationship measured for the base metal in air. However, the test on the ERW was unexpectedly terminated at $K_{max} \sim 40 \text{ MPa m}^{1/2}$ by unstable crack extension associated with cleavage fracture. This result suggests that some region of the ERW microstructure has extremely low fracture toughness. The consequence of this inherently low fracture resistance on hydrogen-assisted subcritical cracking must be explored.
