III.5 Hydrogen Embrittlement of Structural Steels

Brian Somerday
Sandia National Laboratories
P.O. Box 969
Livermore, CA 94550
Phone: (925) 294-3141
Email: bpsomer@sandia.gov

Fiscal Year (FY) 2013 Objectives

Establish reliable fatigue crack growth (da/dN vs ΔK) relationships for the fusion zone and heat-affected zone in X65 girth weld supplied by industry partner

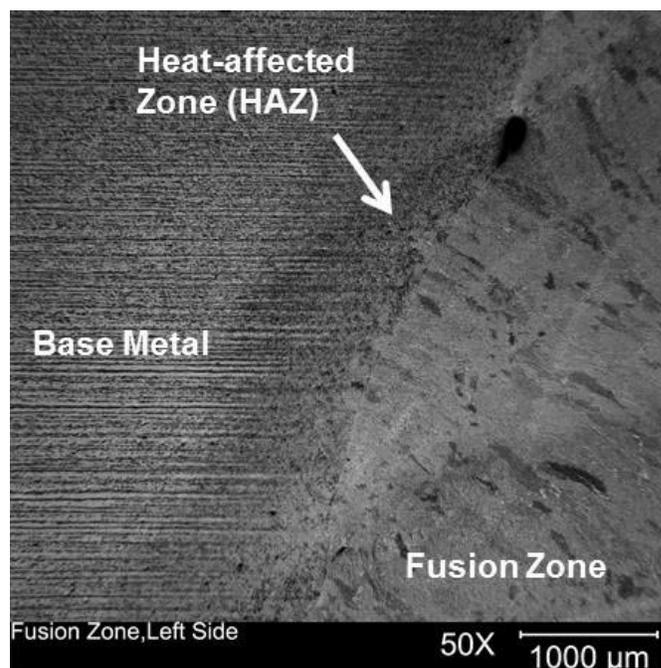
FIGURE 1. Optical-microscope image showing base metal, fusion zone, and HAZ of X65 weld.

weld was provided by an industry partner. The emphasis in FY 2013 was to complete multiple measurements of the da/dN vs ΔK relationship for the weld fusion zone and heat-affected zone in 3,000 psi (21 MPa) hydrogen gas. An optical-microscope image revealing the base metal, weld fusion zone, and the HAZ is shown in Figure 1. This image demonstrates that the material regions have distinctly different metallurgical structures, particularly the base metal and fusion zone.

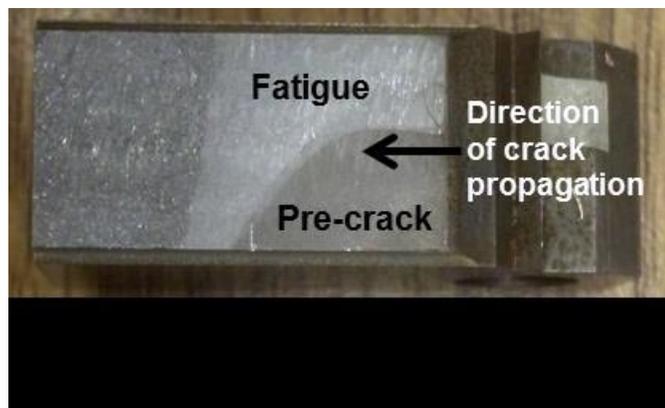
FIGURE 2. Optical-microscope image of fracture surface from compact tension specimen of X65 fusion zone showing a non-uniform pre-crack front (darker region, bottom right).

Preliminary da/dN vs ΔK data for the X65 fusion zone and the HAZ revealed unexpectedly lower crack growth rates compared to X52 base metal in hydrogen gas at low ΔK values. Welds are expected to be more sensitive to hydrogen-assisted crack growth. Further analysis of the X65 weld fusion zone and the HAZ samples revealed that the pre-cracks deviated from their anticipated path, as shown for the fusion zone sample in Figure 2. The crack did not span the entire thickness of the specimen, instead exhibiting a non-uniform crack front, thus rendering the measured data unreliable. To mitigate the deviation of the crack front during pre-cracking, X65 fusion zone and HAZ compact tension samples were thinned from their original 13 mm (0.5 in) to 6 mm (0.25 in). Previous work has shown that thinner samples consistently exhibit more uniform crack fronts during pre-cracking while the change in sample geometry still conforms to ASTM E647 standard. In order to improve confidence in attaining a uniform crack front, side grooves were not machined and the specimen sides were polished to allow for observation of pre-cracks before initiating fatigue crack growth testing in hydrogen gas. The X65 HAZ specimen was observed to have uniform pre-crack fronts whereas the X65 fusion zone had non-uniform pre-crack fronts, e.g. significant crack growth on one side and negligible on the other.

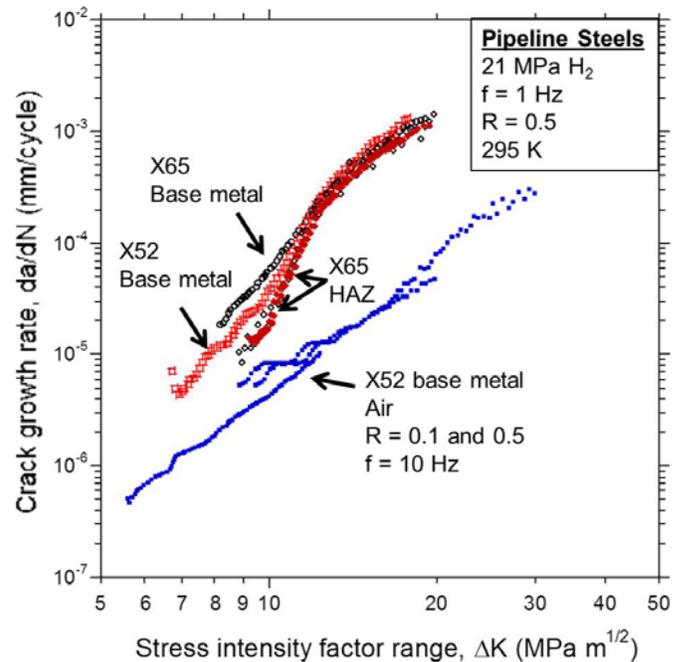
FIGURE 3. Fatigue crack growth relationships (da/dN vs ΔK) for X65 base metal and HAZ in 3,000 psi (21 MPa) hydrogen gas. The results are compared to measurements for X52 base metal in hydrogen gas and X52 base metal in air.

The results from the X65 HAZ thinned specimen are shown in Figure 3 in comparison with X52 and X65 base metals. The data for the thinned specimen essentially overlay the original X65 HAZ data, both in 21 MPa H_2 gas. Both sets of data exhibit slightly lower crack growth rates at low ΔK values compared to the base metals, but all materials show similar trends at high ΔK values. The specimens were fractured after test completion and a side-by-side comparison of the two X65 HAZ specimens is shown in Figure 4. The optical images show that the thinned specimen exhibited a more uniform crack front during the pre-crack stage;

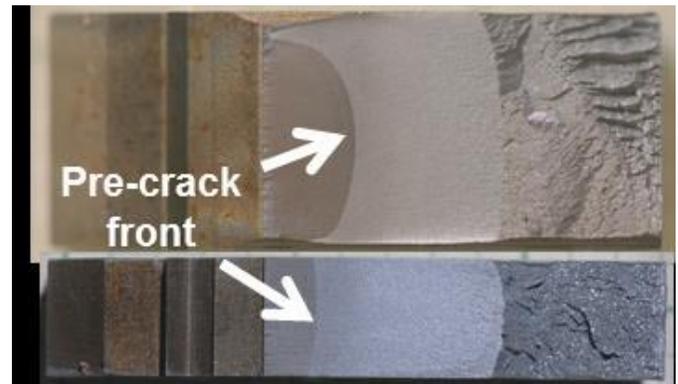
FIGURE 4. Optical-microscope images of fracture surfaces from compact tension specimens of X65 HAZ specimens comparing pre-crack fronts. The top specimen was the original geometry and the bottom was thinned to 6 mm (0.25 in).

however, both exhibited similar uniformity during fatigue crack growth in hydrogen.
