Accelerating Acceptance of Fuel Cell Backup Power Systems

Donald F. Rohr
May 16, 2012
H2RA007

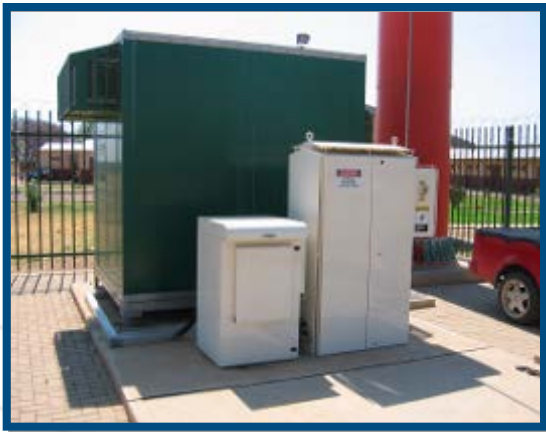
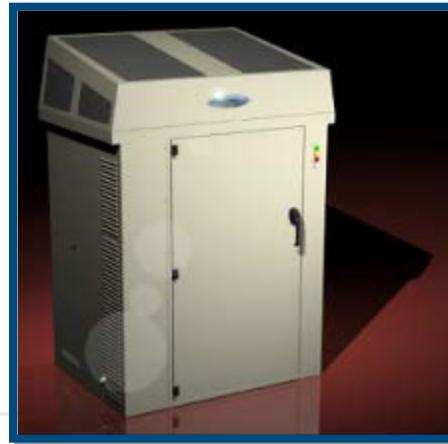
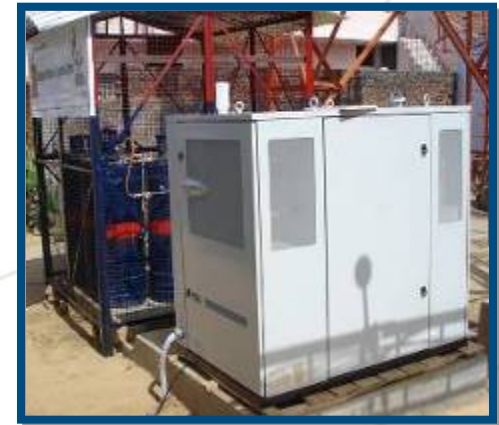
GenCore®

Backup Power

- Hydrogen fueled
- Start time < 1 minute
- Run time = 4 hours

GenSys™

Extended Backup Power

- LPG fueled
- Readily available backup
- Run time = indefinite

Continuous Power

- LPG fueled
- Start time = 3 hours
- Run time = indefinite

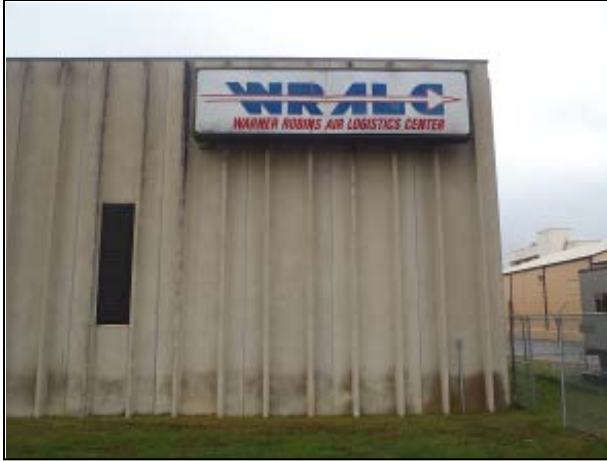
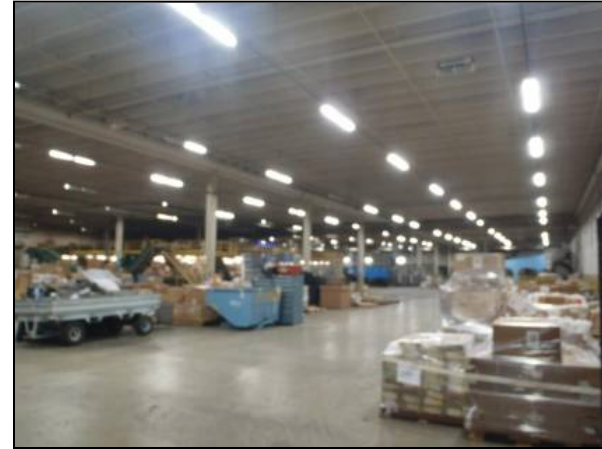
Task 2: RAFB Site Application

- The team visited the Defense Distribution Depot - Robins AFB (DDWG), Georgia for detailed site analysis for installation of Fleet 1
- Ten GenSys LT systems will back up the lighting at the Air Logistics Center

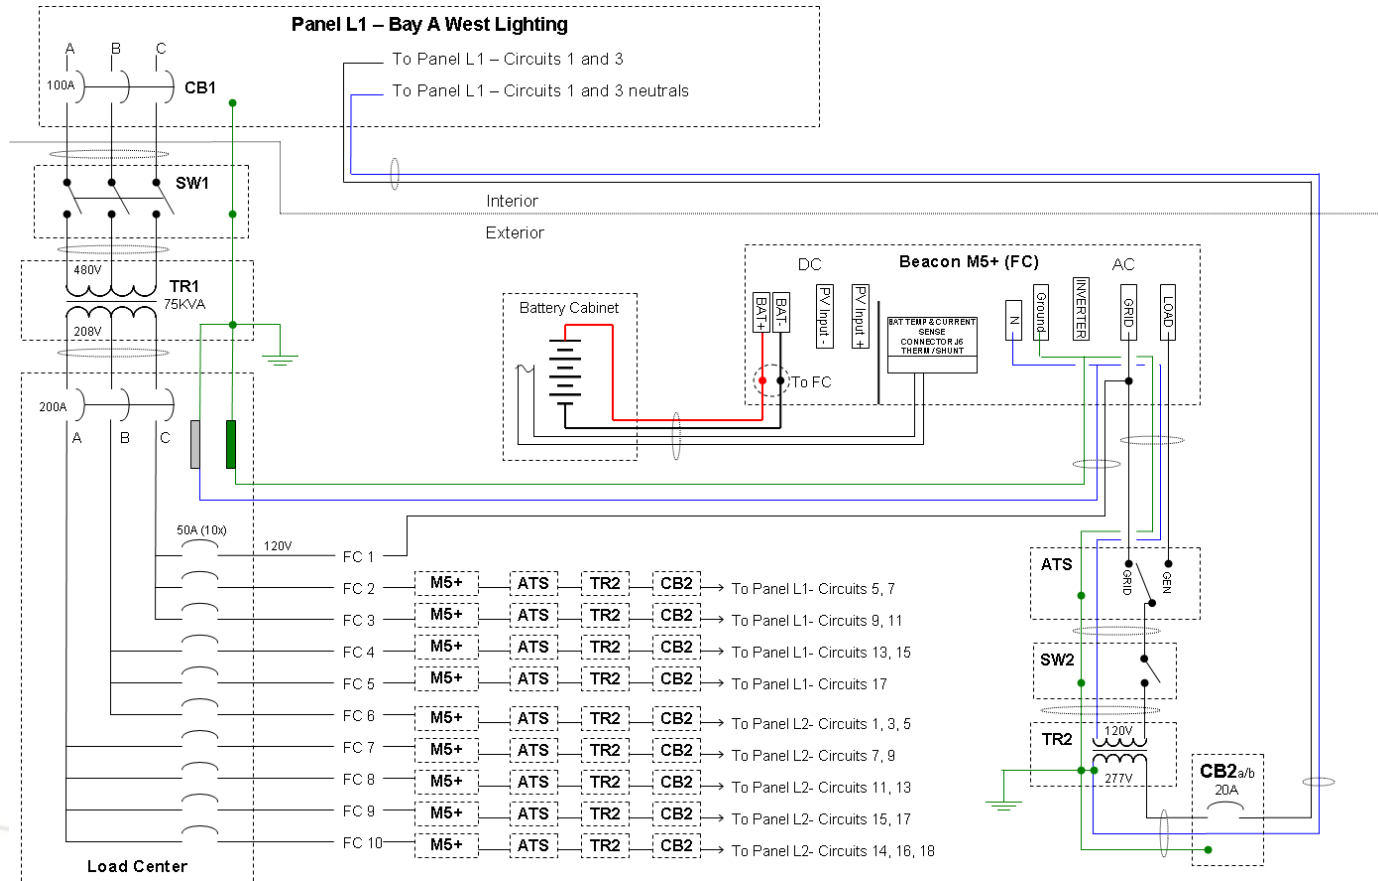
Task 3: RAFB Backup Power Grid

Systems provide backup to multiple load circuits

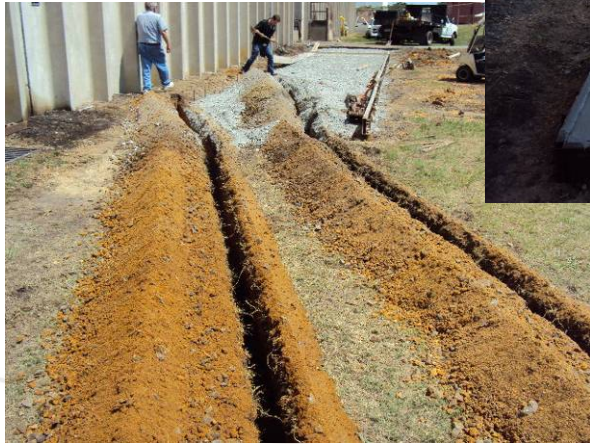
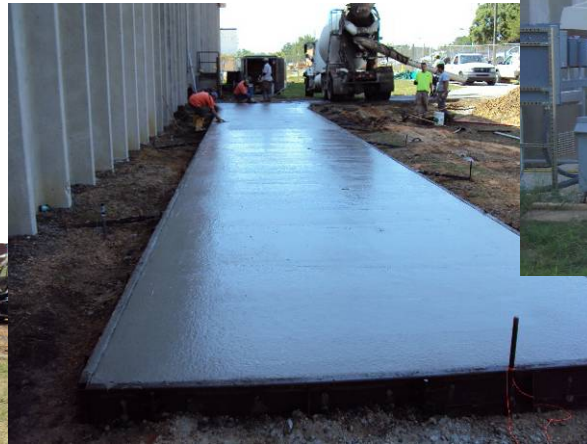
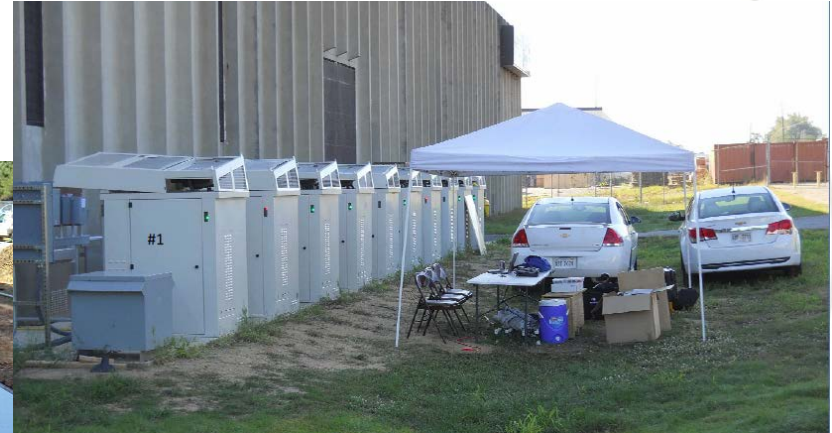
Task 4: RAFB Installation

Site prepared and systems installed

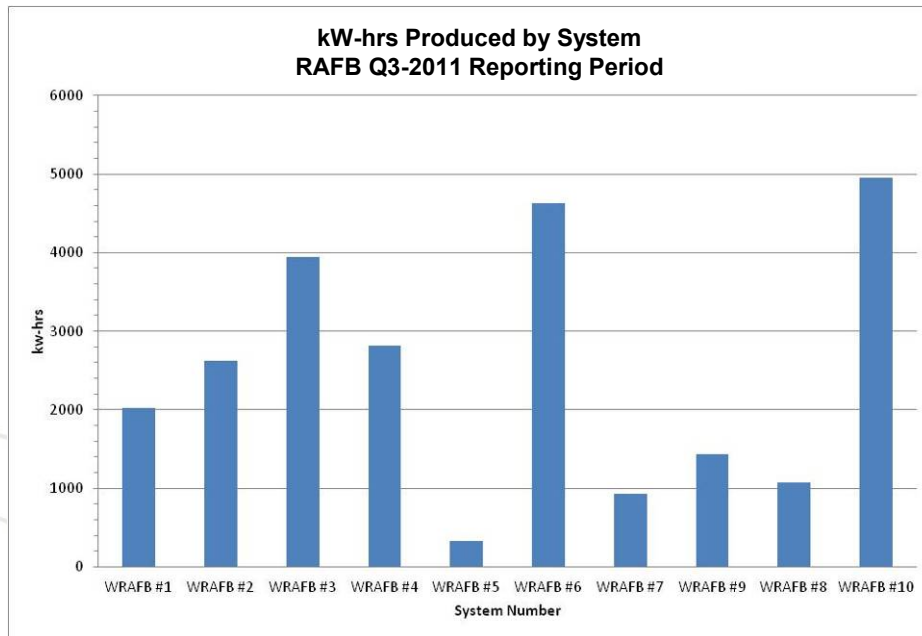
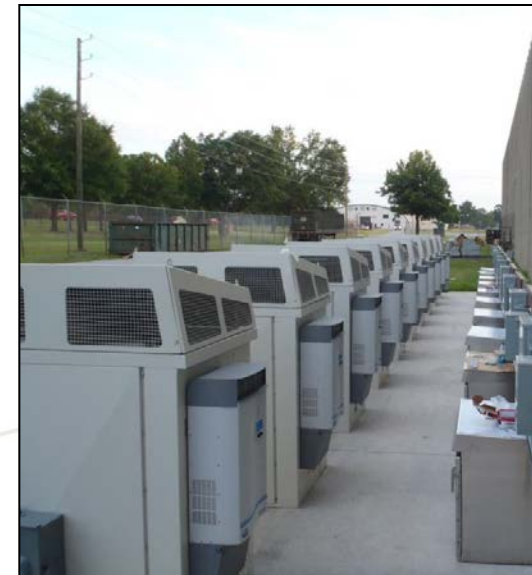
Robins AFB Fleet Metrics

Systems were being brought online in 2011Q3

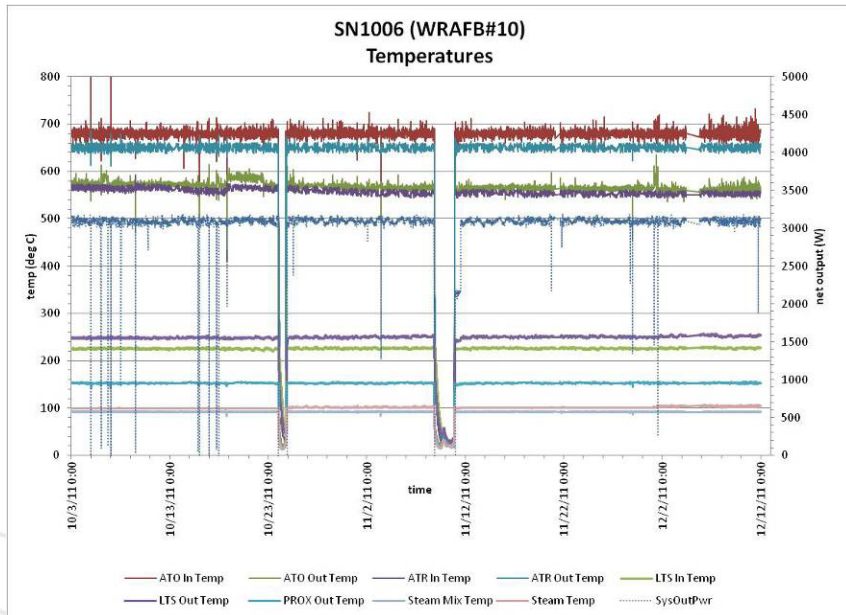
Task 5: RAFB Trended Data

- System variables tracked
- Trouble-shooting can be accomplished through remote login
- If degradation occurs, leading indicators can be determined

More consistent operation in 2011Q4

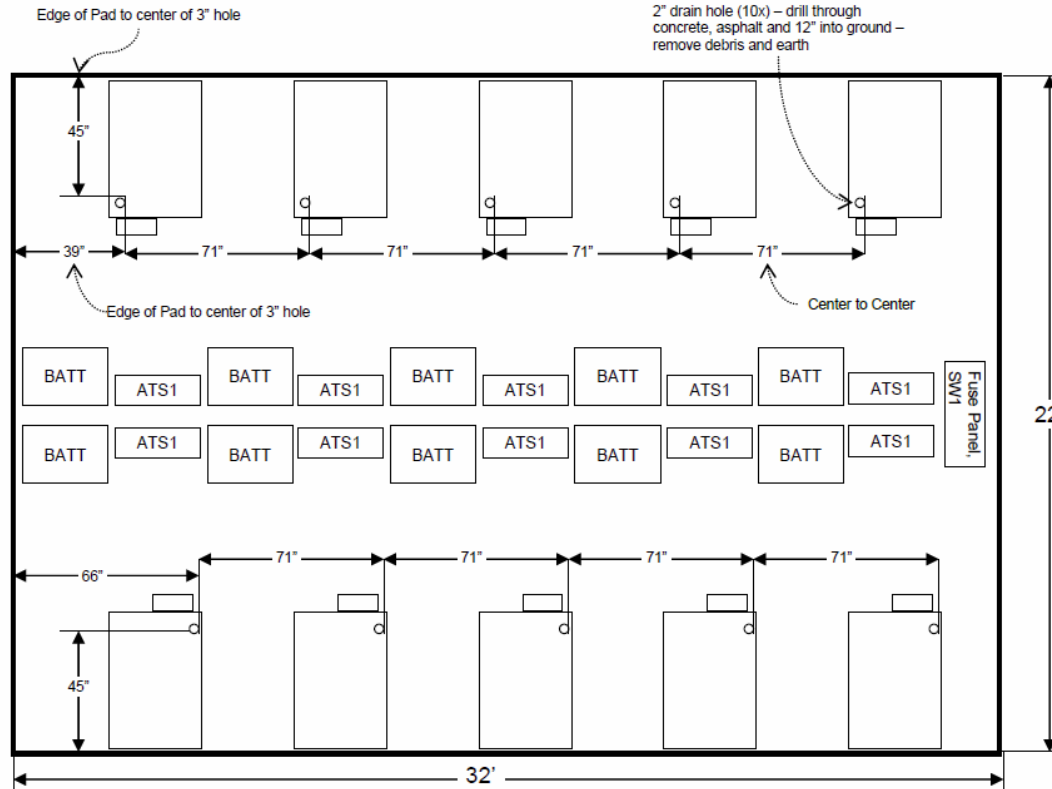
Task 3: Ft Irwin Pad Layout

Similar application to RAFB, more aggressive environment
